# Toorumbree Creek to Belgrave Falls Reach Plan

## River Assessment and Management Plan

**December 2014**

Final report prepared by NSW DPI – Fisheries NSW, a part of the Department of Trade and Investment, Regional Infrastructure and Services for NSW North Coast Local Land Services.

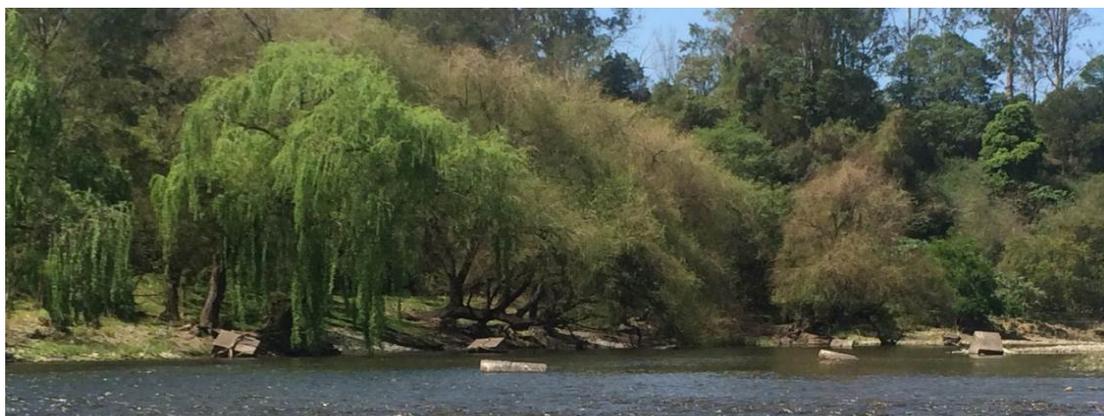
*Figure 10: Willows present on the riverbank.*

A wide variety of exotic plant species, including Willows (Figure 10) were identified throughout the study area as a result of the habitat mapping. Table 4 lists the main species of exotic plants identified and their declaration status for the Kempsey Shire Local Government Area and/or Weed of National Significance.

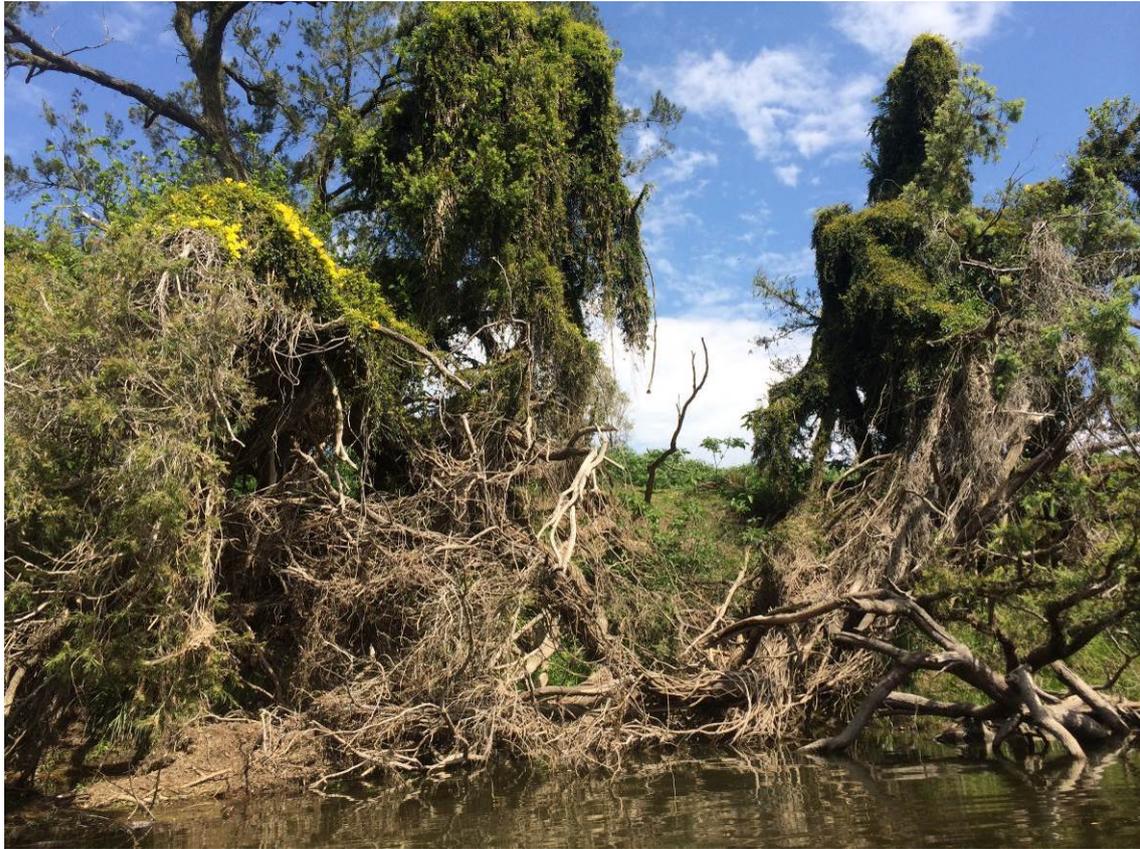
Figure 11: Cat's Claw Creeper smothering native riparian vegetation along the Macleay River.

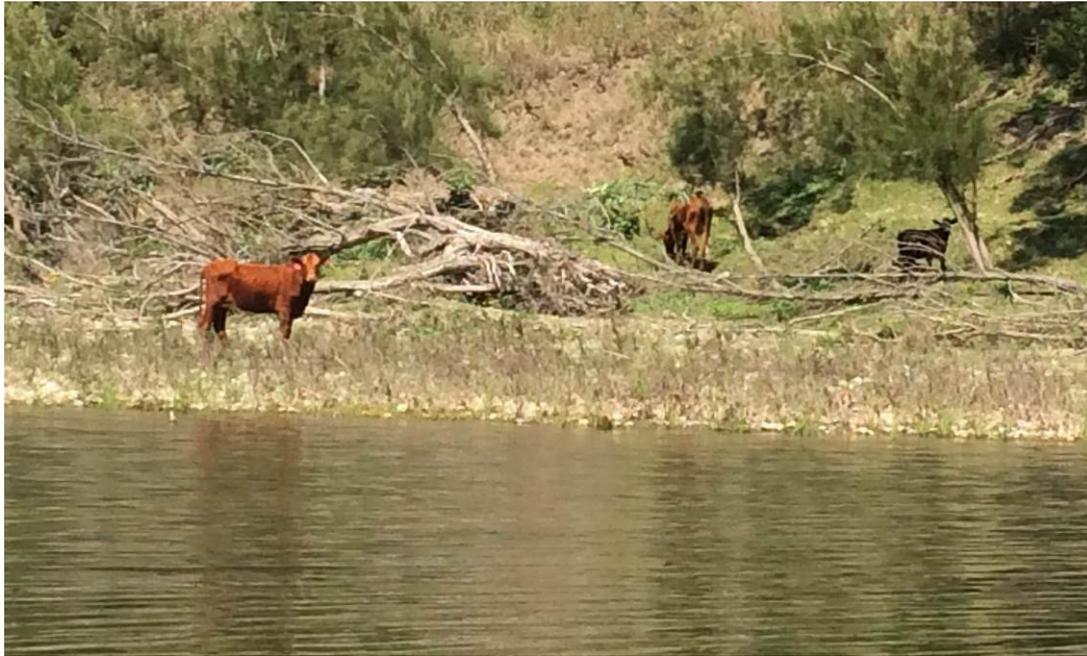
Figure 19: Stock in the study area.

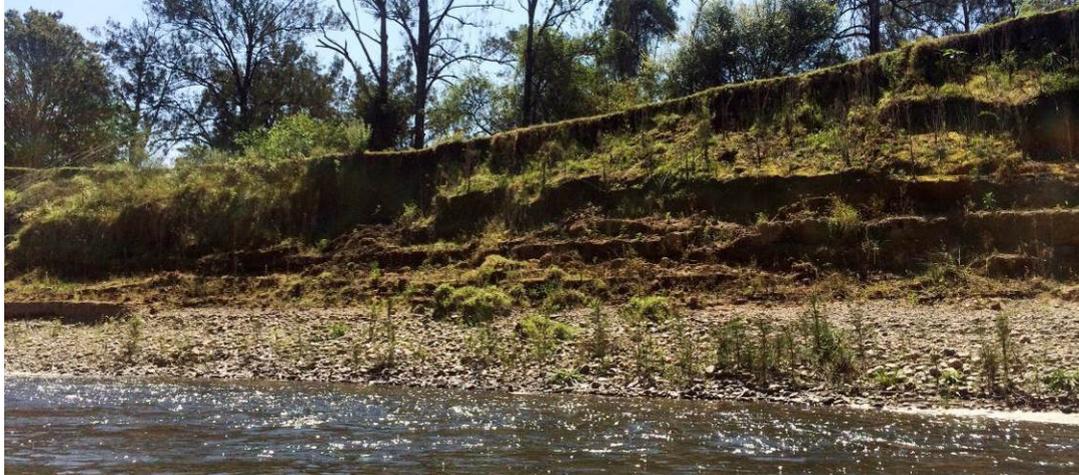
Figure 21: Bank scour and slumping erosion with stock access tracks also present.

In some areas, significant scouring and block failure was identified on the outside of large bends (see Figures 21 and 23). The likely causes for this type of erosion may be a combination of land clearing and changes in river morphology as a result of natural channel migration and/or induced channel migration due to changes in flow dynamics caused by artificial bed controls or flow training.

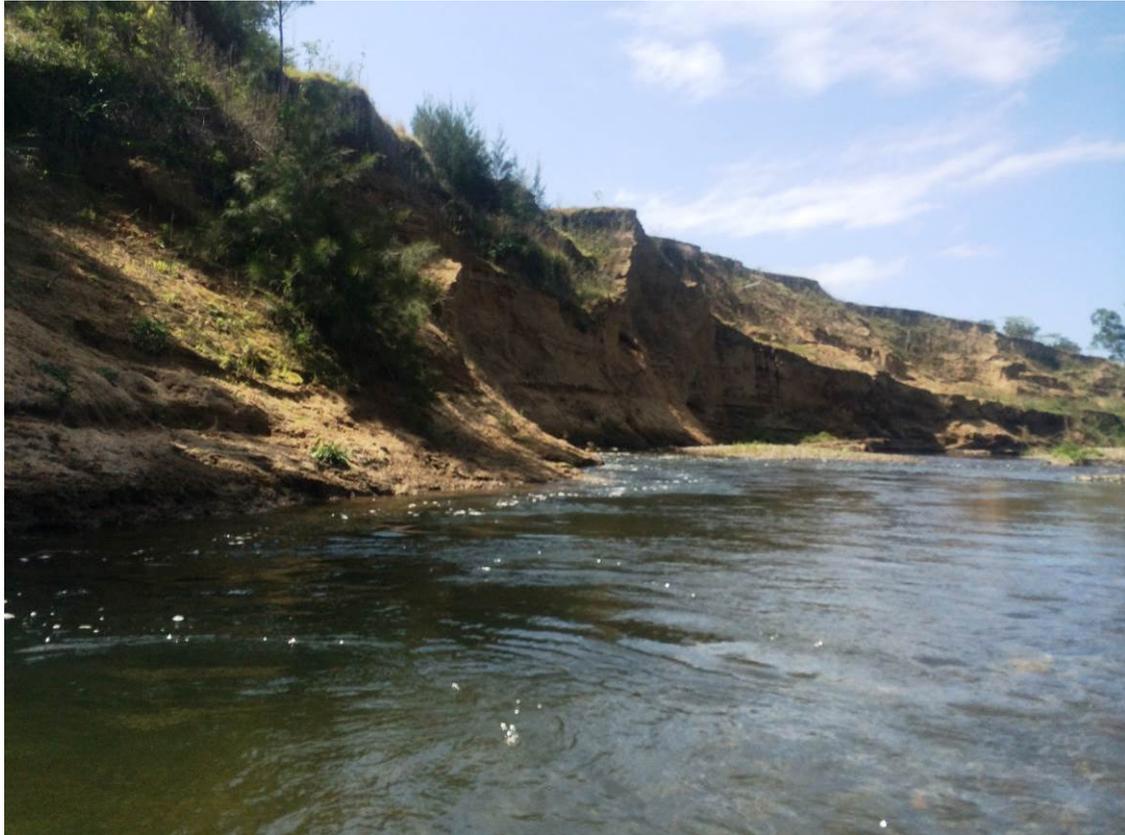
Figure 23: Erosion (slumping) on an outside bend.

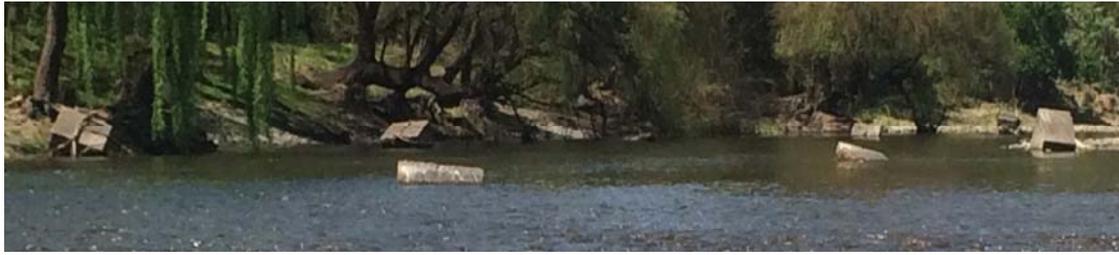
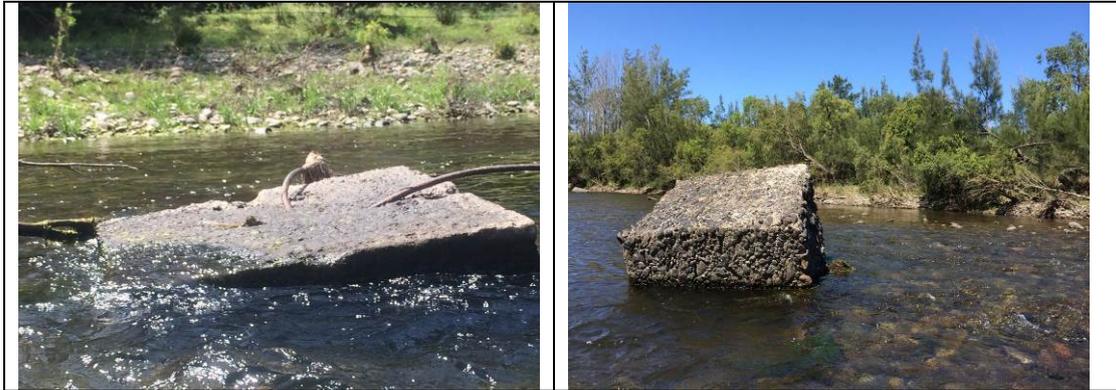
Figure 24 a: Concrete blocks mid-stream, an historic erosion control activity.

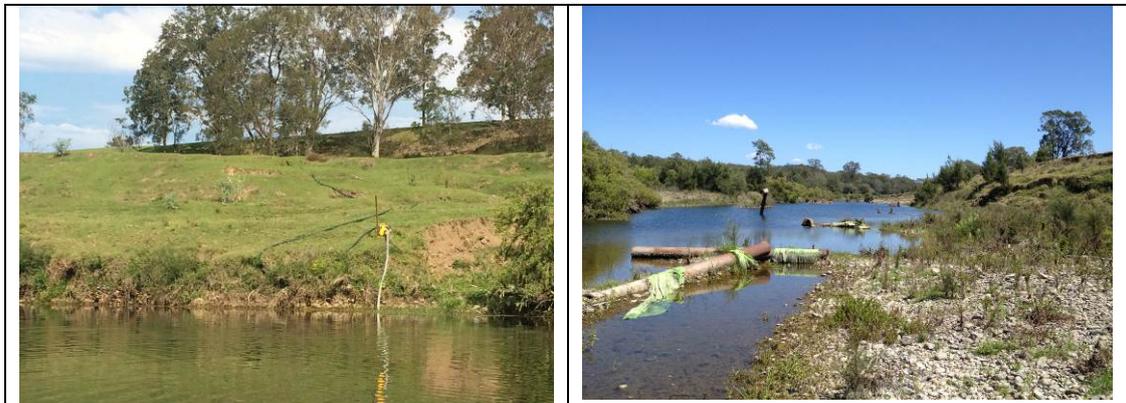
In addition, in Reach 9 at Belgrave Falls defunct large volume pipes and equipment were observed, which were the flood-damaged remains of the South Kempsey water main (Figure 25b). A new mains pipe has since been drilled to pass under the bed of the Macleay (Ron Kemsley, pers. comm.)

Figure 25: (a) Small domestic pump, (b) remnants of old water main pipe at Belgrave Falls.

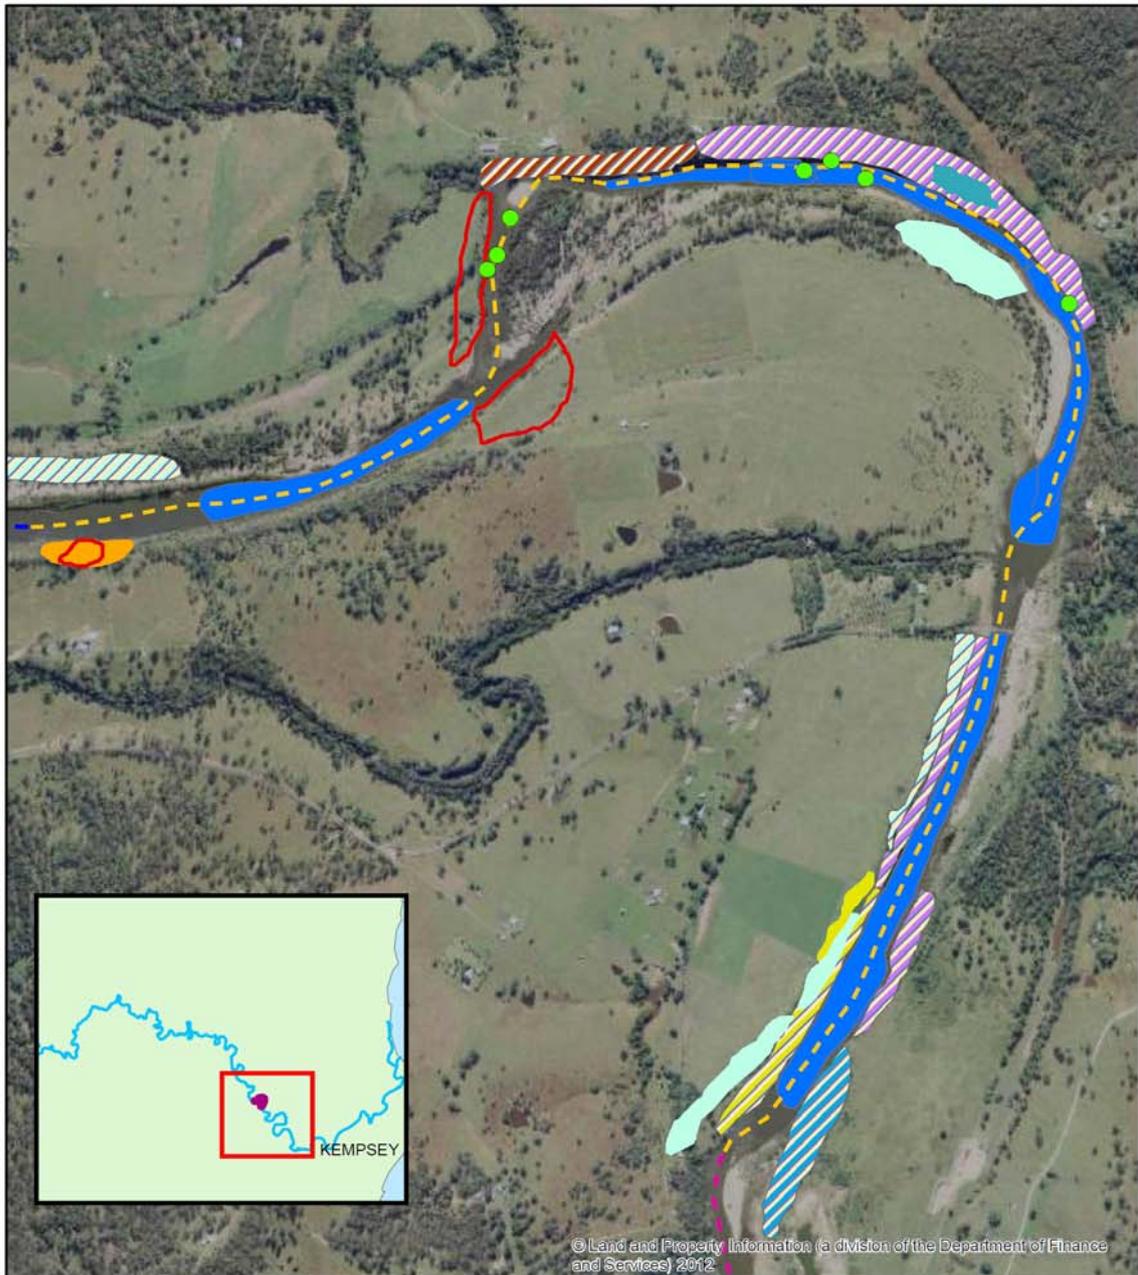
Figure 29: Recommendations for Priority Reach 3

Figure 29 identifies areas of "highest priority" for grazing management, these relate to areas that had visible stock damage present. The remainder of the reach would also benefit from discussions regarding riparian grazing management strategies with relevant landholders.

The following recommendations are made for Priority Reach 3:
