LOCOMOTIVE 3801 PROJECT

CRAIG MACKEY, 3801 PROJECT MANAGER

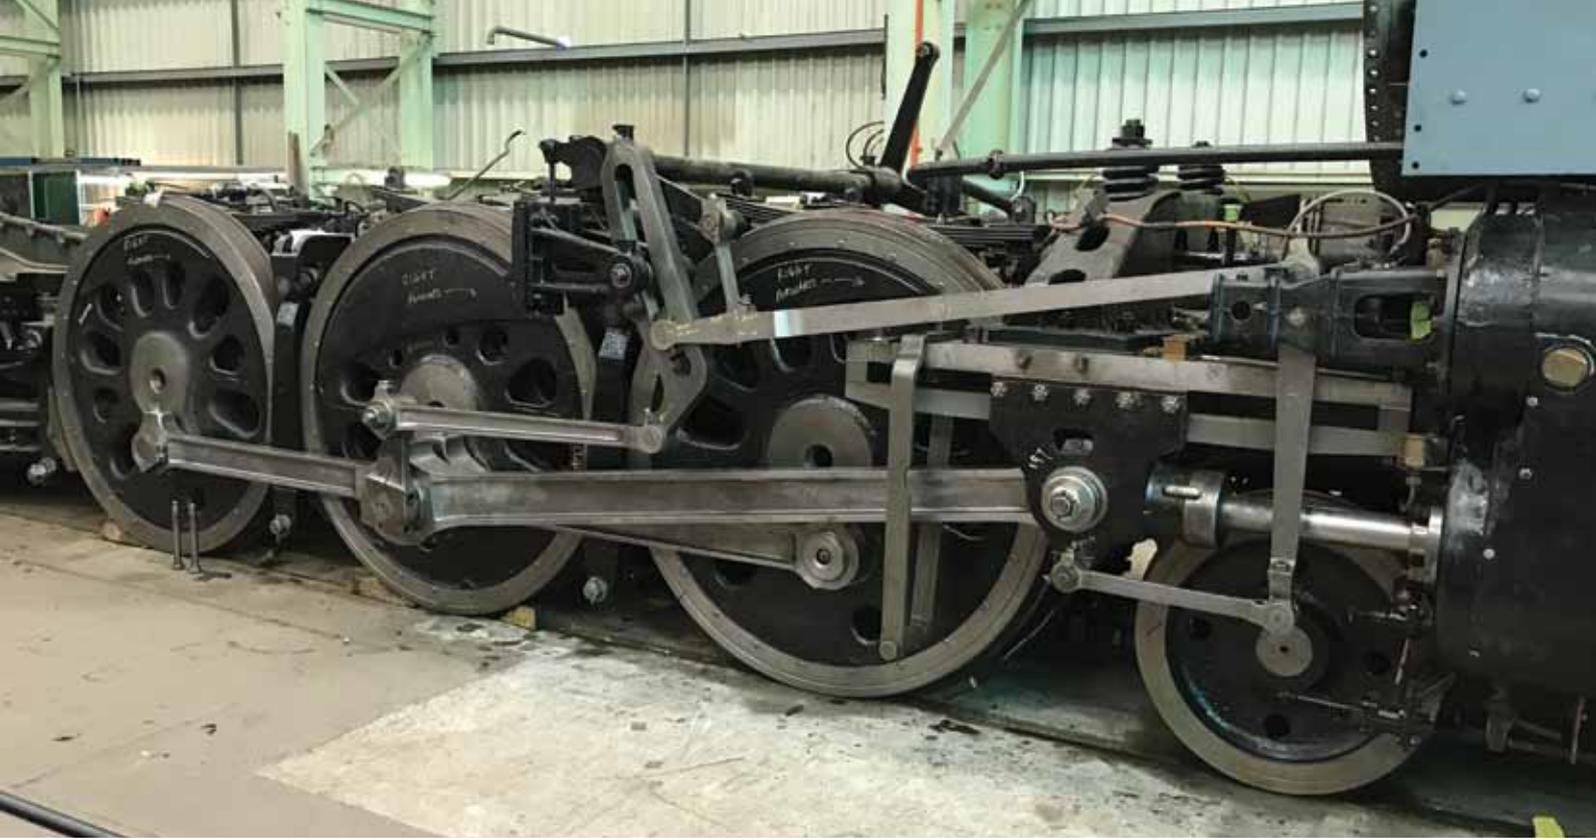
Test assembly of coupling, connecting and valve gear rods shown on the Fireman's side of 3801. With the rods assembled on both sides of the engine, it rolls silently and smoothly – a good indication that all the work to refurbish the running gear has been successful.

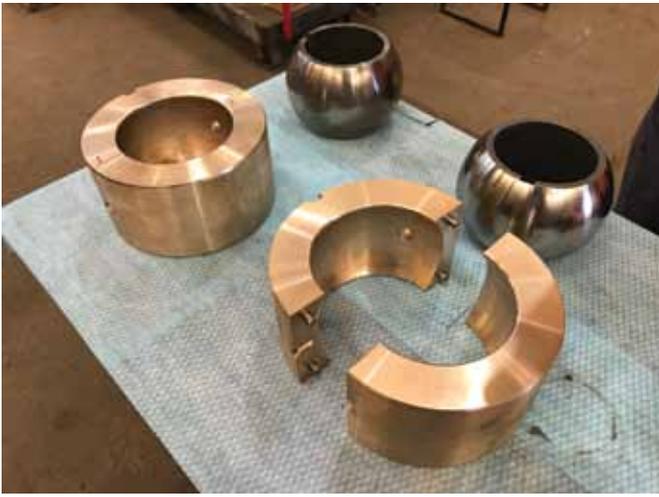
The connecting rods are a special case since the little ends are fitted with a ball and split bush arrangement – the final assembly being pressed into the rod eye. We arranged for the eyes to be ground to identical size to simplify manufacture of the split bushes.

The balls and split bronze bushes that are pressed into the little end eyes of the connecting rods.

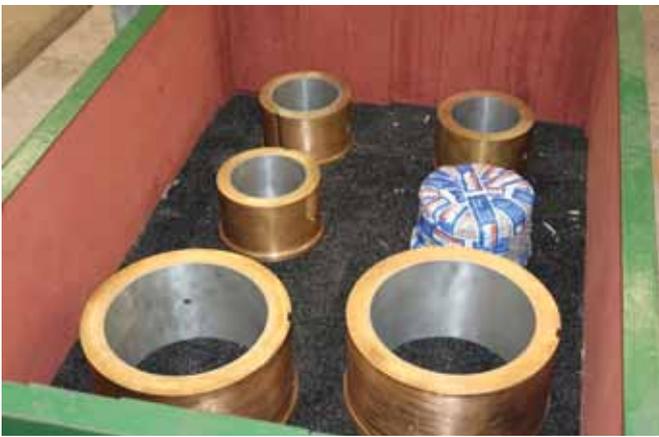
The new coupling rod bushes after delivery from Weir Minerals with new white metal lining.

New bronze bushes for the coupling rods and rotating bushes for the connecting rods were machined at Chullora by the team and these were sent to Weir Minerals for application of the white metal lining. Weir returned the bushes finish bored to size ready to be shrink fitted into the rods. Oil-ways were cut into the linings afterwards at Chullora.

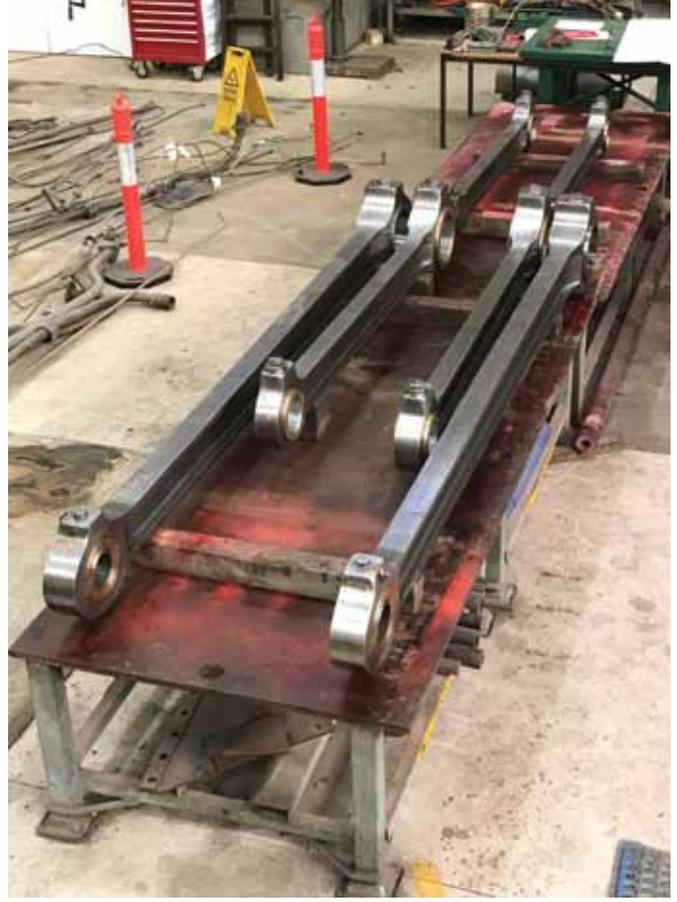
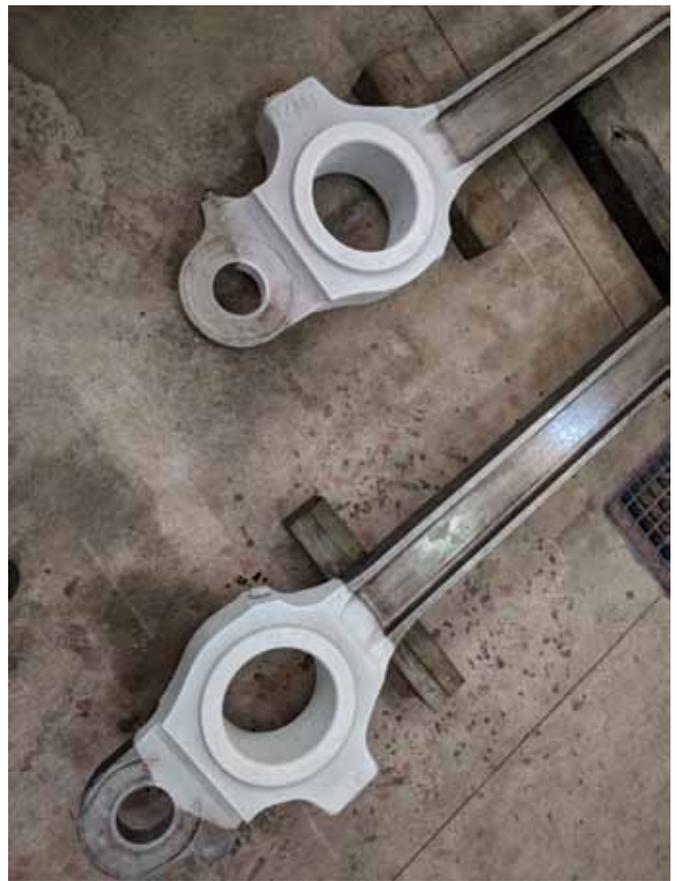
Above and left: One of the large 11½ inch bushes and key shown with a lifting appliance ready for shrink fitting with liquid nitrogen. If everything goes well, the bush simply drops into the bore and warms to room temperature and expands back to normal size. A graphic illustration of the cooling effect of the liquid nitrogen showing the extent to which the body of the rods are cooled and form frost from the moisture in the air.

With all the components on hand, the bushes (and fitted keys) were frozen with liquid nitrogen and shrink fitted into the rod eyes. The final step is fitting the bush retaining set-screw (but ensure it does not bottom out on the bush and indent the white metal).

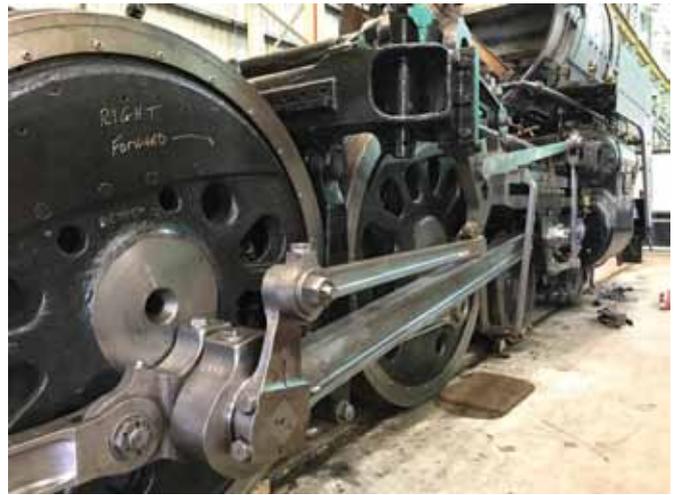
The completed assembly of running gear on the Fireman's side of 3801.

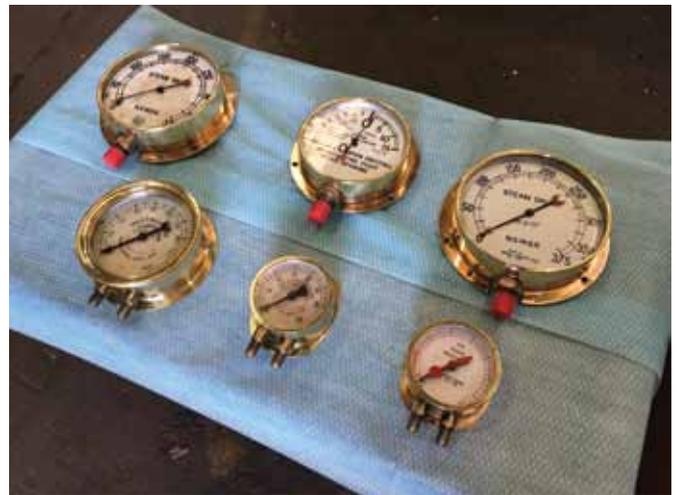
Not all the work on 3801 is big heavy engineering/fitting type work. The steam and air-brake gauges in the cab need the attention of an instrument fitter and the work involved is not unlike that of a clock-maker. These gauges had been calibrated way back in 2010 in preparation for the German boiler, but are now long out of date. Now that we have an instrument maker on our volunteer team, we've taken the opportunity to strip apart, clean and do some minor repairs to the gauges, then give them a long overdue external polish. The old red lines that were on the 215 lb. mark have been removed and the 245 lb. has been marked as the working pressure. We do have a dead-weight tester at Chullora so that we can perform our own calibration check, but we are required to send the gauges to an accredited repairer for checking and issuing a calibration certificate – this will take place within days.

The steam pressure and air-brake gauges of 3801 underwent refurbishment on our instrument maker's workbench. The final result, cleaned and polished, ready for calibration.

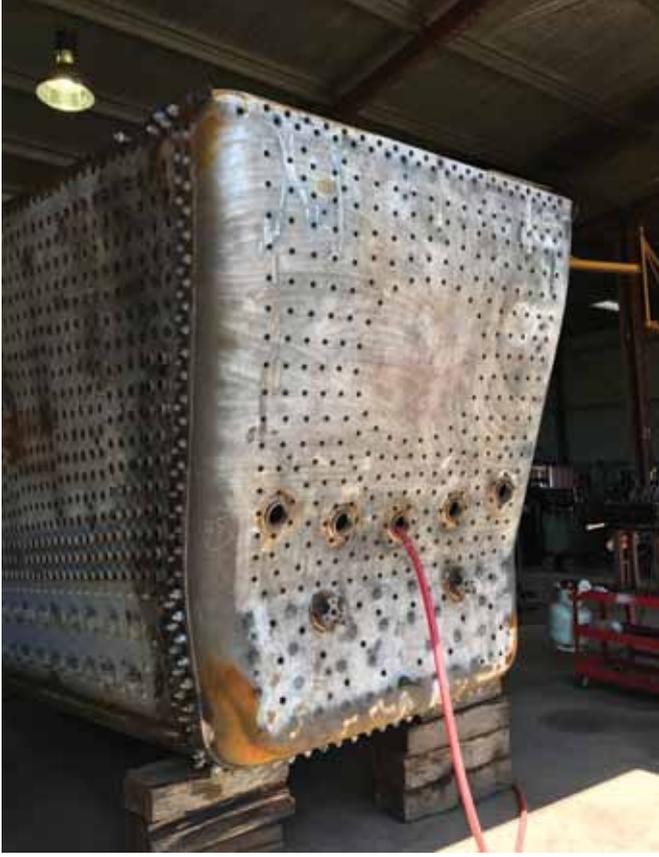
The flanged plate for the outer casing backhead has been fitted to the boiler casing and foundation ring. The marking out for stay holes has been completed and the holes pilot drilled. The doubling plate at the top vertical section has been riveted on and seatings for the water gauge glasses attached. Bushes for the five washout plugs have been welded in place and tapped. The plate has been finally riveted to the shell and is complete except for the firehole. With the backhead complete, the foundation ring could be removed and used as a construction jig for the inner firebox.

The outer backhead plate completed and riveted into the casing.

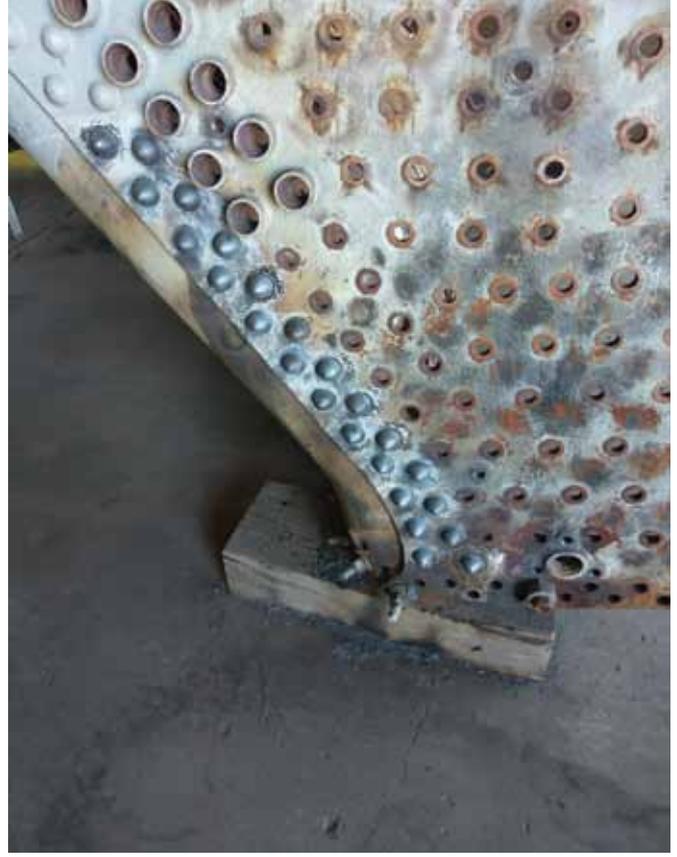
We became aware that a number of rivets on the side seams at the throat plate were dubious and these have been cut out and replaced (24 on each side).

Side seam rivets replaced on both sides of the firebox casing.

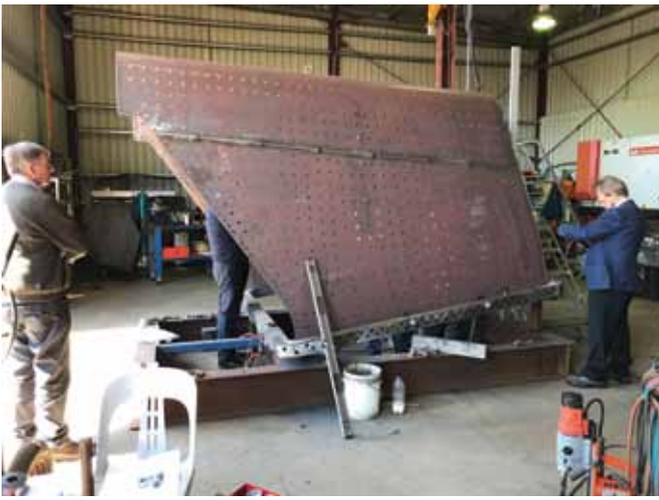
The new inner firebox wrapper has been assembled. This was formed from three profile cut plates. A fair amount of time was expended to prepare drawings of the plates with all the stay holes explicitly dimensioned so that if we replace another 38 class firebox, there will be a significant labour saving against manually marking out the stay pattern. The original railway drawings show the layout of the stays and imply the methodology of the laying-out, but require the boilermaker to pitch out the stay pattern manually on the plates. Having the plates in three sections, provided a margin of adjustment in case there were any discrepancies between the actual boiler and the drawings (there were a few).

Stages in the erection of the inner firebox, showing the wrapper plate fitted to the foundation ring and the inner backhead plate in position.

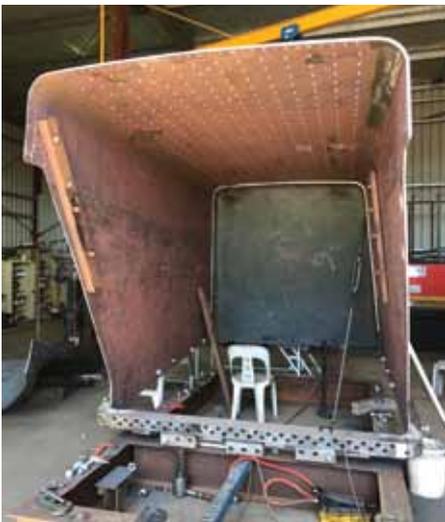
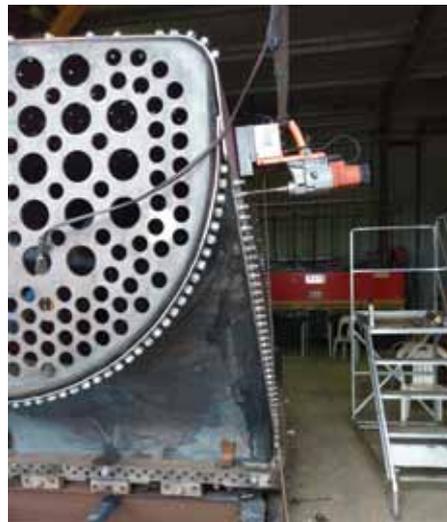
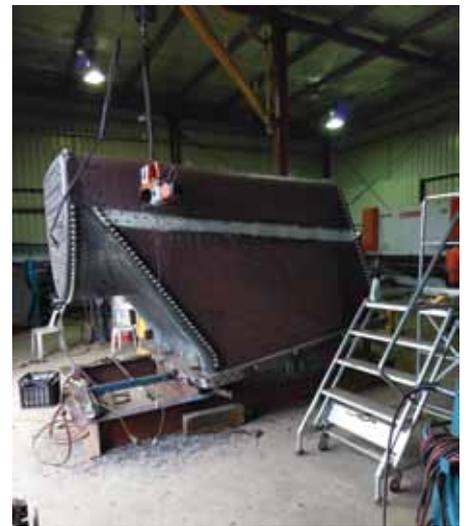
The final two plates to be fitted to the firebox are the tubeplate and throatplate. Since the foundation ring is trapezoidal in plan view, this requires the sides of the throatplate to be worked inwards to be tangent with the wrapper sides. As well, the front of the throatplate has to match the curved profile of the tubeplate and the wrapper closed around the profile of the tubeplate. All this work is very time consuming and proceeds incrementally, especially where heat must be applied locally to allow working the plates. The images in this report should give the interested reader an idea of the work involved. ■

The progressive fitting of the throatplate and wrapper plate around the firebox tubeplate.
