PRHTA BRIDGE ASSESSMENT AND REMEDIATION STRATEGIES POST-HURRICANE MARIA

Alvin Rodríguez, PE, MSCE; Elvin Pérez, PE, MSCE; Mauricio Torres, PE, MECE

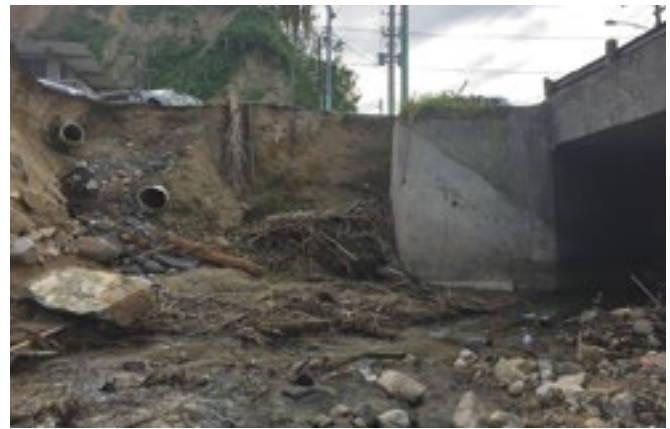
The river bed and embankment were impacted from the erosion and floating debris caused by the high velocity of the river flow. In the worst cases, adjacent roads or parking lots partially collapsed due to the failure of the embankment. No apparent damage was observed at embankments already protected by gabions or stone revetment.

Fig. 2. Upstream embankment landslide Bridge No. 879, Utuado PR

To prevent further soil slope instability, the installation of riprap over a filter blanket was recommended. For steep slopes, grouted riprap was selected as the soil stabilization method. In cases where protection of an adjacent structure was required, the construction of a gabion gravity wall or a concrete gravity retaining wall as specified in the PRHTA standard drawings were specified.

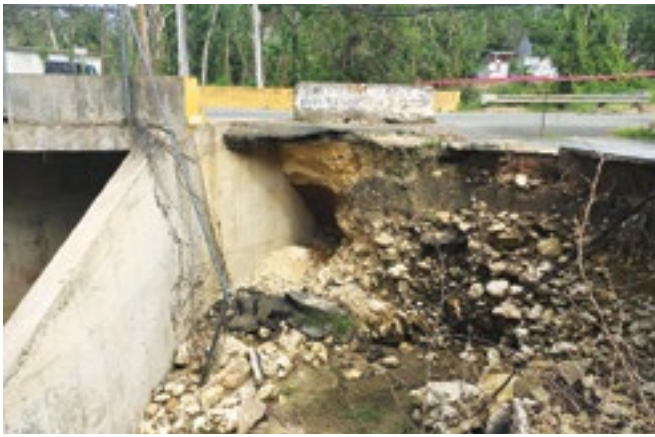
During the bridge assessments, it was observed that considerations are needed not only for the upstream embankment, but the downstream embankment as well. It was noted that the overtopping of the bridge roadway in addition to the debris blockage at the bridge underpass created a turbulent condition that caused instability on the downstream embankment. The turbulent flow infiltrated behind the bridge wingwalls resulting in erosion and scour. Similar damage occurred at bridges where the river bank had been diverted over time or had shifted from its original position due to previous major flood events.

Fig. 3. Downstream wingwall slope instability Bridge No. 446, San Sebastián P.R.

To prevent further erosion and instability behind the wingwalls, a deposit of borrowed fill material and the installation of dumped or grouted riprap were considered.

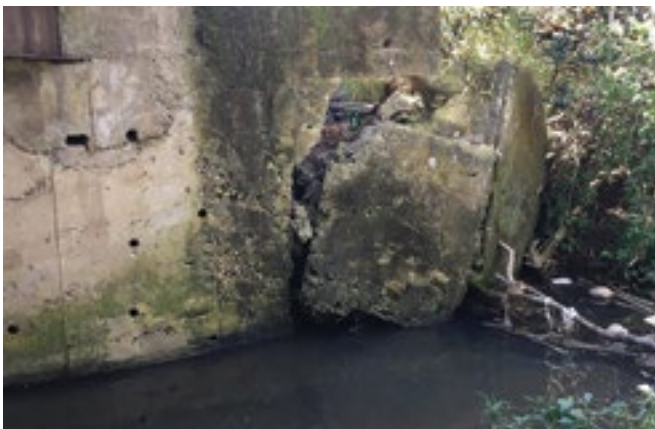
Fig. 4. Upstream partial wingwall collapsed Bridge No. 141, Cabo Rojo, PR

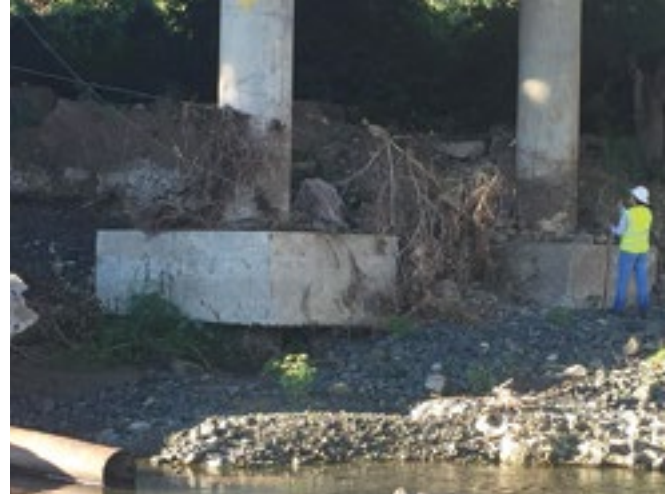
The erosion and scour at the abutment and pier footings was one of the observed damages of major concern due to the potential risk of bridge load capacity reduction and instability. After detailed evaluations, measurements and analysis, no apparent load capacity reduction was determined at the assessed bridges. Nonetheless, the critical condition was remediated to avoid incremental degradation due to future flood events.

Fig. 6. Scour and exposed footing and piles at interior pier of Bridge No. 2086, Sabana Grande PR

To address the scouring conditions of the bridge abutment and pier footings, it was determined to specify a flowable concrete pour with a 28-day concrete compressive strength of 500 psi beneath the footing. If the scour extent was measured to be beyond one meter in depth below the existing footing, a filter fabric was placed around the piles to avoid negative friction loads. Negative friction reduces the vertical load carrying capacity of the bridge. A grouted riprap was then installed above the exposed footing with a minimum thickness of 0.45 meters with a slope of 2H:1V measured from the river stream line for additional protection.

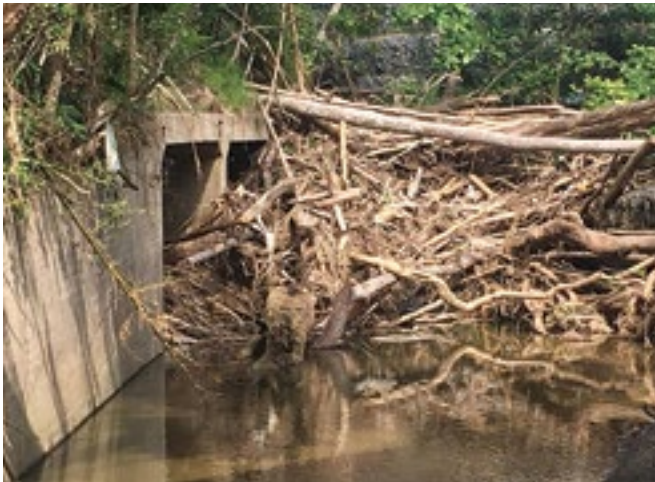
The debris accumulation at the upstream side of the bridge was typically observed at all the bridges assessed. The major concern was in low elevation multi-cell box culvert type bridges where the debris accumulated at the upstream end creating an obstruction to the water flow. This obstruction generated excessive lateral loading at the bridge and in cases creating turbulent flow and instability at the downstream embankment due to river overflow. Damages to the safety barriers at bridges where debris totally obstructed the water flow were observed, thus requiring emergency repairs for safe access. In addition, the asphalt wearing surface on some of the bridges was damaged requiring new asphalt to be placed.

Fig. 8. Typical debris at low elevation multi-cell box culvert type bridges.

The immediate removal of debris was recommended to avoid potential bridge failure due to excessive lateral load. The accumulation of debris at the center piers impeded the detailed inspection at these areas. Future inspections were recommended to assess footing exposure and scour effects

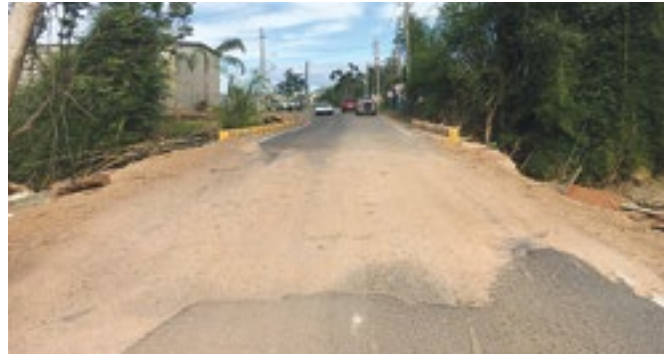
Fig. 9. Damage at approach pavement on Bridge No. 256, San Sebastian PR
