Dump of Building materials near gate of Sutterby Church

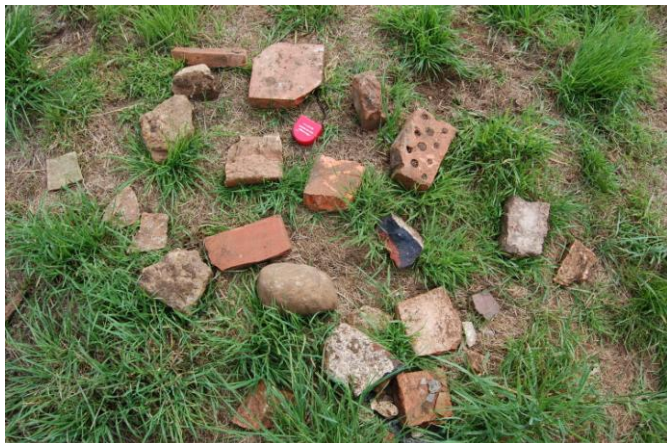
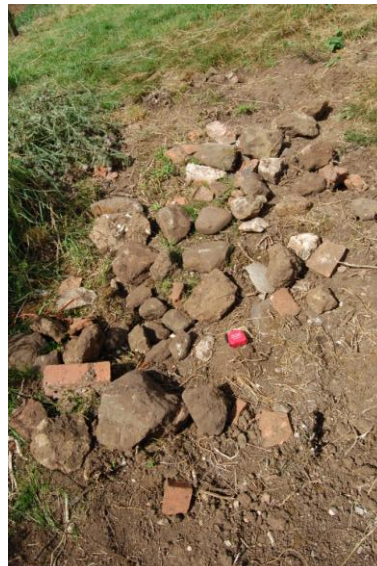
Building rubble found to the west (above) and the east (right) of the gateway to Sutterby Church

The materials to the west of the gateway were dominated by floor and roof tile. Only one piece of stone was in this collection and this was a finely worked fragment of limestone, possibly a piece of window mullion (retained - see description/illustration 2) below).

The materials to the east of the gateway were dominated by fragments of Spilsby sandstone - several with mortar adhering and one with signs of tooling. There were also many fragments of brick.

The two piles may relate to different episodes of construction or repair at the church. It is tempting to speculate whether the eastern dump was perhaps connected with the repairs authorised in the faculty of 6 May 1743 when the porch was built. However, if so, the discard of such a useful large piece of stone as that noted in 1) below, is puzzling.

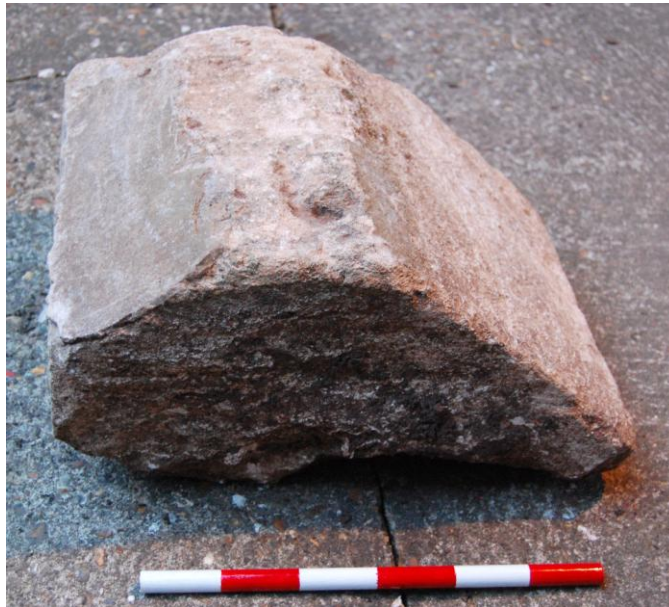
- 1) Large piece of worked, fairly coarse, fossiliferous limestone (probably Barnack or Clipsham)
Dimension: Irregular c. 35 x40 x20cms high

Probably originally a piece of a large window cill, later reused/reworked. Original upper surface (possibly with glazing groove) cut away. Smoothed layer of mortar or plaster (5-8mm thick) on one worked face probably relates to secondary use.

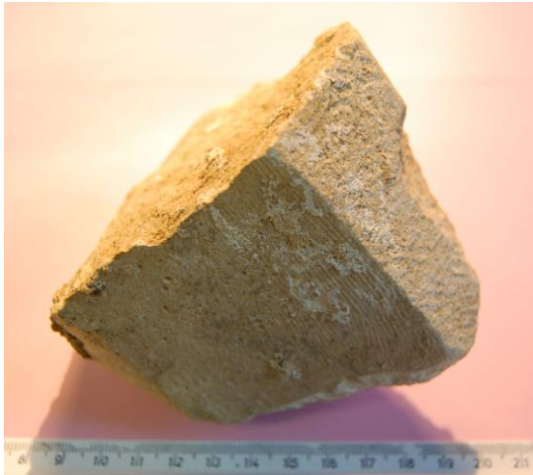
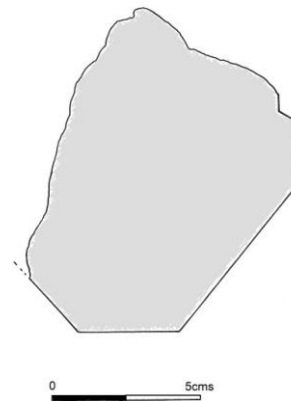
2) Small fragment of fine, worked limestone (probably Lincoln limestone)
Part of window tracery/mullion with remains of a glazing groove.
Late 14th to 15th century

Dimension: Irregular c. 8.5 x 10.5 x 7.5cms high
Fragments of mortar on base - possibly traces of limewash on worked surfaces
Fine claw chisel tooling marks evident - probably on an interior face as no erosion evident
