CIVIL AERONAUTICS BOARD  
AIRCRAFT ACCIDENT REPORT

MIDAIR COLLISION INVOLVING  
BEECHCRAFT, C-35, N 1839D, AND WYOMING AIR NATIONAL GUARD F-86L, 52-3662,  
NEAR CHEYENNE, WYOMING, MUNICIPAL AIRPORT, DECEMBER 15, 1959

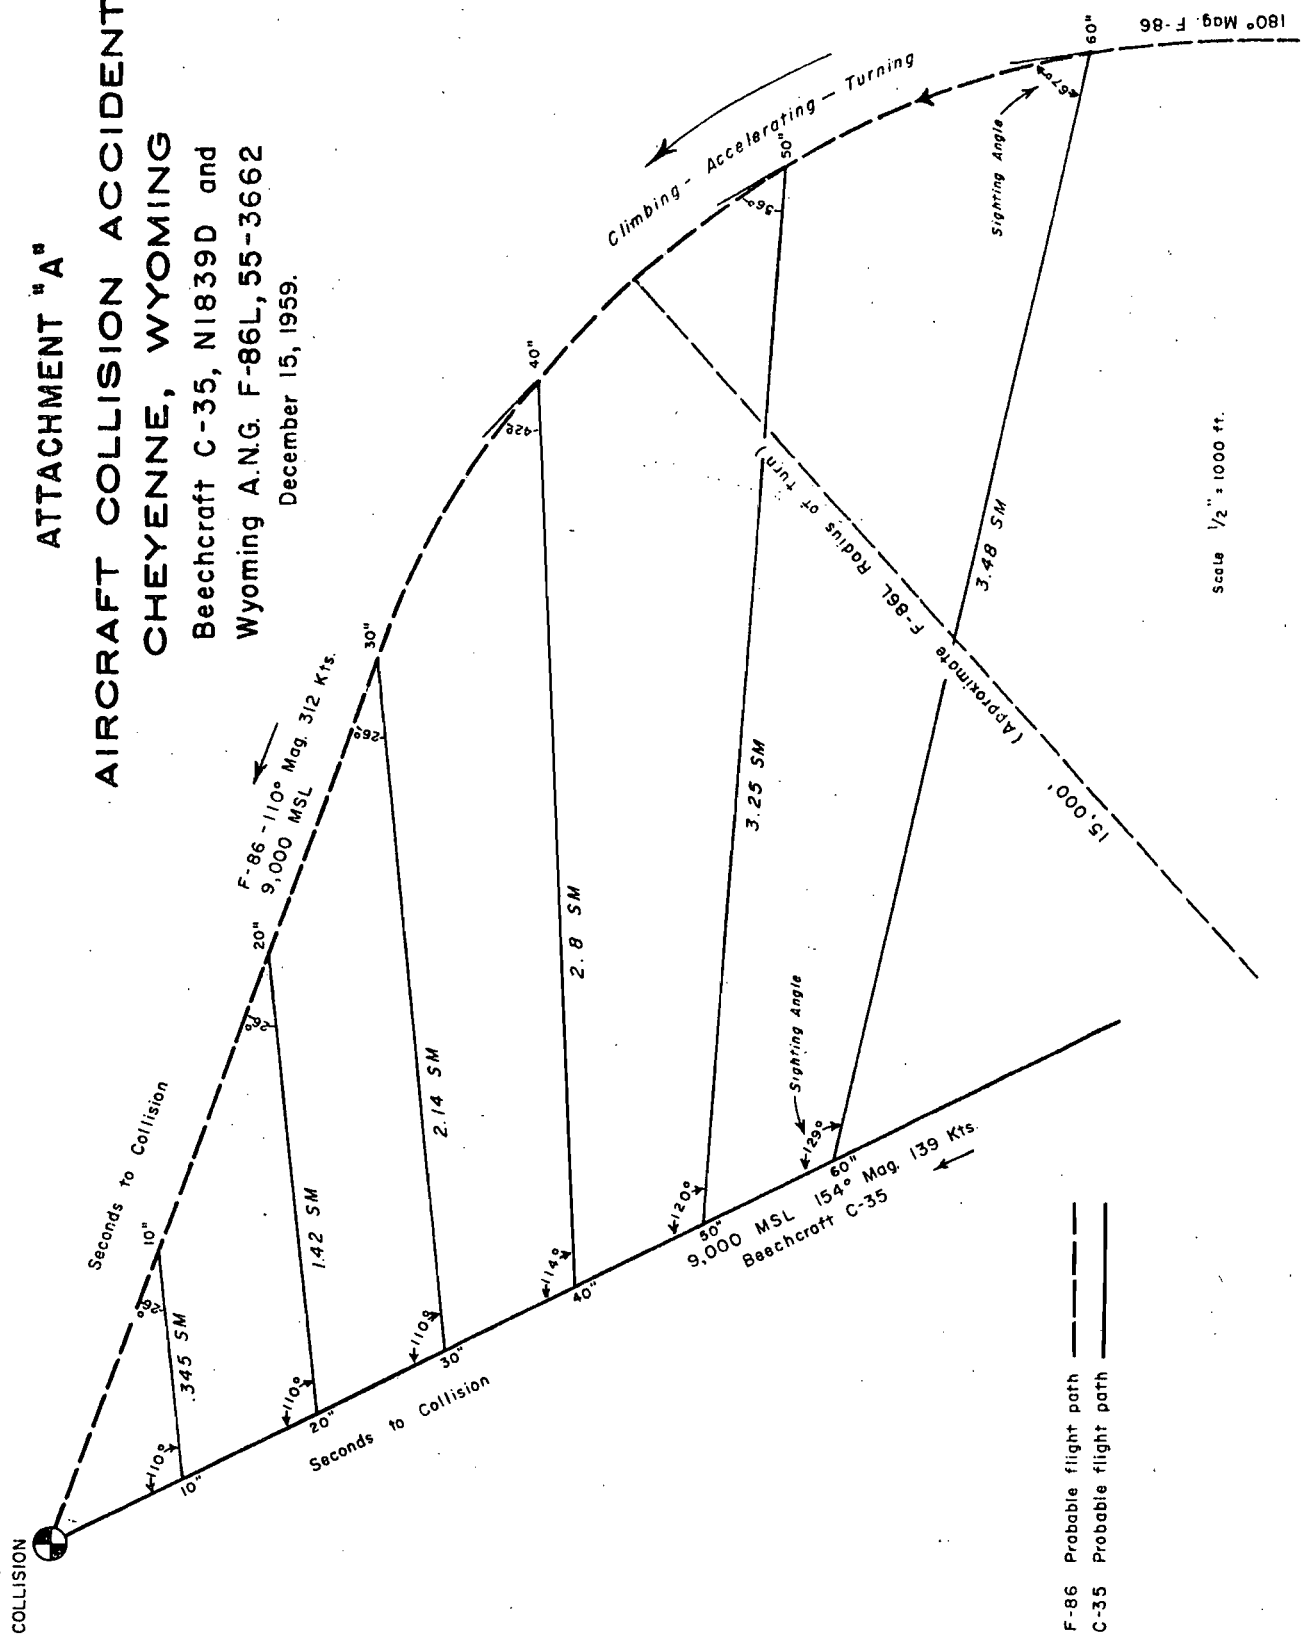
**ATTACHMENT "A"**  
**AIRCRAFT COLLISION ACCIDENT**  
**CHEYENNE, WYOMING**  
 Beechcraft C-35, N1839D and  
 Wyoming A.N.G. F-86L, 55-3662  
 December 15, 1959.

An analytical study (Attachment A) based on all of the evidence shows that at the start of the 60-second period the colliding aircraft were separated 3.48 statute miles. At this time the F-86L's were positioned 129 degrees to the right rear of the Beechcraft and the Beechcraft was 67 degrees to the left of the nose of the aircraft of the jet formation leader. During the final 30-second period the F-86L's were positioned 110 degrees to the right rear of the Bonanza while the Bonanza was 26 degrees to the left of the nose of the aircraft of the jet formation leader. Separation between the planes was then 2.8 statute miles.

As part of the Board's analysis a vector diagram, Attachment A, was prepared using the aforesaid factual material necessary to the study. In this manner the probable flightpaths of the aircraft were determined for the 60-second period of closure prior to the collision. From the study it was possible to determine the relative position of each aircraft to the other at any given period. Similarly, it was possible to assess the opportunities afforded each pilot to have sighted the other's aircraft in order to avoid the collision.

The study shows that at the beginning of the 60-second period the colliding aircraft were separated 3.48 statute miles. At this time the Beechcraft was located 67 degrees to the left of the nose of the jet formation leader's aircraft. It would have been slightly above the leader and visible to him through the canopy glass, presenting a quartering rear profile. During the first 30 seconds, while the F-86L's were turning, the angular position of the C-35 gradually shifted to a position about 26 degrees to the left of the nose of the leader's aircraft and to approximately eyelevel. During the final 30 seconds, with formation straight and level, the position of the Beechcraft would remain unchanged.

The study also shows that at the beginning of the 60-second period the F-86L formation was positioned 129 degrees to the right rear of the nose of the Beechcraft, or approximately 40 degrees to the rear of the 90-degree position. The jets would have been below the level of the Beechcraft. During the first 30 seconds the position of the jet formation would gradually shift forward until it was positioned level at a sighting angle of 110 degrees to the right rear of the nose of the C-35. During the final 30 seconds this position would remain unchanged.
