2017 Ferrari Club of America Major Award Winners 1969 365 GTB/4 Speciale s/n 12925, Luigi Chinetti Memorial Award for Outstanding Ferrari Road Car (foreground), 1960 250 GT Pinin Farina Coupe Series II s/n 1747 GT, National Vintage Preservation Award for Best Preserved Ferrari Pre-1980 (background).

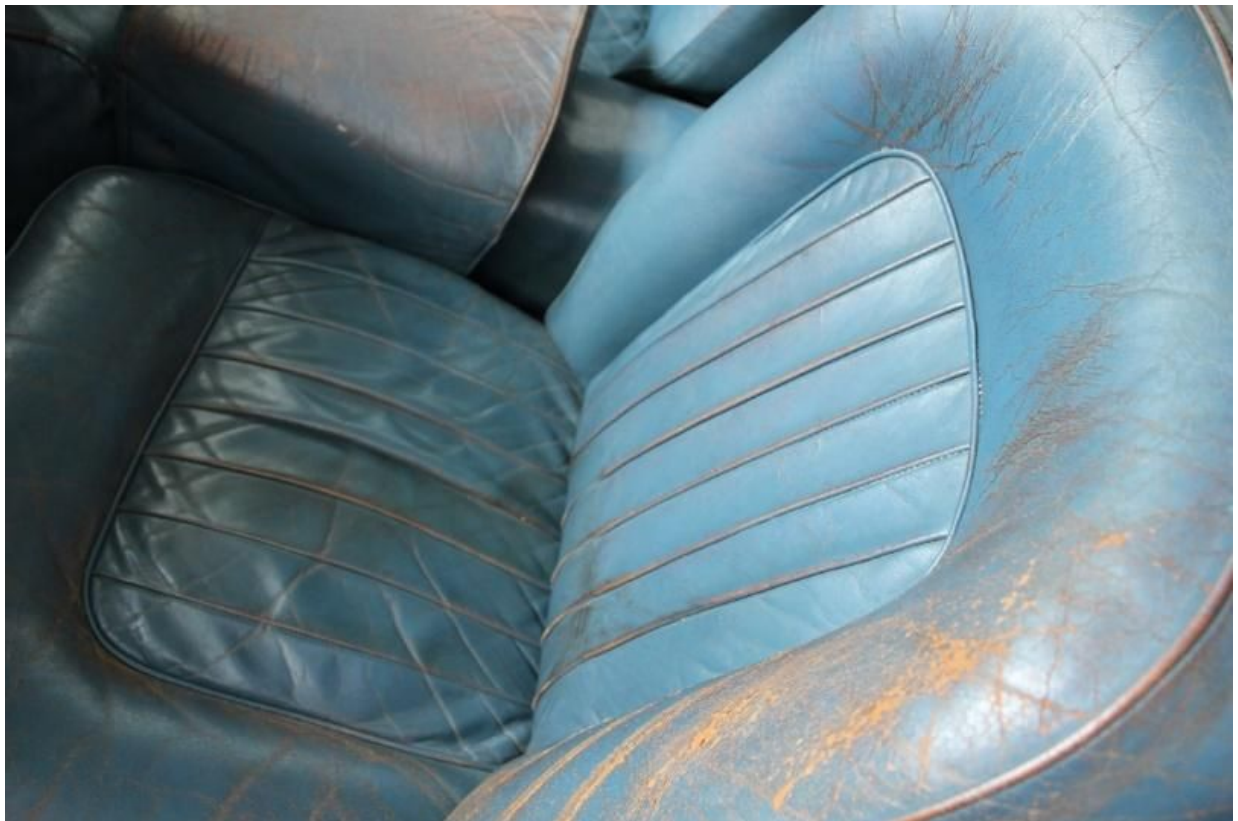
1. Worn seats with original dye. 250 Coupe. Image David Eichenbaum

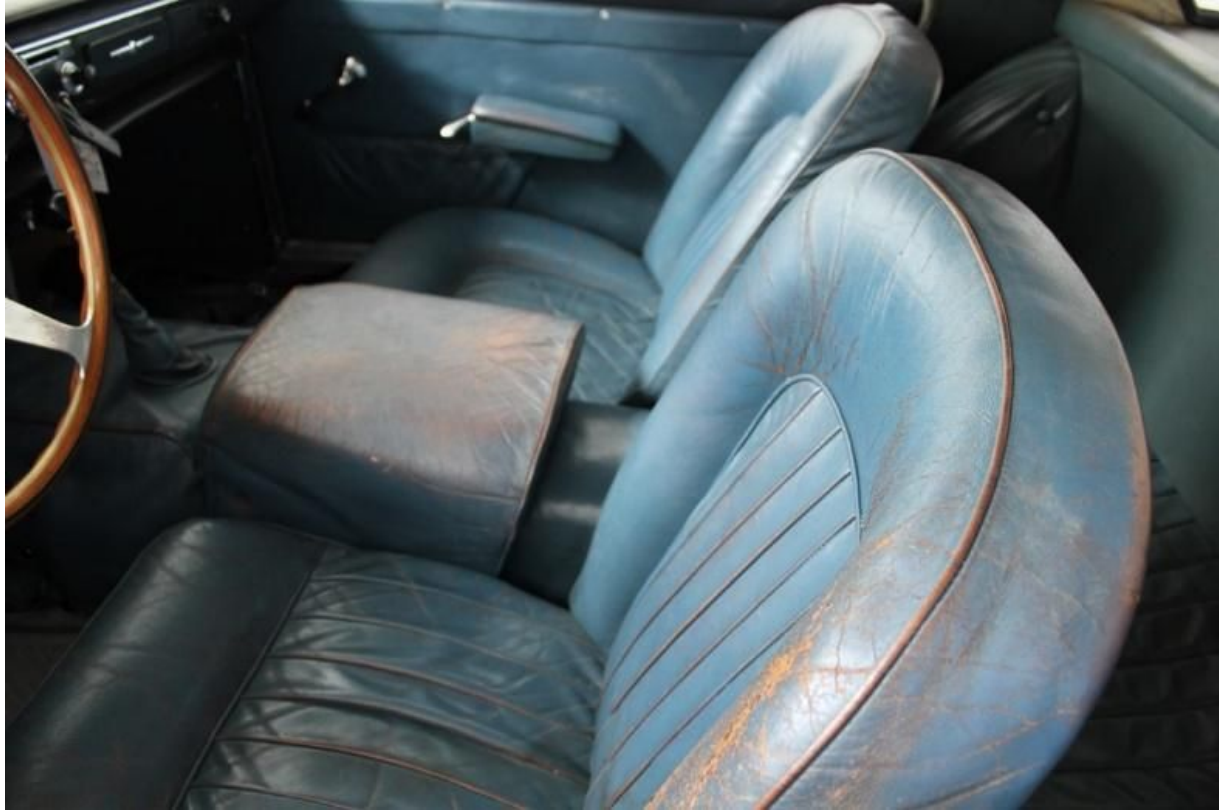
2. Worn seats with original dye. 250 Coupe. Image David Eichenbaum

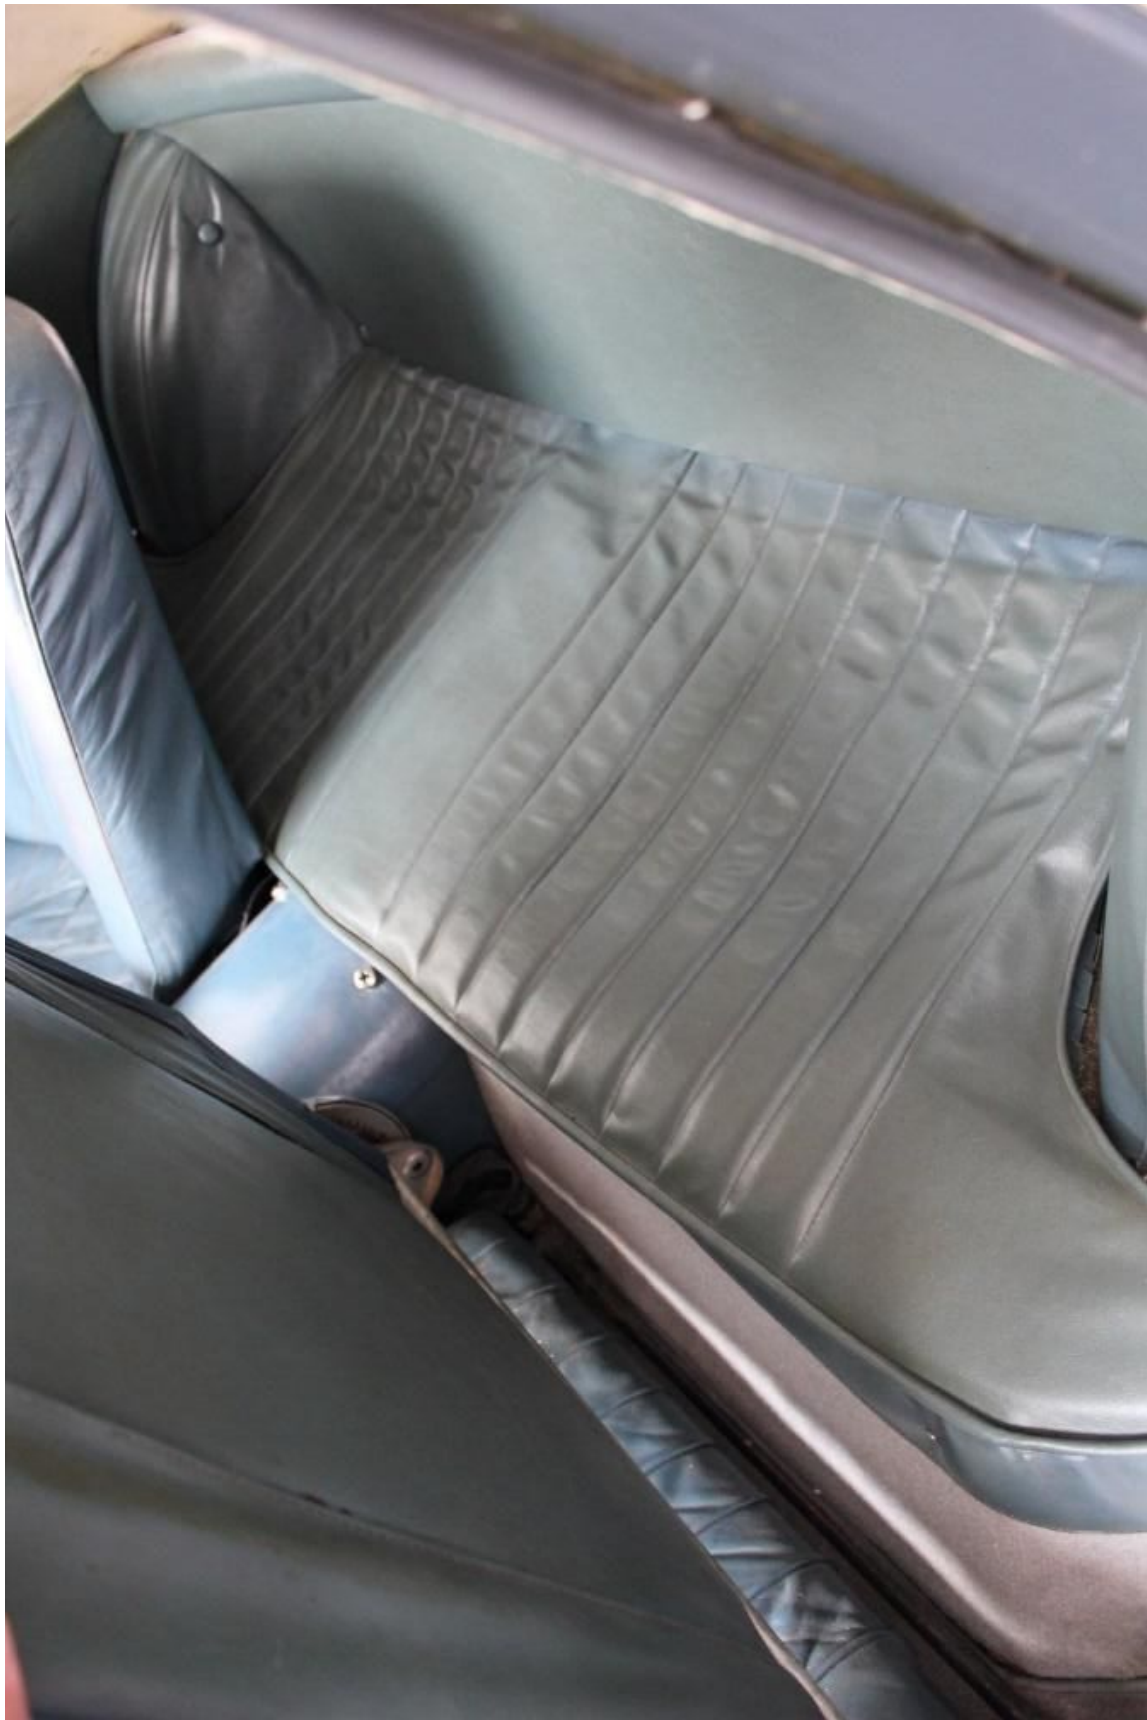
3. Worn original vinyl, pleats and piping. 250 Coupe. Image David Eichenbaum

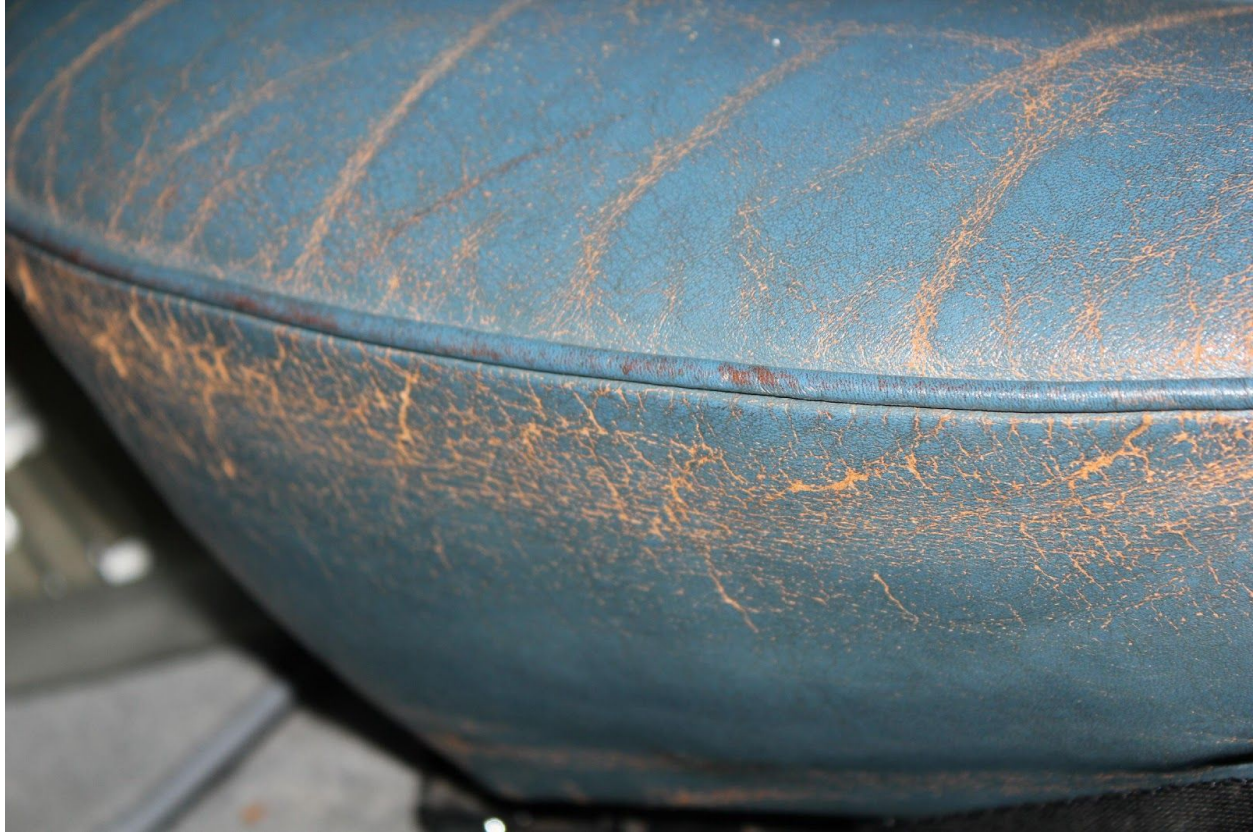
4. Detail of original leather dye and piping with original material underneath. 250 Coupe. Image David Eichenbaum

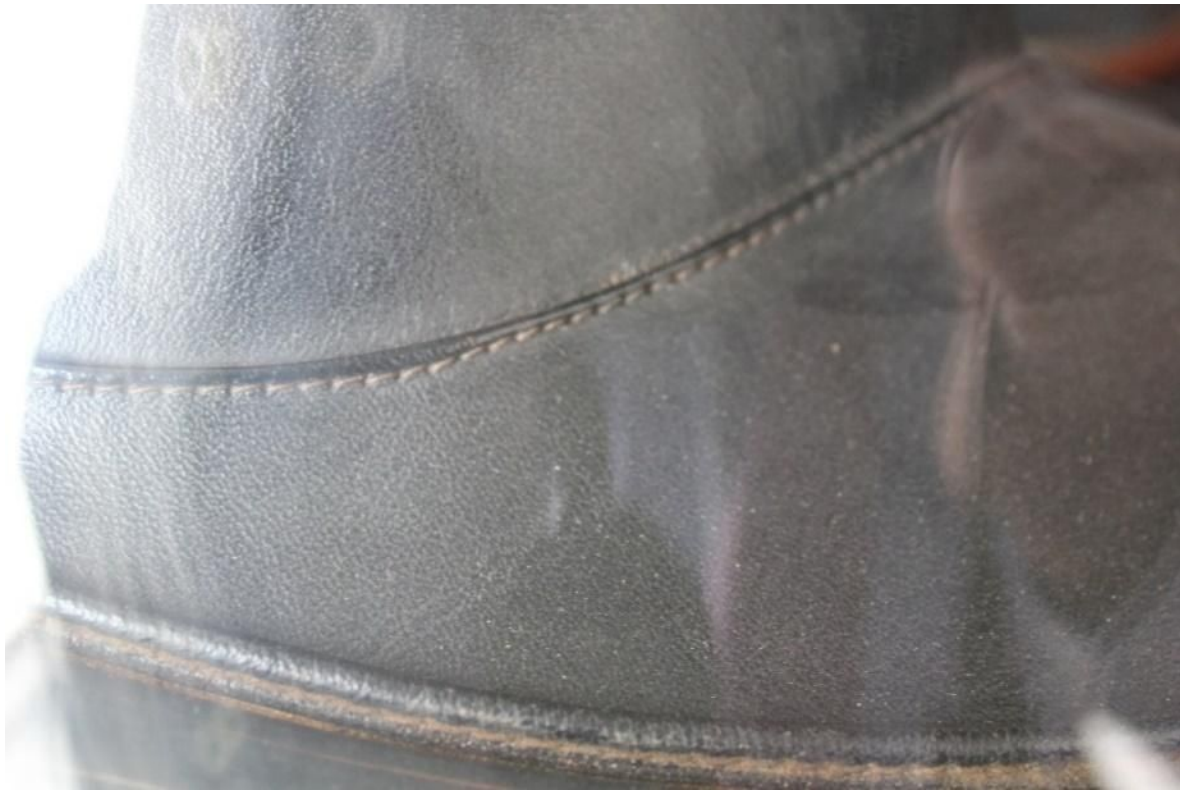
5. Original seats show grain, piping, stitching and workmanship. 250 Coupe. Image David Eichenbaum

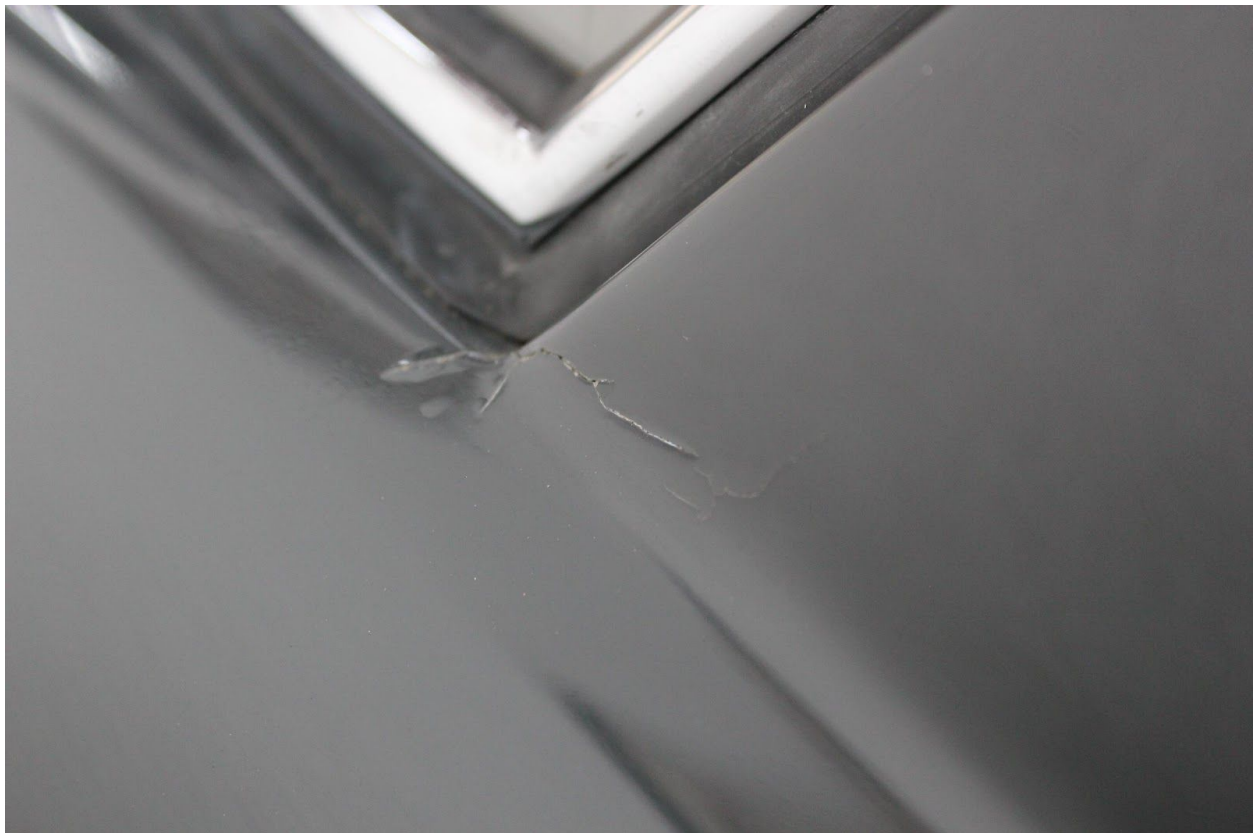
6. Typical cracking in older lacquer paint. 250 Coupe. David Eichenbaum

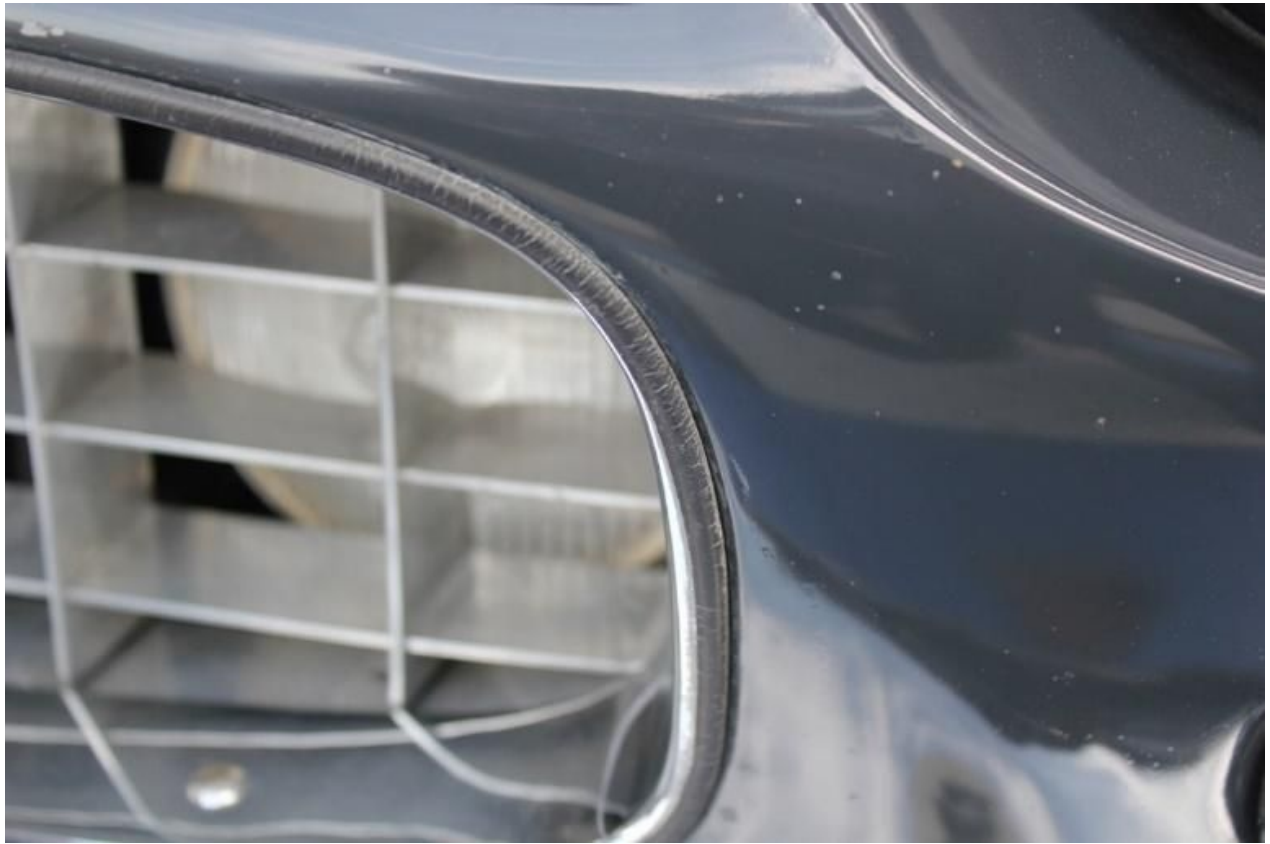
7. Molding showing wear still performs original function. 250 Coupe. Image David Eichenbaum

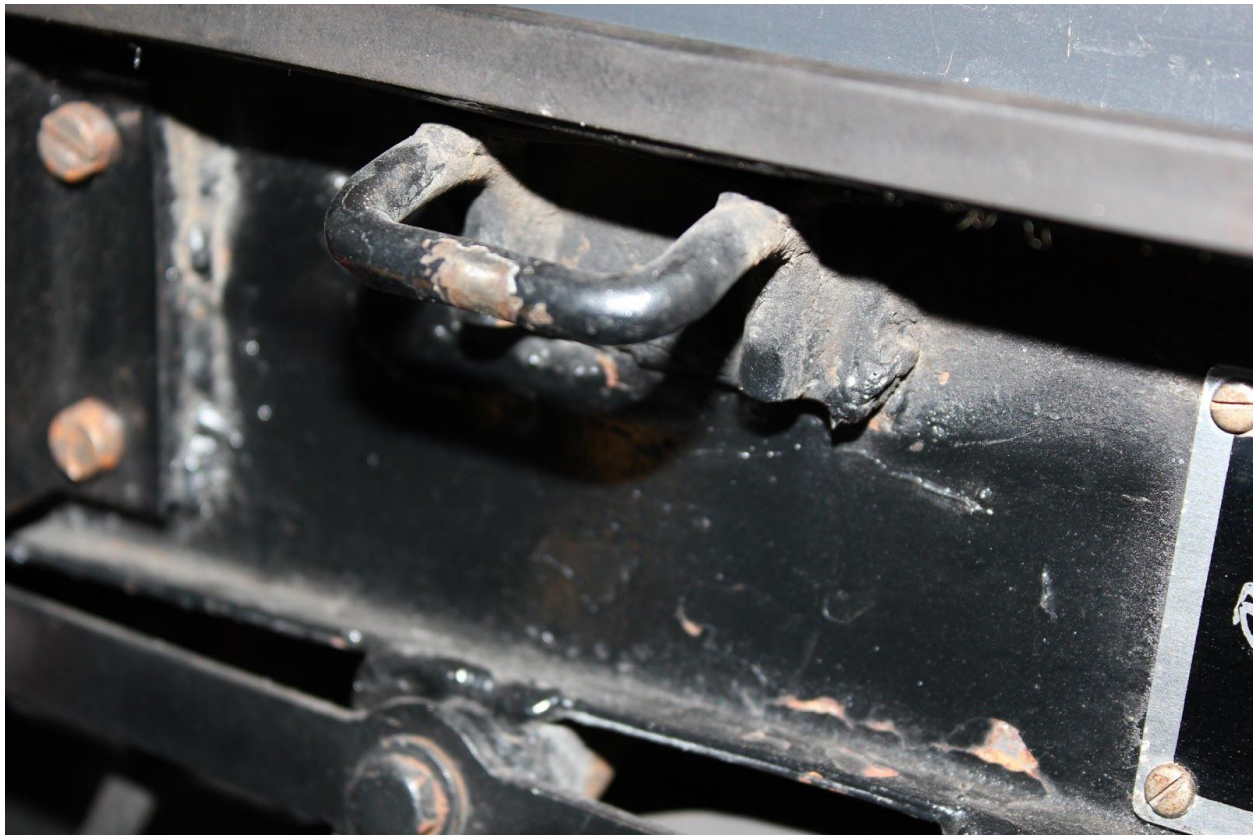
8. Hood latch originally painted over with welded latch and evidence of use. 250 Coupe. Image David Eichenbaum

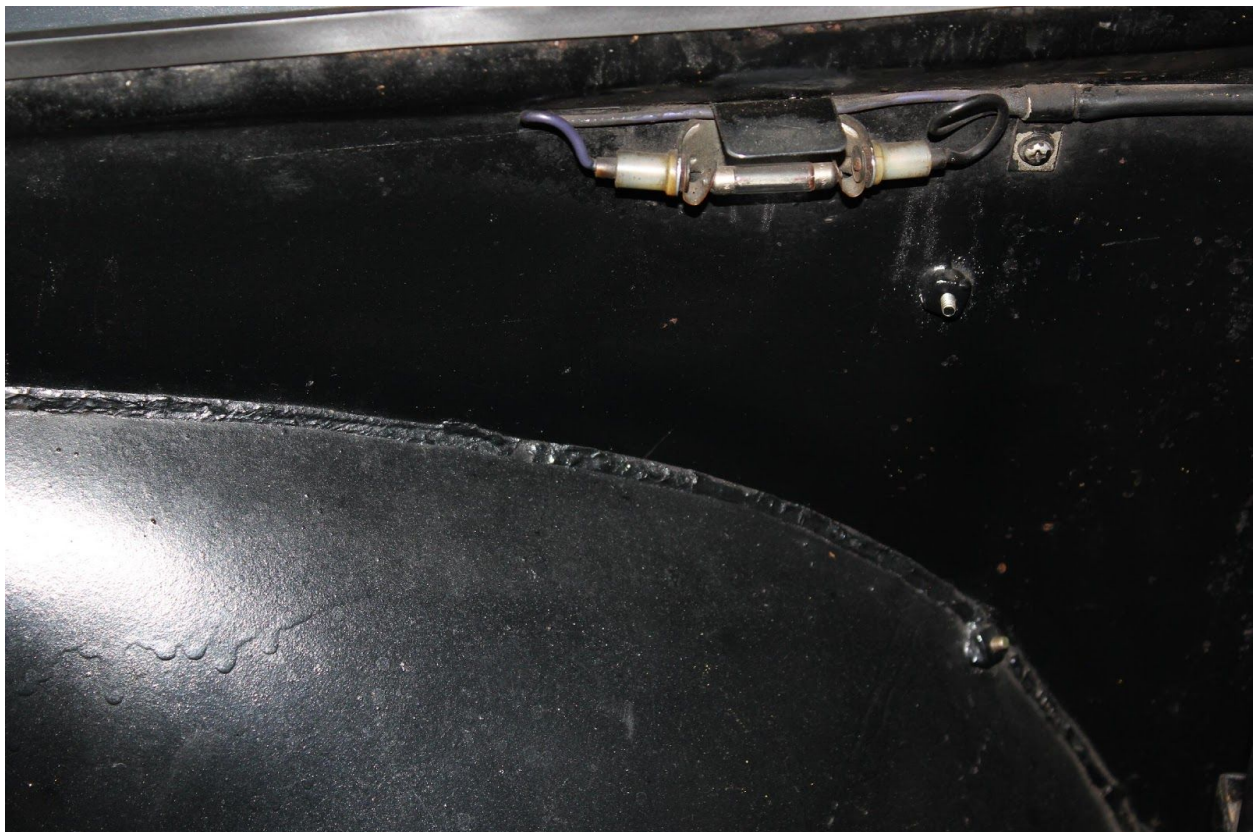
9. As built wiring and interior light with rough weld and run in inner fender paint. 250 Coupe. Image David Eichenbaum

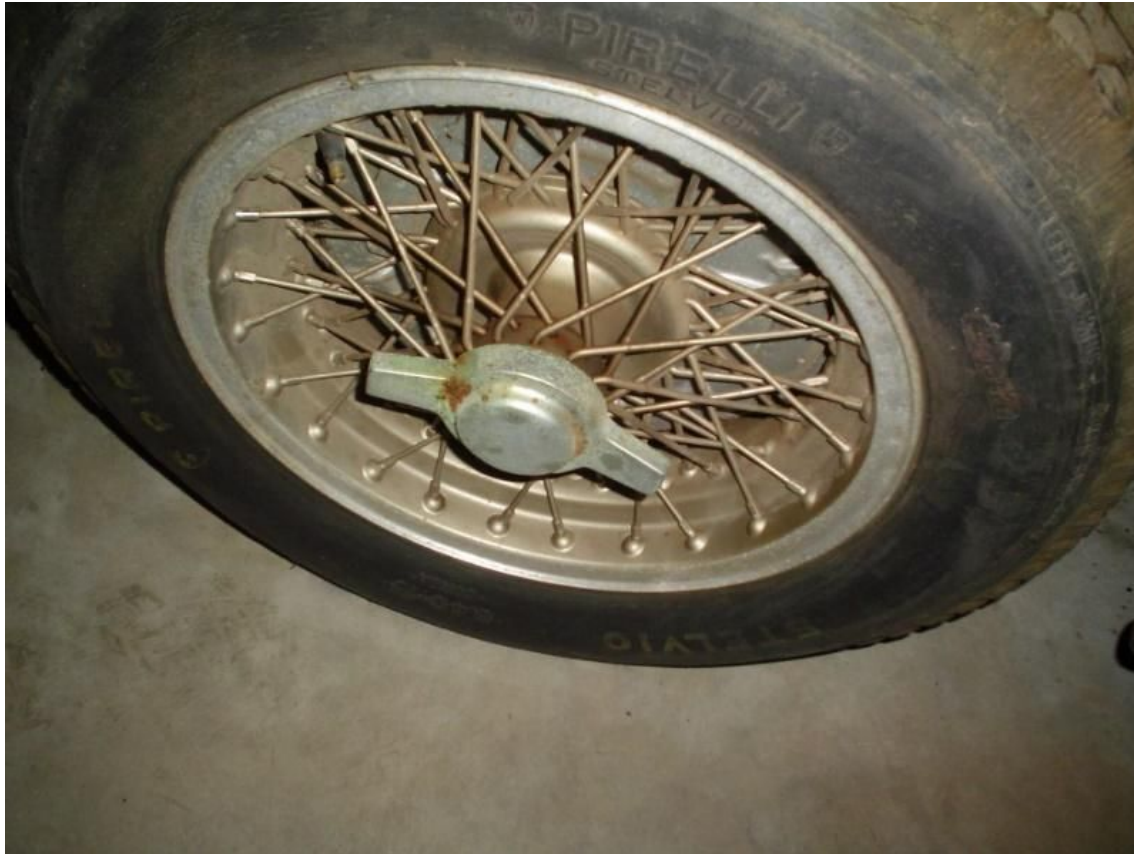
10. Early wheel still represents original configuration and finish. 250 Europa. Image David Carte

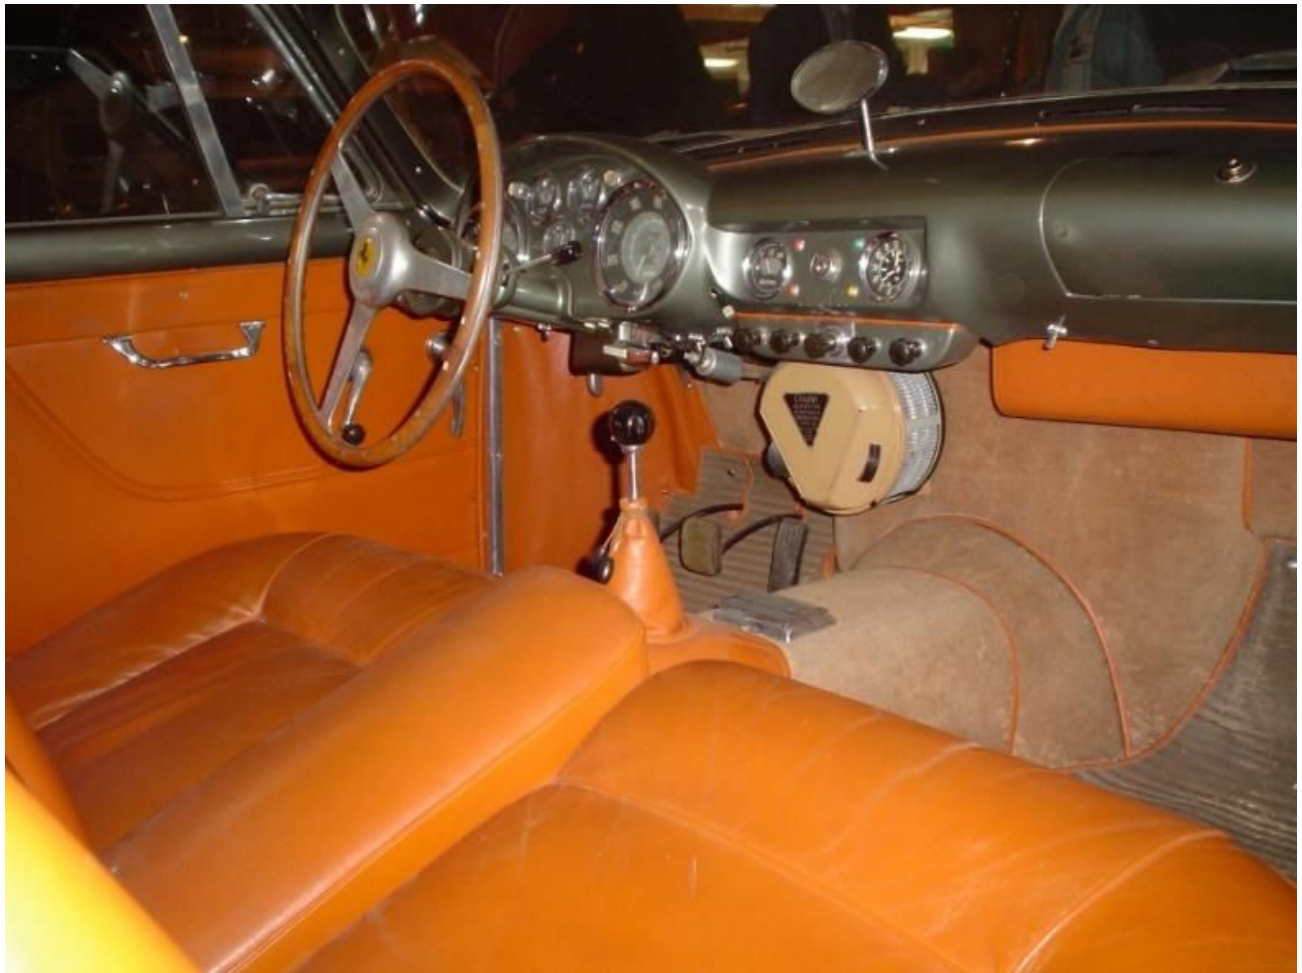
11. Original door skins, carpets, heel pads, piping, tassels, heater and dash. 250 Europa. Image David Carte

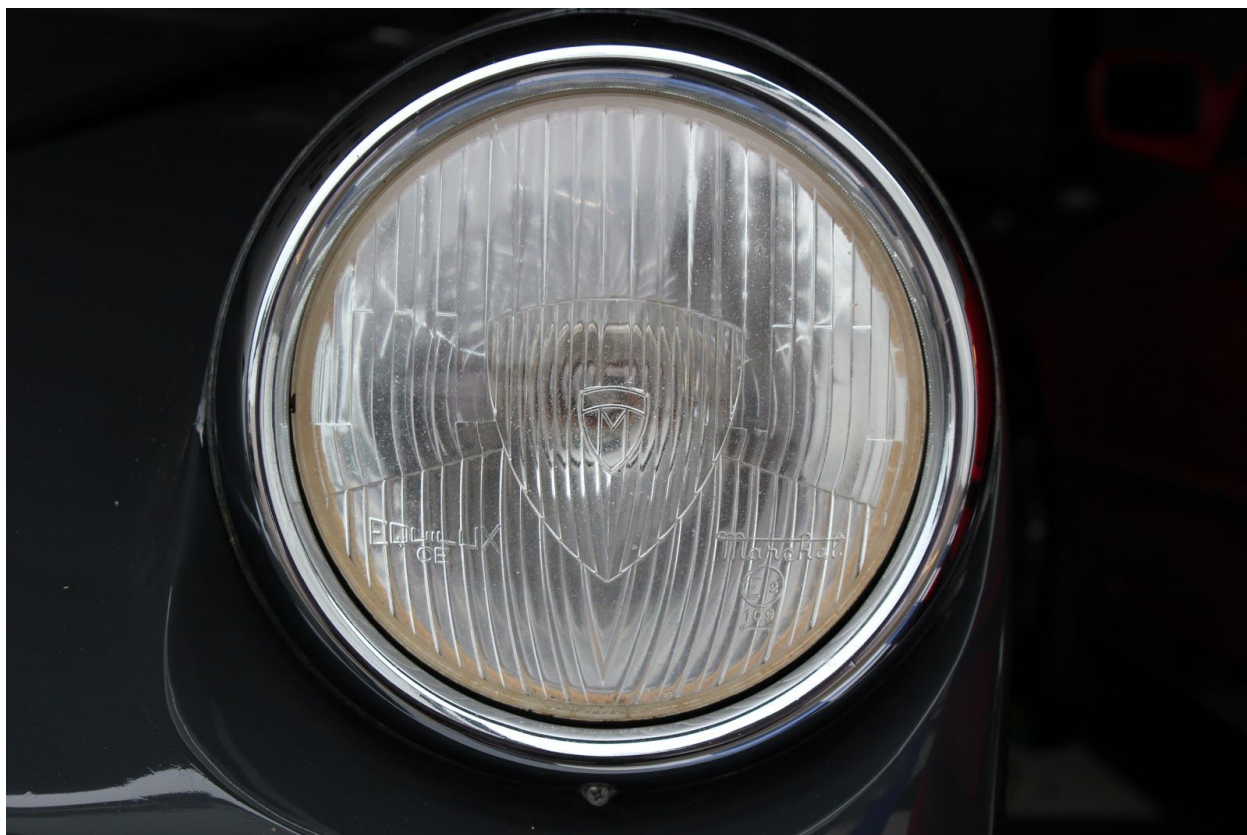
12. Marchal headlight with patina consistent with cars vintage. 250 Coupe. Image David Eichenbaum

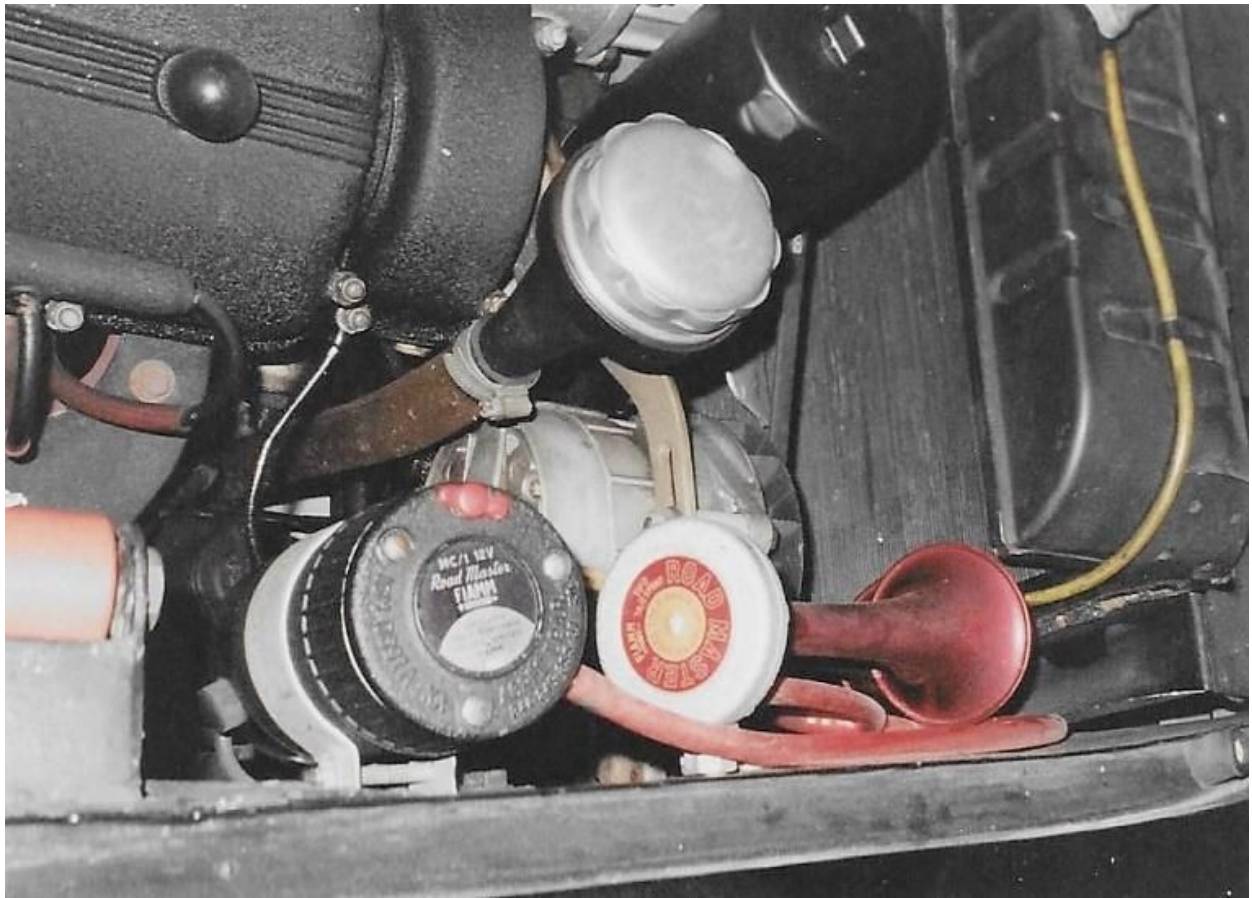
13. Typical unrestored engine details – except for painted filter. 250 GT Lusso. Image David Carte

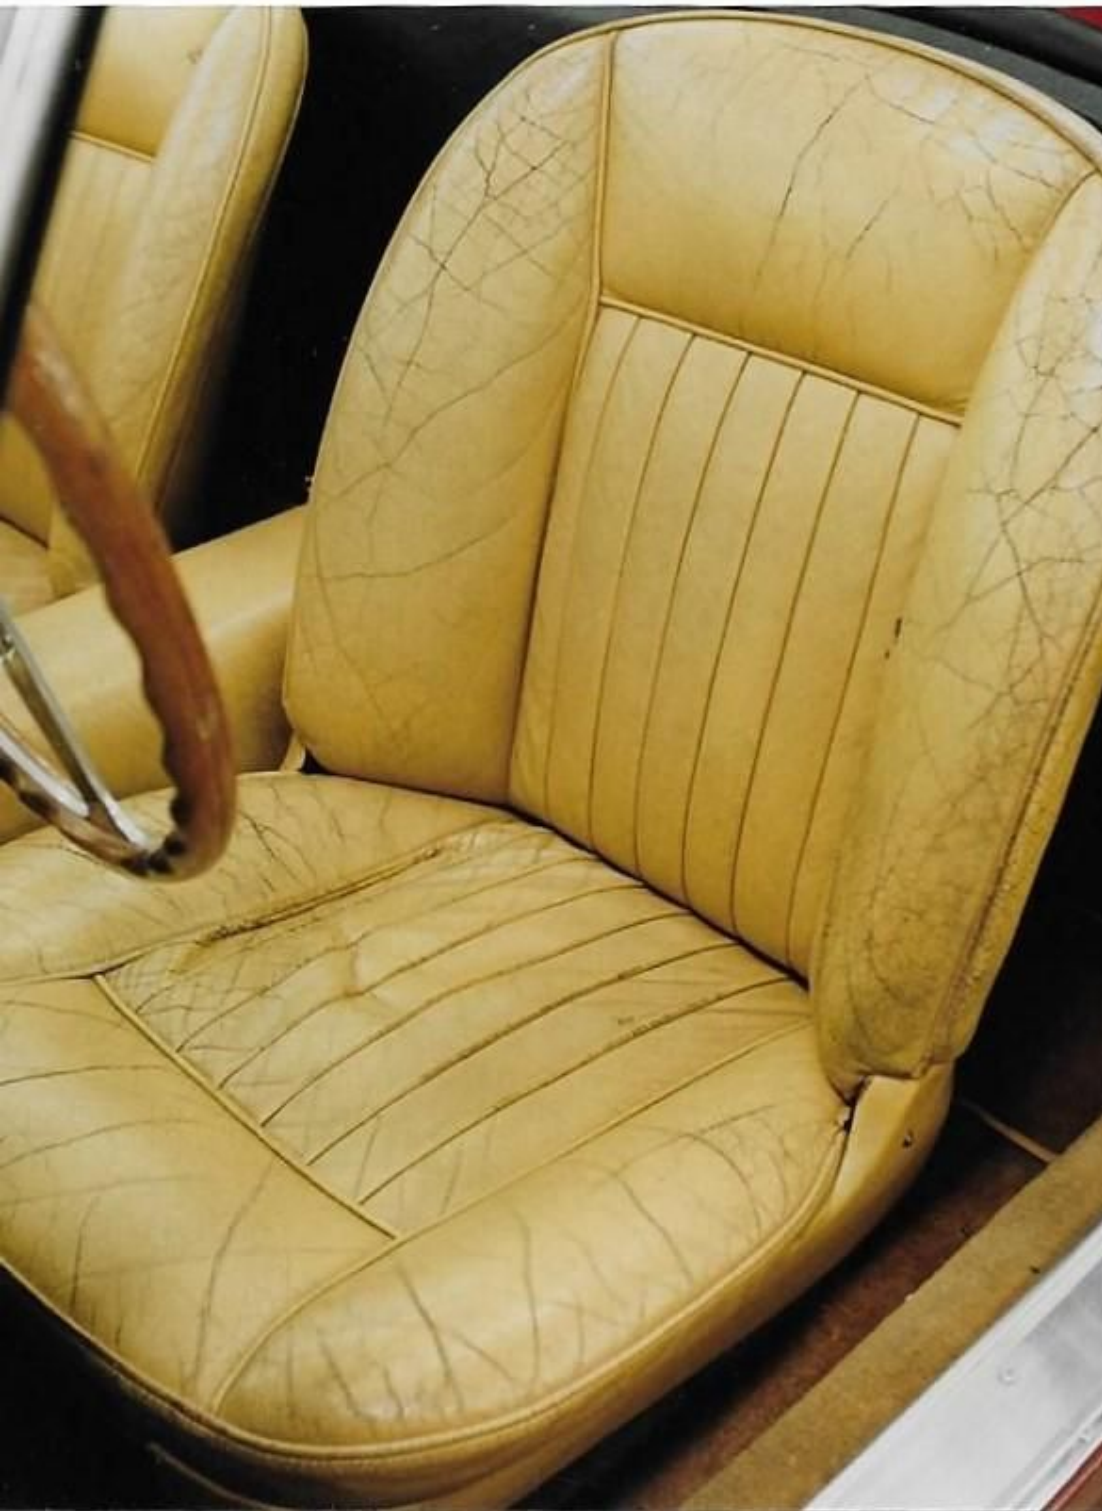
14. Serviceable seat with minor tear. 250 Cabriolet. Image David Carte

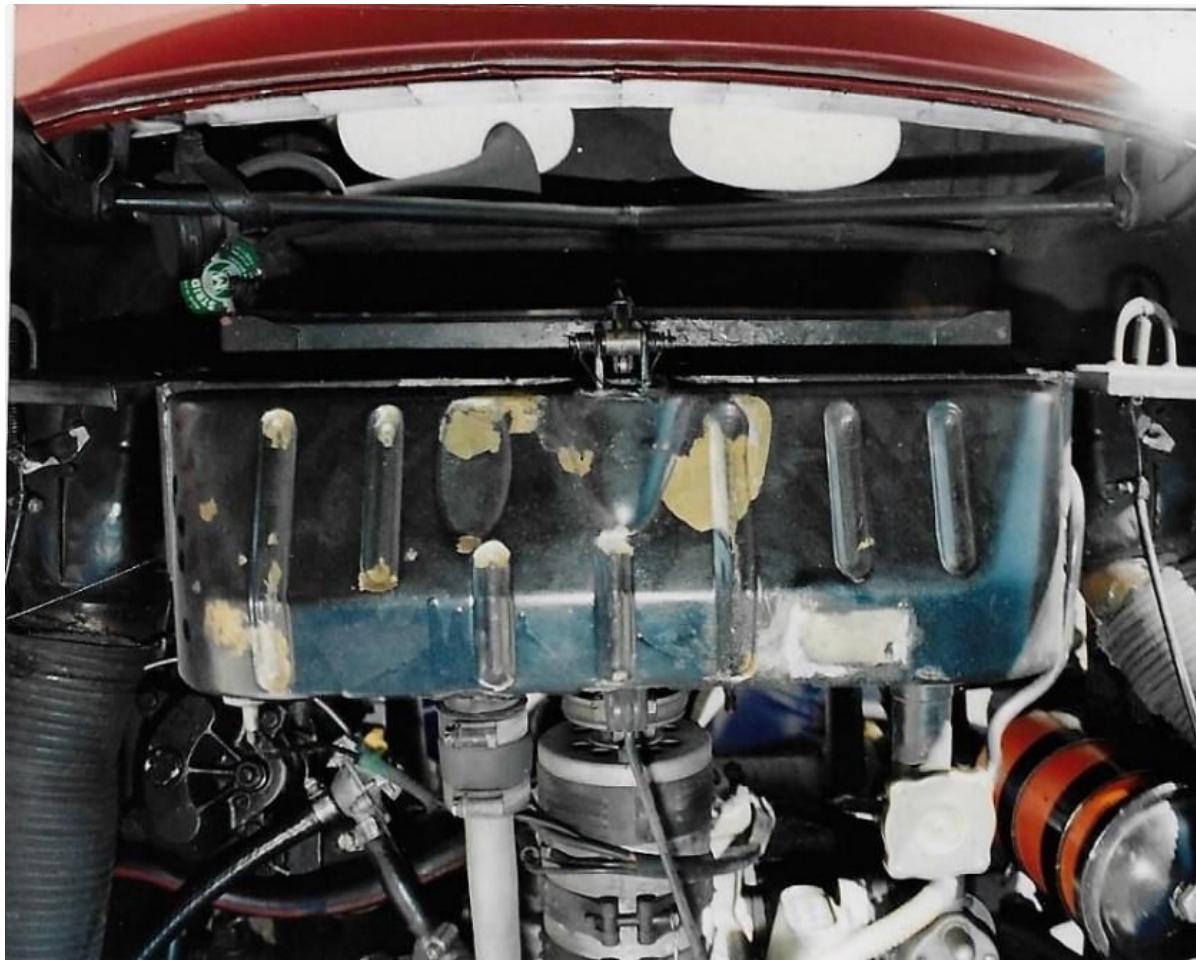
15. Weathered radiator functioning as original. 250 Cabriolet. Image David Carte

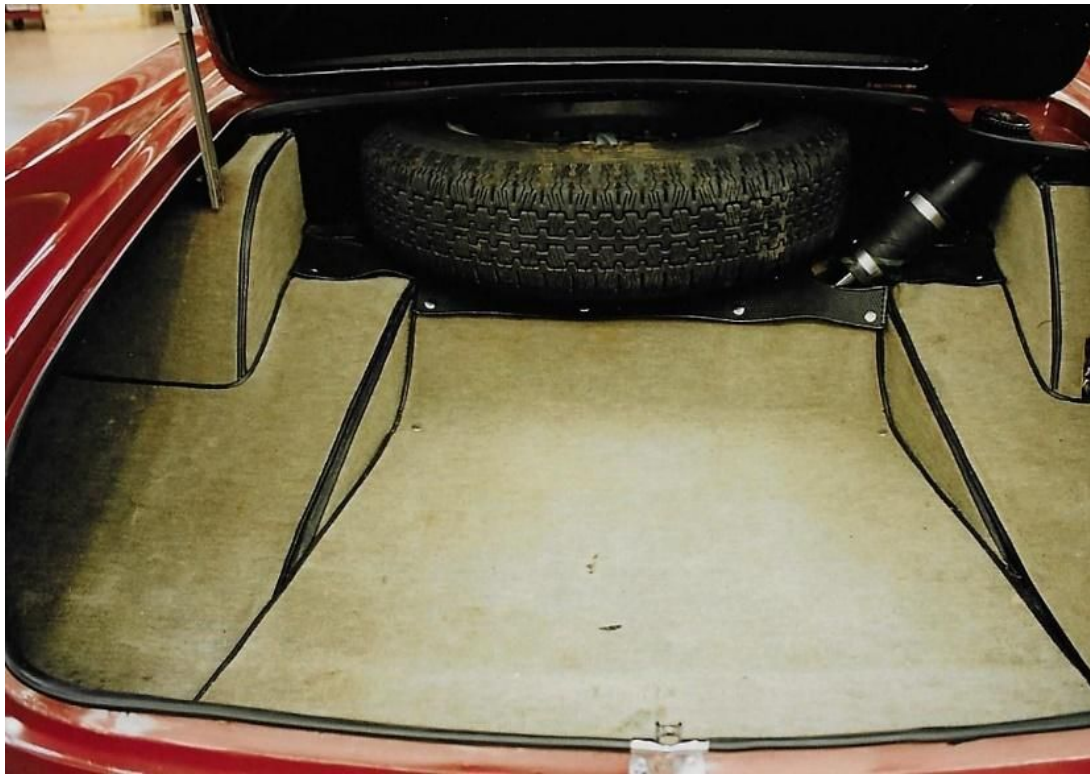
16. Original trunk and carpeting. Modern clamps and tire. Missing wiring block cover. 250 Cabriolet.
Image David Carte

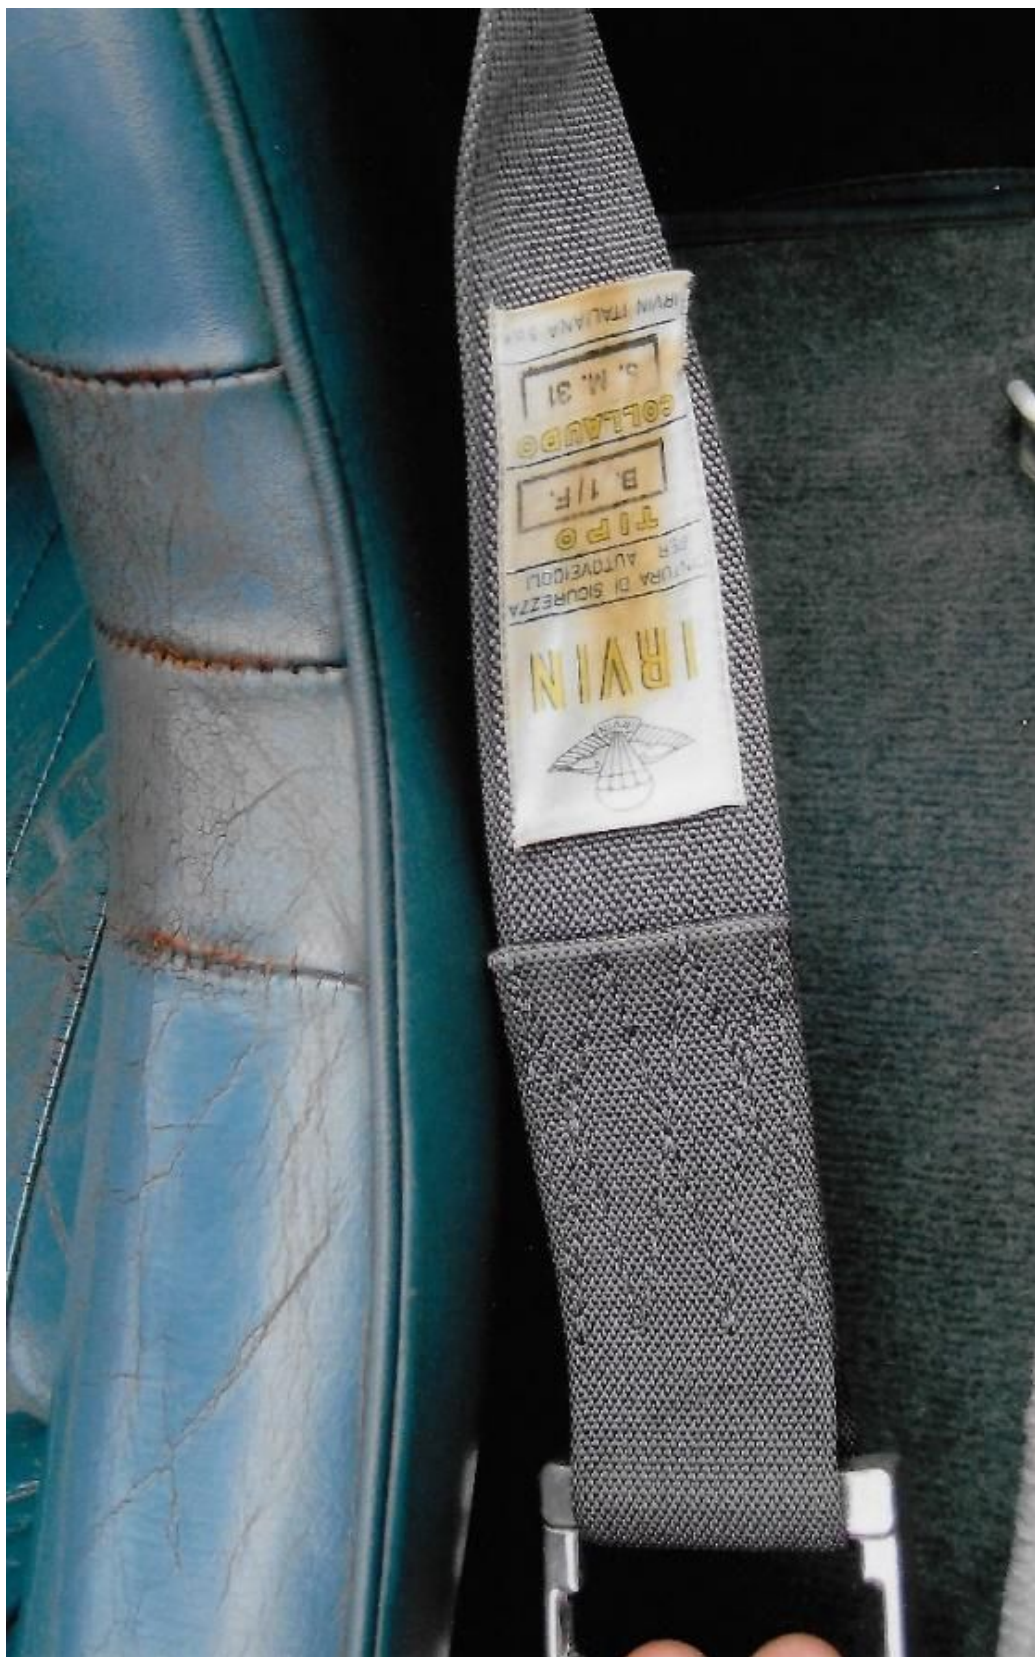
17. Seat and period belt. 250 Lusso. Image David Carte

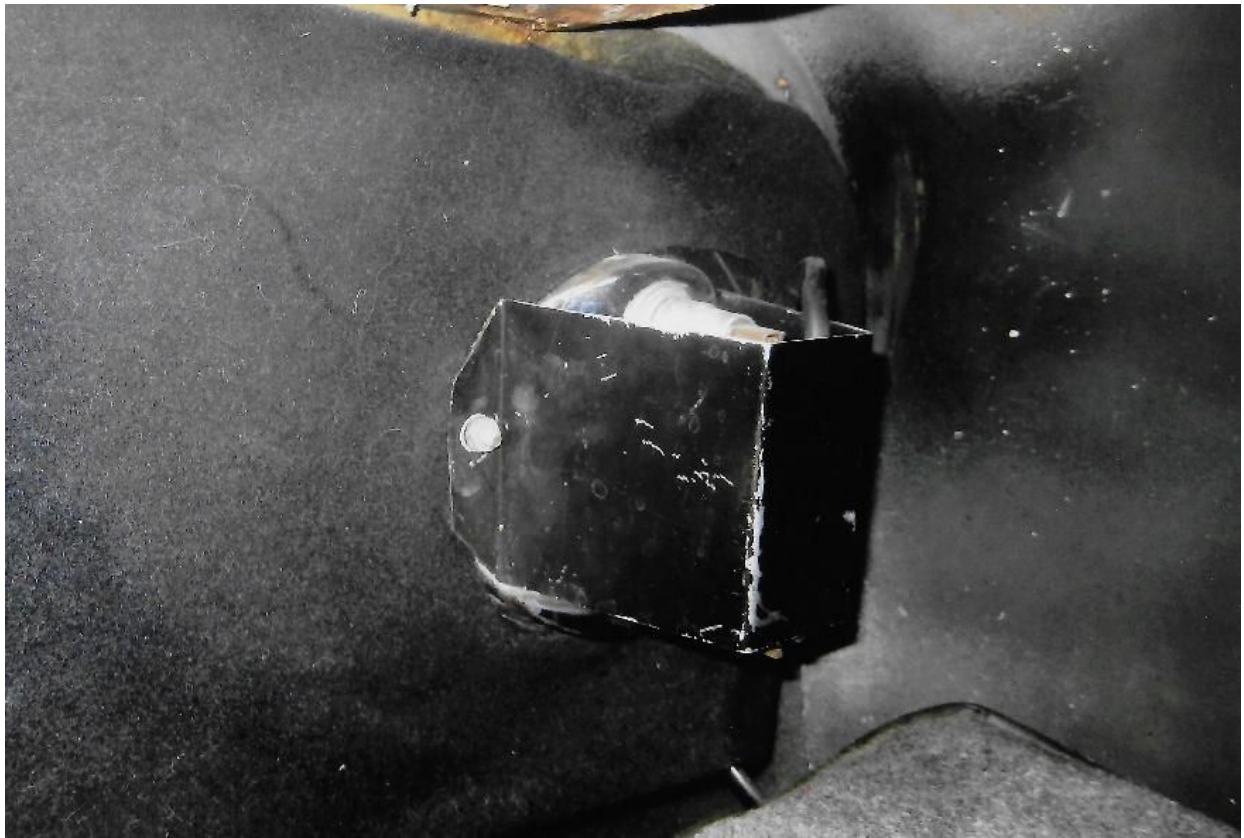
18. Inside trunk worn from use but serviceable. 250 Lusso. Image David Carte

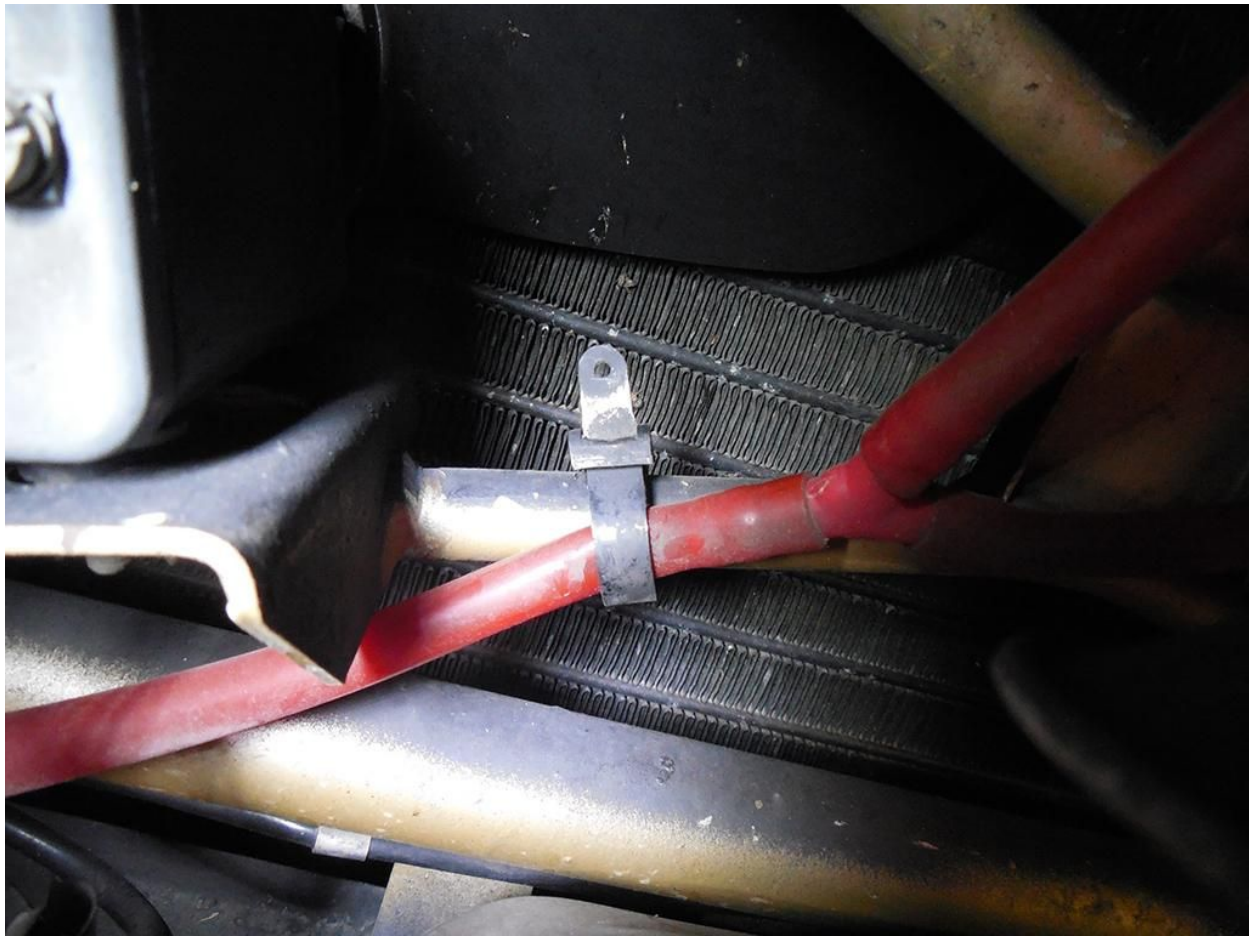
19. Black overspray on body-colored frame expected as inner fenders were likely sprayed from rear before radiator and engine were installed. 330 GTC. Image Tom Yang

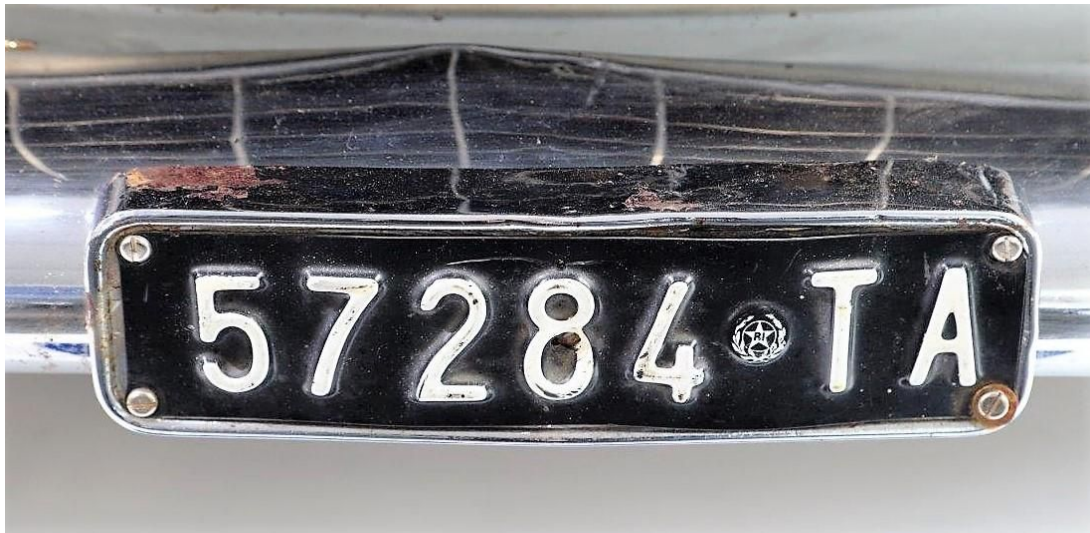
20. Front license plate frame – rough but original. 250 Europa. Image David Carte
