2017 Ferrari Club of America Major Award Winners 1969 365 GTB/4 Speciale s/n 12925, Luigi Chinetti Memorial Award for Outstanding Ferrari Road Car (foreground), 1960 250 GT Pinin Farina Coupe Series II s/n 1747 GT, National Vintage Preservation Award for Best Preserved Ferrari Pre-1980 (background).

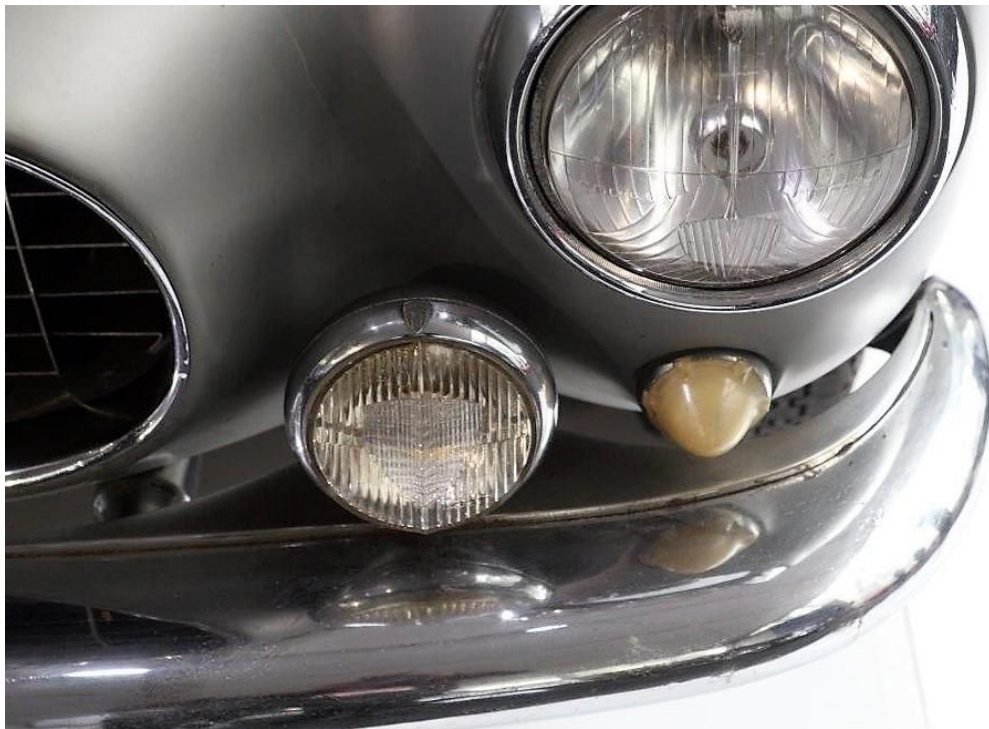
21. Dull chrome and slight blemishes on bumper. 250 Europa. Image David Carte

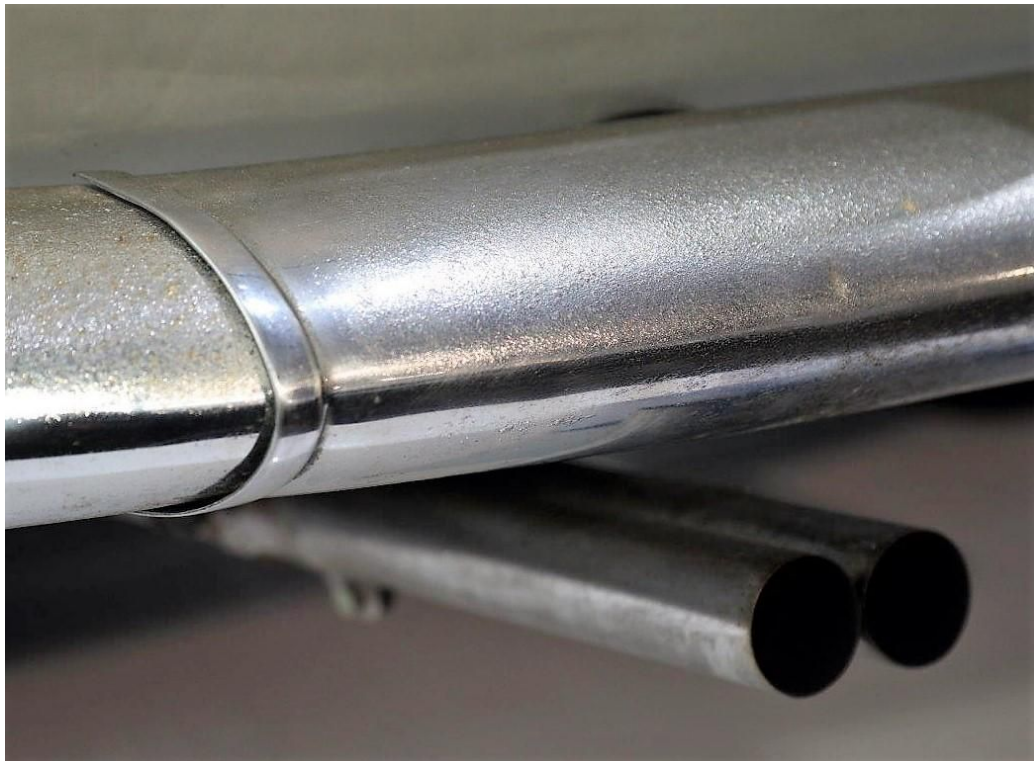
22. Weathering chrome still intact. 250 Europa. Image David Carte

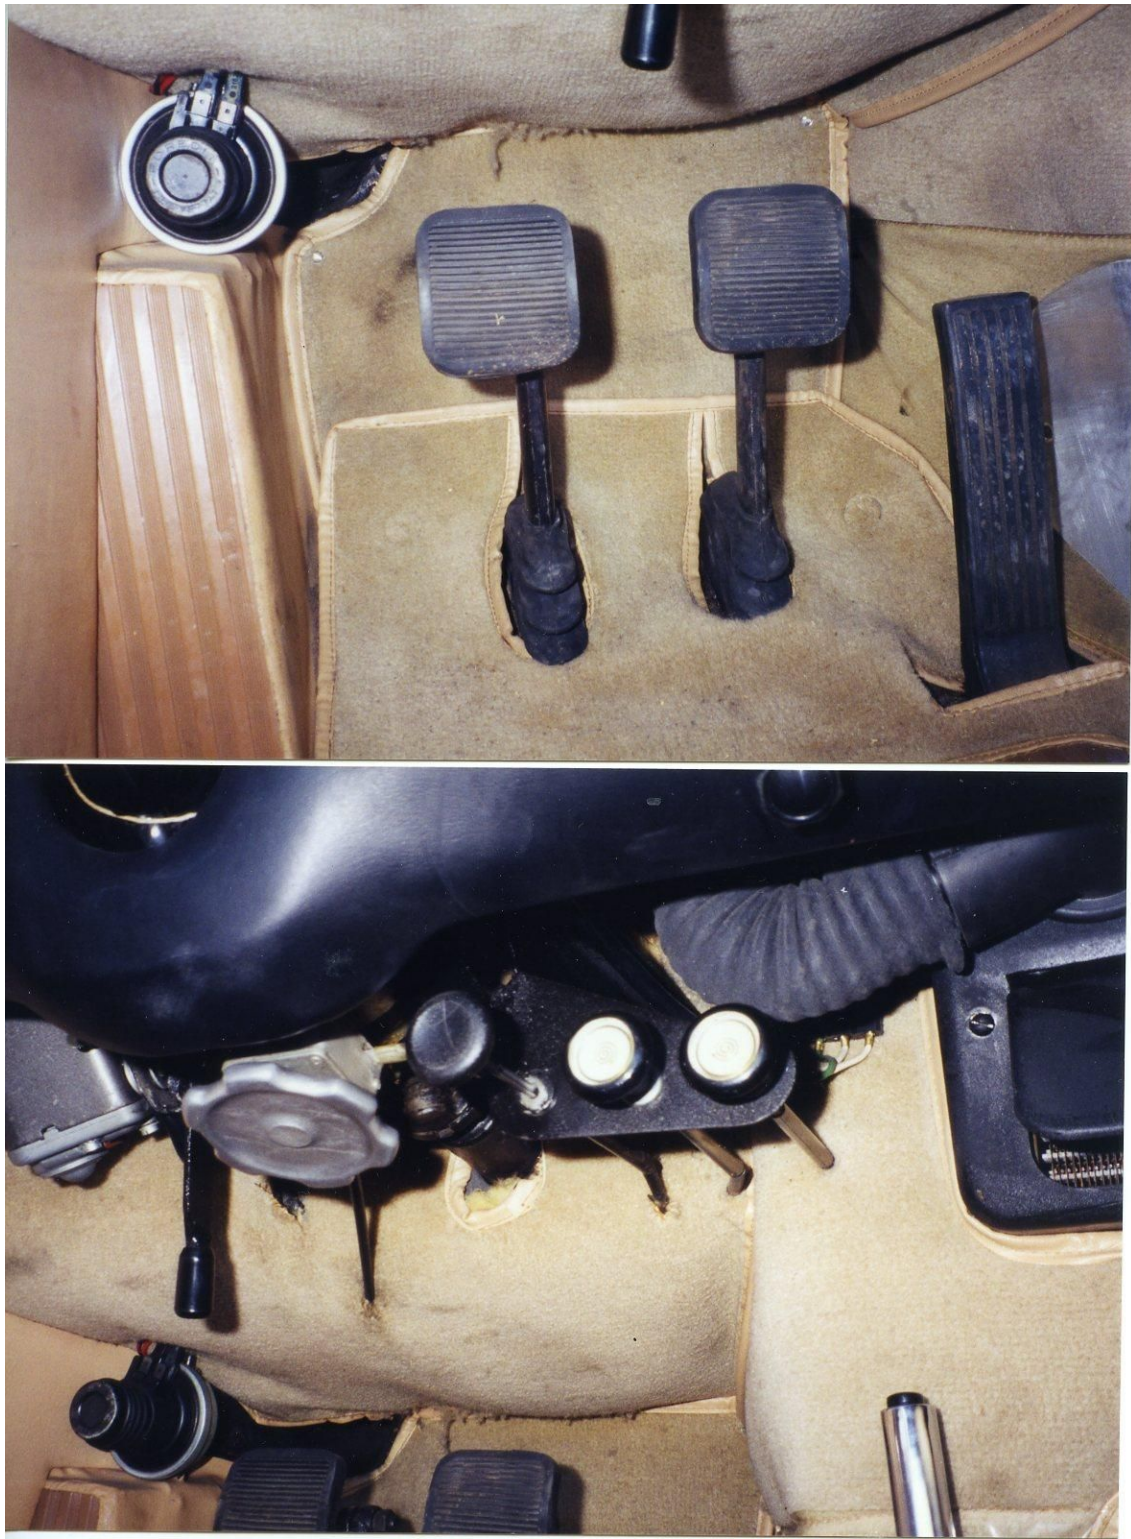
23. Rough fit, uneven stitching and untrimmed cut-outs reflect typical Scaglietti practice. 250 Lusso.
Image David Carte

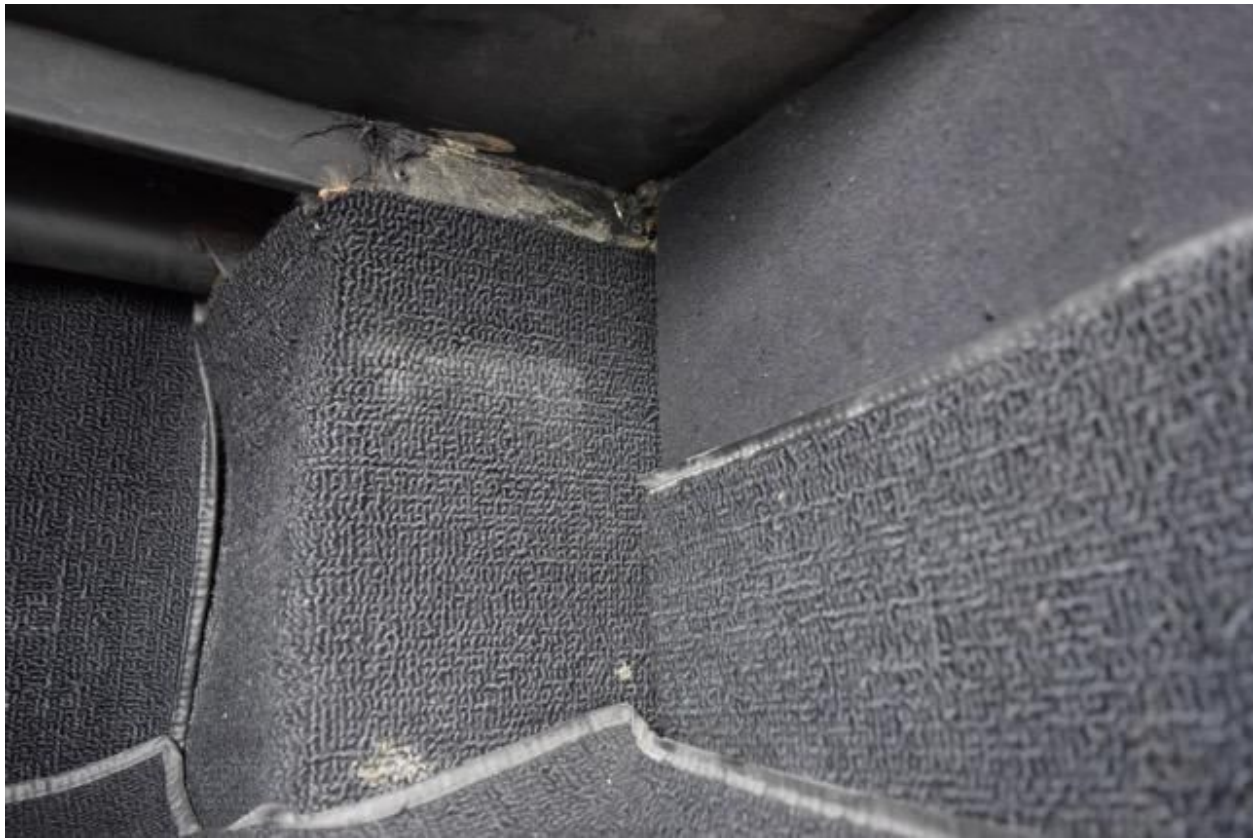
24. Trunk carpet, untrimmed as built with glue overlap on frame. 246 Dino. Image Marco Hartner.

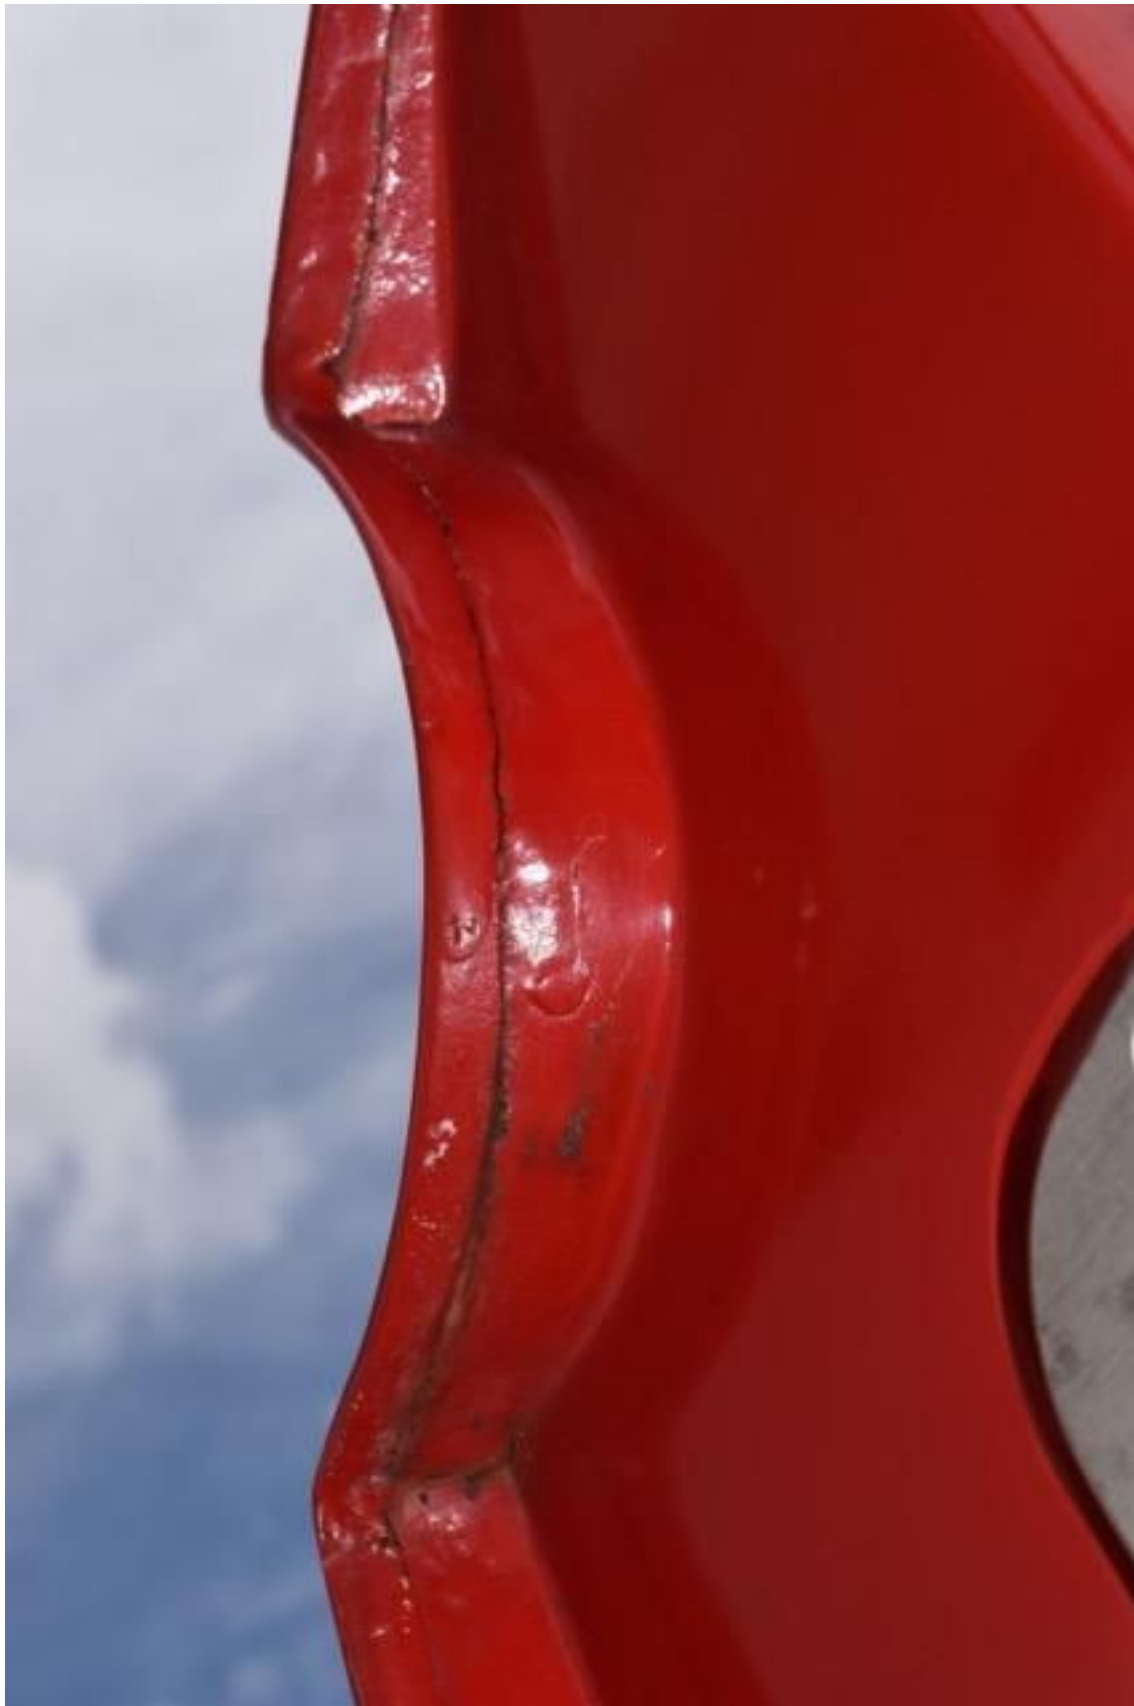
25. Typical rough door-jamb craftsmanship and paint blemes. 246 Dino. Image Marco Hartner

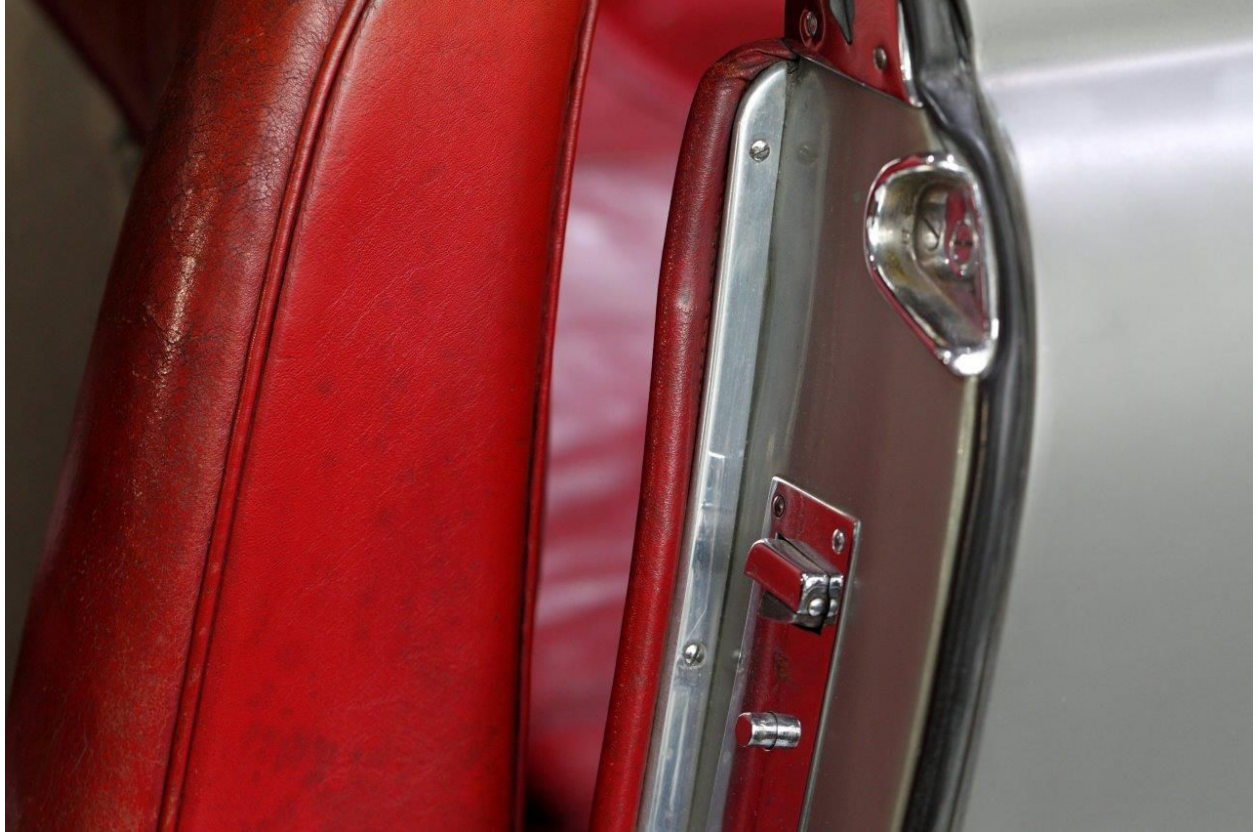
26. Unrestored interior with original door jamb chrome and rubber seal. 250 Europa. Image David Carte

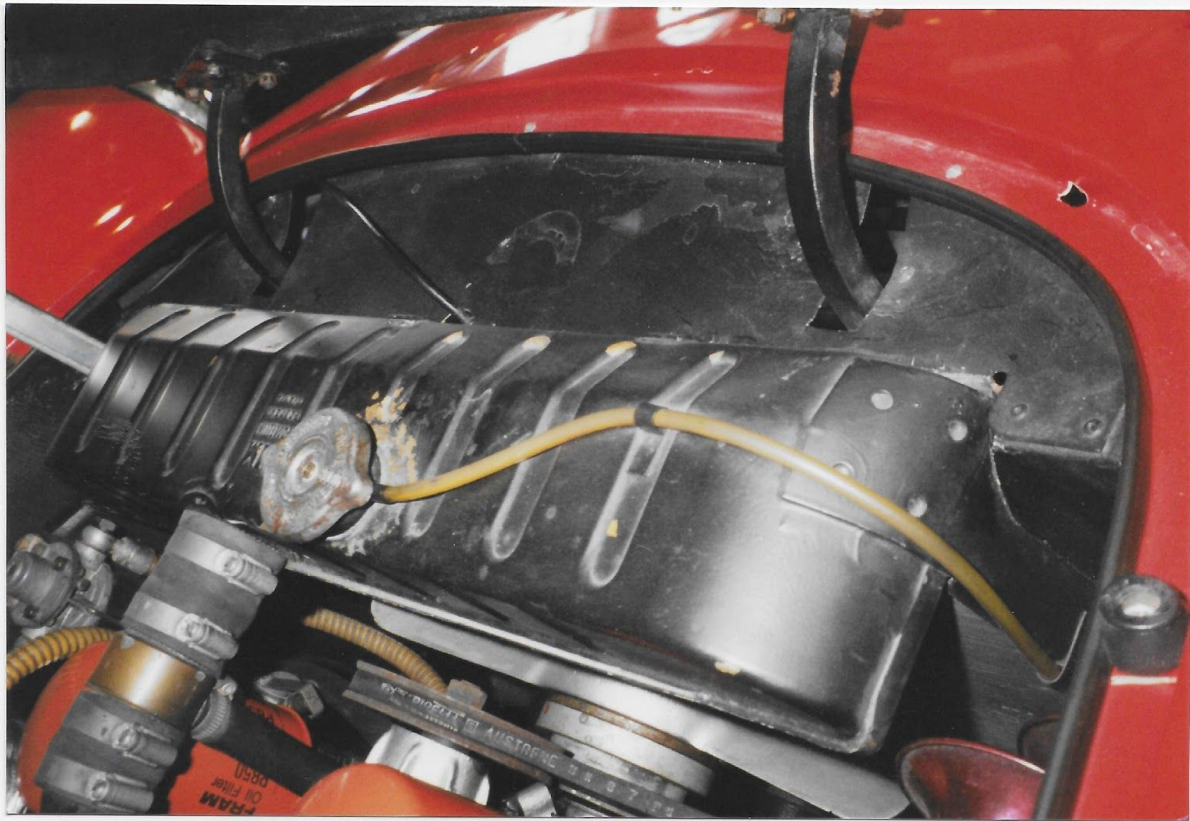
27. Weathered original details but belt probably replaced (acceptable). 250 Lusso. Image David Carte

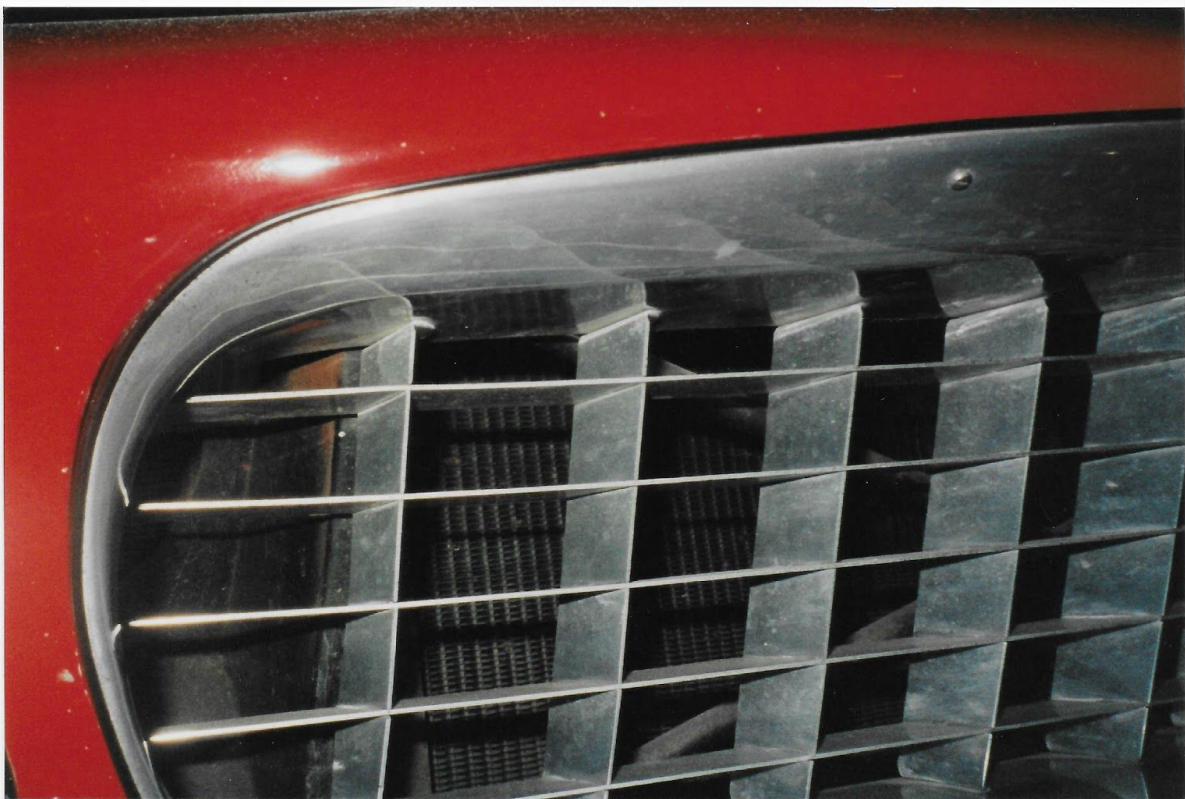
28. Original grill surround, still intact and functional. 250 Lusso. Image David Carte

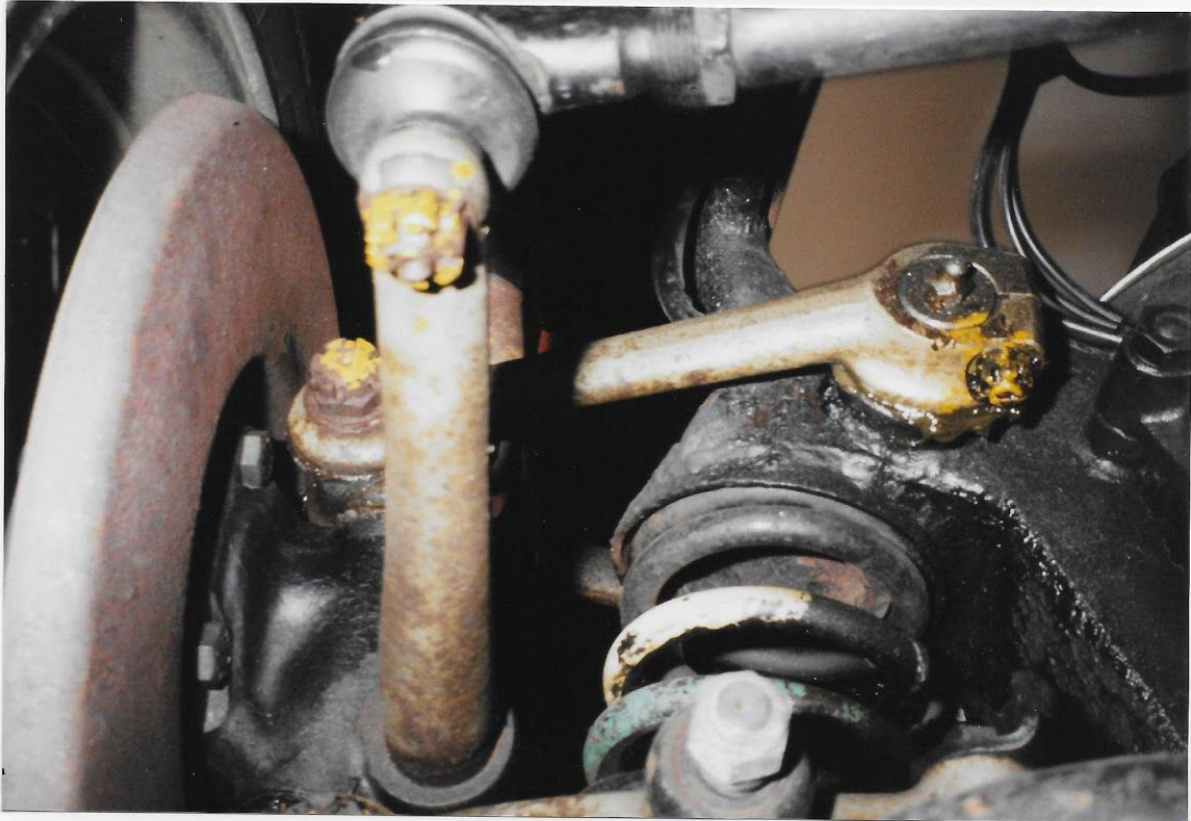
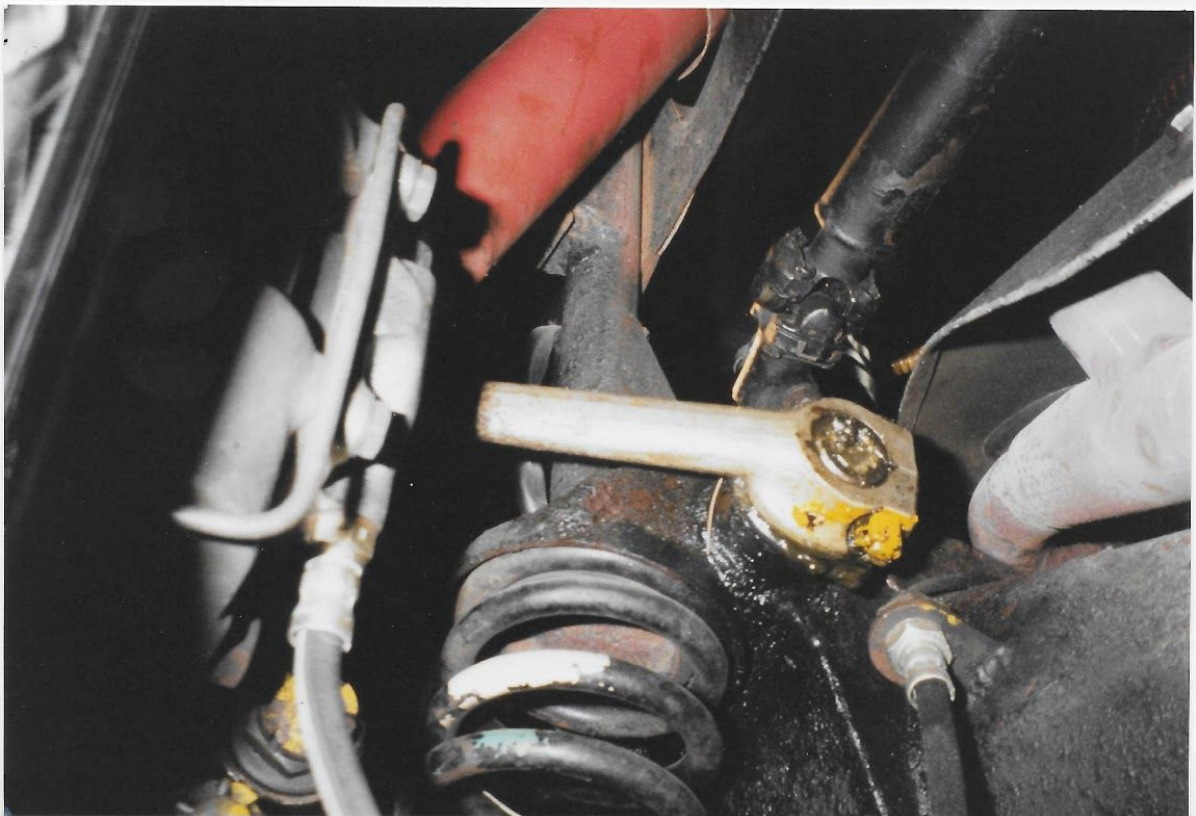
29. As-built suspension with yellow tightening marks intact. 250 Lusso. Image David Carte

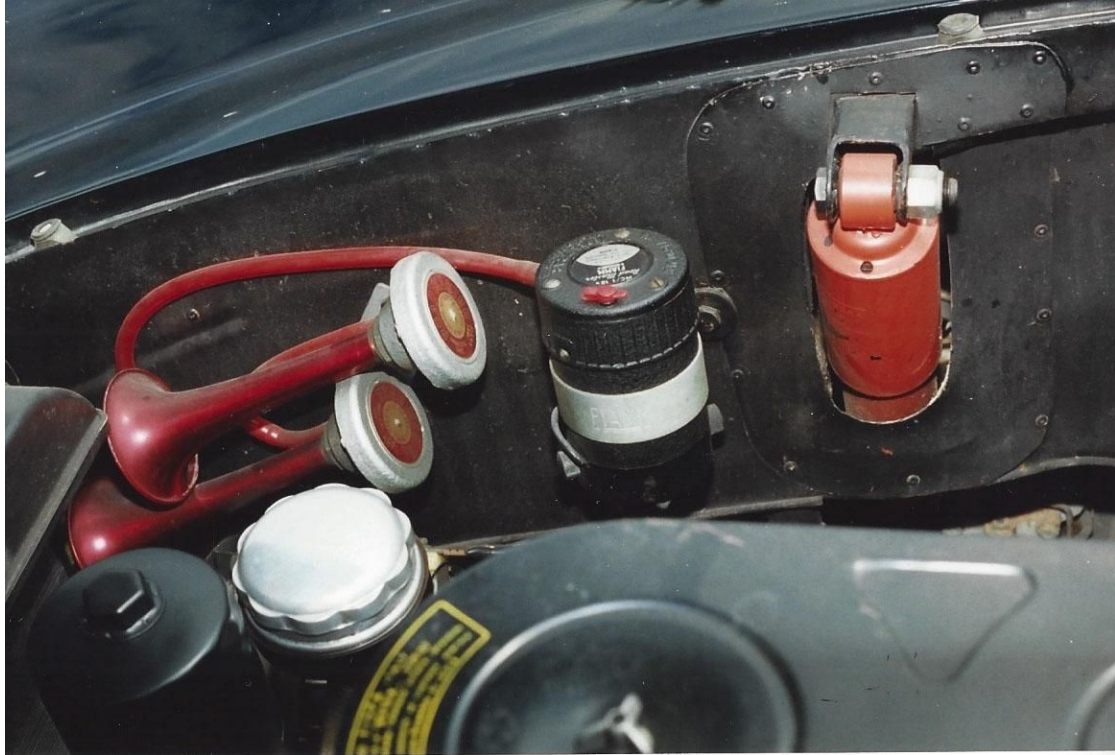
30. Typical original Lusso engine compartment except repainted oil filter. Note rivets, logos, horns. 250 Lusso. Image Greg Jones

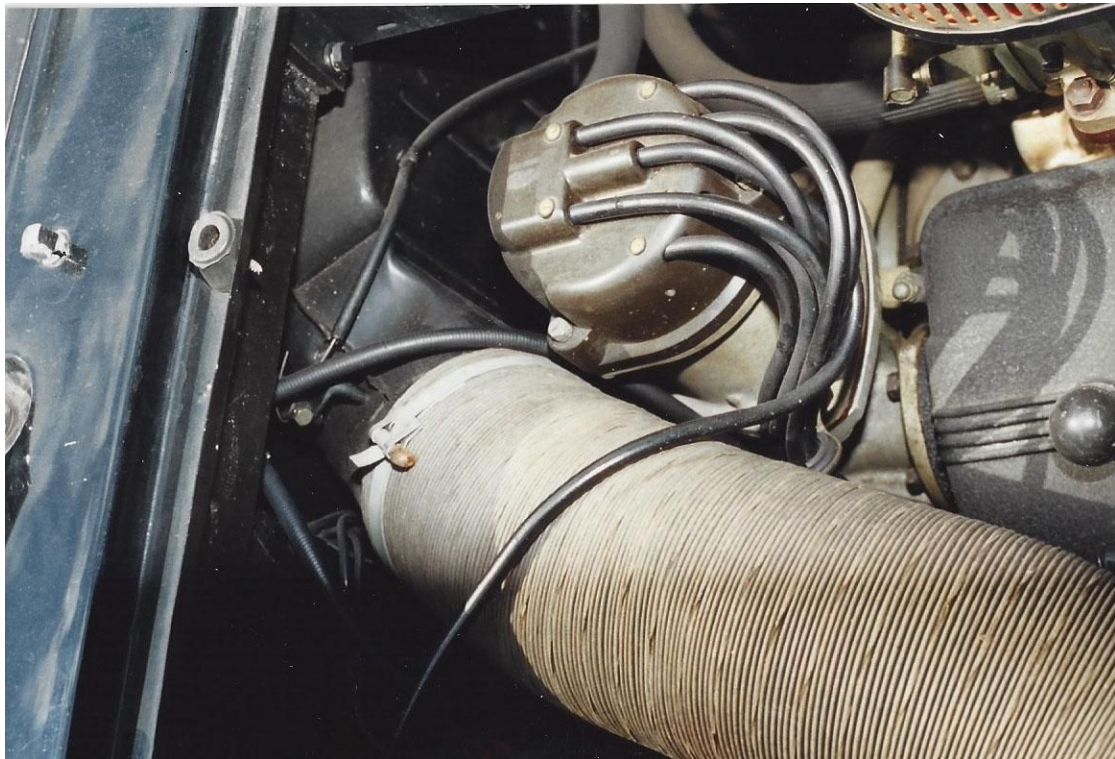
31. Original washer nozzles, paper air hose with Copiglias and other details.. 250 Lusso. Image Greg Jones

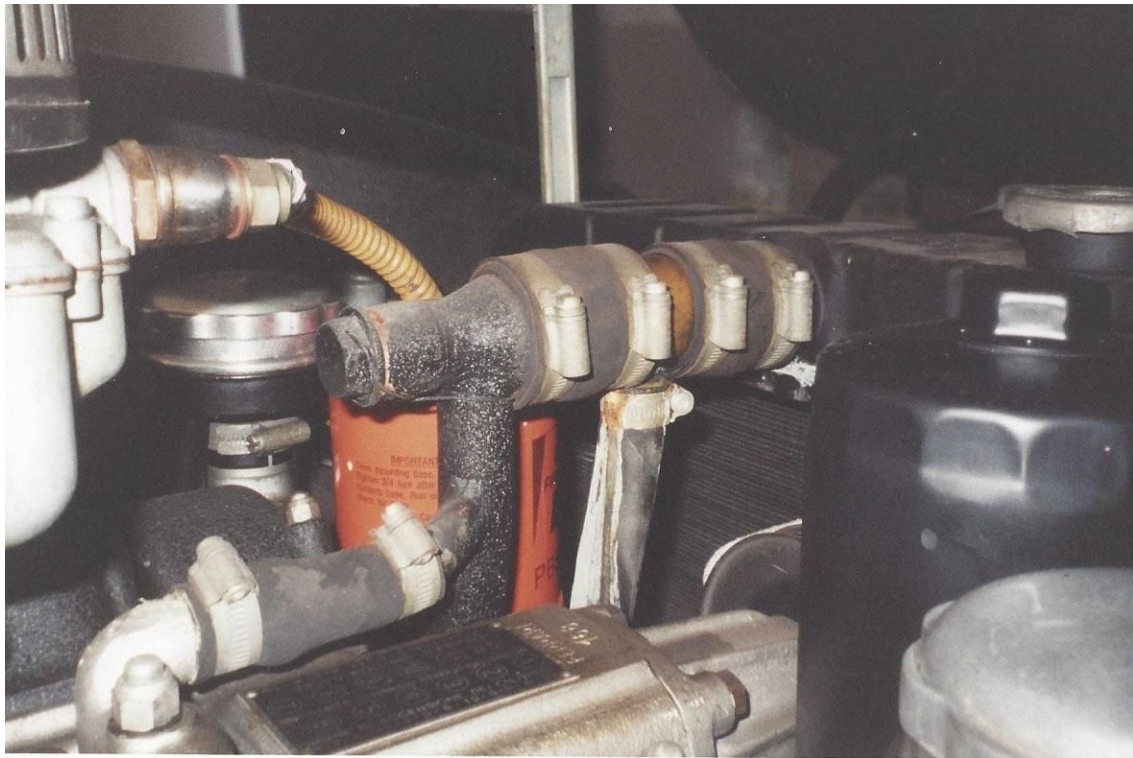
32. Typical use of Cheney clamps. 250 Lusso. Image Greg Jones

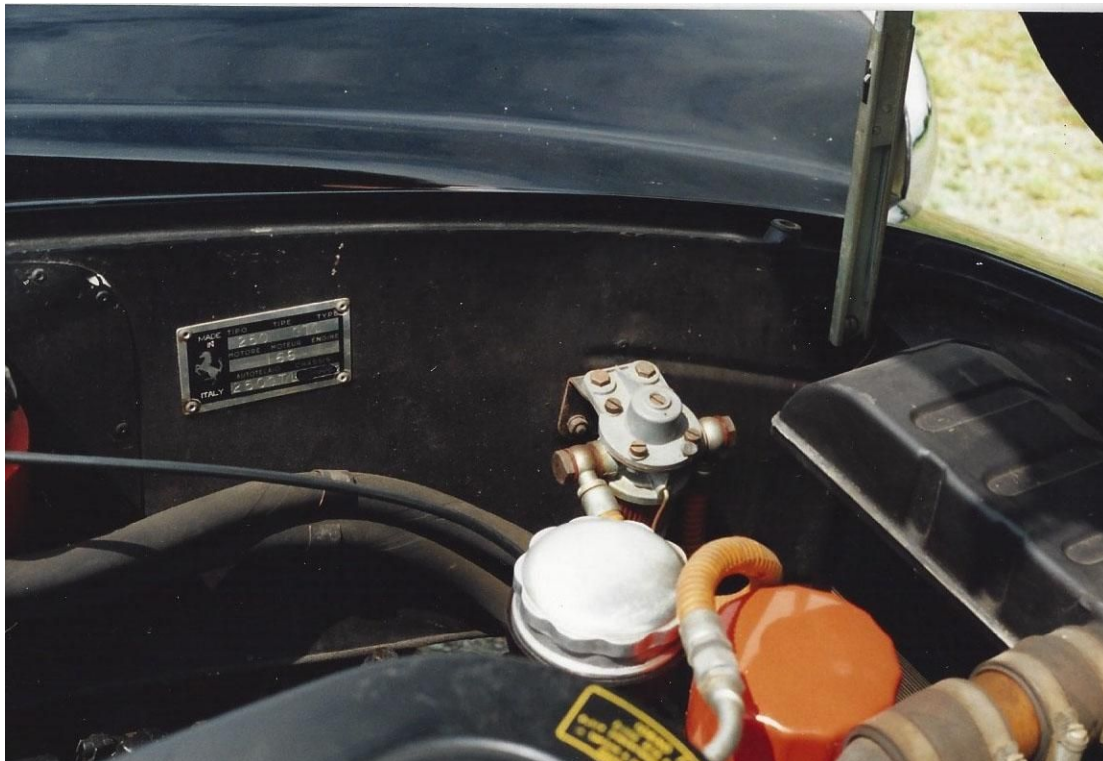
33. Multiple original details for reference. 250 Lusso. Image Greg Jones

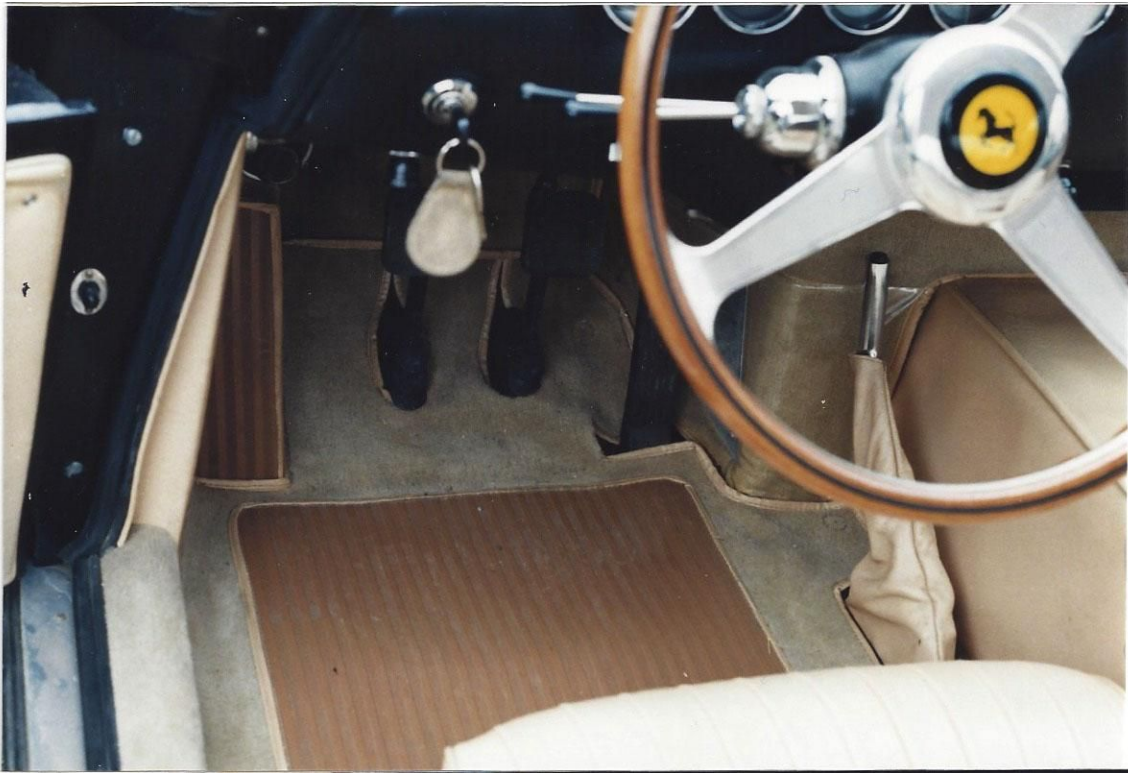
34. Typical interior. Note brake boot, heel pads, keyfob. 250 Lusso. Image Greg Jones

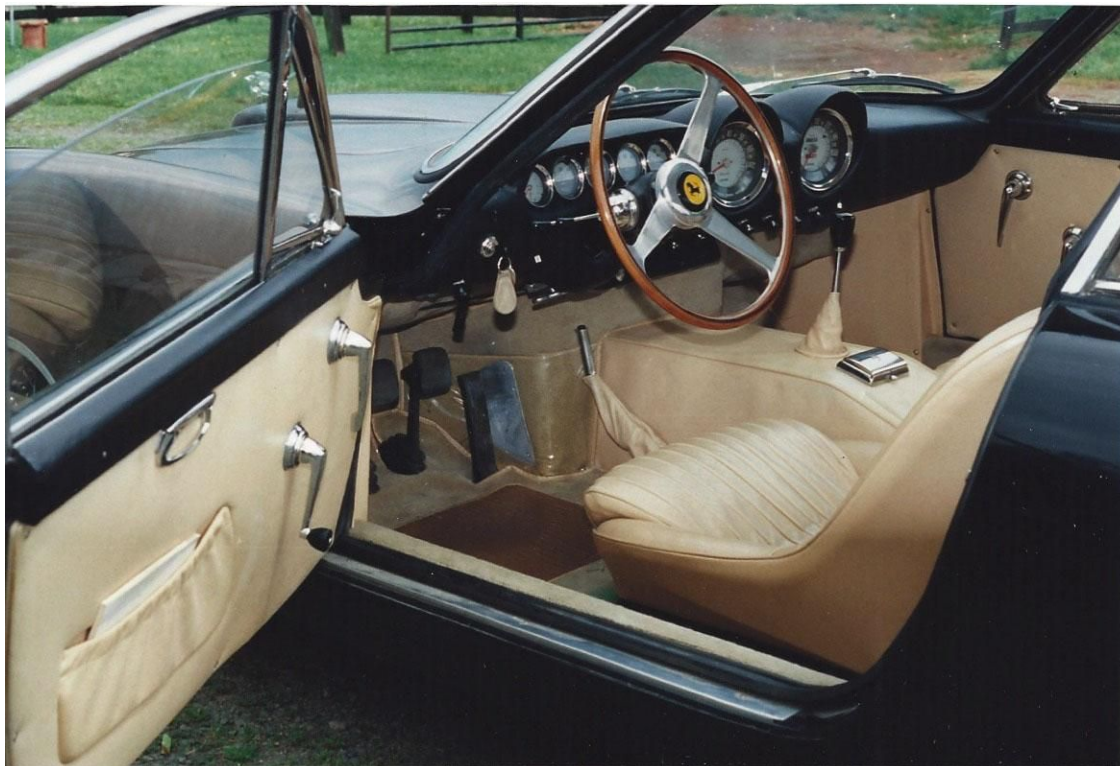
35. Original interior, puckered door pocket and console and plastic scuff guard. 250 Lusso. Image Greg Jones

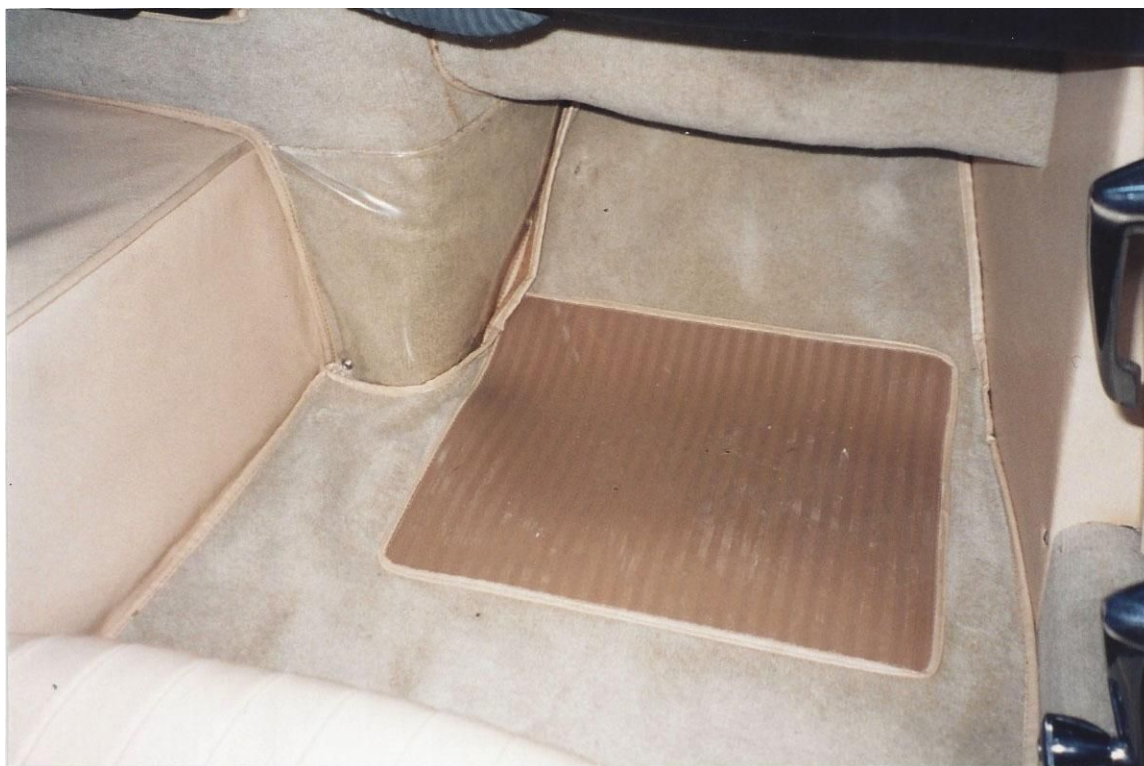
36. Plastic scuff guard, unevenly fitting vinyl bound mat. 250 Lusso. Images Greg Jones

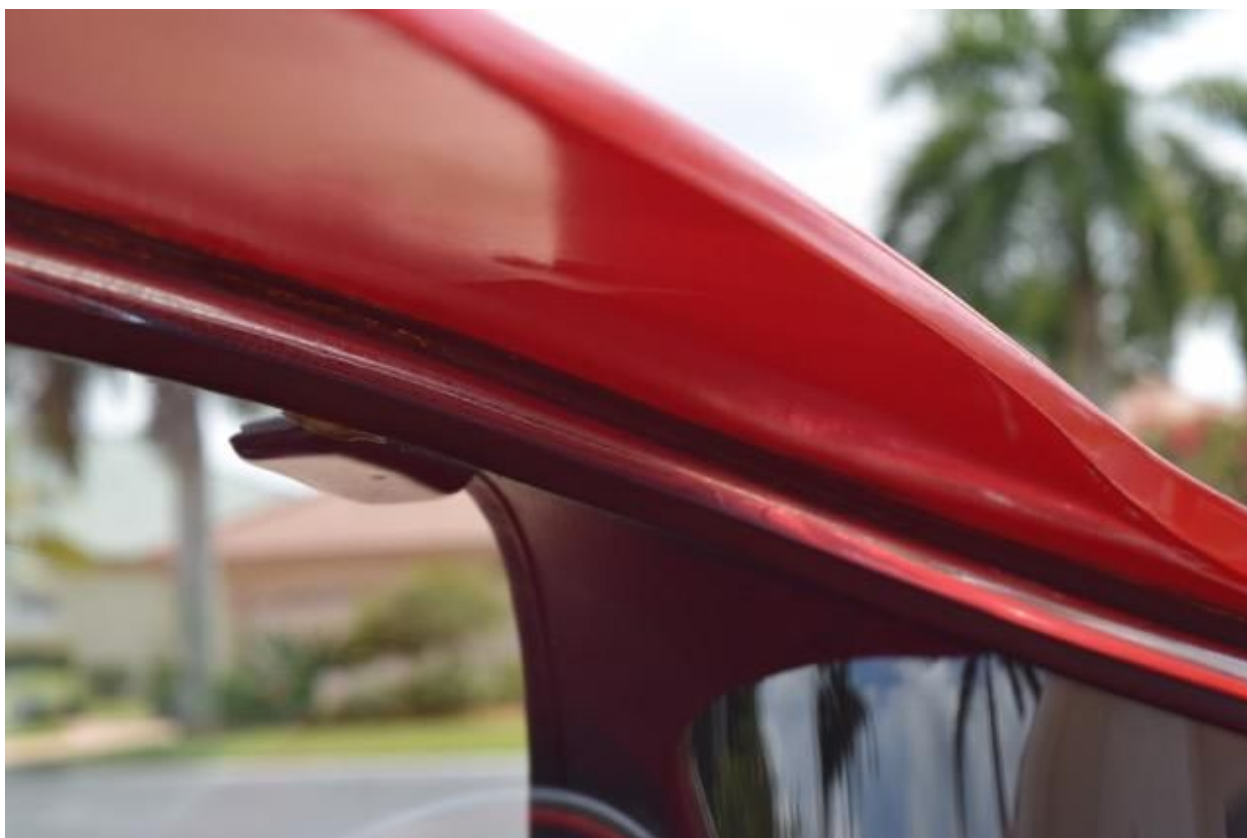
37. Typical factory paint blemish on door jam as delivered. 246 Dino. Image Marco Hartner

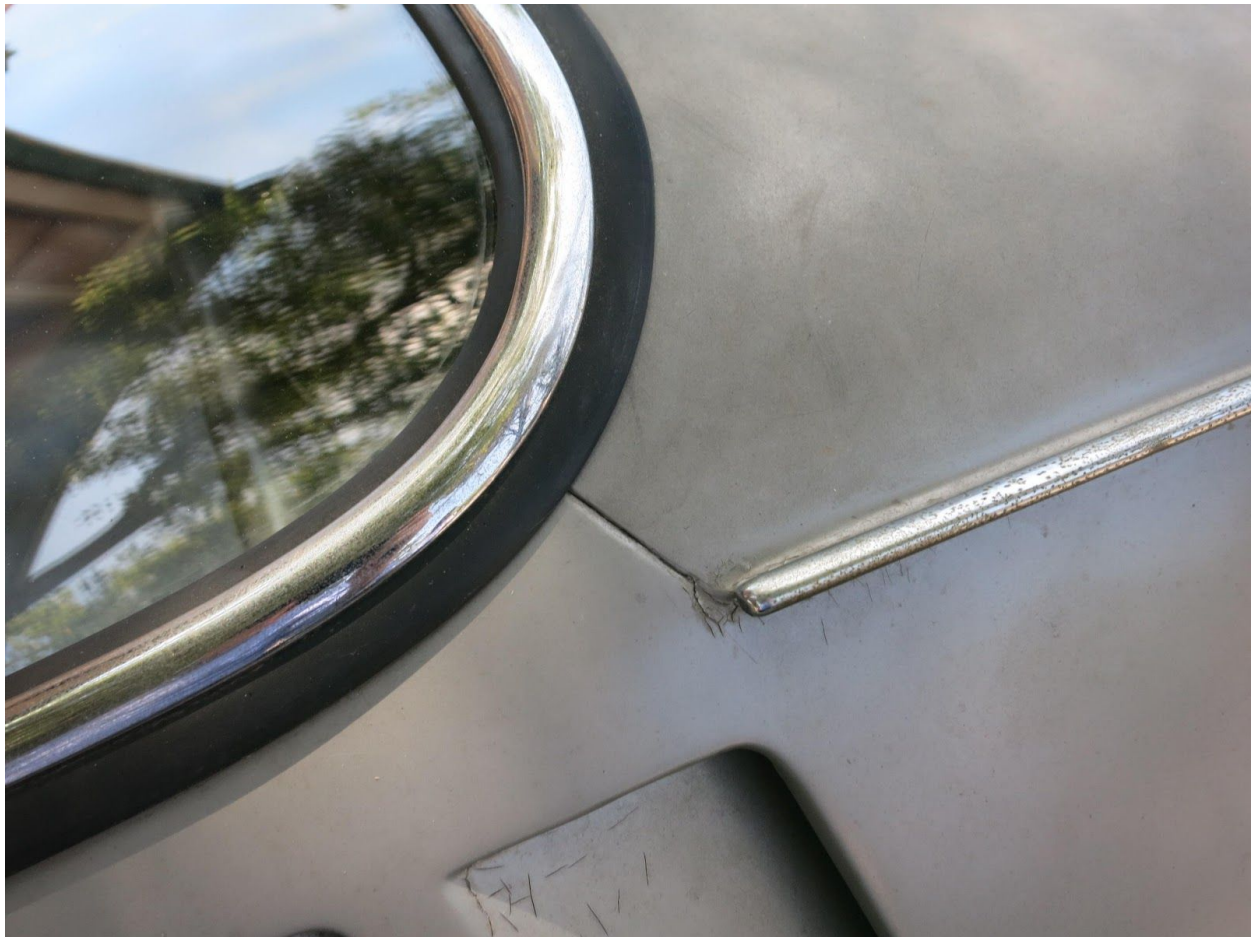
38. Original glass, molding, paint and construction detail. 275 GTB Alloy. Image Donovan Leyden

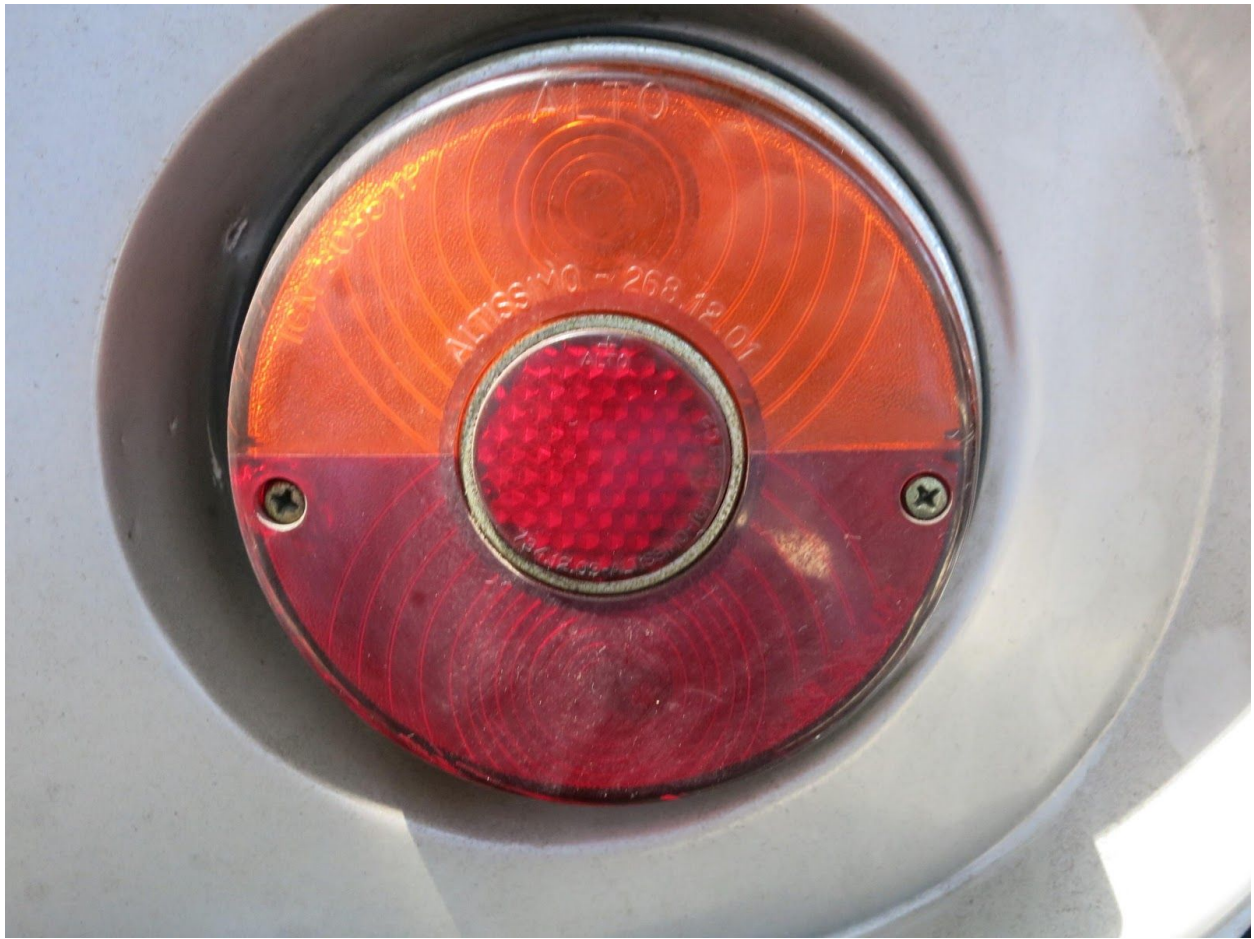
39. Aged tail light lens and screws with appropriate original patina. 275 GTB Alloy. Image Donovan Leyden

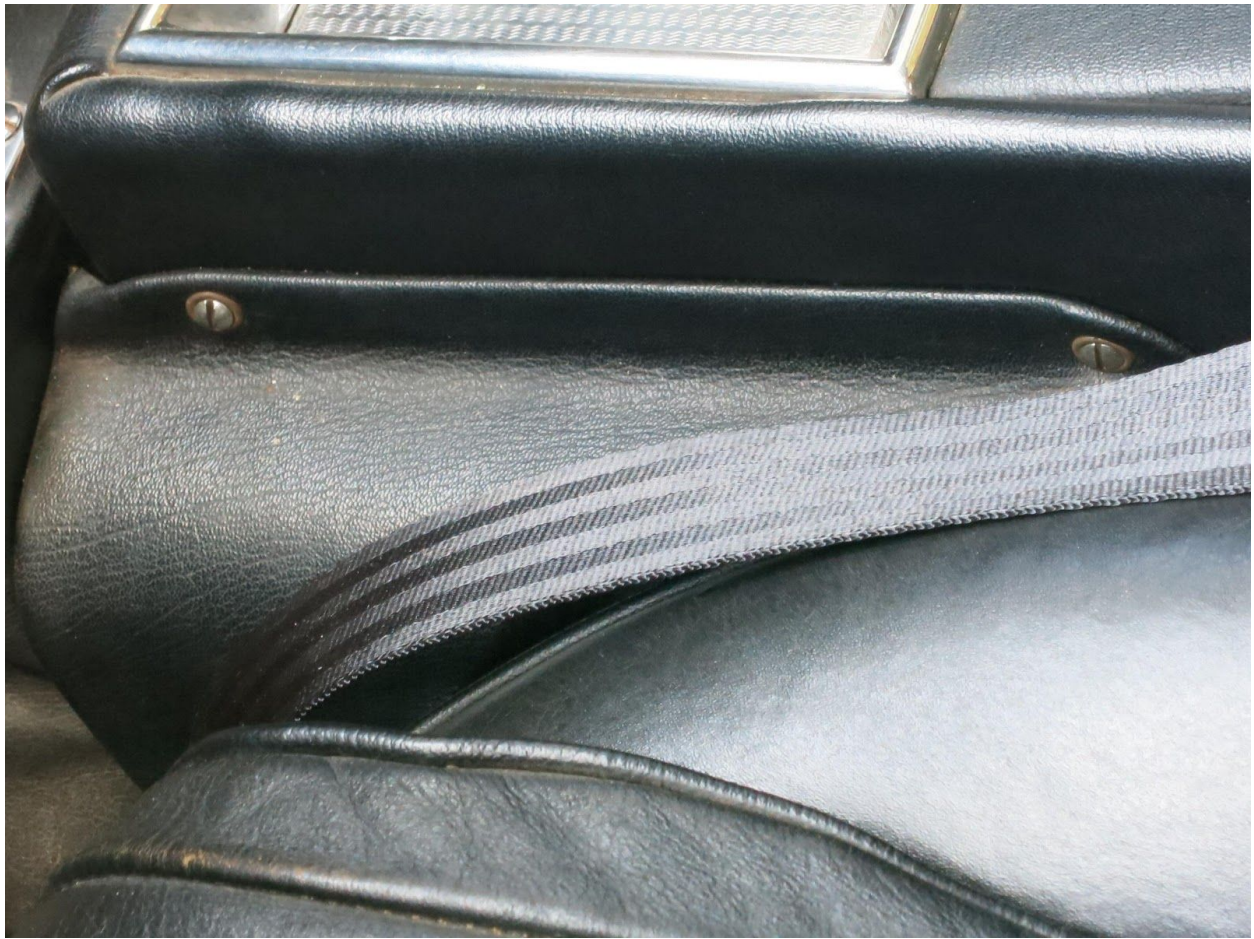
40. Seat and console materials, with original grain, hardware and lap belt. 275 GTB Alloy. Image Donovan Leyden
