2017 Ferrari Club of America Major Award Winners 1969 365 GTB/4 Speciale s/n 12925, Luigi Chinetti Memorial Award for Outstanding Ferrari Road Car (foreground), 1960 250 GT Pinin Farina Coupe Series II s/n 1747 GT, National Vintage Preservation Award for Best Preserved Ferrari Pre-1980 (background).

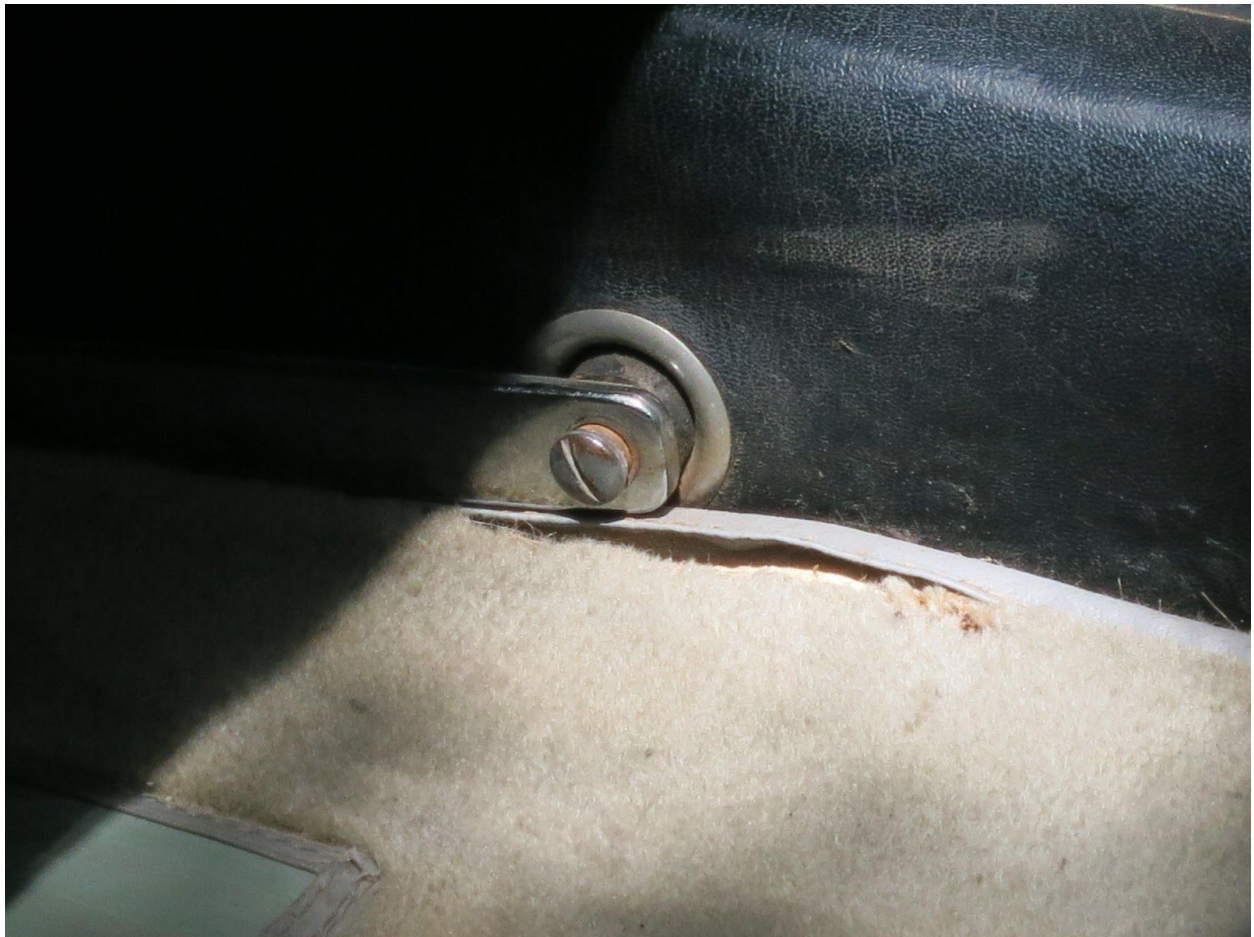
41. Note passenger footrest hardware, carpet weave, vinyl bound and stitched heel pad. 275 GTB Alloy.
Image Donovan Leyden

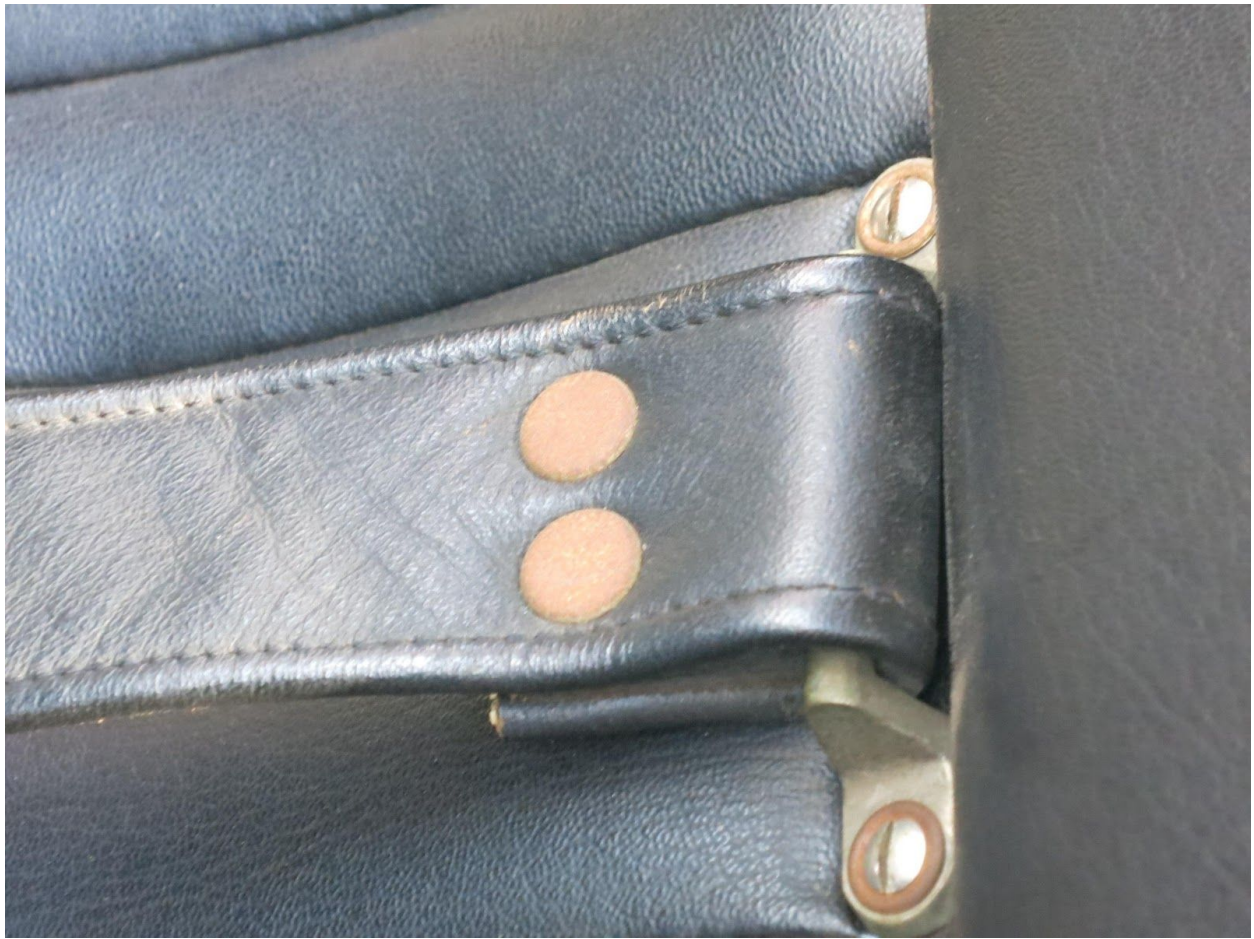
42. Luggage strap and upholstery texture, stitching and hardware. 275 GTB Alloy. Image Donovan Leyden

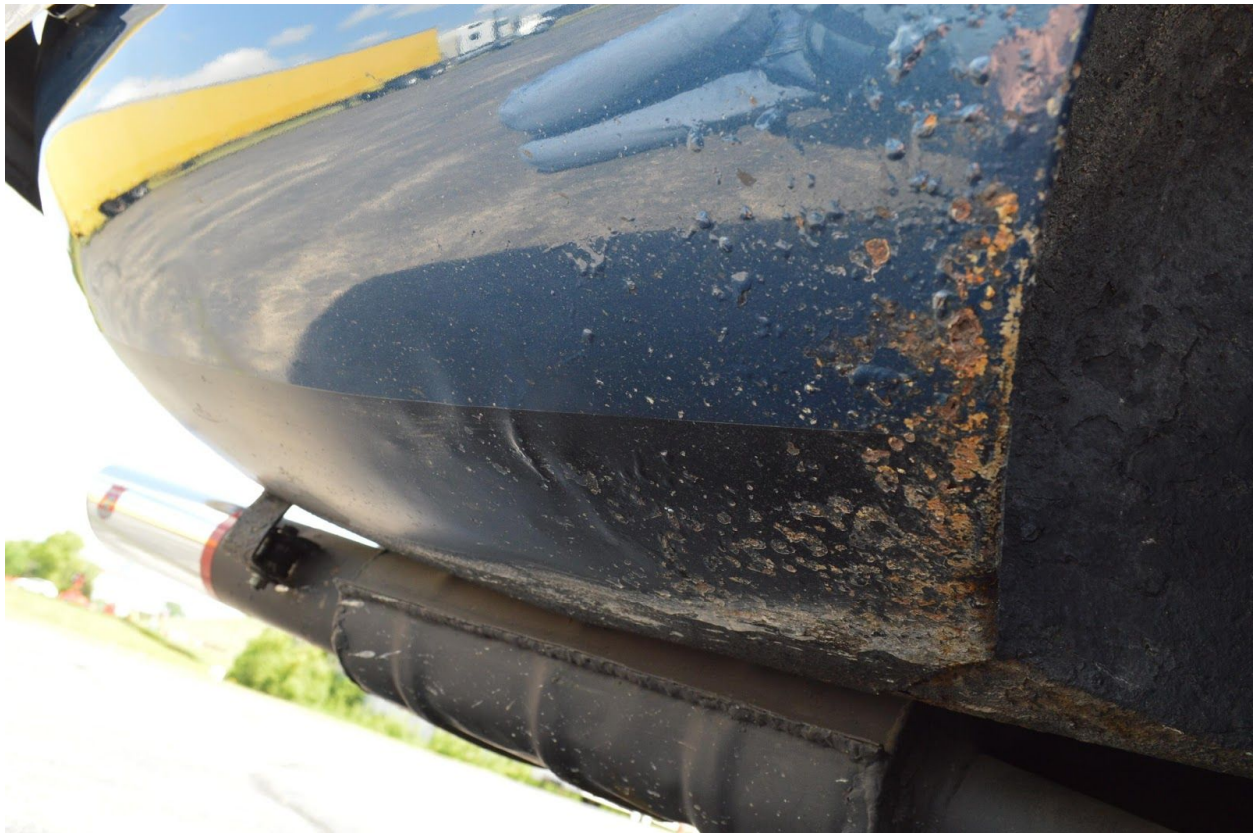
43. Original Daytona Speciale resonator with limited repair (welded cap). Owner resisted temptation to repaint despite some surface rust. Daytona Speciale. Image Dustin Wetmore

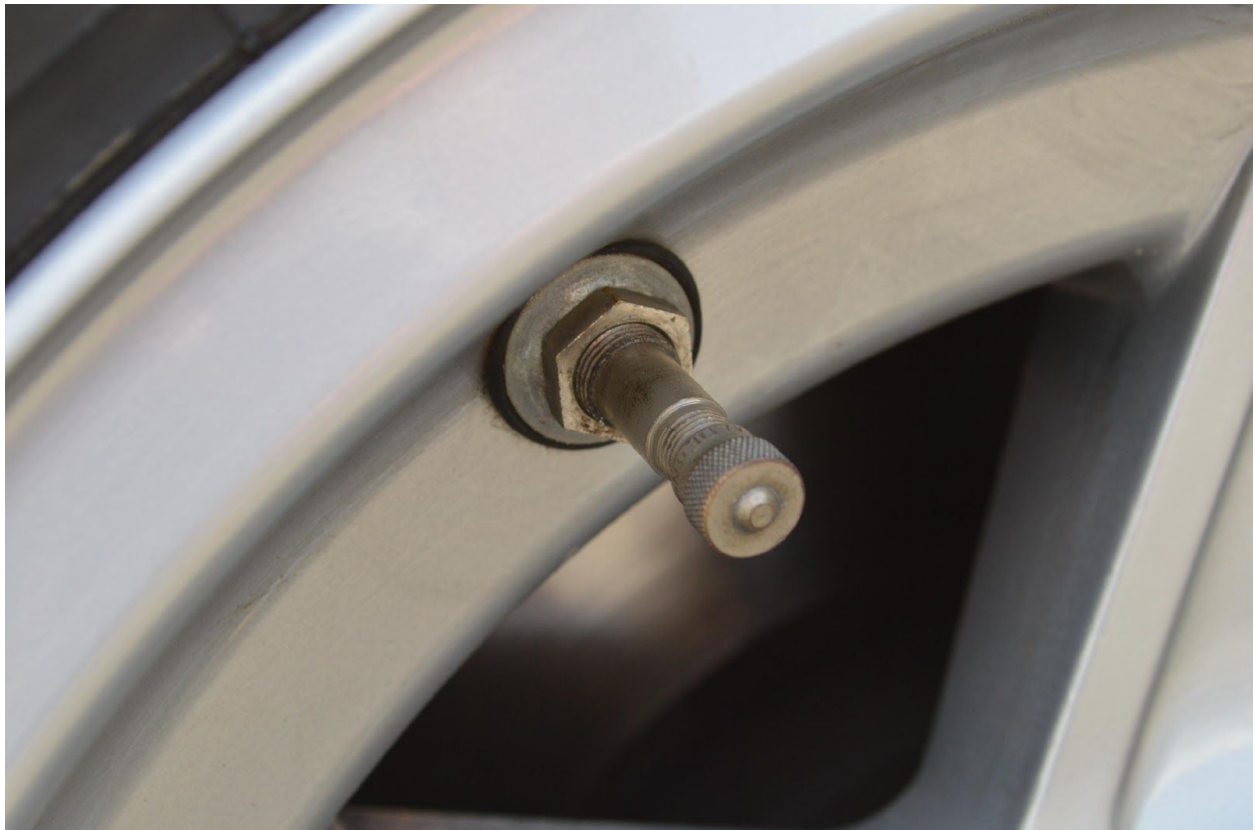
44. Serviceable Michelin XWX tube sleeve. Daytona Speciale. Image Dustin Wetmore

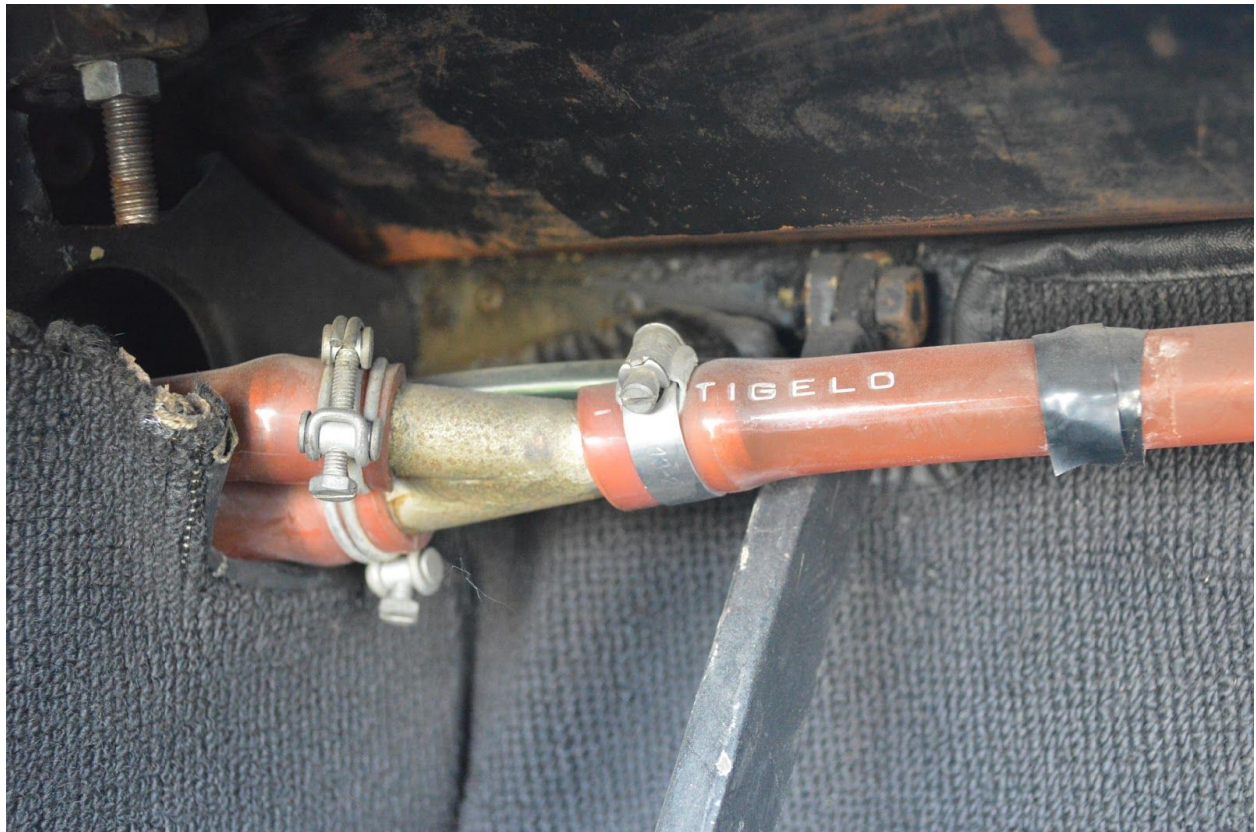
45. Unmolested original trunk, fuel vapor hose and clamps. Daytona Speciale. Image Dustin Wetmore

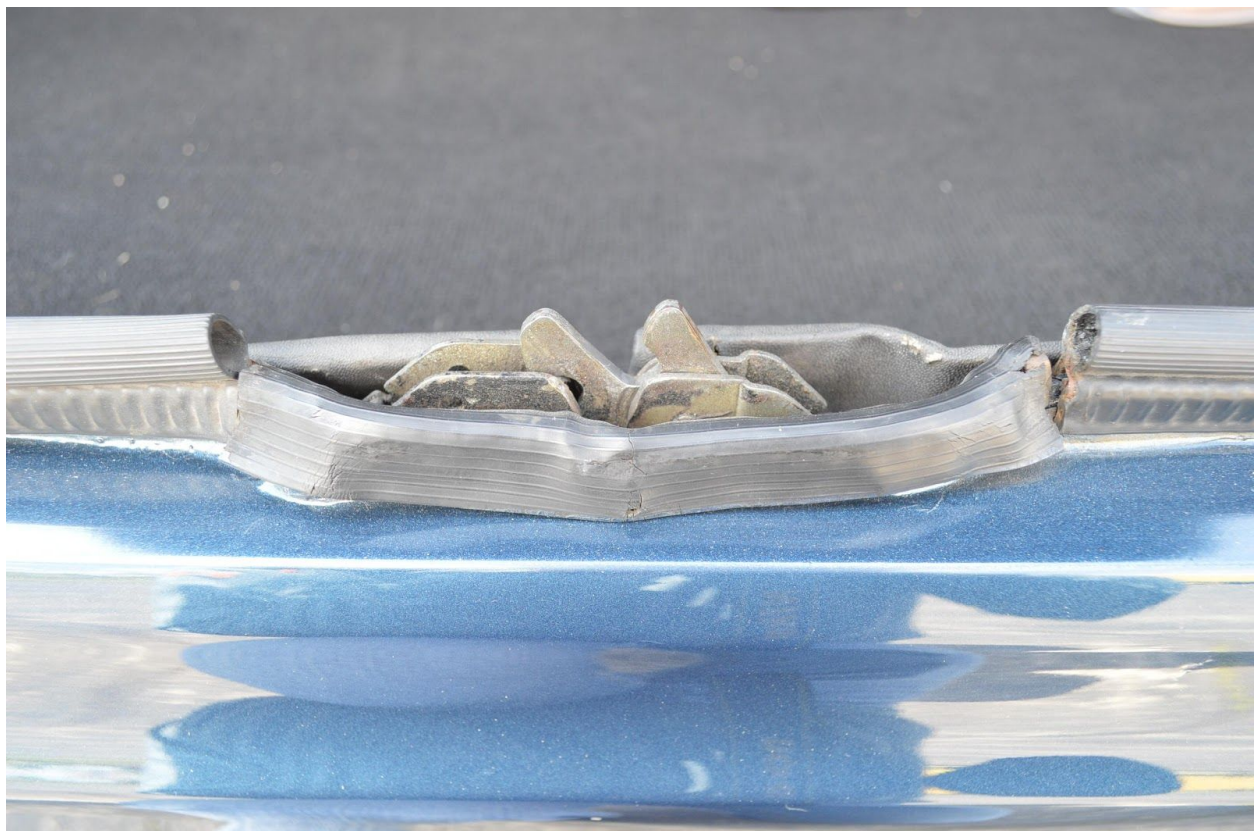
46. Functional trunk latch and moldings. Daytona Speciale. Image Dustin Wetmore

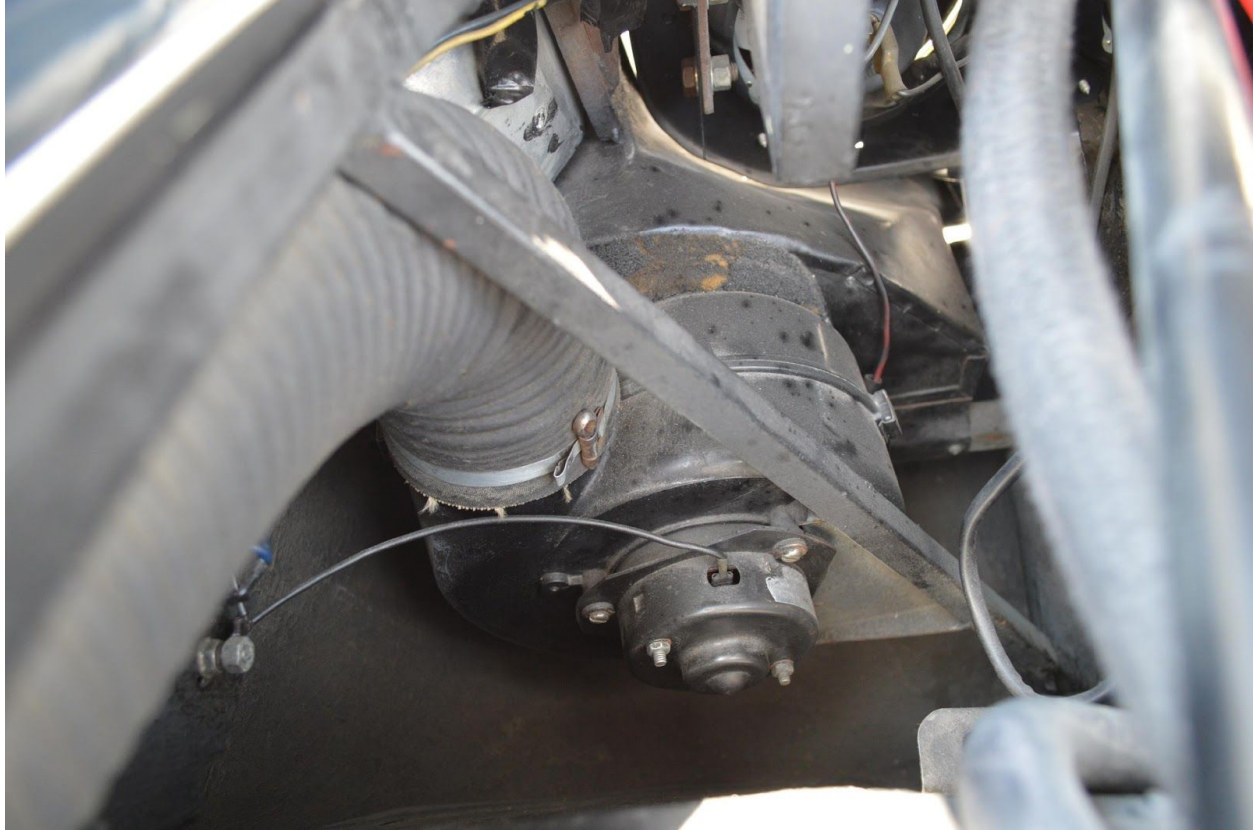
47. Untouched heater hose, clamps, motor. and wiring. Daytona Speciale. Image Dustin Wetmore

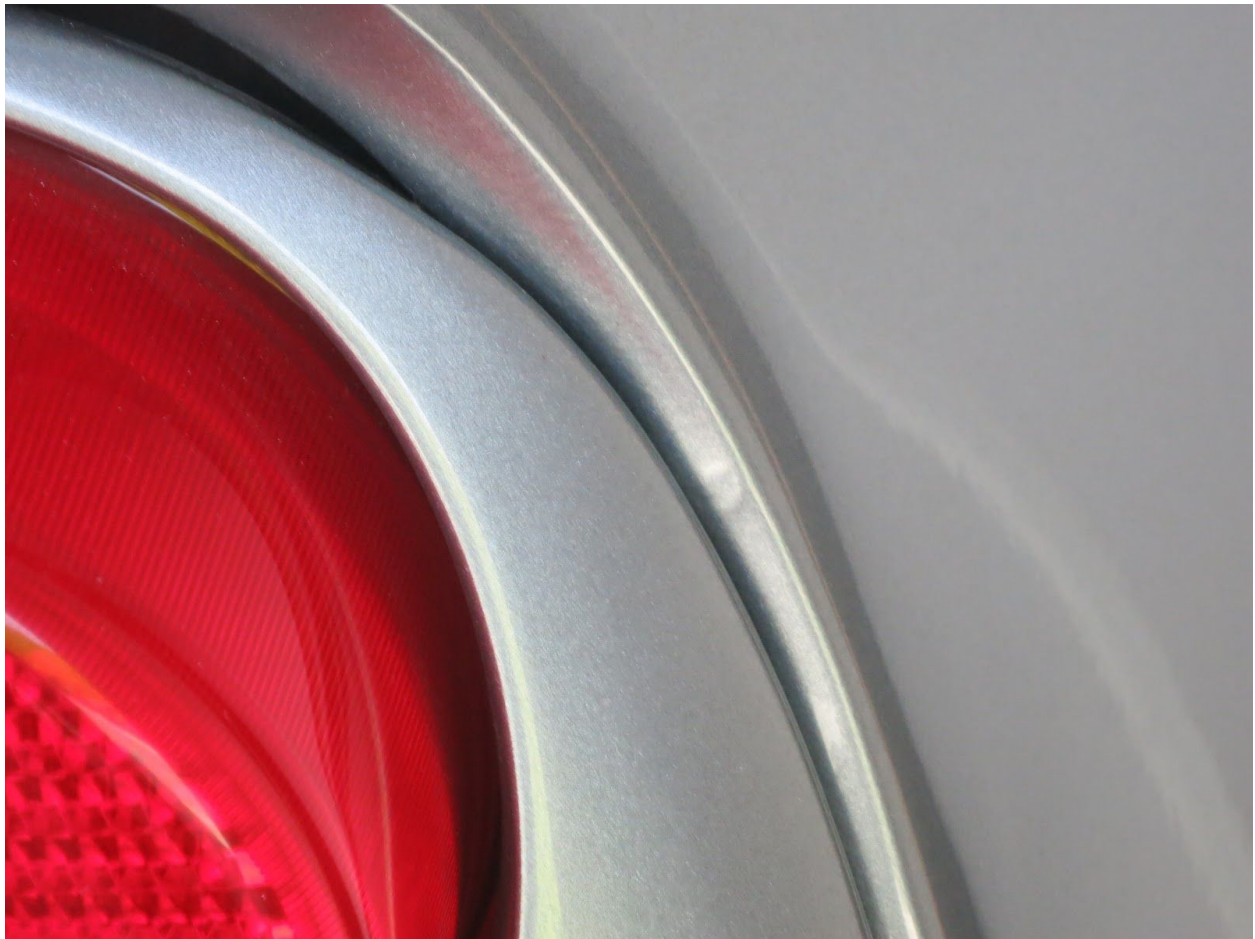
48. Typical factory paint blemish as delivered in unlikely to notice taillight area. Original 355. Image Donovan Leyden

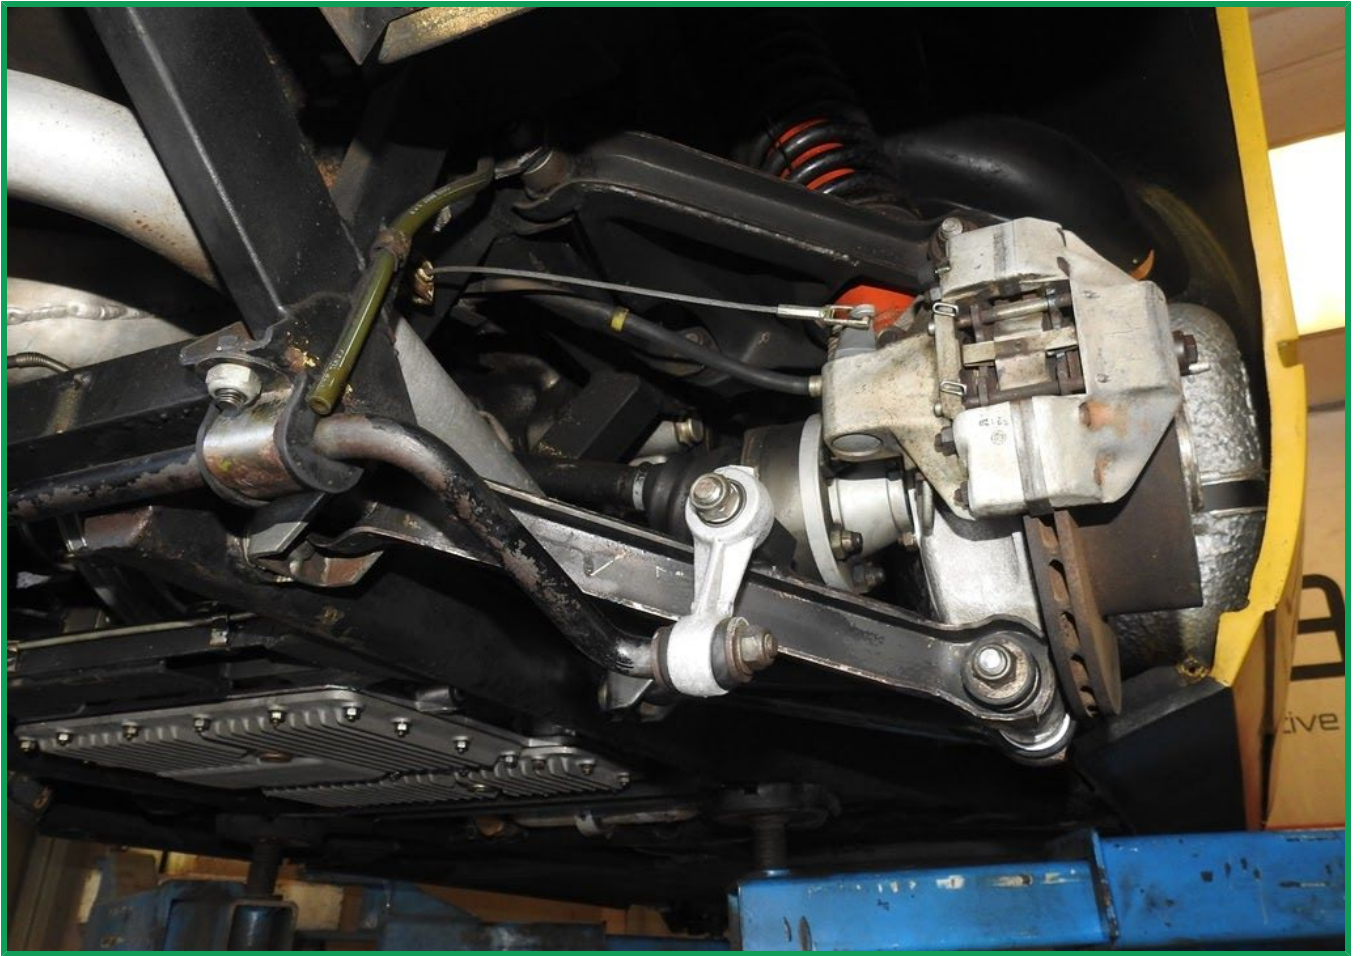
49. Original suspension and brakes with patina and cleaned with cryo. 308. Image [Senega Archive/ERS](#)
