**LONG POINT CAUSEWAY BRIDGE**

Site Number 985901

**COUNTY HIGHWAY 59, SOUTH WALSINGHAM**

**Ontario Structure Inspection Manual - Inspection Form**
**Site Number:** 985901

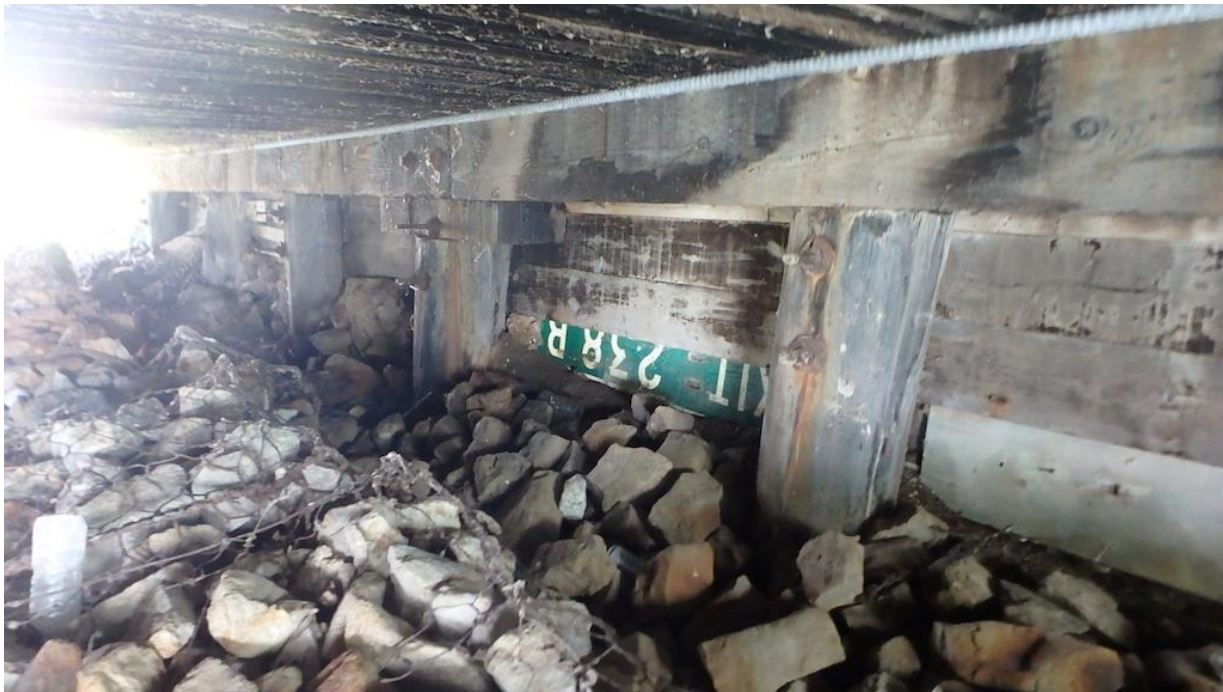
Element Group:	900 Abutments					Length:	
Element Name:	901 Abutment Walls					Width:	11.3
Location:	N & S					Height:	2
Material:	18 Wood					Count:	2
Element Type:	Crib or Gabion					Total Quantity:	45.2 sq.m
Environment:	Benign					Limited Inspection:	
Protection System:	Unknown					Perform. Deficiencies	
Condition	Units	Exc.	Good	Fair	Poor		
Data:	sq.m	0	39.2	6	0		
Comments: Gabion basket are falling apart. Some bulging occurring at abutment walls. Missing board on South abutment wall.							
Recommended Work:    Rehab <input type="checkbox"/> Replace <input type="checkbox"/> Timing:    Urgent <input type="checkbox"/> < 1yr <input type="checkbox"/> 1 - 5 yr <input type="checkbox"/> 6 - 10 yr <input type="checkbox"/>						Maintenance Needs:    Other - Replace missing board <input type="checkbox"/> <input type="checkbox"/> Urgent <input checked="" type="checkbox"/> 1 year <input type="checkbox"/> 2 year

Figure 13 South Abutment Deterioration

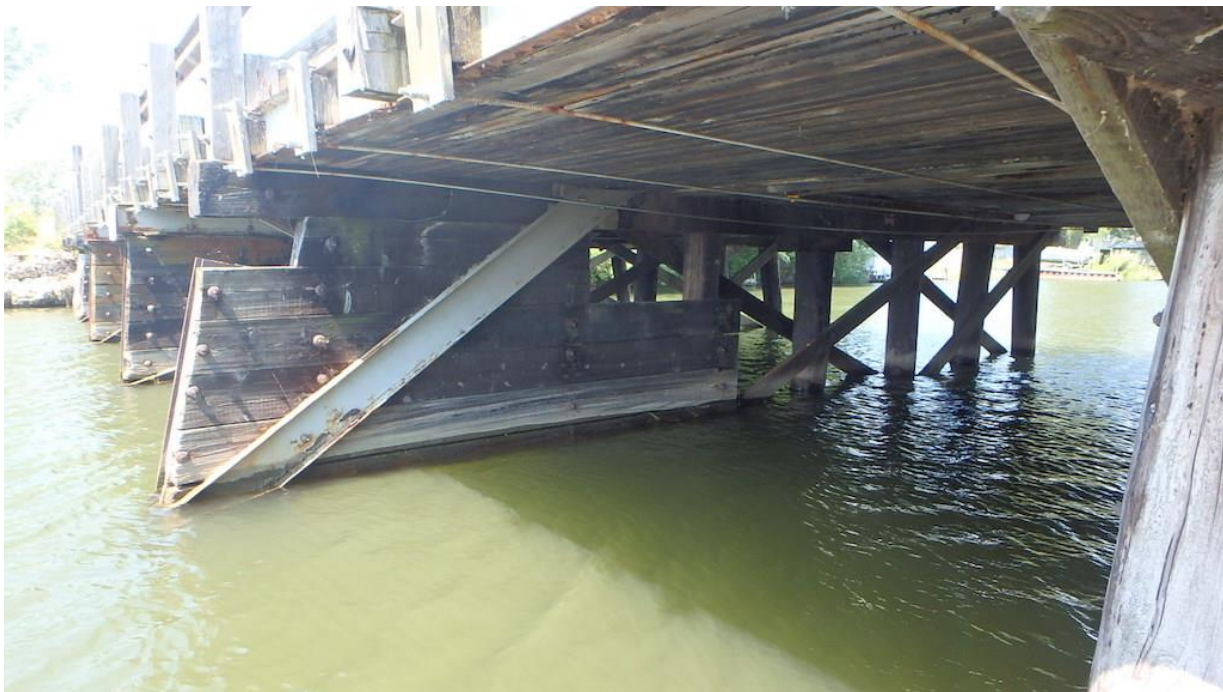
Figure 14 Steel Pier Reinforcement

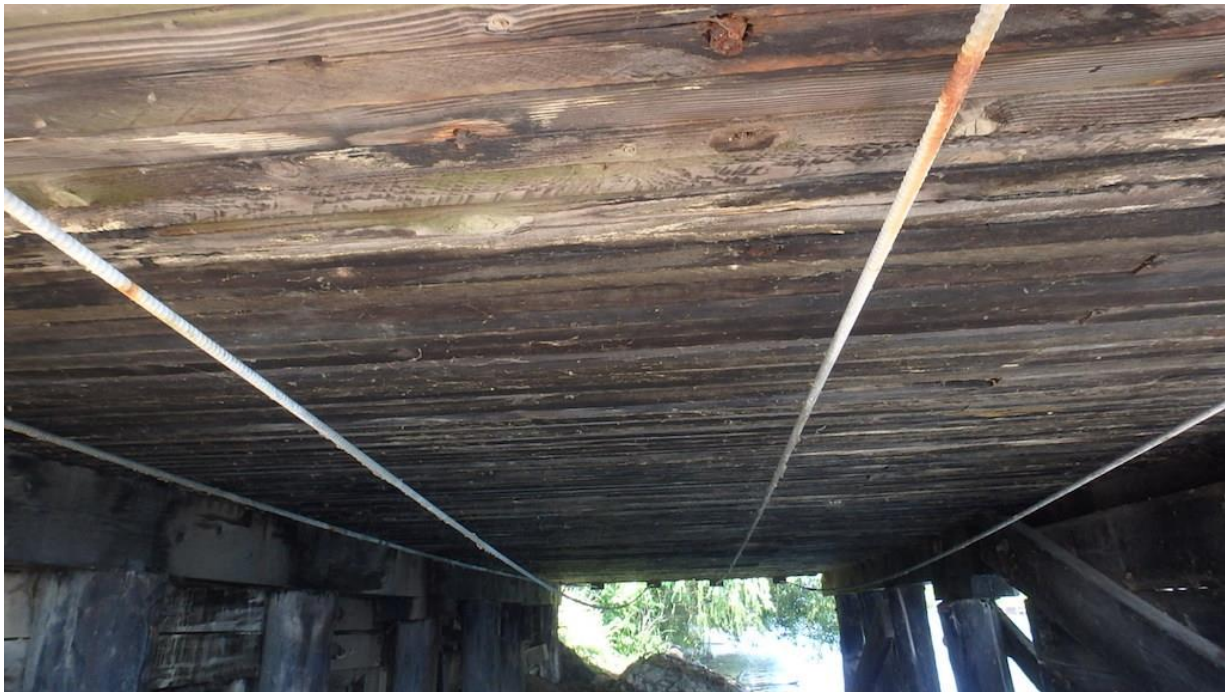
Figure 15 Loose Post Tension Strands

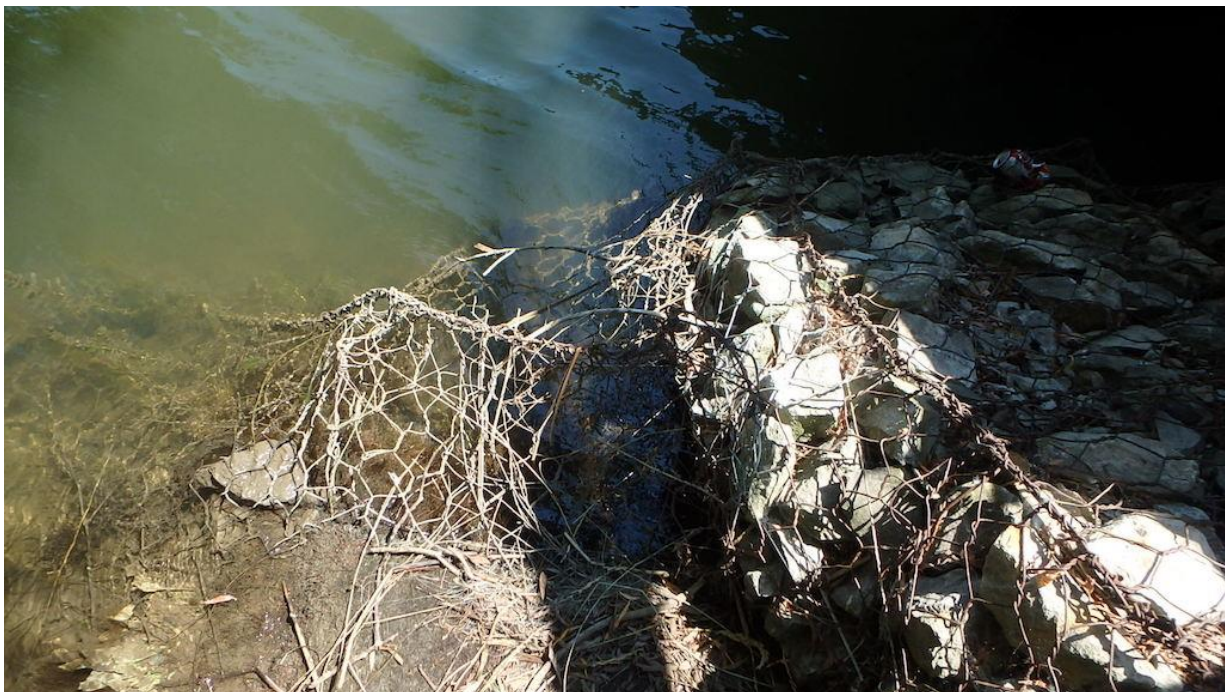
Structure Evaluation:	<input checked="" type="checkbox"/>		
Monitoring			
<input checked="" type="checkbox"/> Monitoring of Deformations, Settlements and Movements:	<input checked="" type="checkbox"/>		
<input checked="" type="checkbox"/> Monitoring Crack Widths:	<input checked="" type="checkbox"/>		
Investigation Notes:			
Underwater investigation recommended. Wooden pile not visible under water level. A longitudinal crack pattern in the first span (South end) is showing in the asphalt surface. Gabion basket protection at both abutments show failure.

Figure 16 Deteriorated Gabion Basket

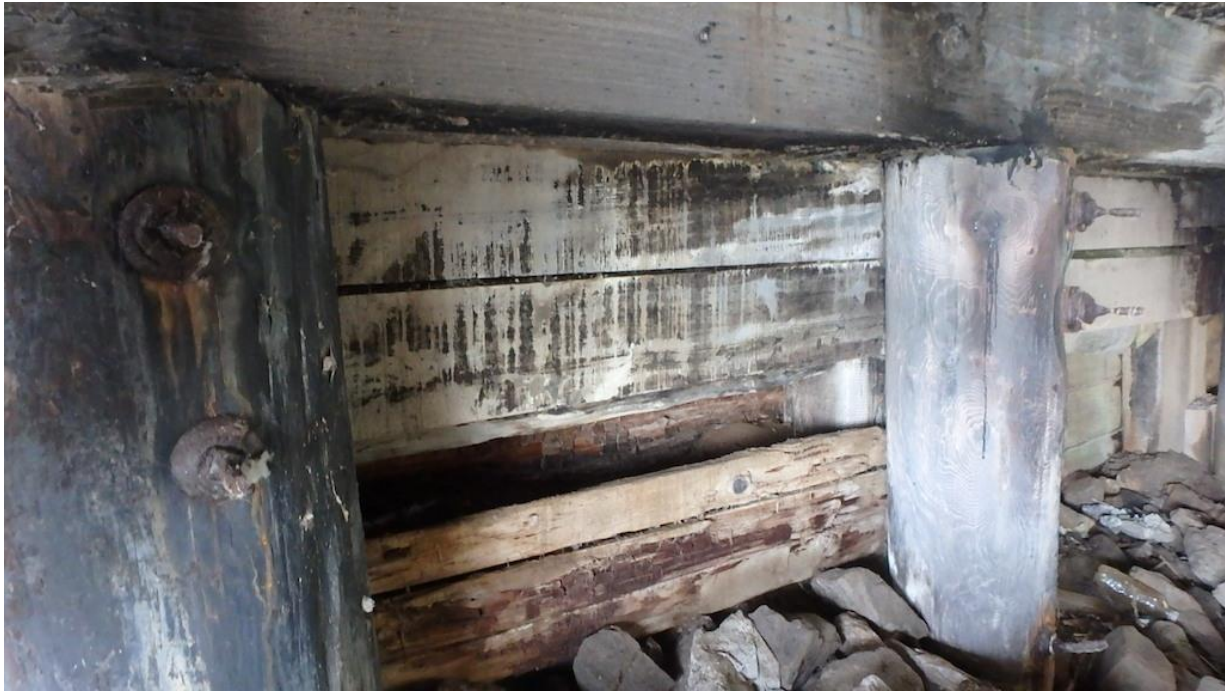
Figure 17 Missing Board in Ballast Wall

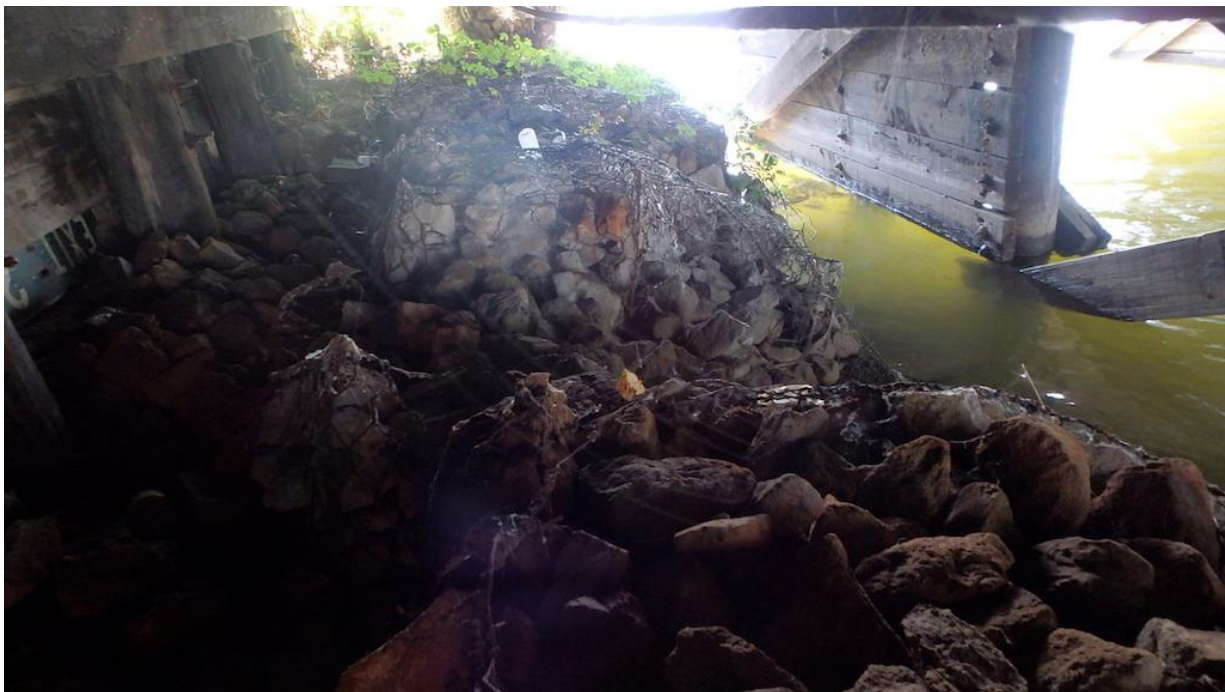
Figure 18 South Gabion Wall Deterioration

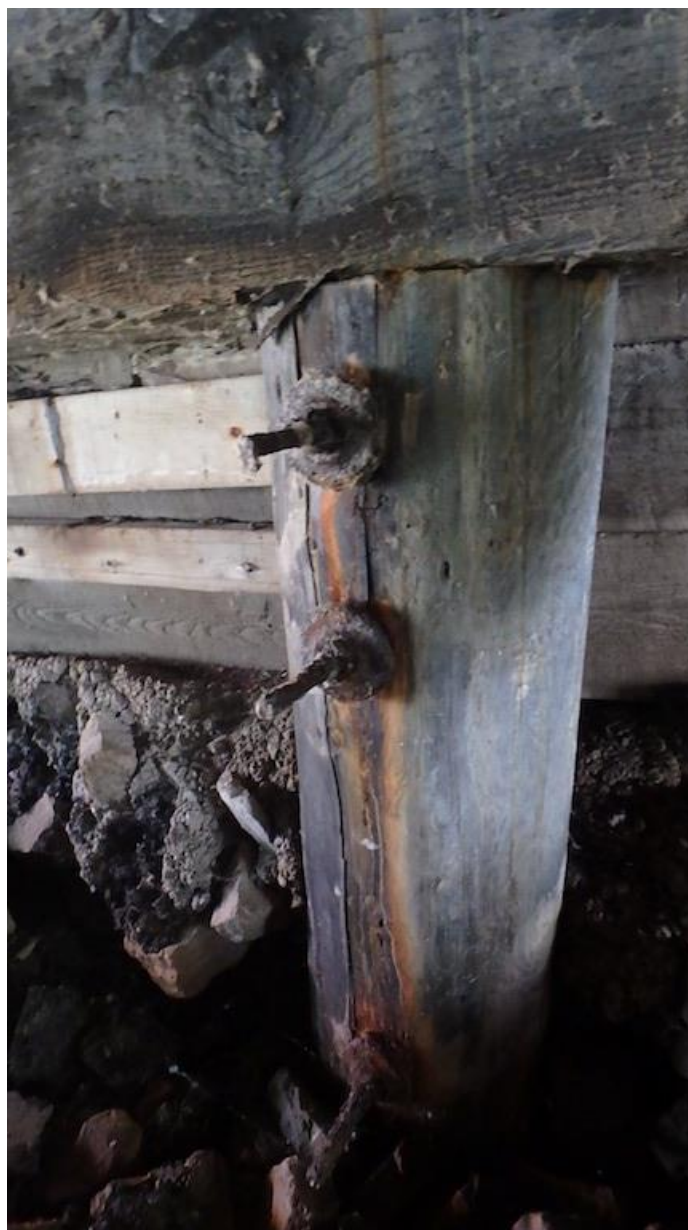
Figure 19      Typical Wood Pile

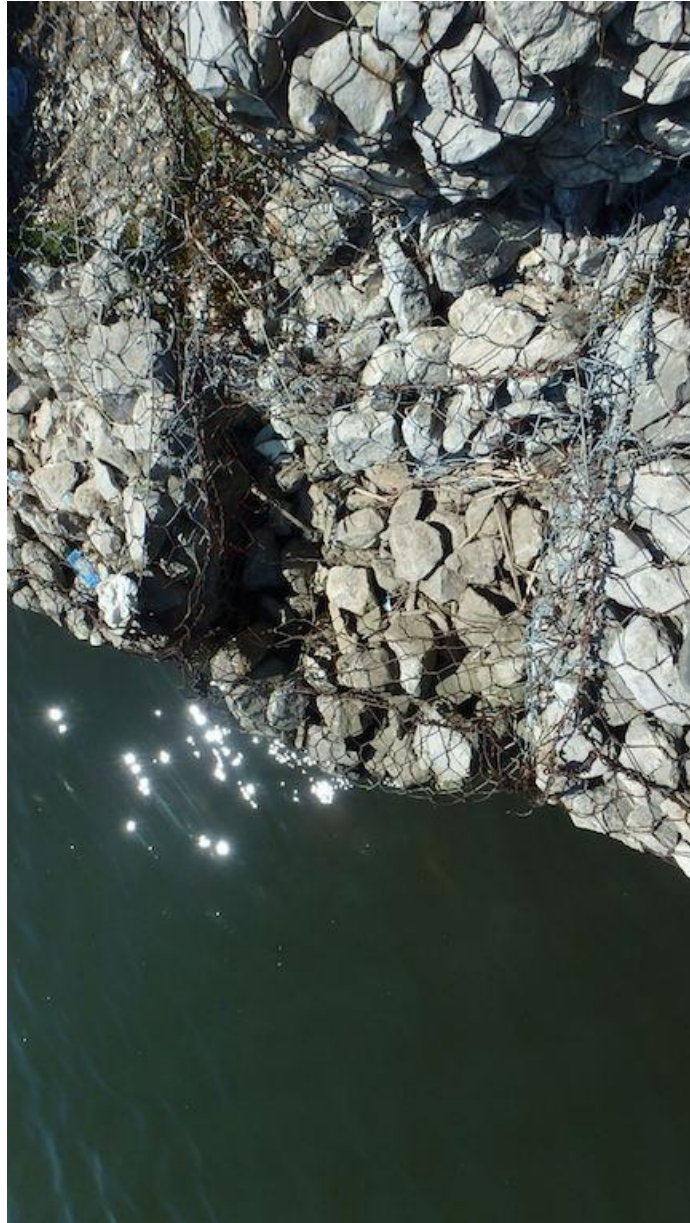
Figure 20 Missing Portion of Gabion Retaining Wall

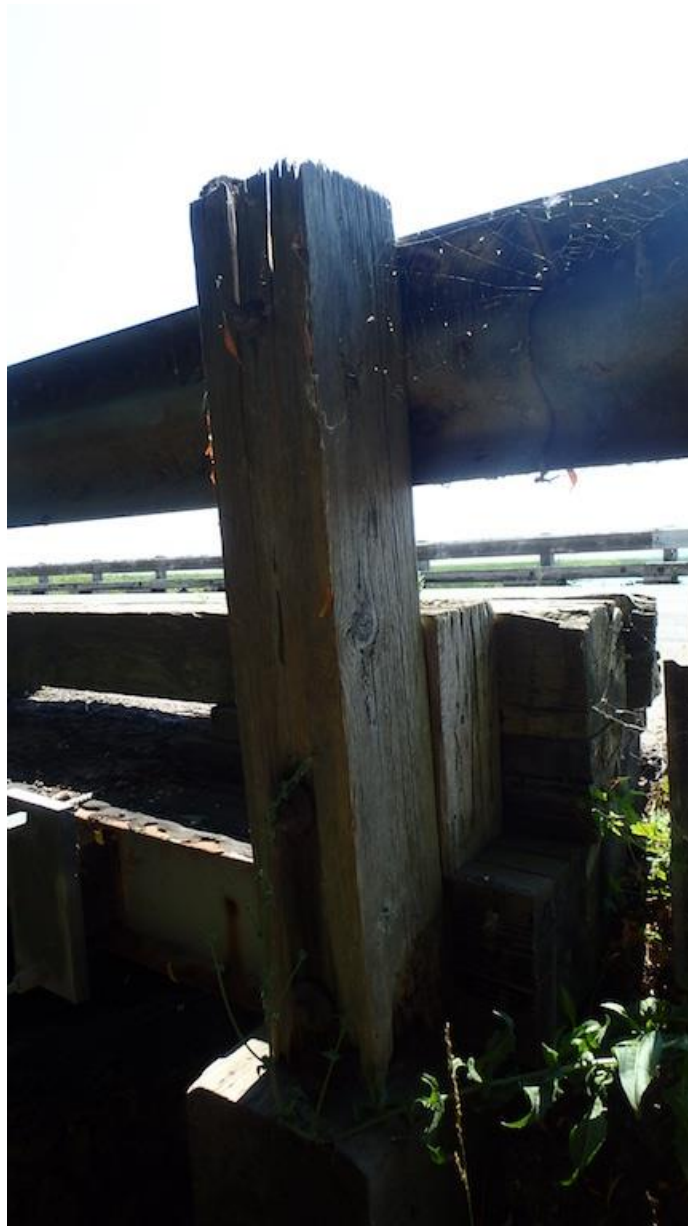
Element Group:	400 Barriers					Length:	
Element Name:	403 Posts					Width:	
Location:	E & W					Height:	
Material:						Count:	30
Element Type:						Total Quantity:	30 Each
Environment:	Severe					Limited Inspection:	
Protection System:	Unknown					Perform. Deficiencies	
Condition Data:	Units Each	Exc. 0	Good 15	Fair 0	Poor 15		
Comments: Half of posts (15) should be replaced.							
Recommended Work:    Rehab <input checked="" type="checkbox"/> Replace <input type="checkbox"/> Timing:    Urgent <input type="checkbox"/> < 1yr <input type="checkbox"/> 1 - 5 yr <input checked="" type="checkbox"/> 6 - 10 yr <input type="checkbox"/>						Maintenance Needs: <input type="checkbox"/> Urgent <input type="checkbox"/> 1 year <input type="checkbox"/> 2 year

Figure 21 Typical Post Deterioration

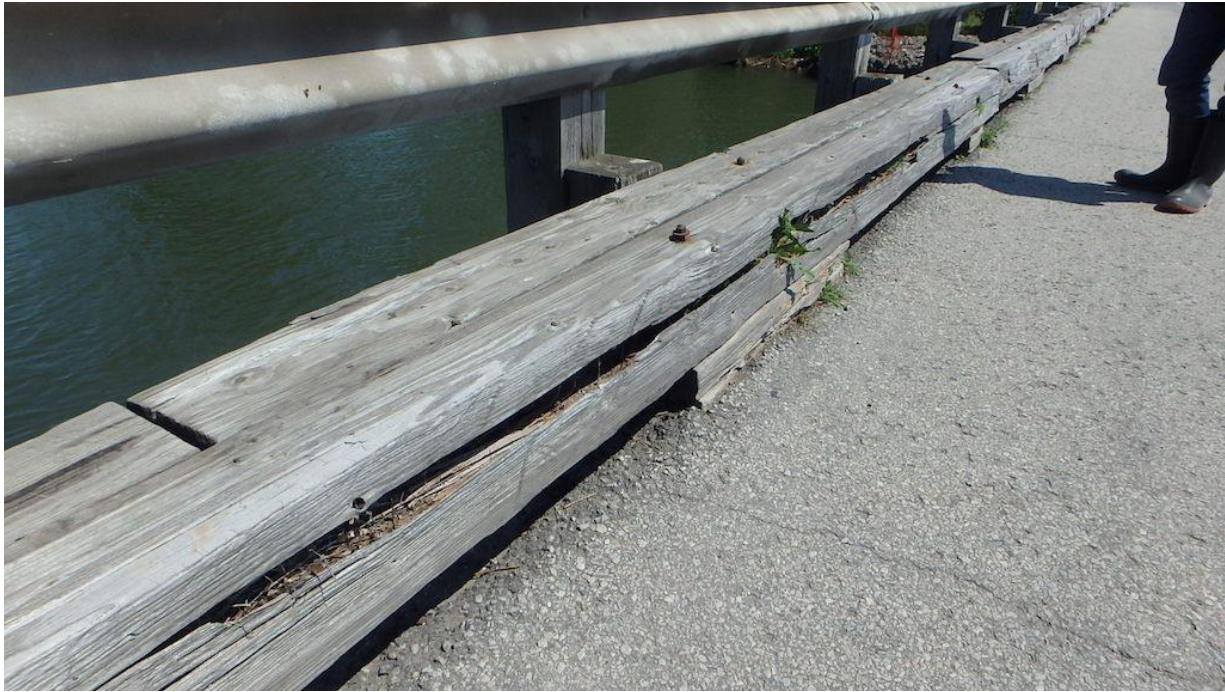
Element Group:	300	Sidewalks/curbs	Length:	
Element Name:	302	Curbs	Width:	
Location:			Height:	
Material:	18	Wood	Count:	1
Element Type:			Total Quantity:	1 Each
Environment:		Severe	Limited Inspection:	
Protection System:		Unknown	Perform. Deficiencies	
Condition Data:	Units Each	Exc. 0	Good 0	Fair 0
			Poor 1	
Comments: Curbs are rotten on East side.				
Recommended Work:    Rehab <input checked="" type="checkbox"/> Replace <input type="checkbox"/> Timing:    Urgent <input type="checkbox"/> < 1yr <input type="checkbox"/> 1 - 5 yr <input checked="" type="checkbox"/> 6 - 10 yr <input type="checkbox"/>			Maintenance Needs: <input type="checkbox"/> Urgent <input type="checkbox"/> 1 year <input type="checkbox"/> 2 year

Figure 22      Deterioration of Wood Curb

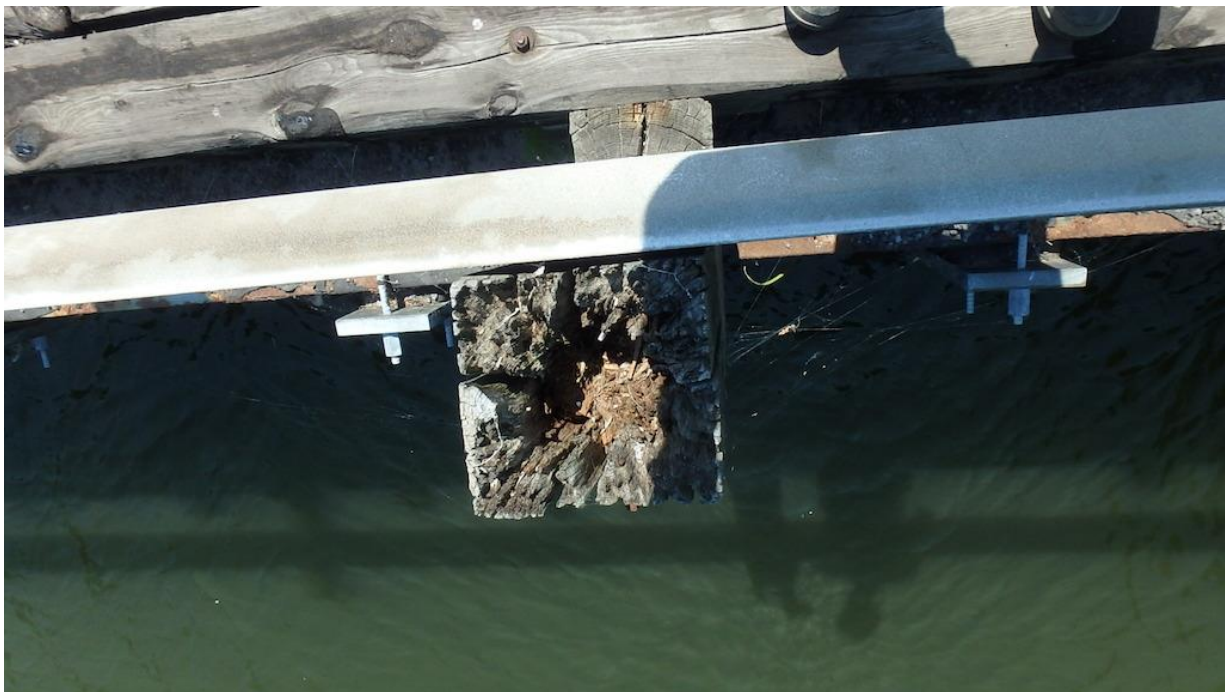
Figure 23      Insect Damage to Guiderail Post

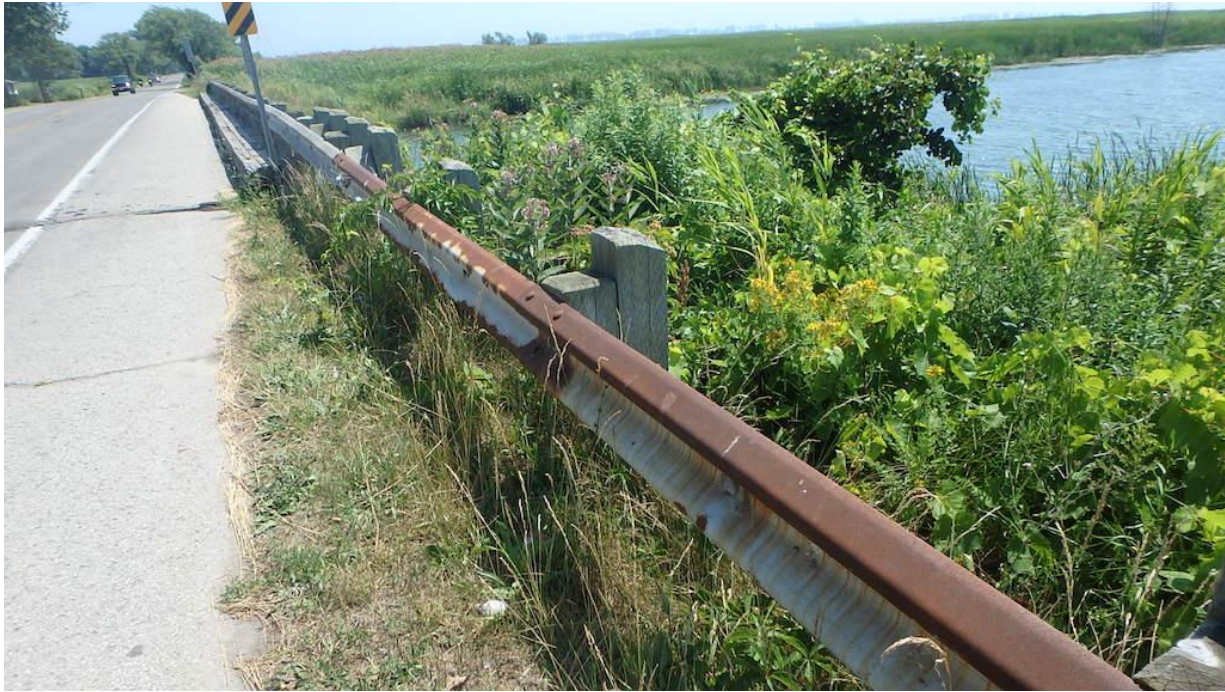
Element Group:	400 Barriers					Length:	125.4
Element Name:	402 Railing System					Width:	
Location:						Height:	
Material:	14 Steel					Count:	1
Element Type:	Steel Flex Beams on Wood Post					Total Quantity:	125.4 m
Environment:	Severe					Limited Inspection:	
Protection System:	Unknown					Perform. Deficiencies	
Condition Data:	Units m	Exc. 0	Good 0	Fair 120	Poor 5.4		
Comments: Replace all railing. Many posts are rotten. Steel beam is loose.							
Recommended Work:    Rehab <input checked="" type="checkbox"/> Replace <input type="checkbox"/> Timing:    Urgent <input type="checkbox"/> < 1yr <input type="checkbox"/> 1 - 5 yr <input checked="" type="checkbox"/> 6 - 10 yr <input type="checkbox"/>						Maintenance Needs: <input type="checkbox"/> Urgent <input type="checkbox"/> 1 year <input type="checkbox"/> 2 year

Figure 24 Corrosion on Guiderail

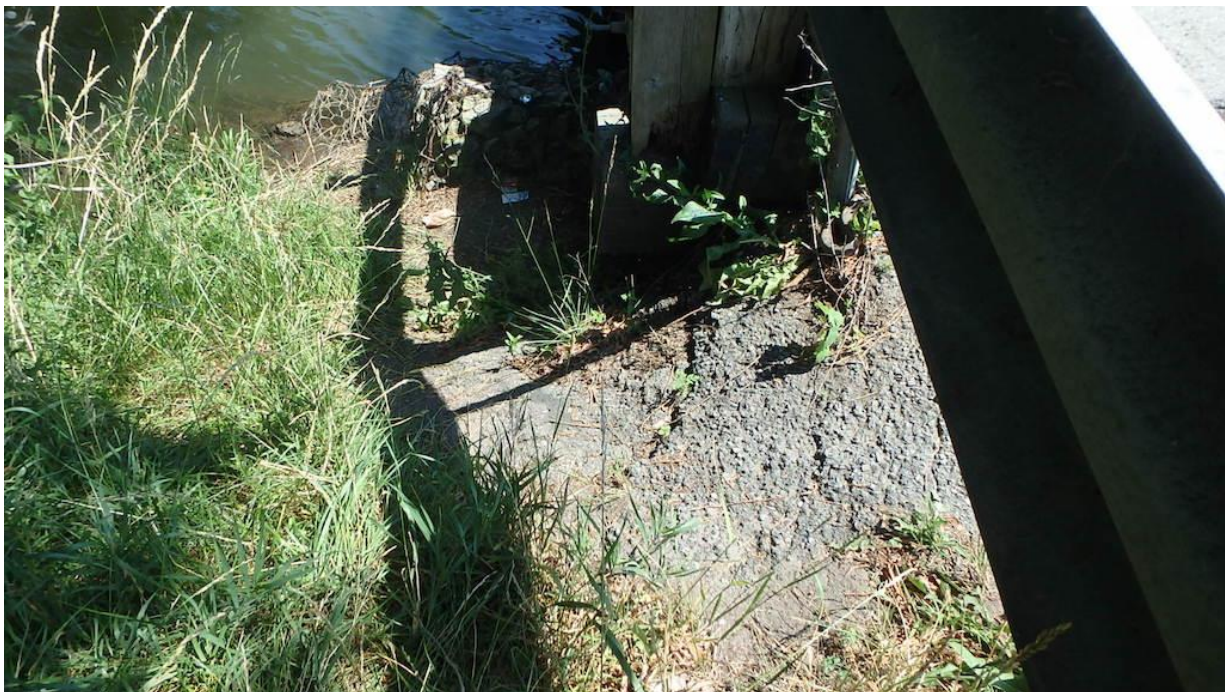
Figure 25 Asphalt Spillway

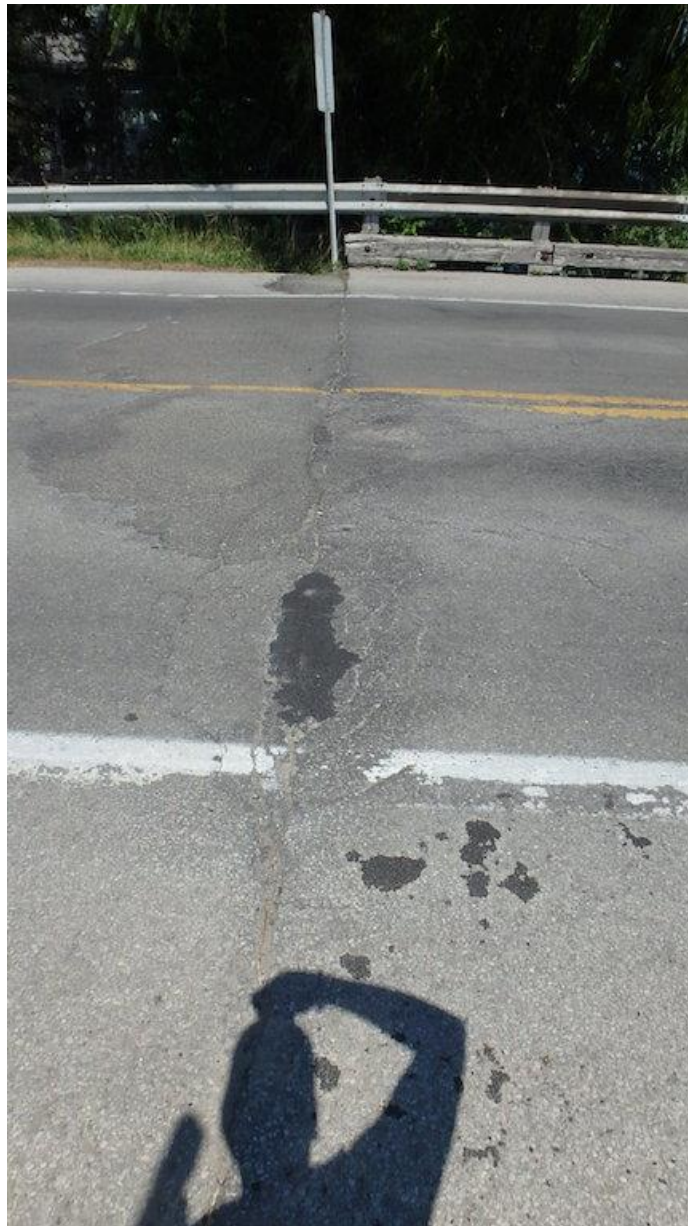
Figure 26 Settlement at North Joint

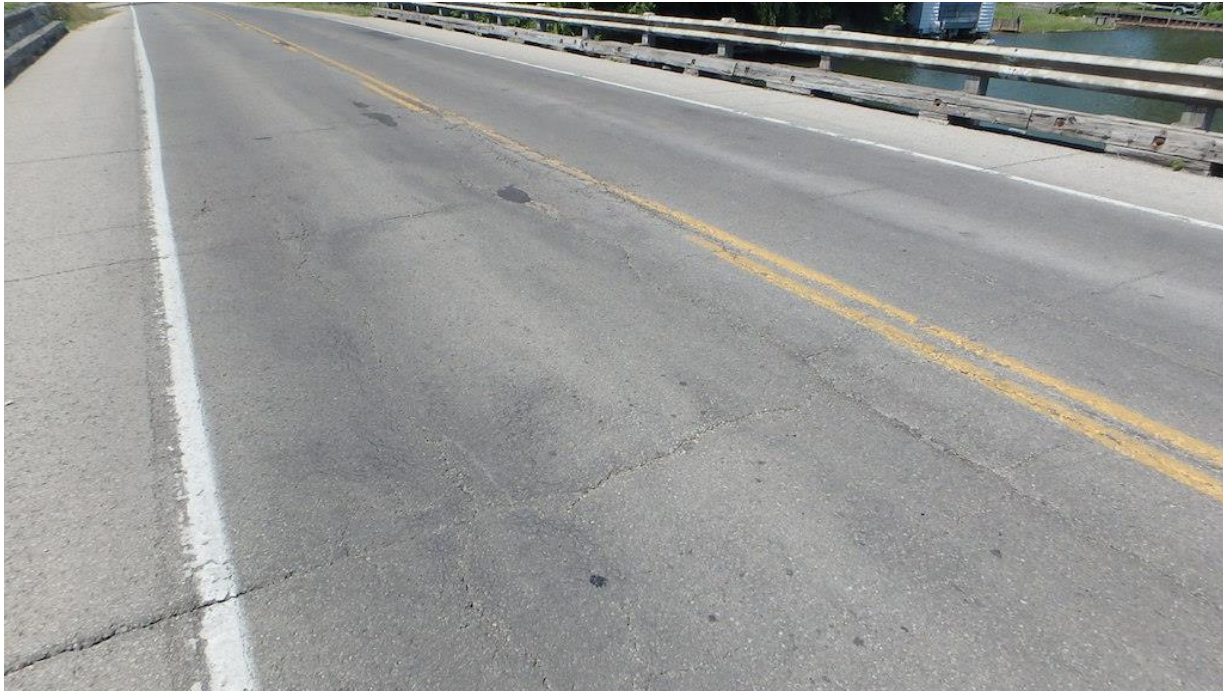
Element Group:	100 Decks					Length:	44
Element Name:	101 Wearing Surface					Width:	10
Location:	Top of Deck					Height:	
Material:	2 Asphalt					Count:	1
Element Type:						Total Quantity:	440 sq.m
Environment:	Severe					Limited Inspection:	
Protection System:	Unknown					Perform. Deficiencies	
Condition	Units	Exc.	Good	Fair	Poor		
Data:	sq.m	0	0	340	100		
Comments: Small crack in road surface at each end of deck. Should be routed and sealed. Waterproofing is not visible, placed in 1997. Some transverse cracking in surface. Pot holes forming. Settlement on deck surface.							
Recommended Work: Rehab <input checked="" type="checkbox"/> Replace <input type="checkbox"/> Timing: Urgent <input type="checkbox"/> < 1yr <input type="checkbox"/> 1 - 5 yr <input checked="" type="checkbox"/> 6 - 10 yr <input type="checkbox"/>						Maintenance Needs: <input type="checkbox"/> Urgent <input type="checkbox"/> 1 year <input type="checkbox"/> 2 year

Figure 28 Transverse Cracks and Settlement on Deck Wearing Surface
