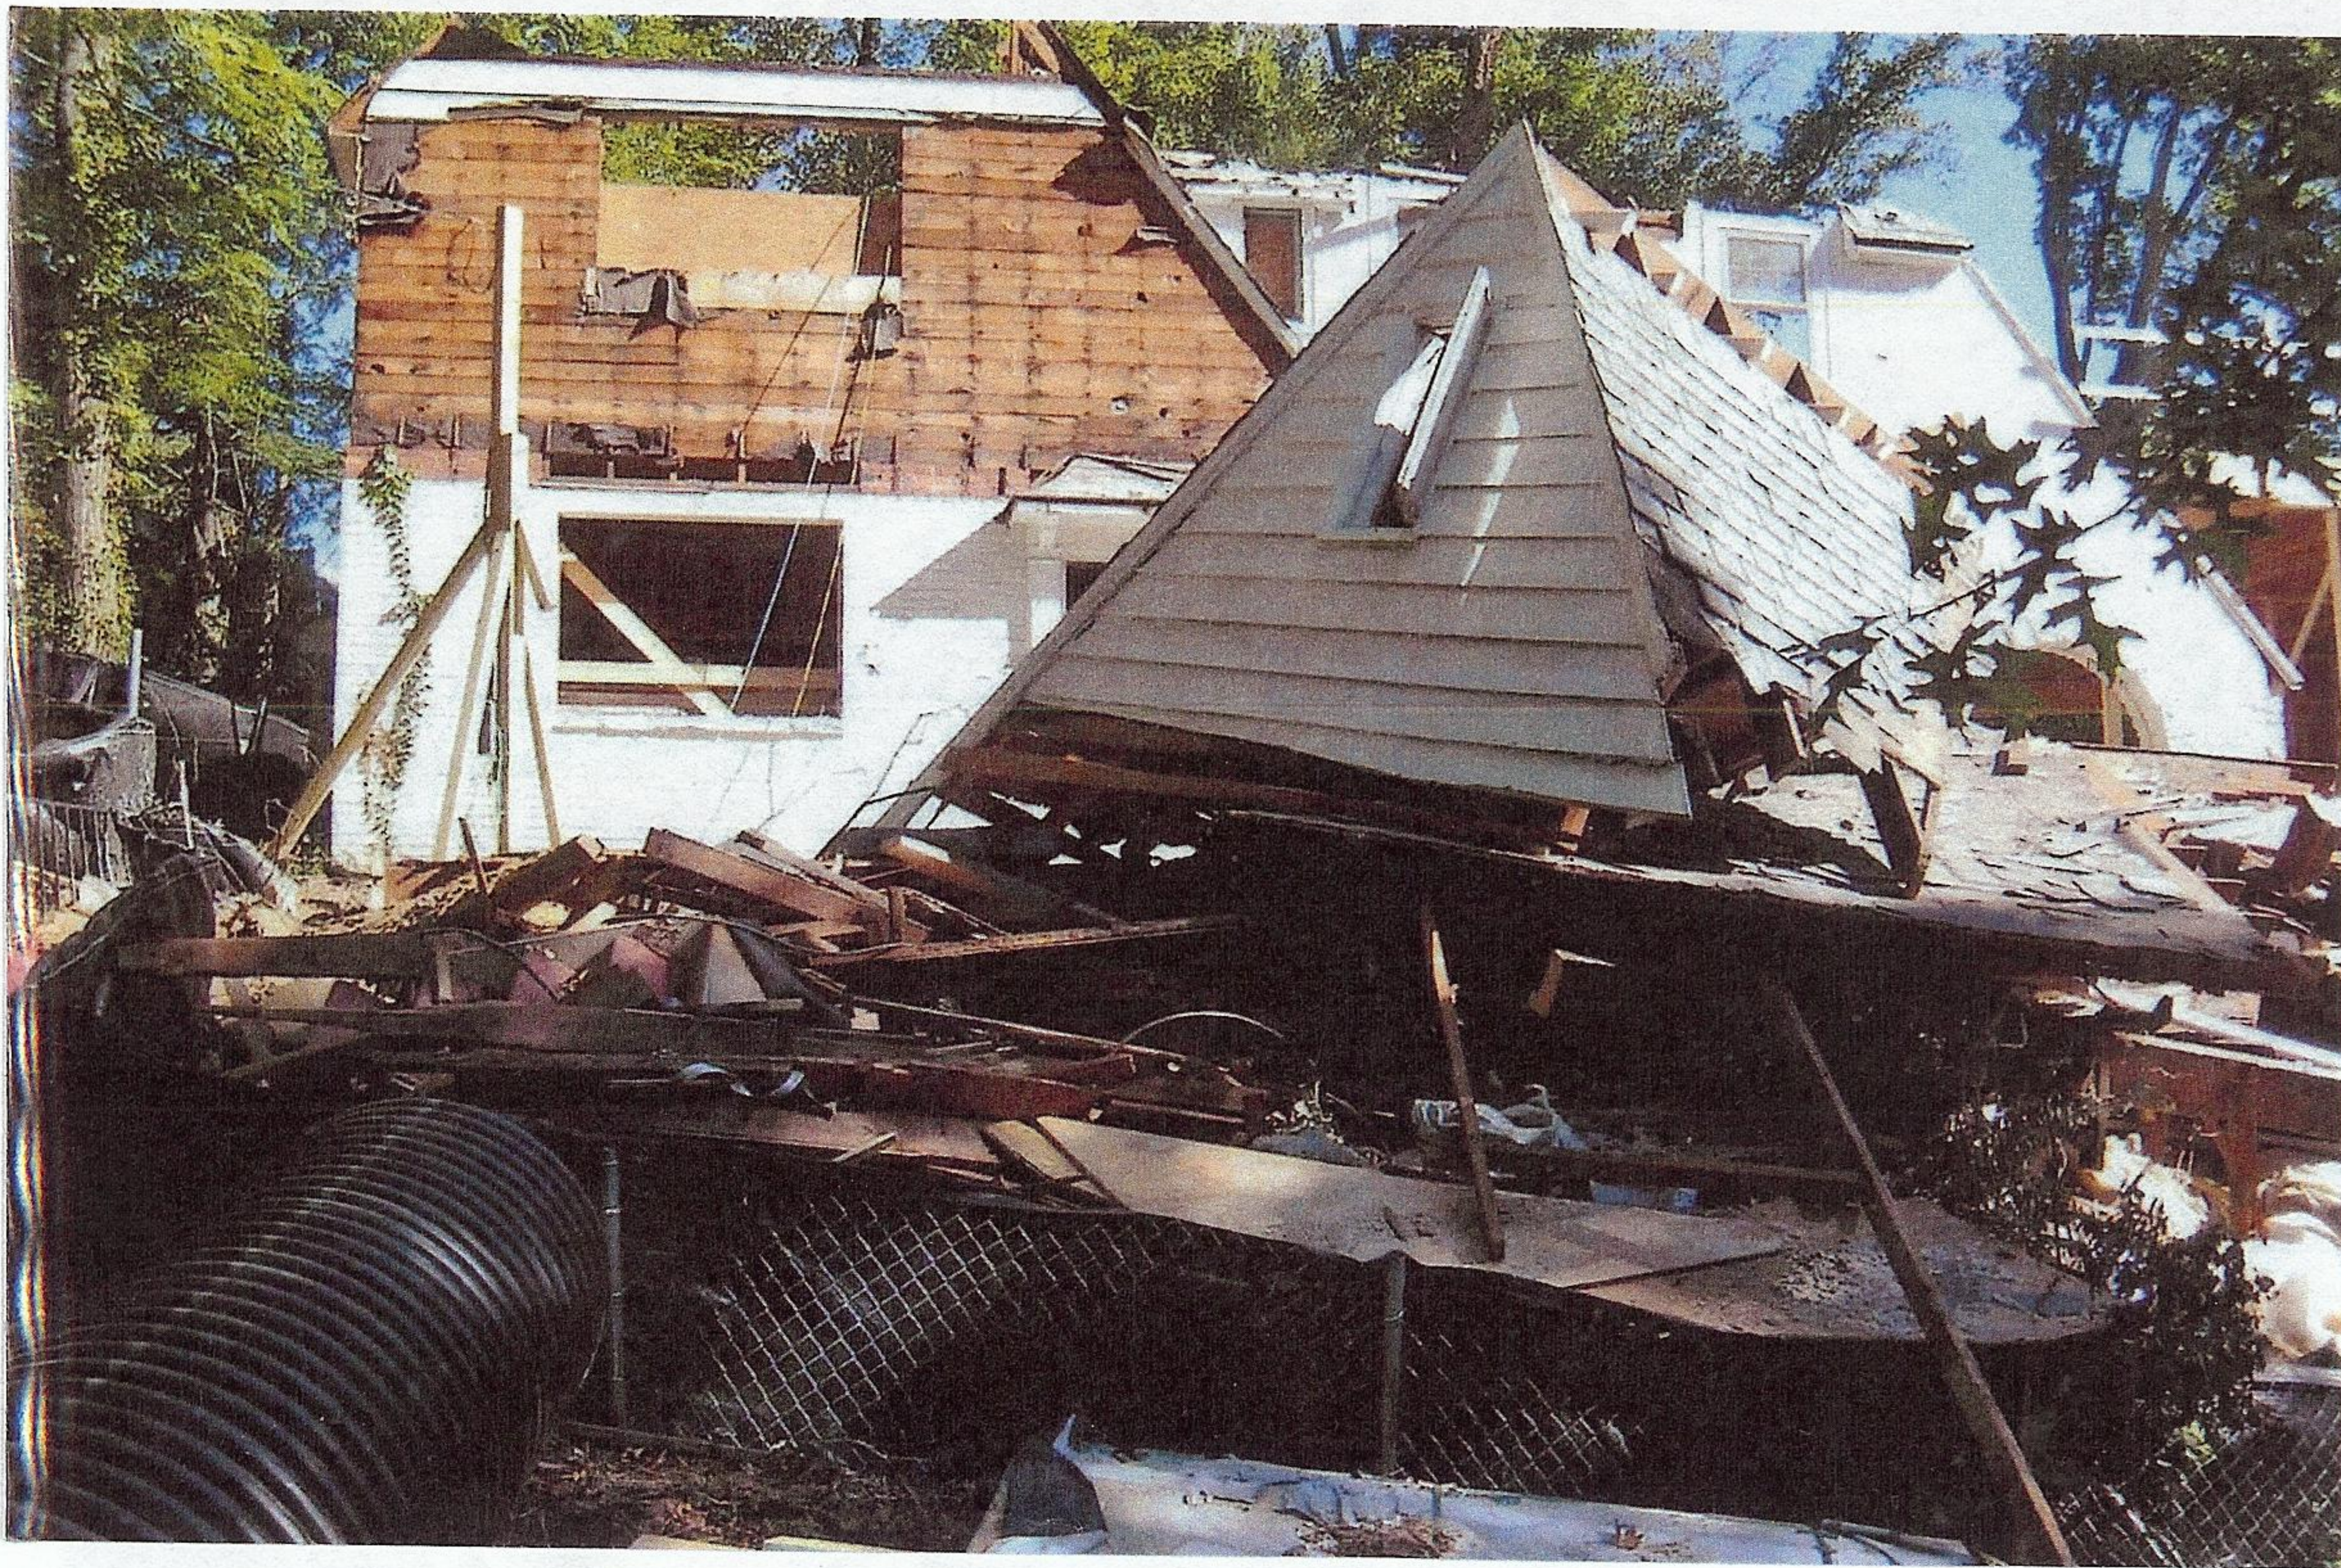
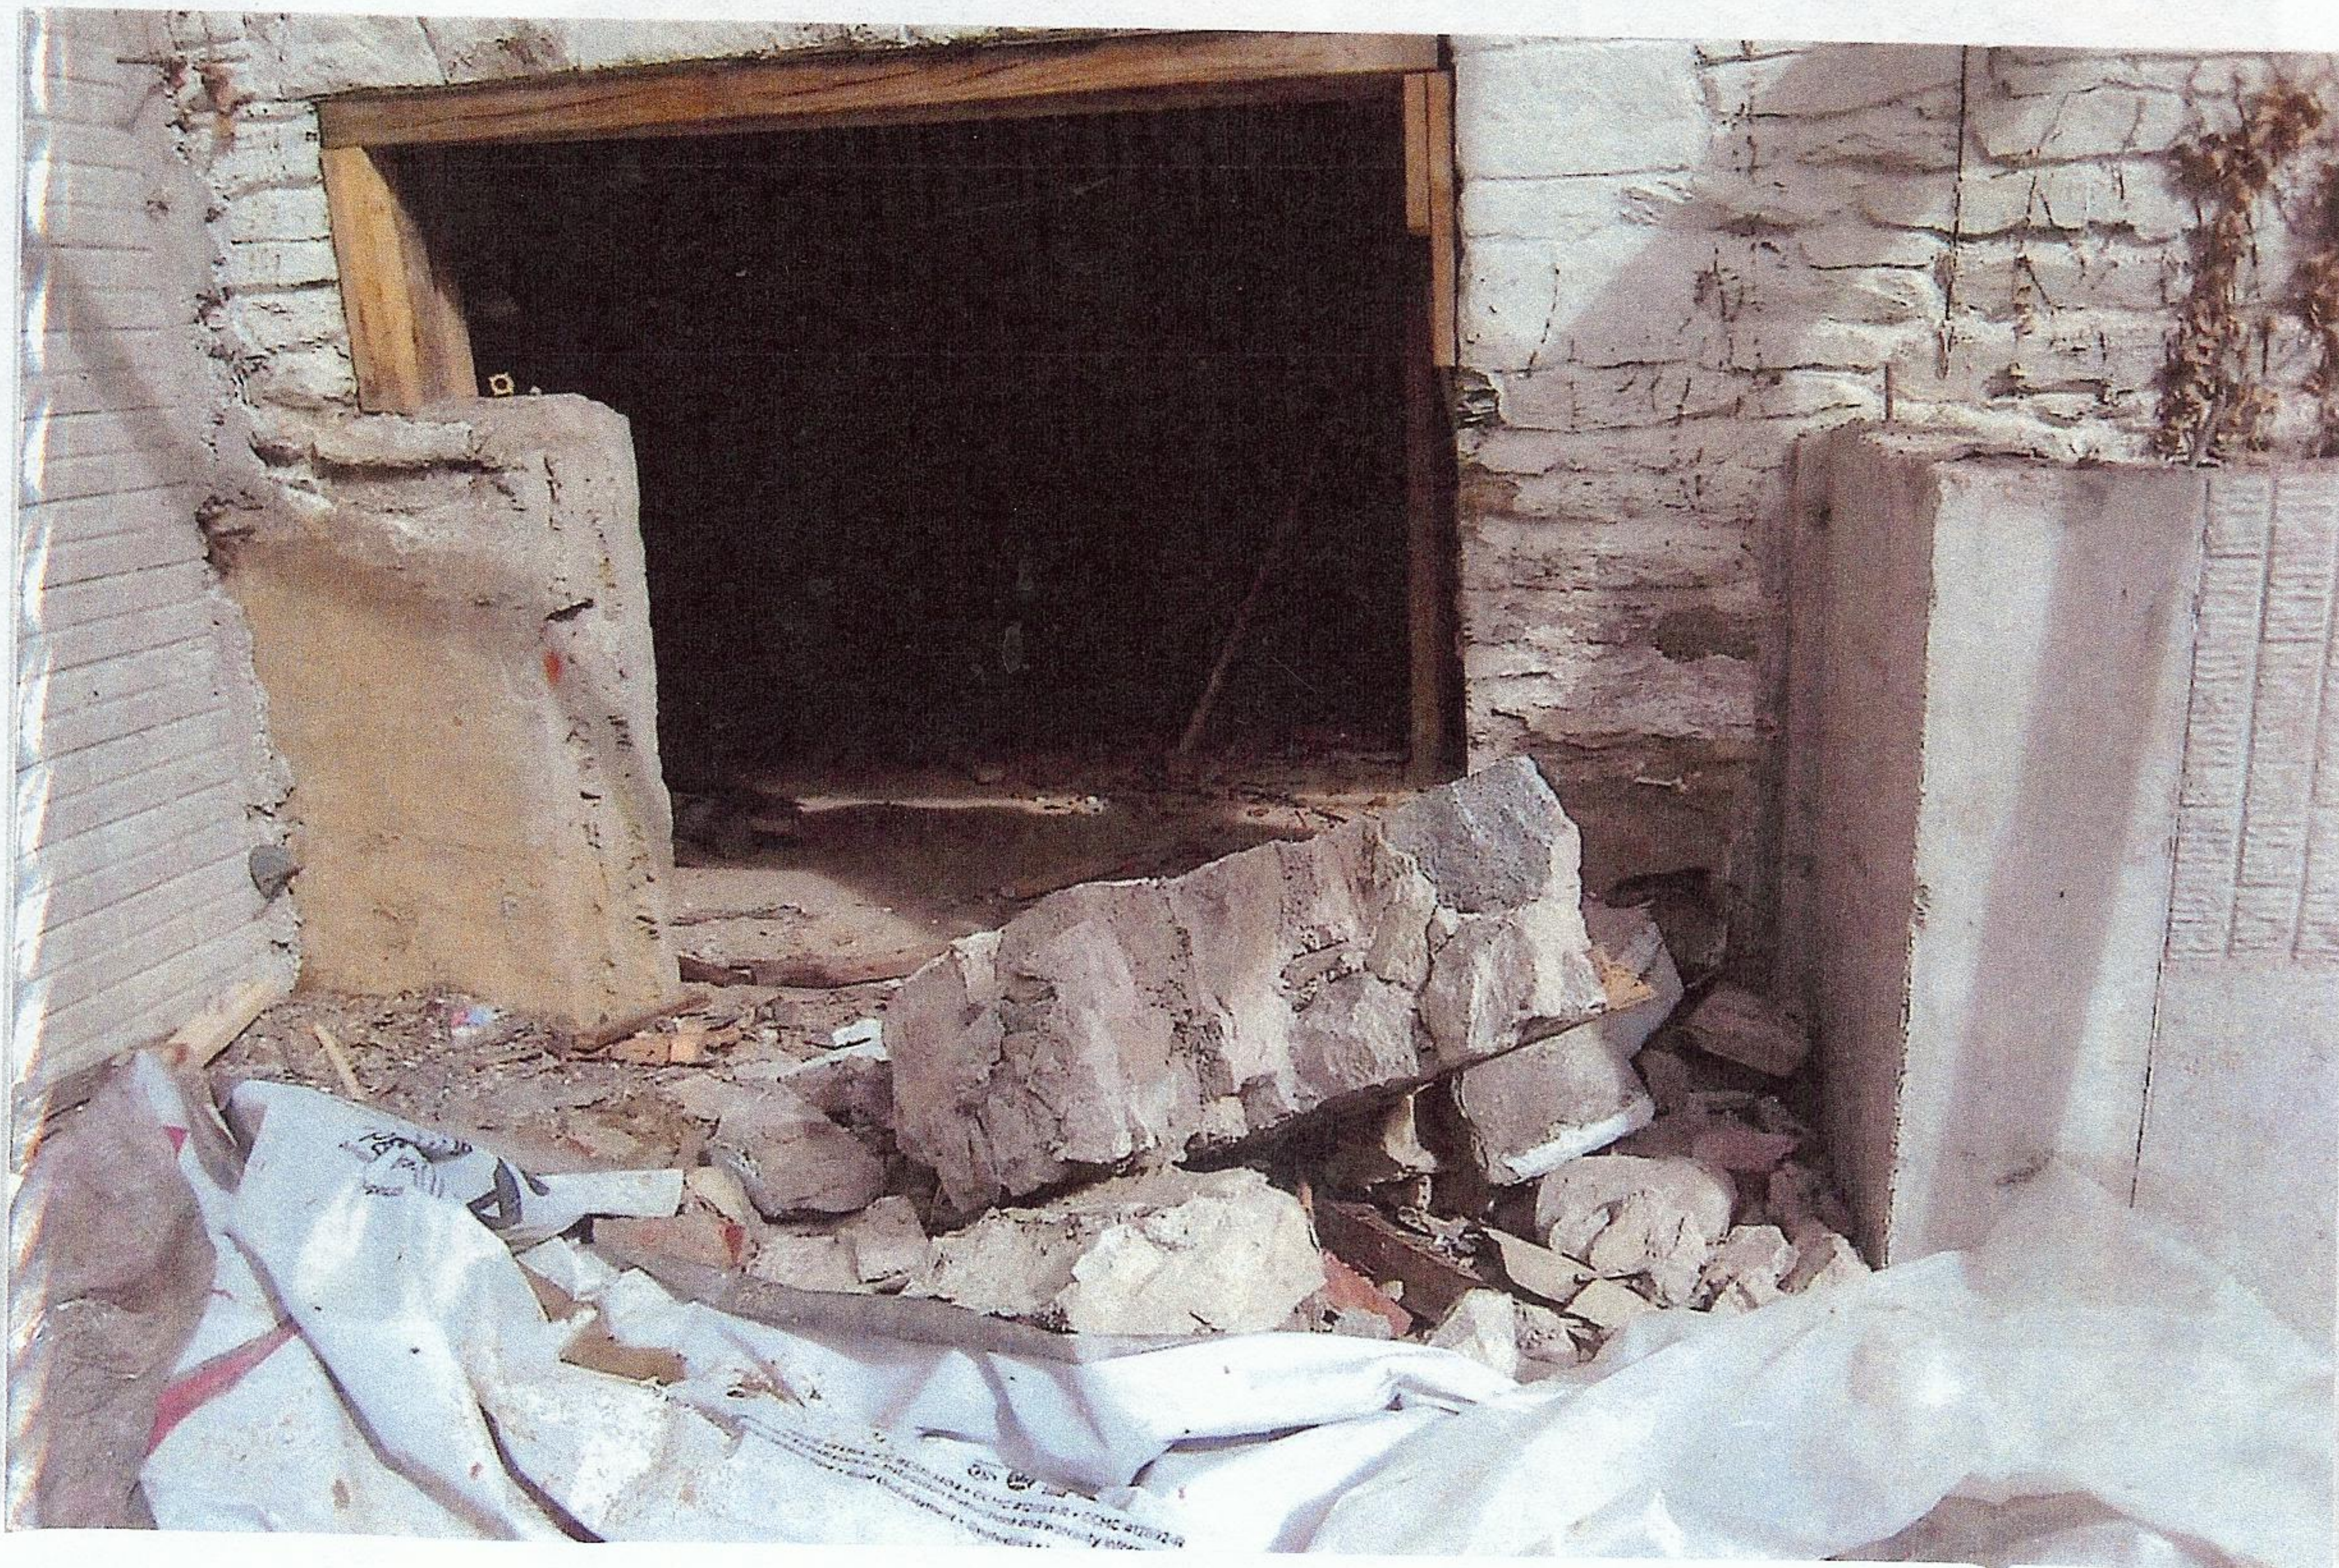
Uncontained exterior LBP dust and debris photographed after the o/c sponsored lead report of July 8 stated that no disturbed paint existed.
