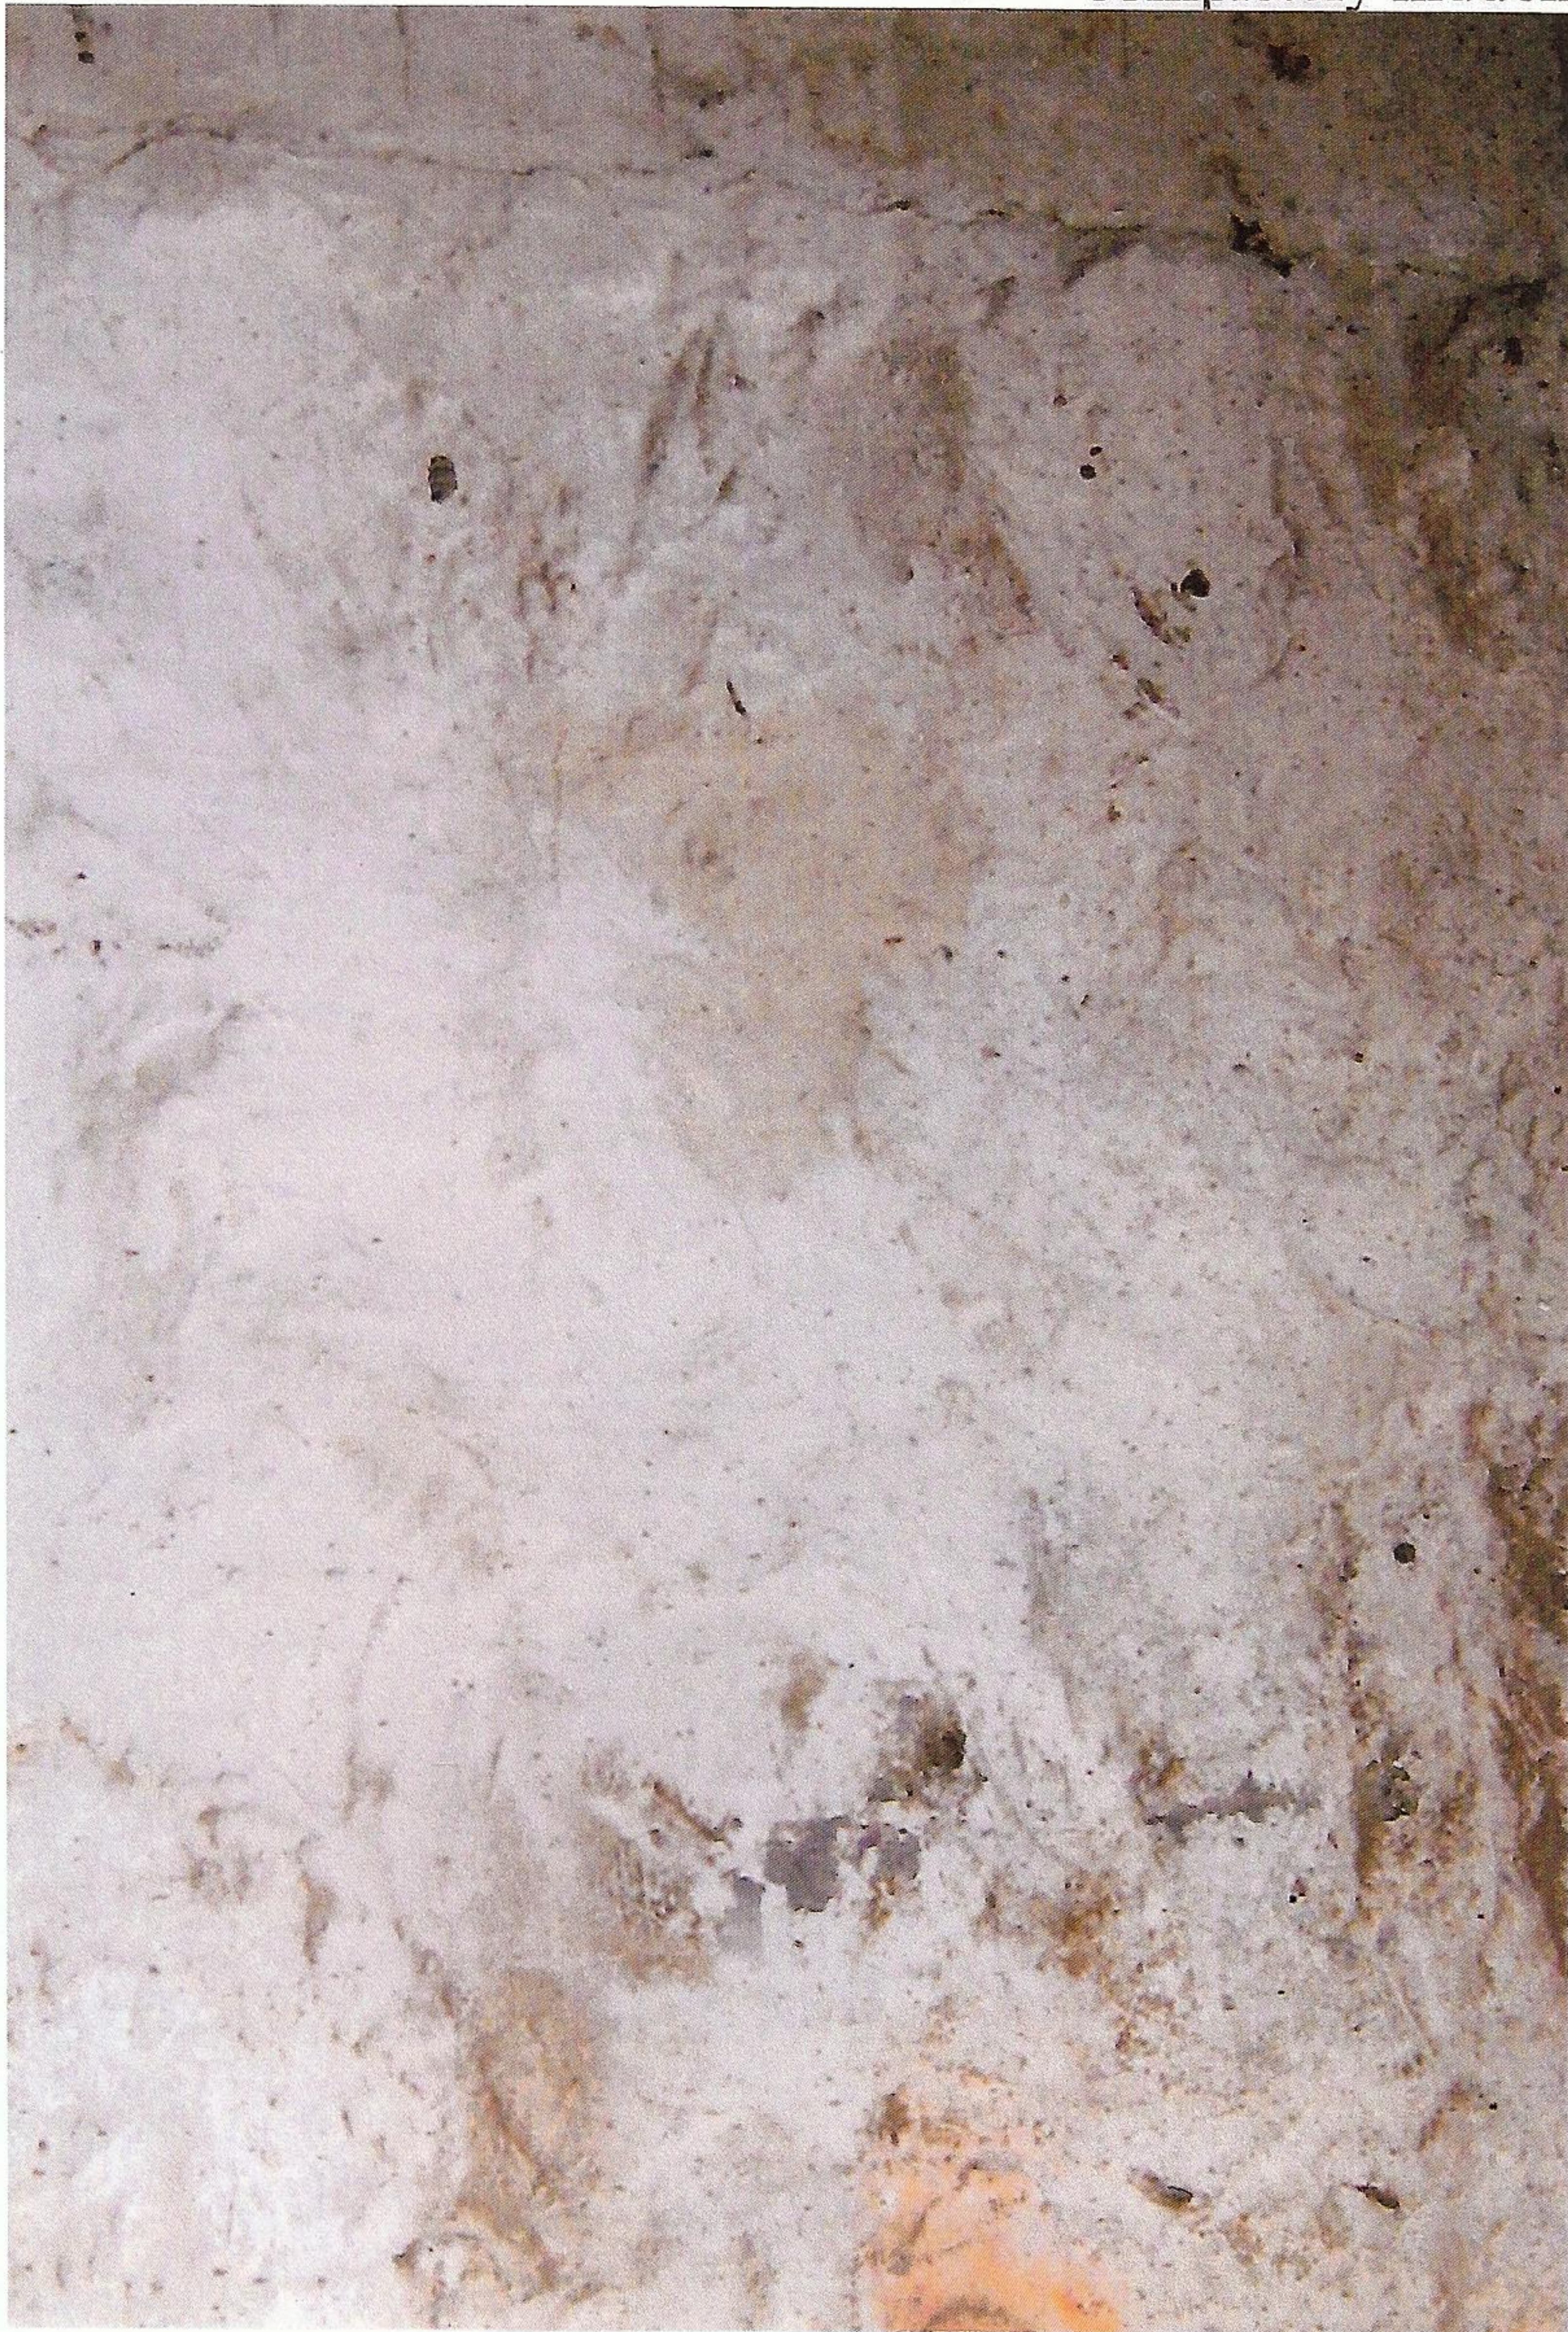
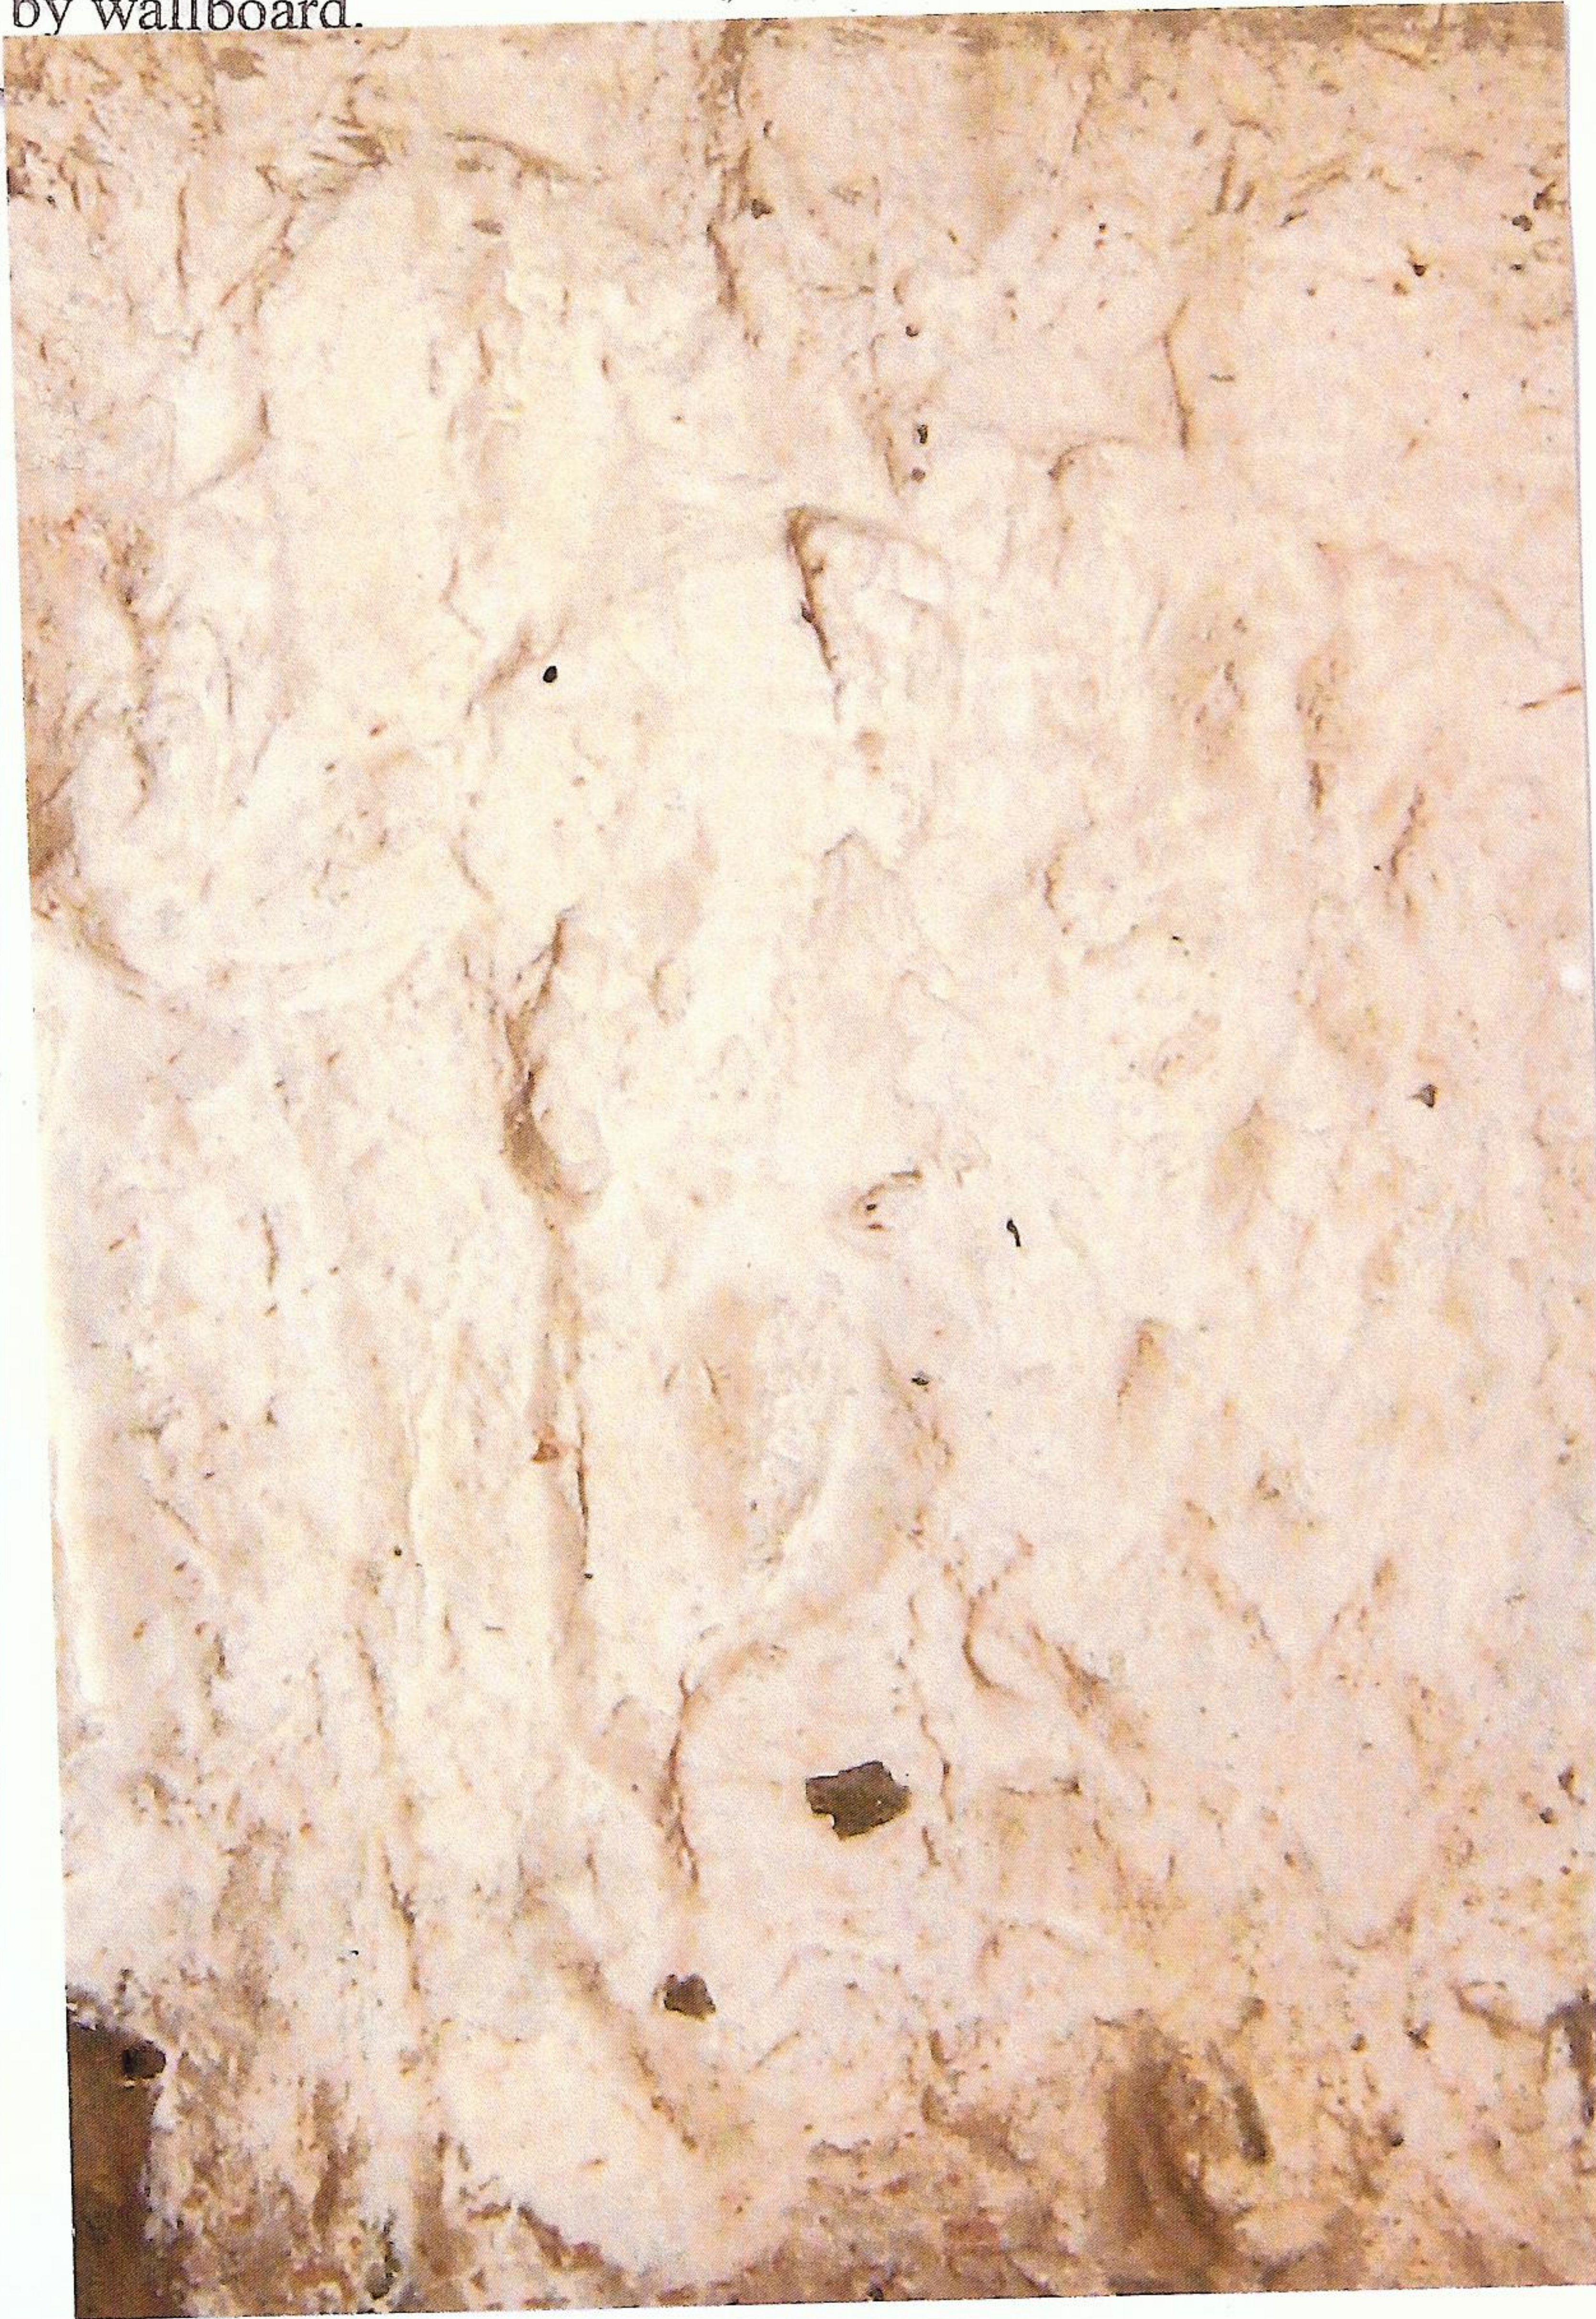
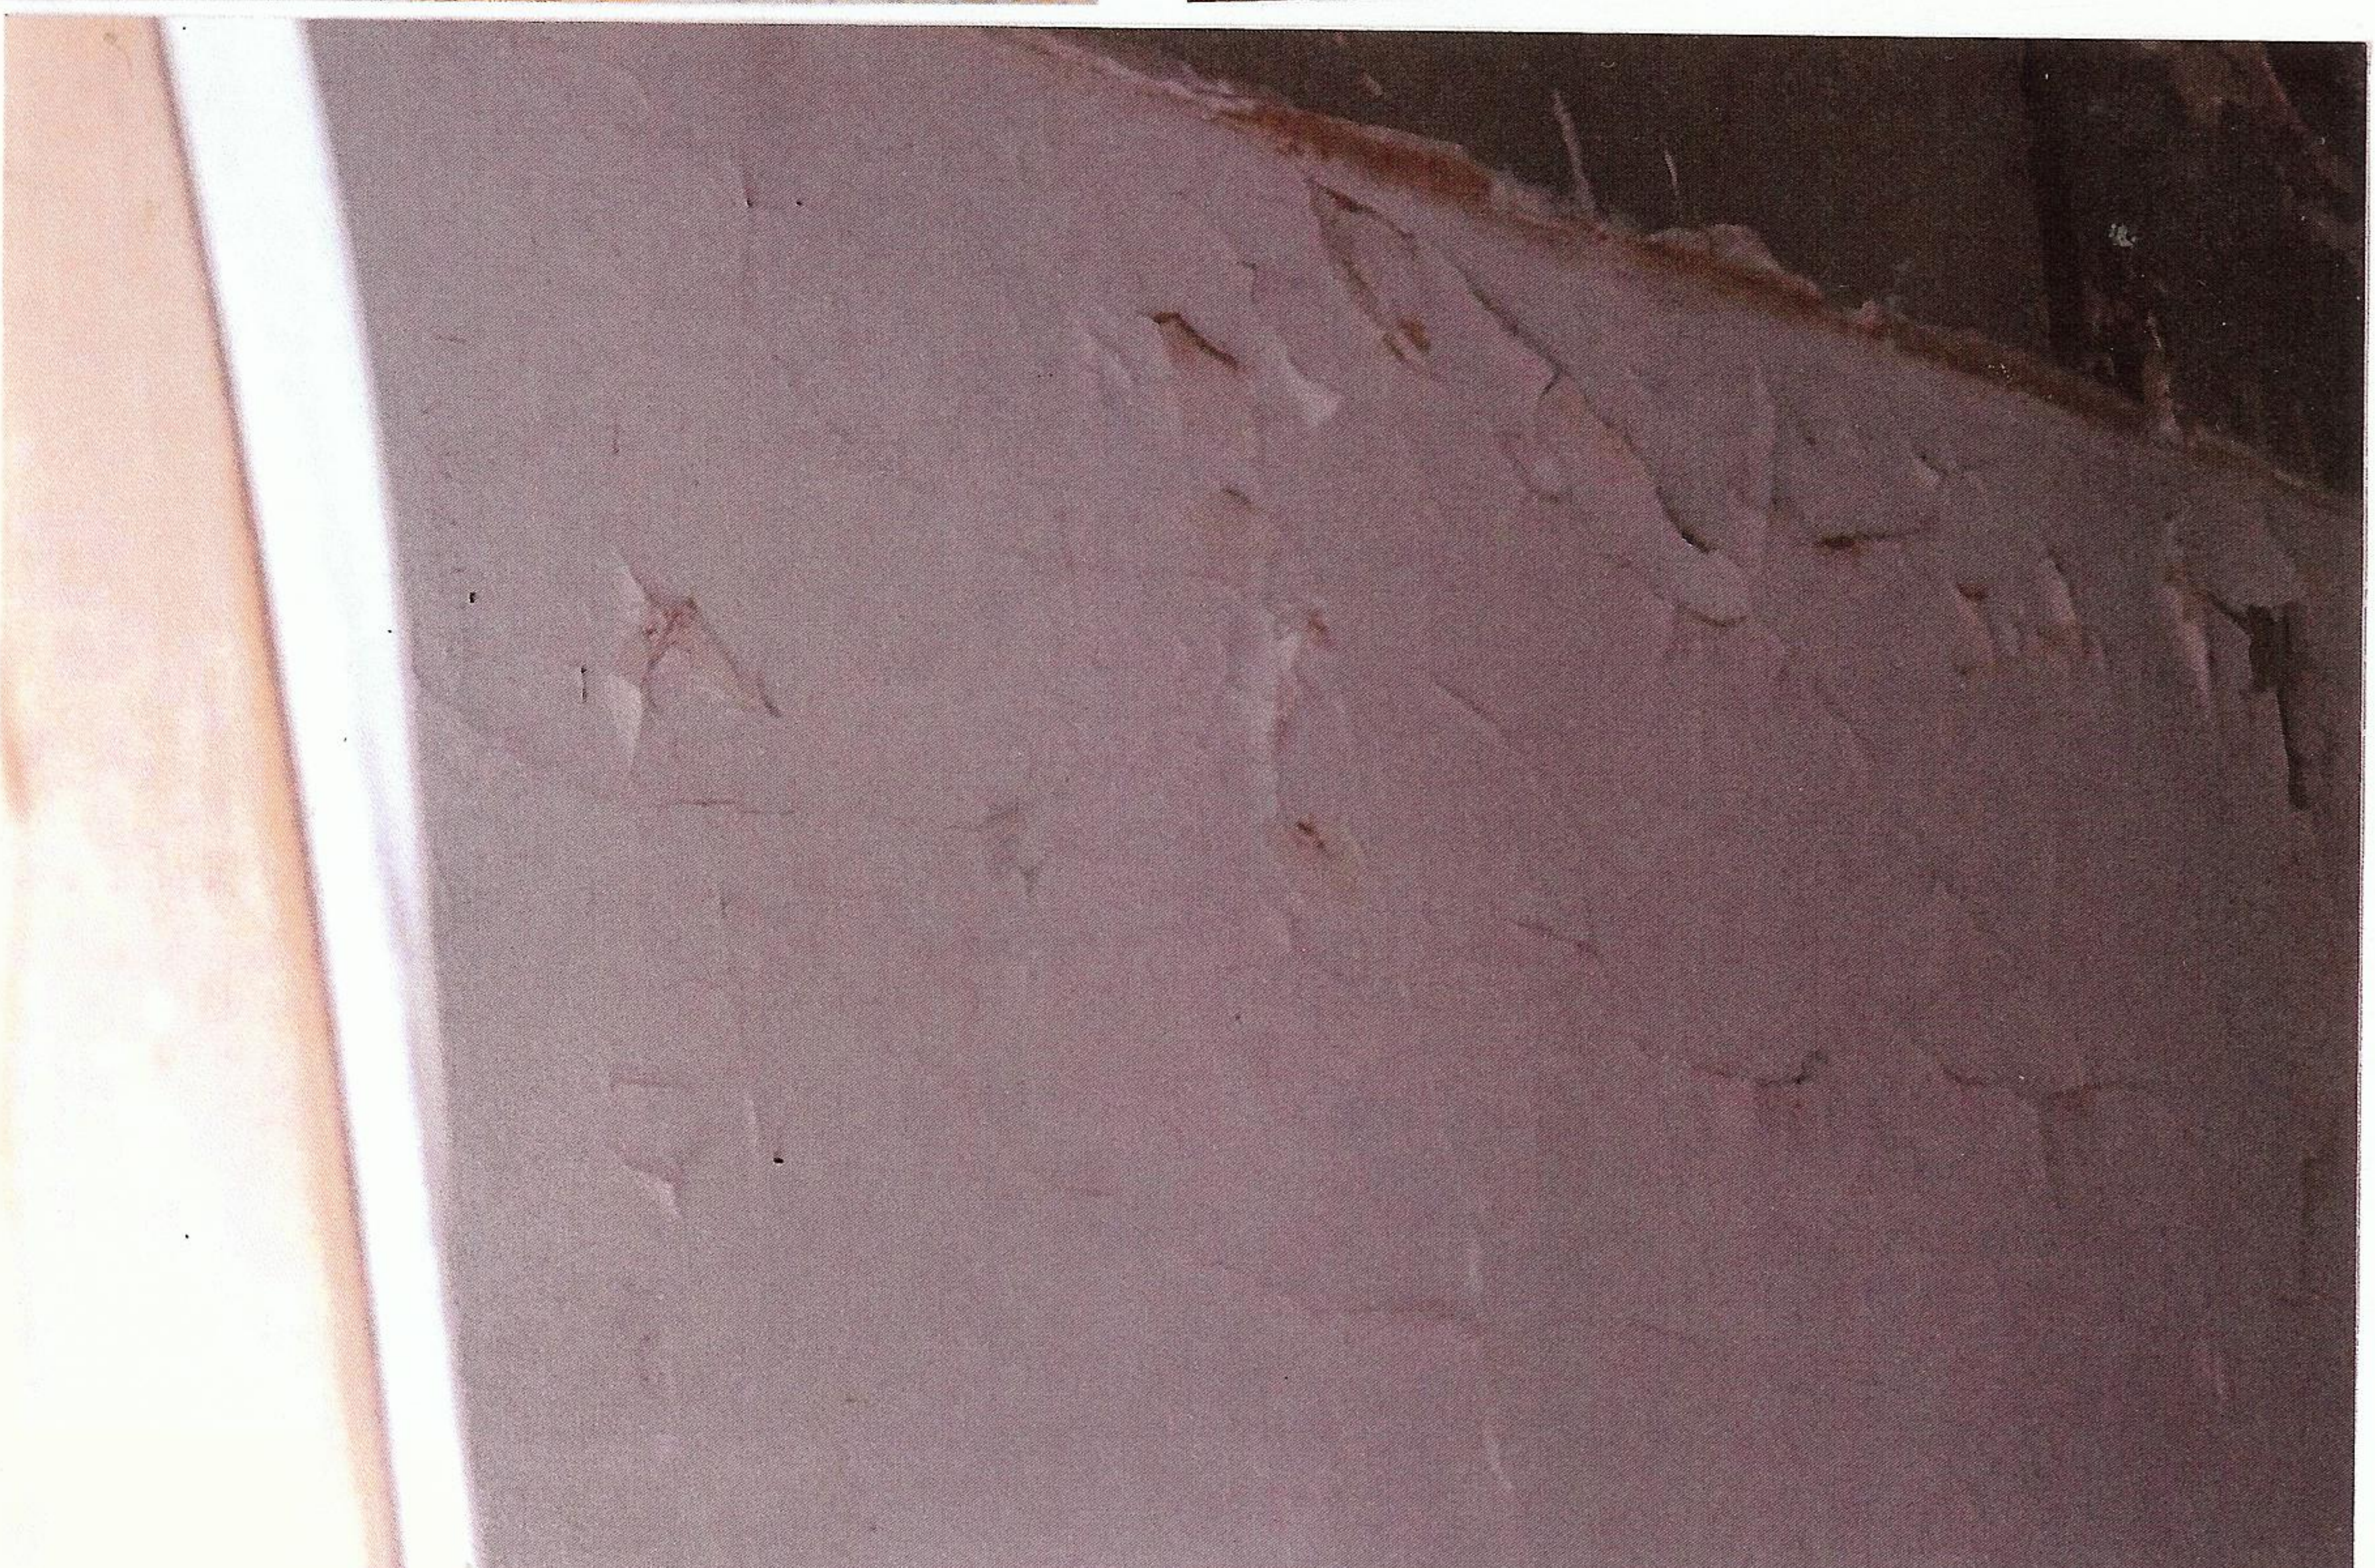
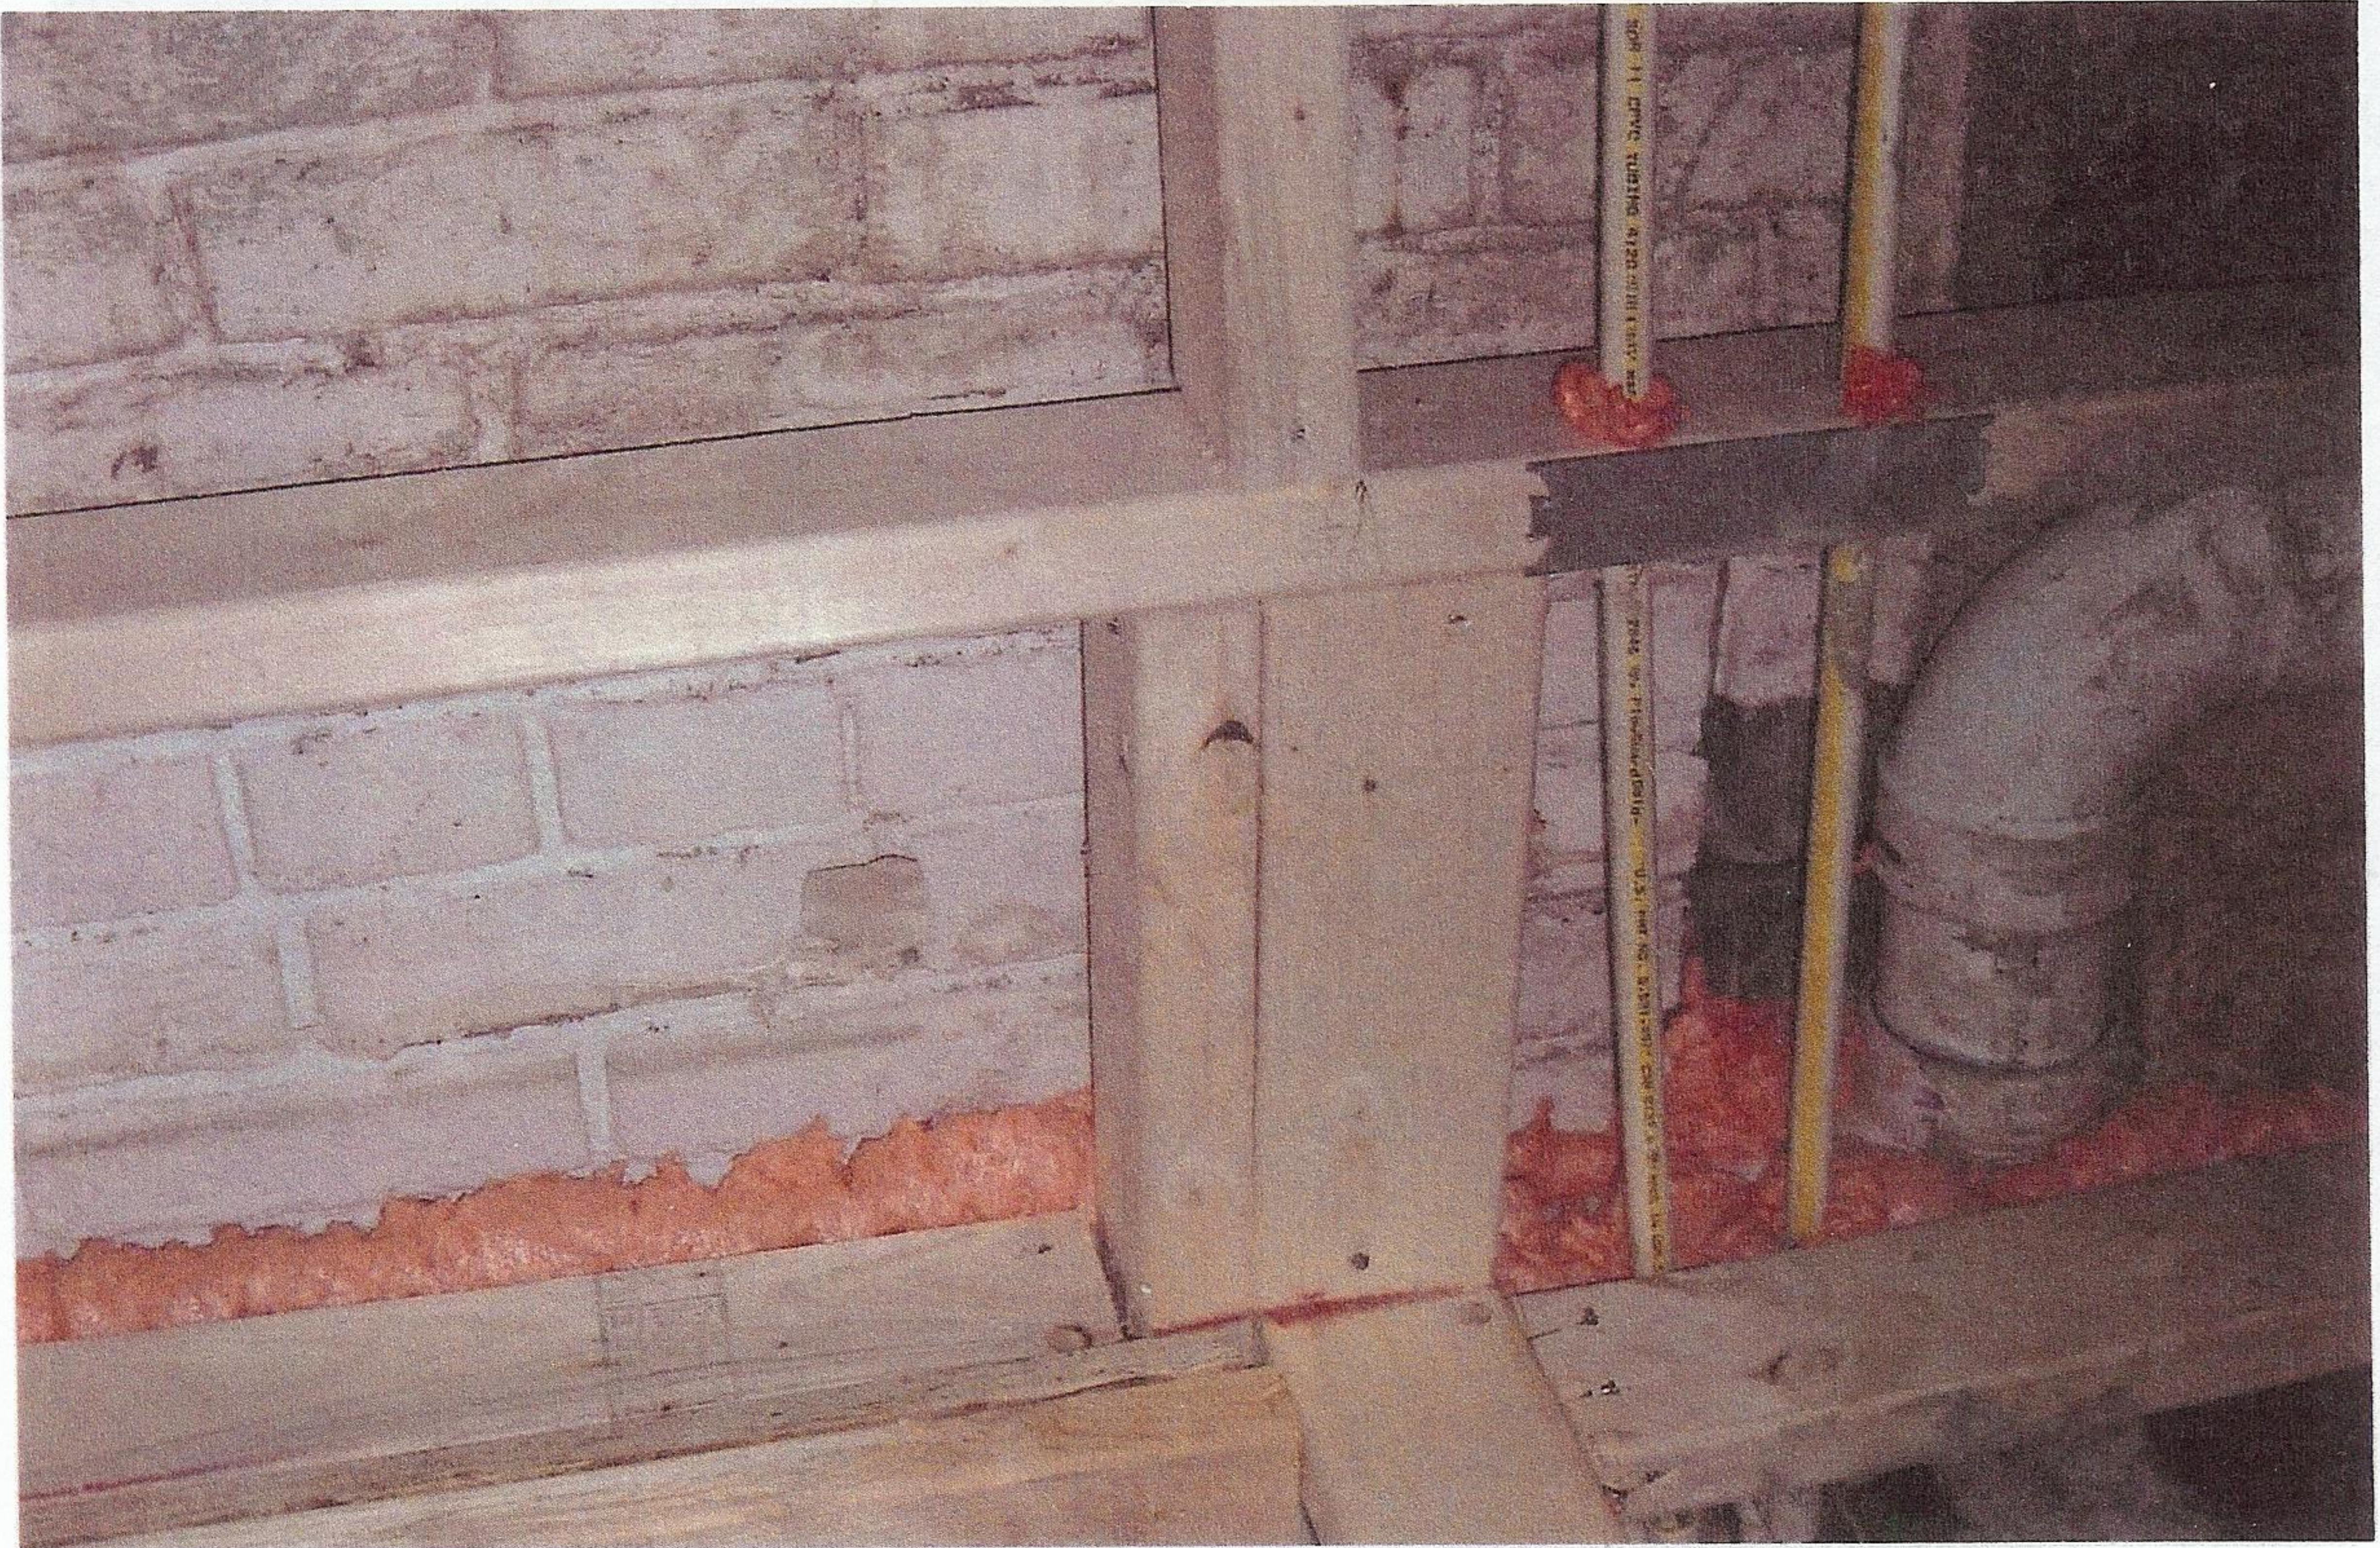
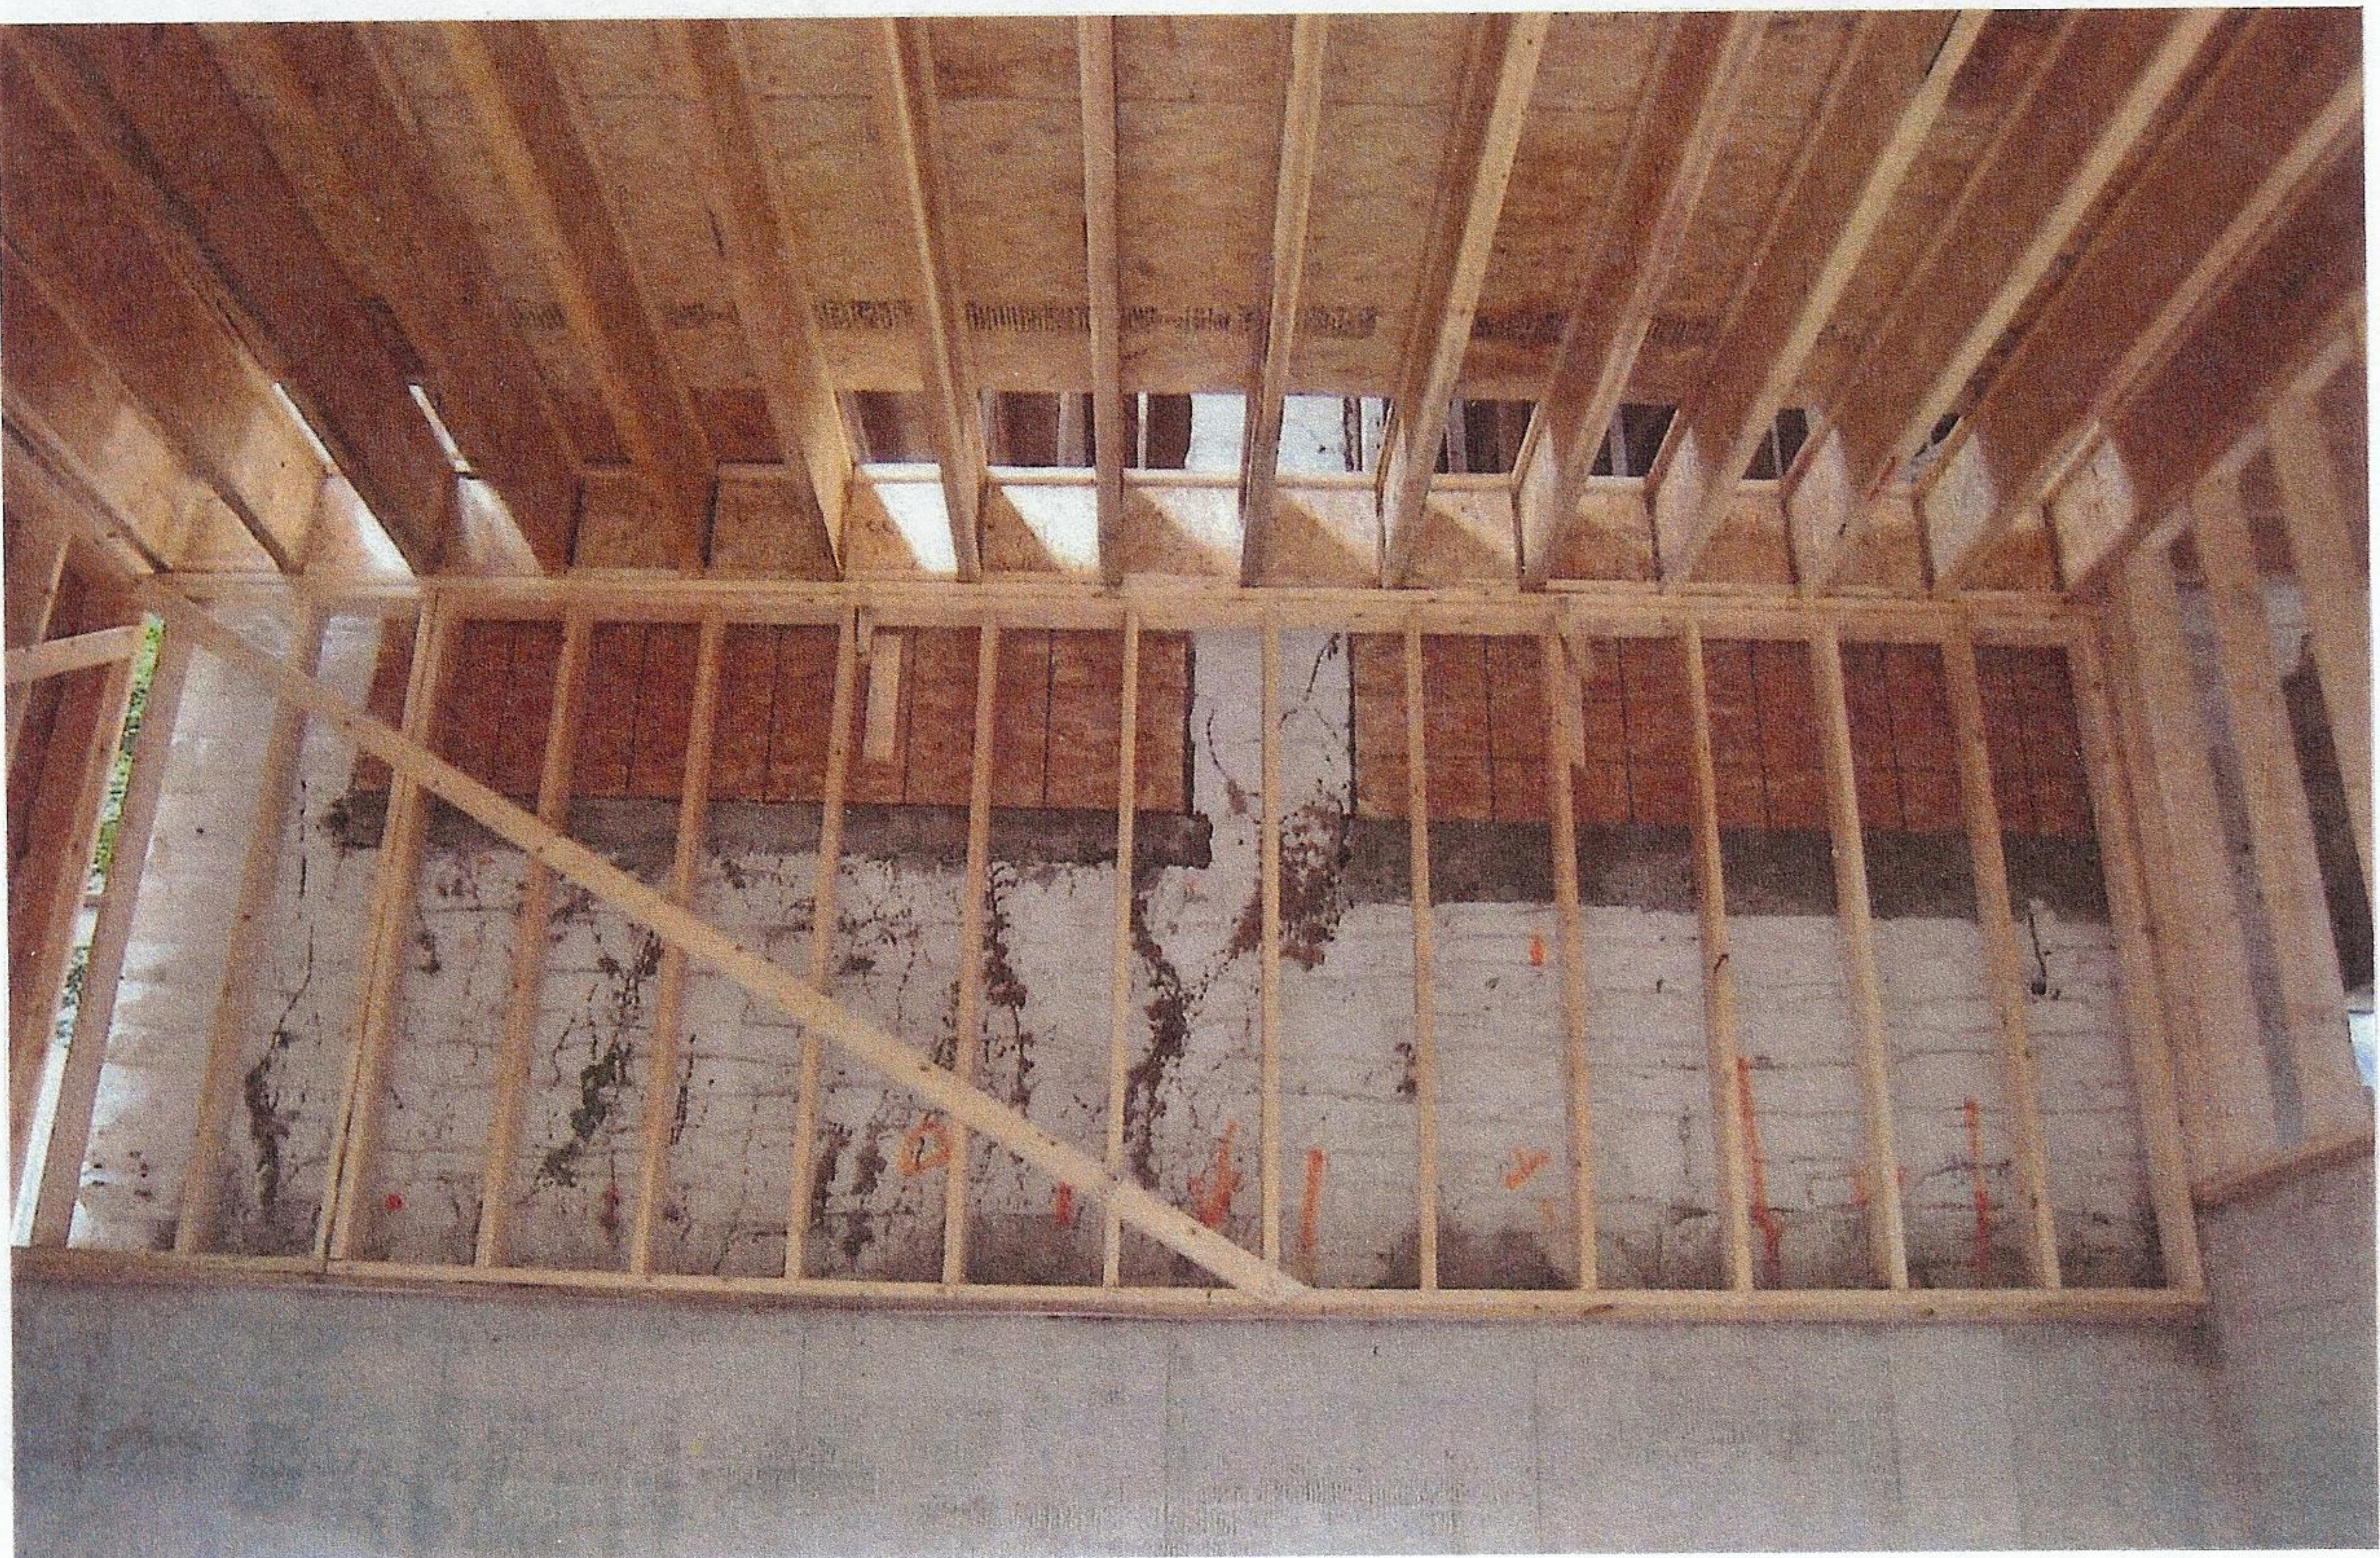
Various LBP hazards throughout the house before and after framing. Now completely hidden by wallboard.
