## **ALERT SERVICE BULLETIN**

**UH-1H-18-20**

**MODEL AFFECTED:** UH-1H

**SUBJECT:** MAIN ROTOR BLADE 204-011-250-113,  
INTRODUCTION OF DAILY WIPE DOWN  
INSPECTION AND SPECIAL 25 HOUR  
INSPECTION.

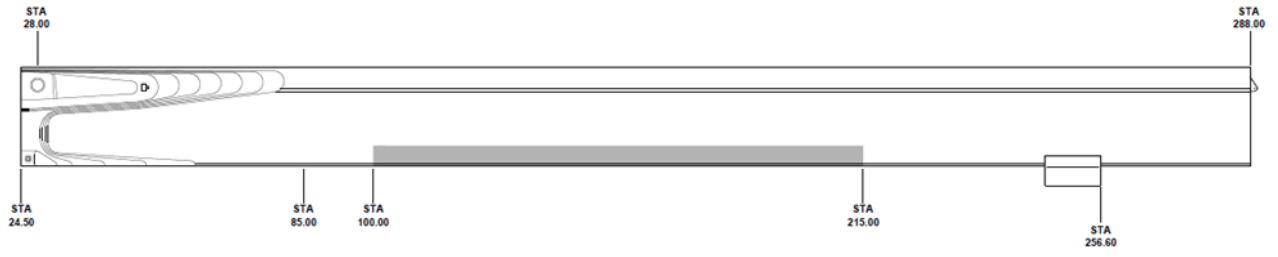
Figure 1 – 204-011-250 Series Main Rotor Blade

Bell has recently been informed of two main rotor blades P/N 204-011-250-113 with chordwise cracks originating from the extreme trailing edge outside of the current inspection area between blade station 190 and 210. Applicability of this bulletin to any spare part shall be determined prior to its installation on an affected helicopter.

1. Prepare the helicopter for maintenance.
2. Inspect the upper and lower skin surfaces of the main rotor blades as follows:
  - a. Wipe the last 4 inches of the trailing edge between blade station 100 and 215 (shaded area) with an alcohol-soaked cloth (C-385) and wipe dry with a clean cloth. (Figure 1)

- b. Using a strong light source at an oblique angle, check for evidence of a dark line. A dark line represents excess alcohol bleeding out of possible cracks or edge voids. (If no defects are found during the inspection, proceed to step 2.f).

- c. Any crack in the surface finish must be investigated further by removing paint in the affected area. Remove paint by hand sanding the affected area in a spanwise direction only, with an abrasive cloth or paper (C-406) 220 grit or smoother to determine if the crack is in the skin. (Any crack in the surface finish may be indicative of a skin crack).

- d. The main rotor blade must be removed from service if any skin cracks are detected. Contact Bell Product Support if any skin cracks are found during the inspection.

- e. If no skin cracks are found, touch-up and refinish the affected area. (TM 55-1520-210-23).
  - f. Carry out main rotor blade preventive maintenance. (TM 55-1520-210-23).
