## Home Inspection Report

123 Happy Street, Colorado Springs, CO 80918

Wednesday, October 17, 2018

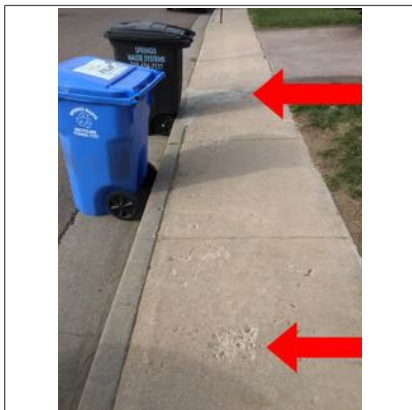
There is spalling on the service walks. Spalling can not be successfully patched. Monitor and replace the slabs as needed.

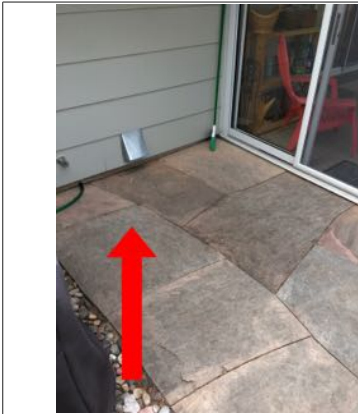
The patio had some settlement and is pitched toward the house allowing water to drain toward the house and foundation, recommend a licensed contractor repair.

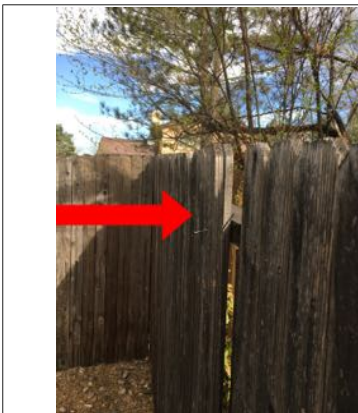
The fence has some damage. Recommend normal maintenance repairs.

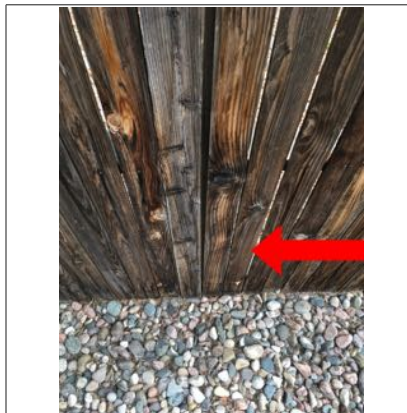
There are loose fence posts. Monitor and repair as needed.

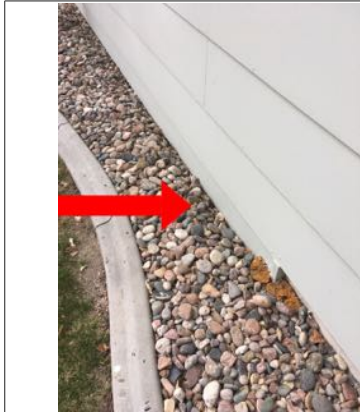
There is soil in contact with the siding. Recommend removing the soil from the siding. Repair any damaged areas as needed.

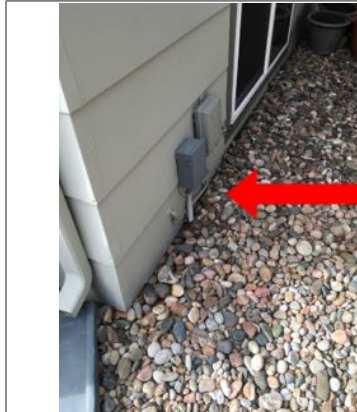
There is soil in contact with the siding. Recommend removing the soil from the siding. Repair any damaged areas as needed.

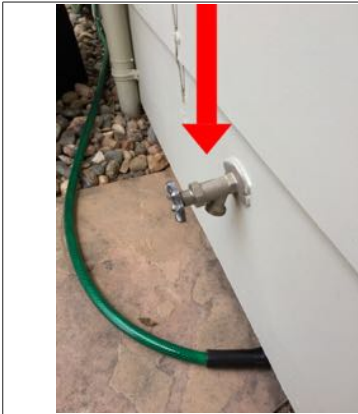
Hose bib(s) are not equipped with anti-siphon devices, possible cross contamination can occur without an anti-siphon device, recommend installing an anti-siphon device.

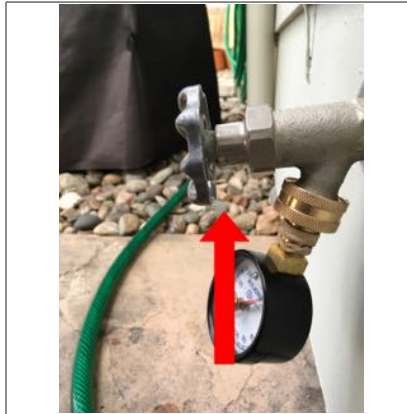
Hose bib(s) are leaking/dripping, recommend licensed plumber repair.

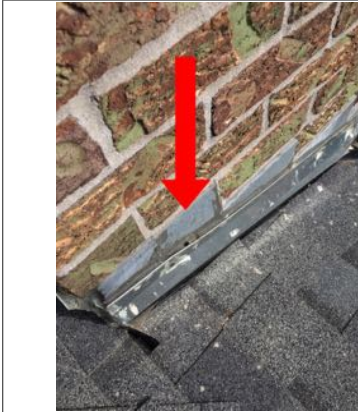
The chimney flashing has been caulked which has dried and cracked. Recommend a licensed roofer re-caulk. Ongoing maintenance will be needed. Contact a licensed roofer as needed.

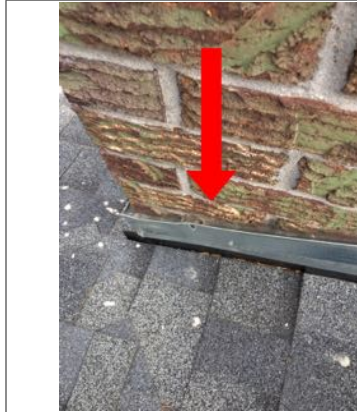
The chimney flashing has been caulked which has dried and cracked. Recommend a licensed roofer re-caulk. Ongoing maintenance will be needed. Contact a licensed roofer as needed.

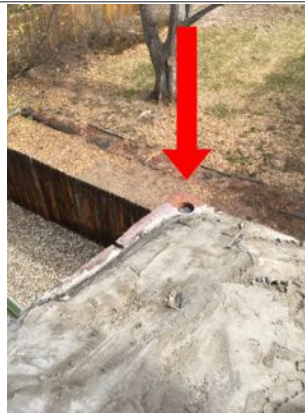
The chimney cap doesn't correctly cover the top row of bricks. Recommend a licensed chimney sweep repair.

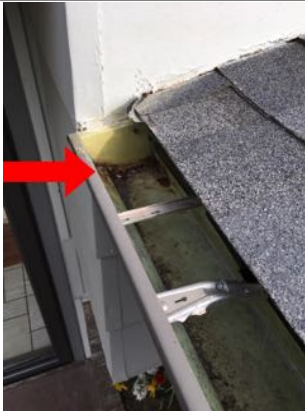
Gutters were incorrectly pitched, recommend a licensed professional repair.

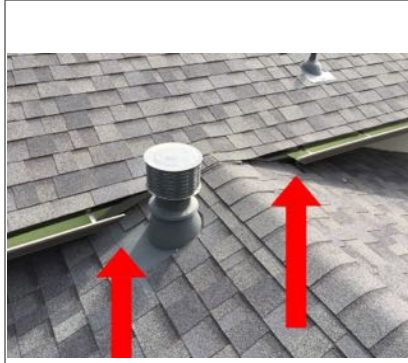
Gutters terminate on roof surfaces. This is a common practice, but will concentrate a large amount of water on one location of asphalt shingles. This will allow more wear on one location. Recommend redirecting the water discharge to other gutters or to the ground.

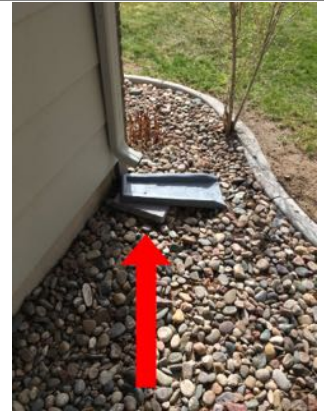
The downspouts don't direct water far enough away from the house. Recommend adding downspout extensions to discharge away from the house. 5-6' extensions recommended.

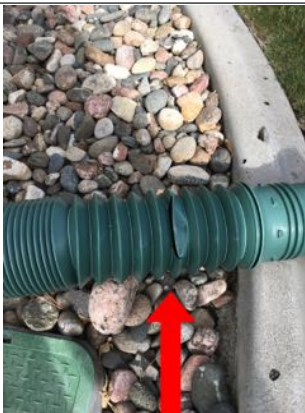
The gutter extension is damaged. Recommend replacing the damaged extension.

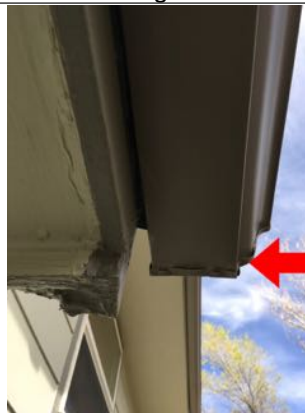
Gutters are leaking at the seams - recommend a licensed contractor repair.

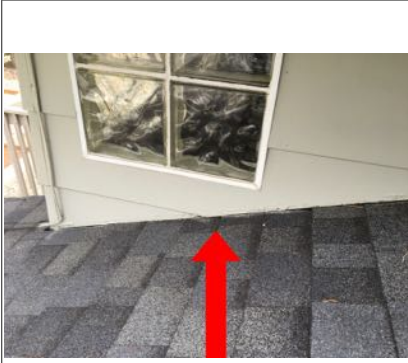
The siding is in contact with the roof. This may allow water to damage the siding over time. Recommend monitoring and repair as needed.

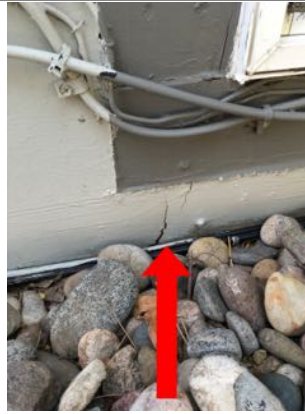
There are a number of areas where the siding has been damaged at the ground. Recommend removing soil from touching the siding and repair of damage as needed.

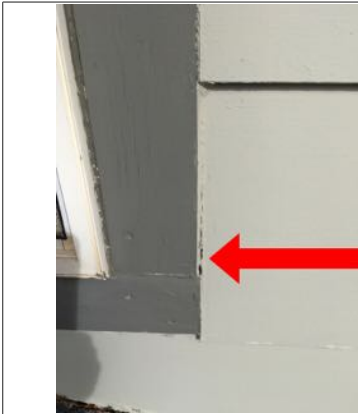
Some of the caulking has dried and cracked, recommend removing and replacing.

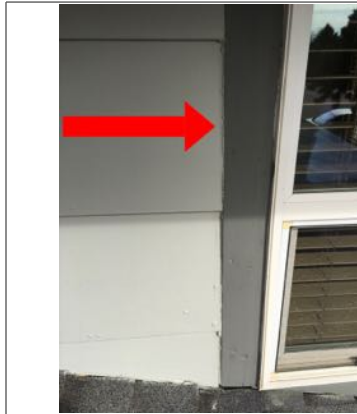
Some of the caulking has dried and cracked, recommend removing and replacing.

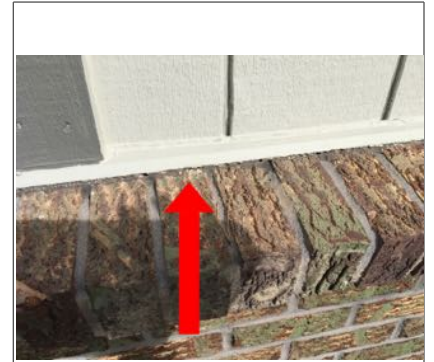
Some of the caulking has dried and cracked, recommend removing and replacing.

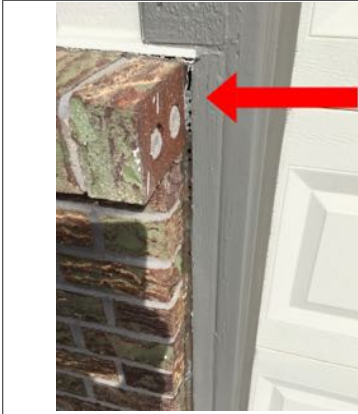
Some of the caulking has dried and cracked, recommend removing and replacing.

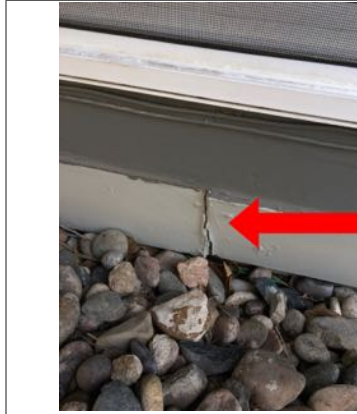
Some of the caulking has dried and cracked, recommend removing and replacing.

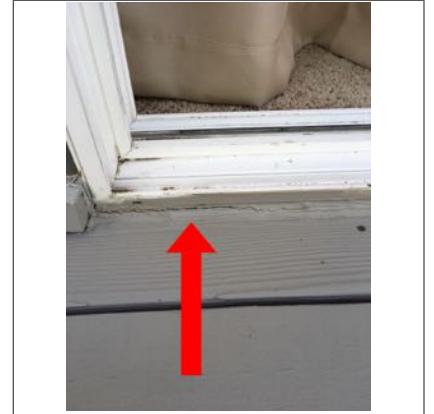
Some of the caulking has dried and cracked, recommend removing and replacing.

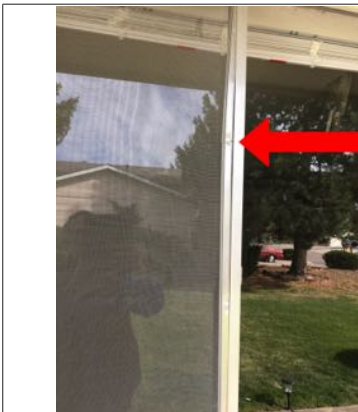
Some window screens are torn or damaged. Repair as needed.

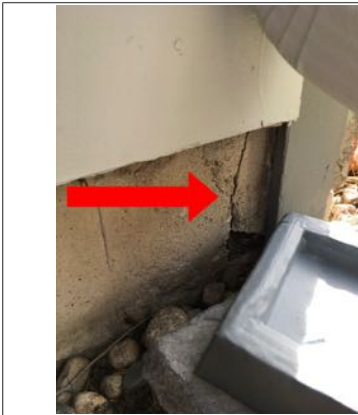
There are typical vertical cracks in the foundation. Recommend monitoring and consulting a licensed foundation expert if any cracks become active.

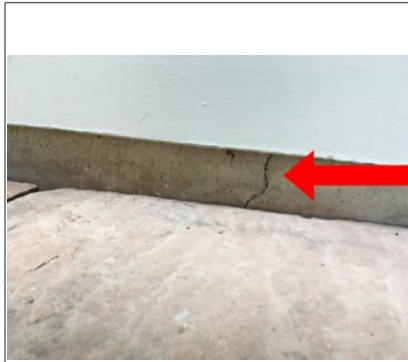
There are typical vertical cracks in the foundation. Recommend monitoring and consulting a licensed foundation expert if any cracks become active.

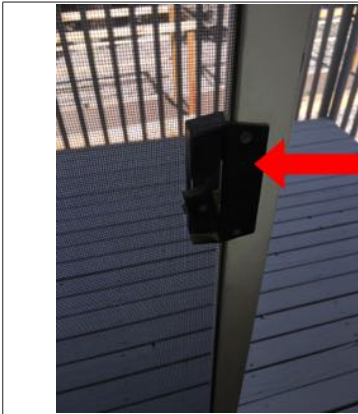
The master bedroom screen door hardware is damaged. Replace the damaged hardware as needed.

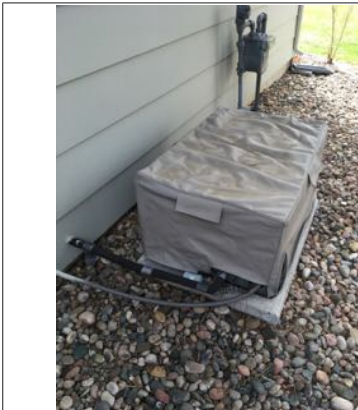
The air conditioner could not be operated because the unit was winterized.

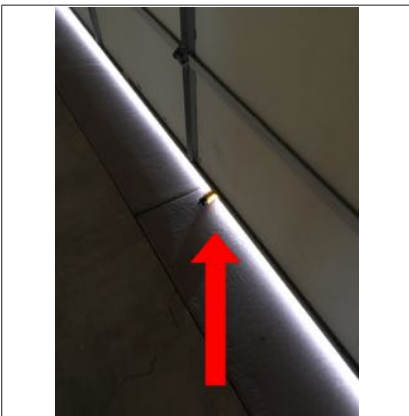
The garage safety reverse was not operating. This is a safety concern. Recommend adjusting the door opener so the safety reverse operates correctly.

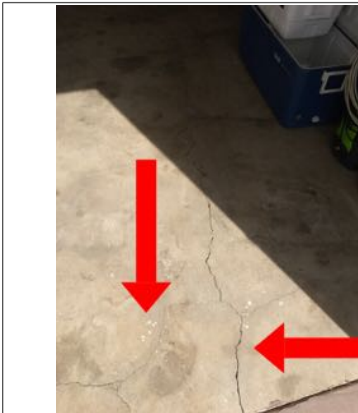
The garage floor has typical cracks. Recommend sealing with a product like Sikaflex and monitoring. Consult a licensed contractor as needed.

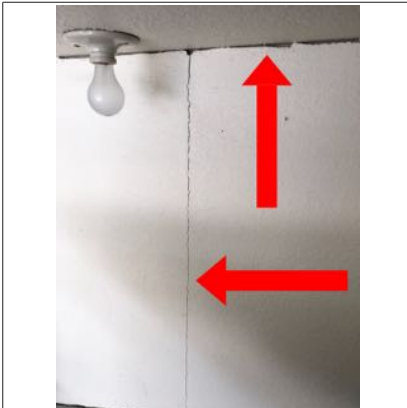
The fire separation wall was damaged between the garage and the living area of the house. This is a safety hazard. Recommend a licensed contractor repair.

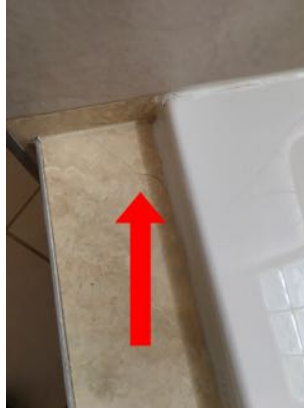
There is a cracked tile near the bathtub. Repair/replace as needed.

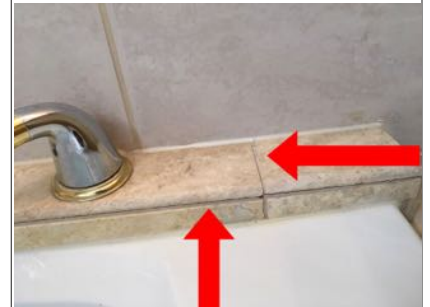
There are areas of missing/ cracked grout in the bathroom. Recommend re grouting.

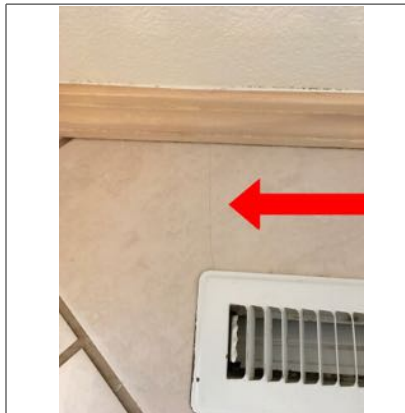
There is a cracked floor tile.  
Replace the tile as needed.

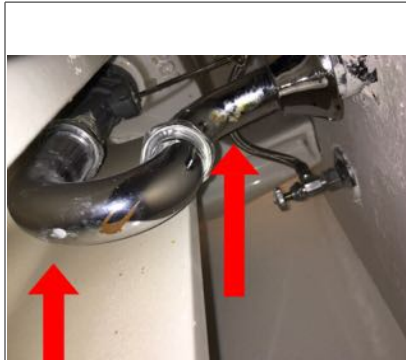
The P-Trap is corroding and will fail if not replaced. Recommend a licensed plumber repair.

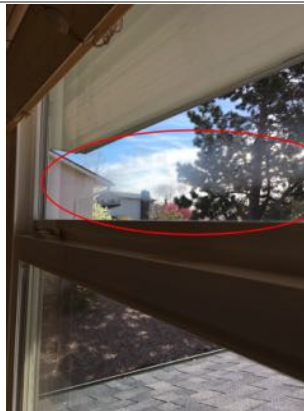
There is evidence of leaking insulated glass in the bedroom. Recommend repair/replacement of window.

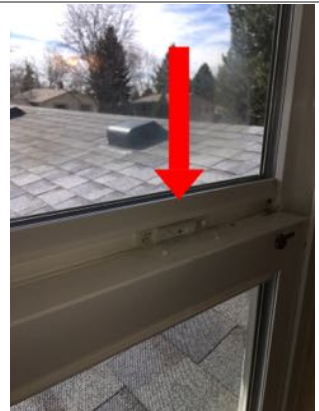
The window hardware is missing. Recommend installing new hardware.

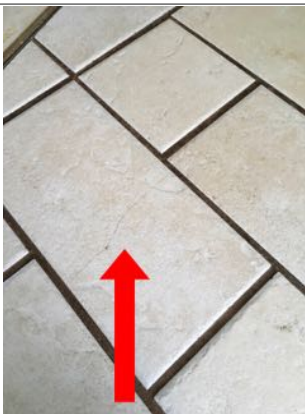
There is a cracked tile at the entrance to the kitchen. Replace the tile as needed.

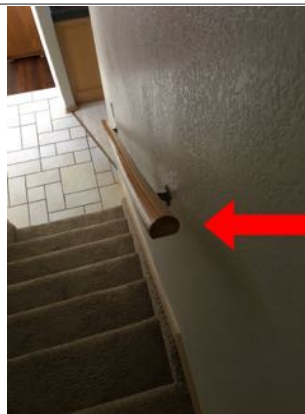
The handrail doesn't wrap to the wall. This is a safety concern. Recommend installing a hand railing that properly wraps to the wall.

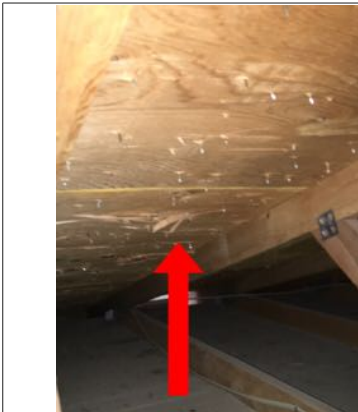
There are some areas of sheathing damage. Recommend monitoring and repair as needed.

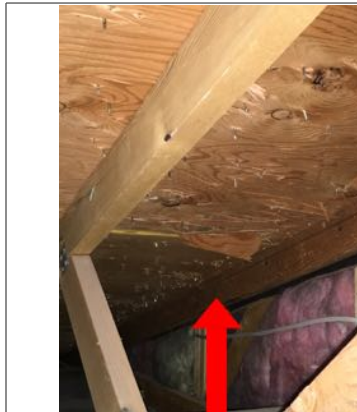
There are some areas of sheathing damage. Recommend monitoring and repair as needed.

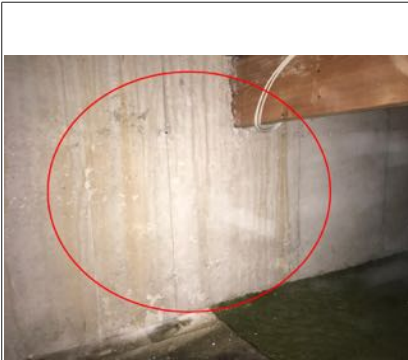
There are areas with moisture stains. No active leaking was detected. Monitor and repair as needed.

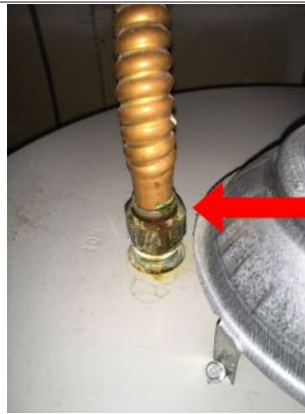
The water heater has an active leak. Recommend a licensed plumber repair.

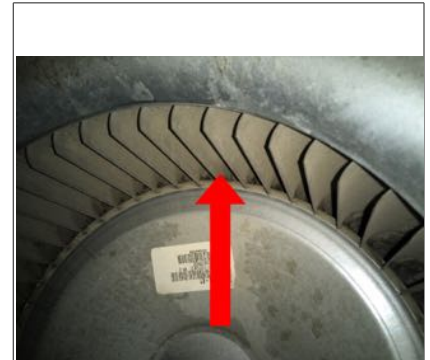
The furnace is dirty and in need of a normal cleaning by a qualified technician. Recommend the furnace be serviced as part of its normal annual maintenance.

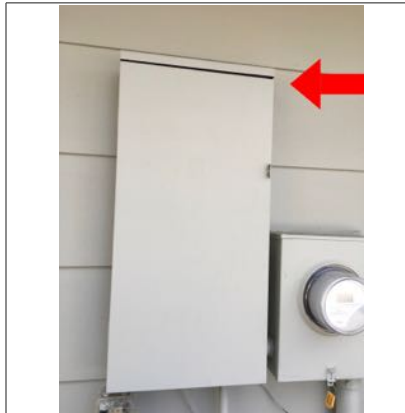
The electrical panel cover doesn't fully close. Recommend a licensed electrician repair as needed.
