NUTS & BOLTS

Volume 26—October 2008 Fall/Winter Issue 26

SPRINKLER PIPE FAILURES

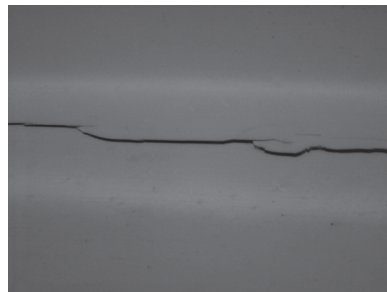
Figure 1: Axial crack in CPVC sprinkler pipe to due preservative oil washed in with the water 100x

ESC cracks tend to be axial. As they appear in figure 1, they are zig zag. Sometimes they are branched and sometimes stop-and-go. Usually they have surprisingly uniform crack openings on the ID, and crack initiation is usually on the ID. Sometimes they are at the top of the pipe where an insoluble contaminant has floated. ESC cracks frequently stop adjacent to cemented joints.

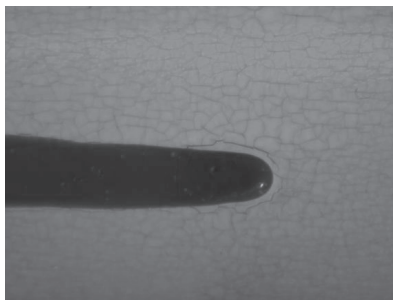
We also see crazing such as figure 2.

When assembling CPVC, incomplete insertion at a fitting can leave a blob of glue that can cause ESC. Similarly, excess glue can leave a blob that starts CPVC, figure 2.

Figure 2: ESC surrounds an adhesive drip inside a CPVC pipe. Crazing is due to vapor from the adhesive.
