ROAD TRAFFIC CRASH INVESTIGATION REPORT

INVOLVING THE HON. MINISTER OF STATE FOR
LABOUR AND PRODUCTIVITY
BARR JAMES OCHOLI, SAN

Presented to the Federal Executive Council

09
MAR
2016

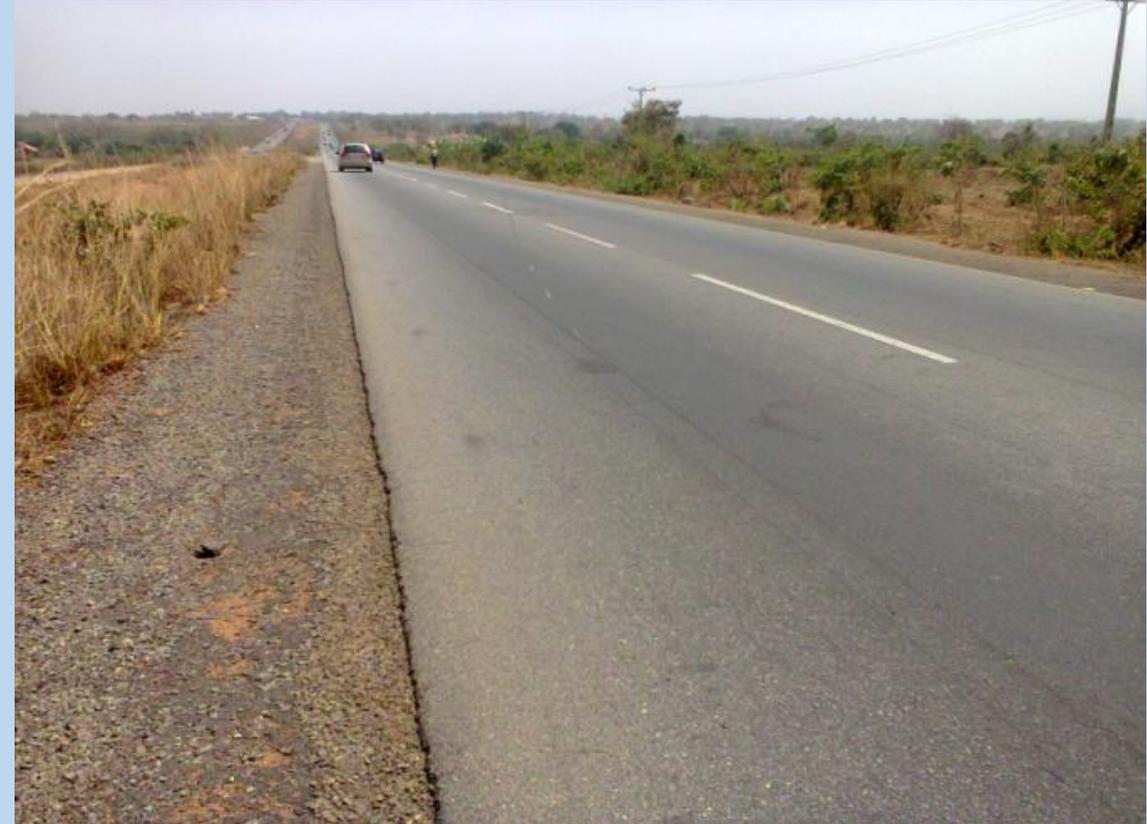
LOCATION OF CRASH

- Kaduna – Abuja expressway is part of the Lagos-Kaduna – Kano Trunk A1 highway
- The dual carriageway here is a standard 2- way, 4- lane bituminous asphalt paved surface.
- The road width of each of the east and west carriageway is about 7.8 metres wide, with partially eroded hard shoulders.

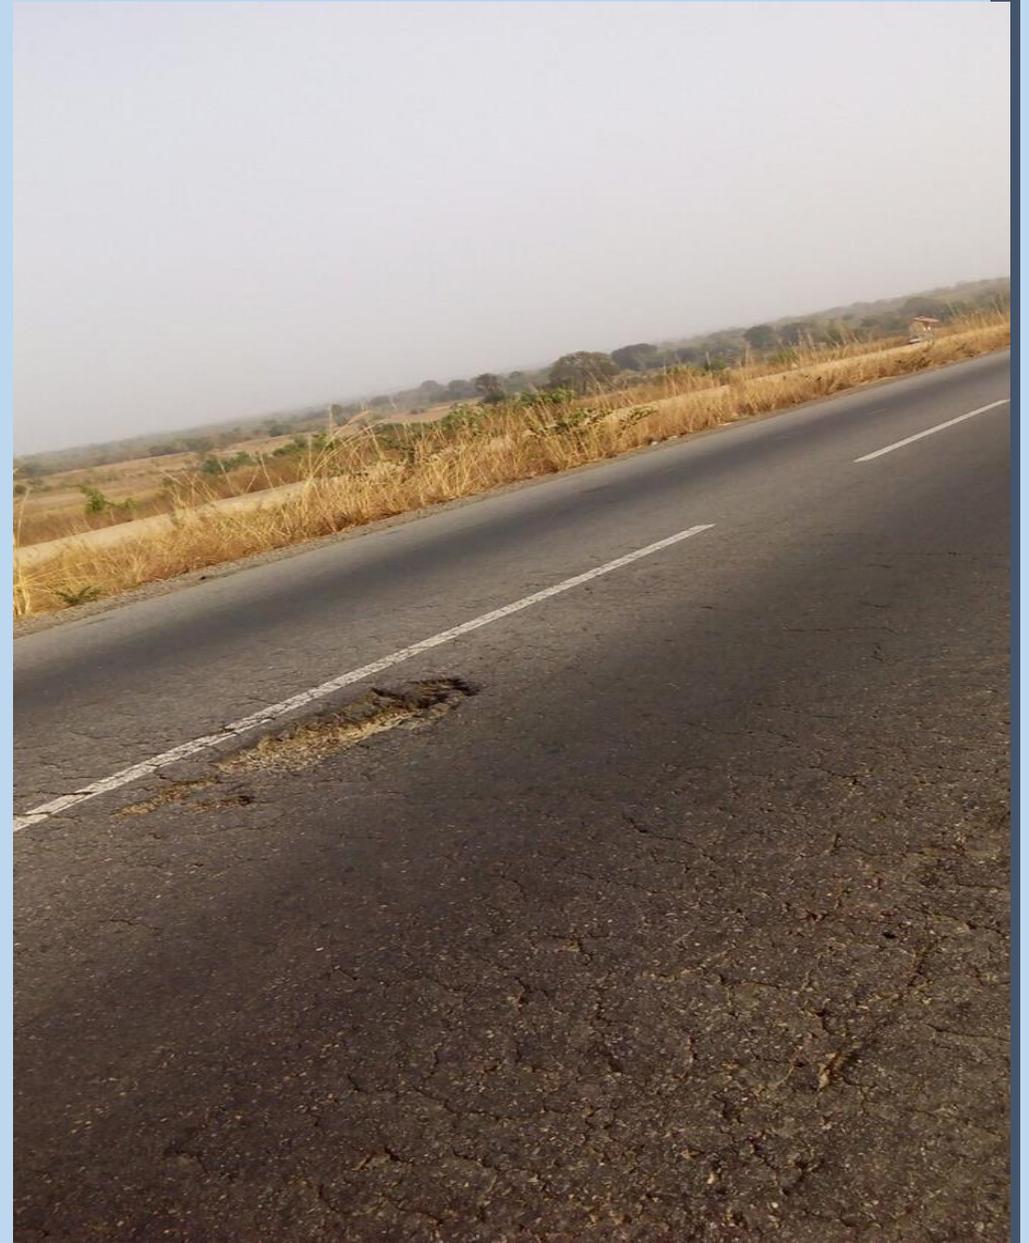
LOCATION OF CRASH III

- The daily average traffic volume count conducted within this area shows figures of about 2,800 and 1,500 per hour for the east and west bound directions of the Abuja – Kaduna Expressway respectively
- This stretch of roadway serves heavy vehicle traffic of articulated trucks and other private/ commercial vehicles of various utility designs that travel to and from northern Nigeria

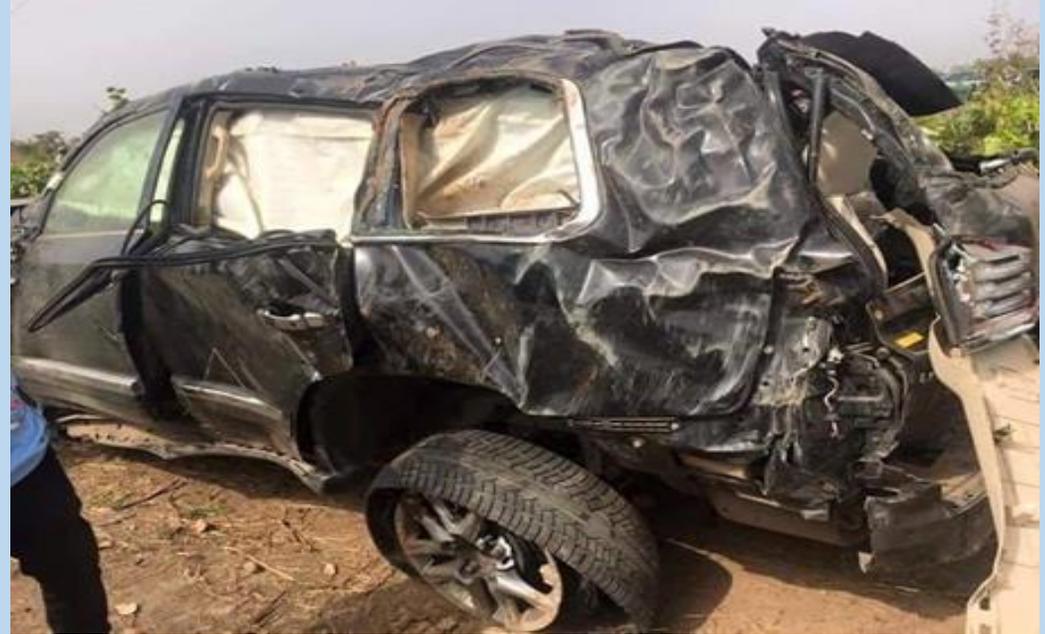
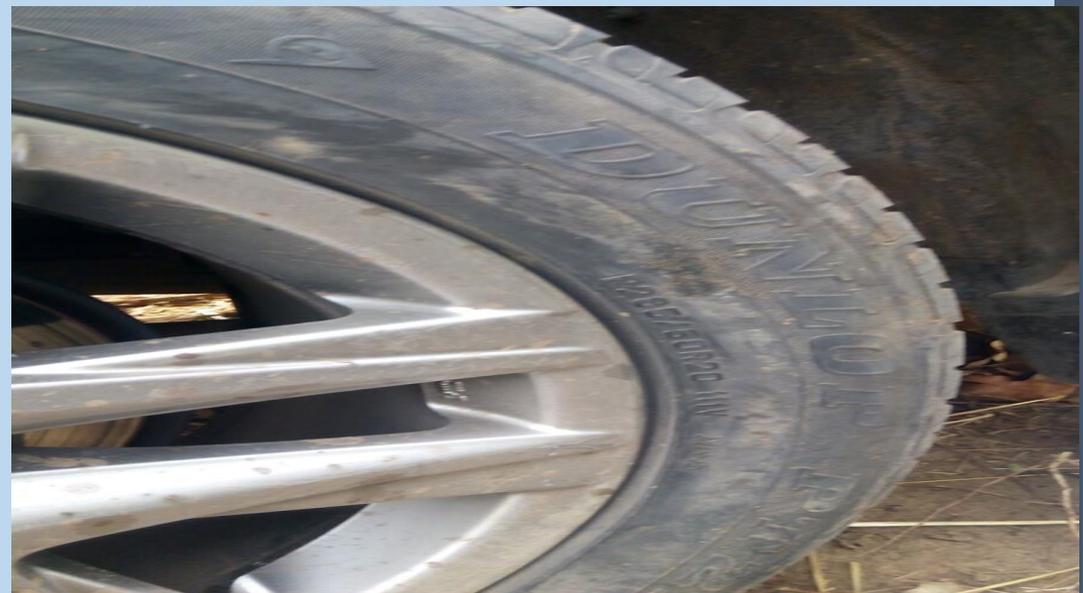
ANALYSIS OF THE CRASH

On Sunday, March 6, 2016, about 1515 hours, a Lexus LX570 SUV operated by the Federal Government of Nigeria and occupied by the Minister of State for Labour and Productivity Barr James Ocholi, his wife, son, driver and orderly, were travelling in the inner lane of westbound roadway of Kaduna – Abuja trunk 'A' express road at a very high but undetermined speed

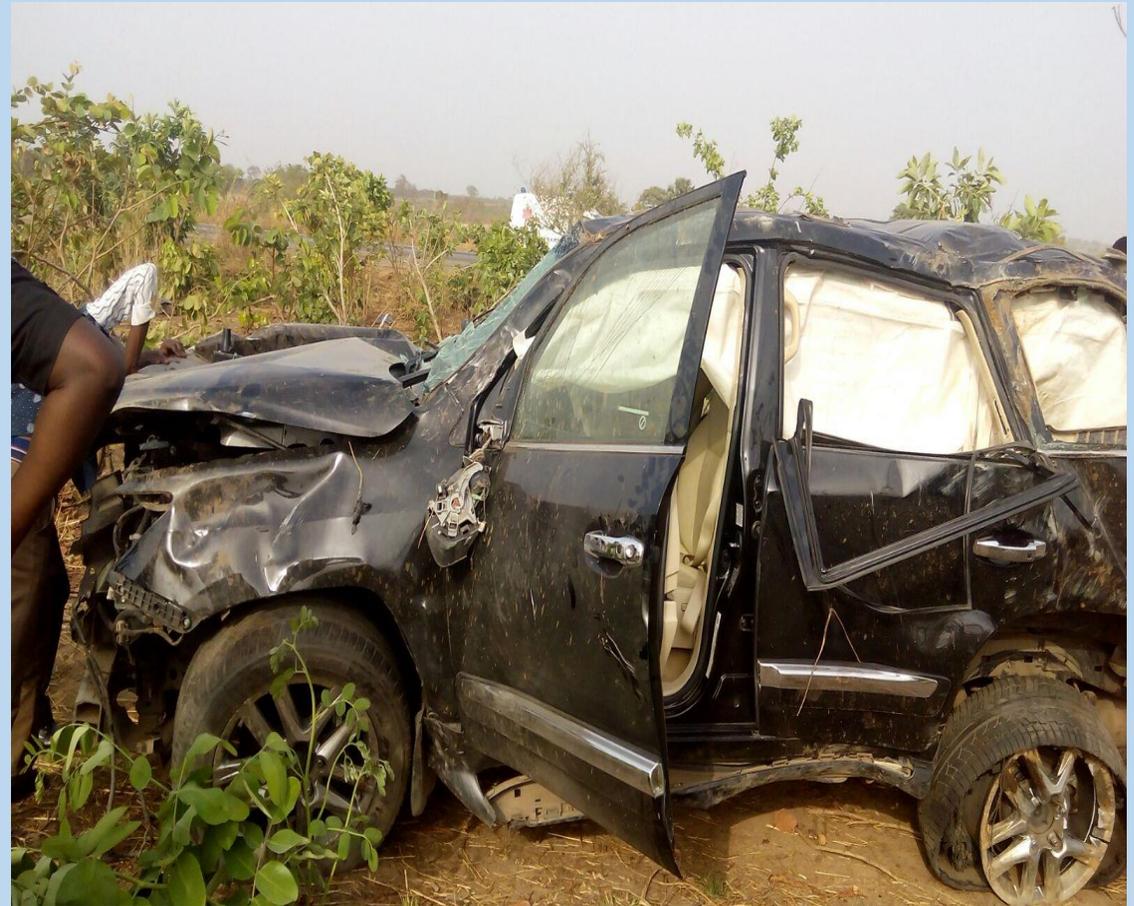
ANALYSIS OF THE CRASH II

As the driver approached km34, Rigana village (the crash site), near Doka General Hospital Kaduna state Nigeria about 180km to Abuja, the vehicle had a rear left tyre burst, the driver who was on a very high speed, applied hard brake and the rear of the car skidded

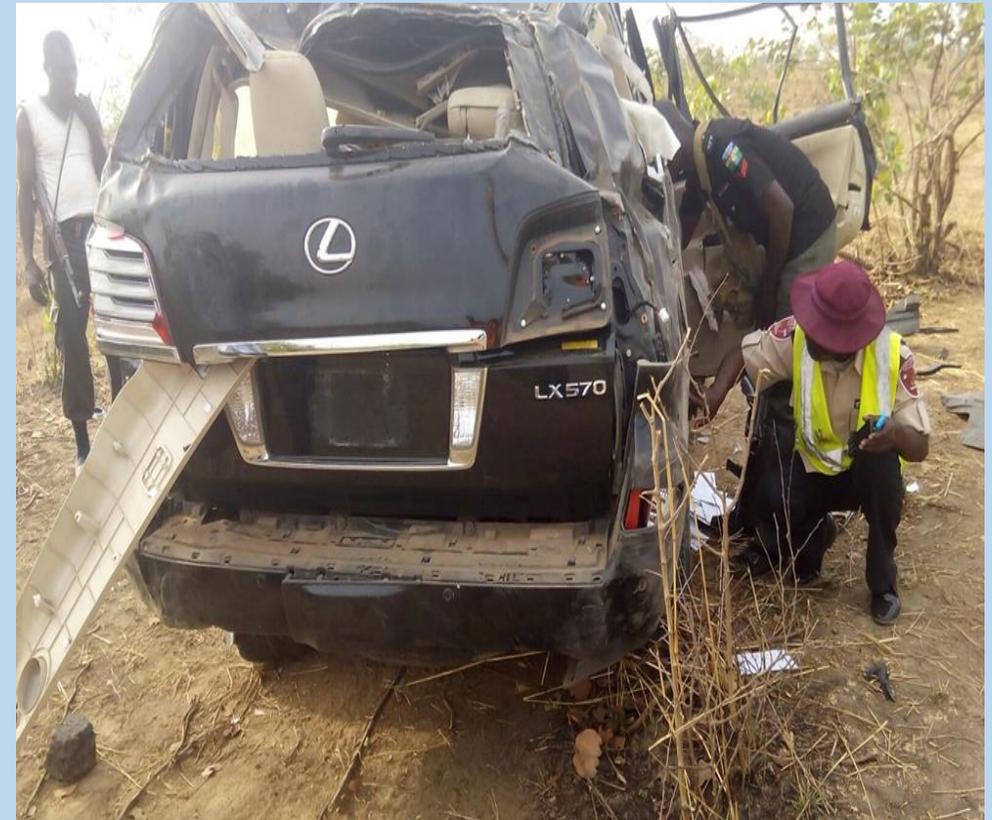
ANALYSIS OF THE CRASH III

- The driver was unable to maintain control of the vehicle as it departed the inner lane of the roadway, made a deep long groove mark of about 9.30m from the burst left rear rim while the right rear tyre made a yaw mark about 15 metres
- The vehicle continues an uncontrolled movement into the bush part on its right, uprooting some shrubs and grasses before it somersaulted severally

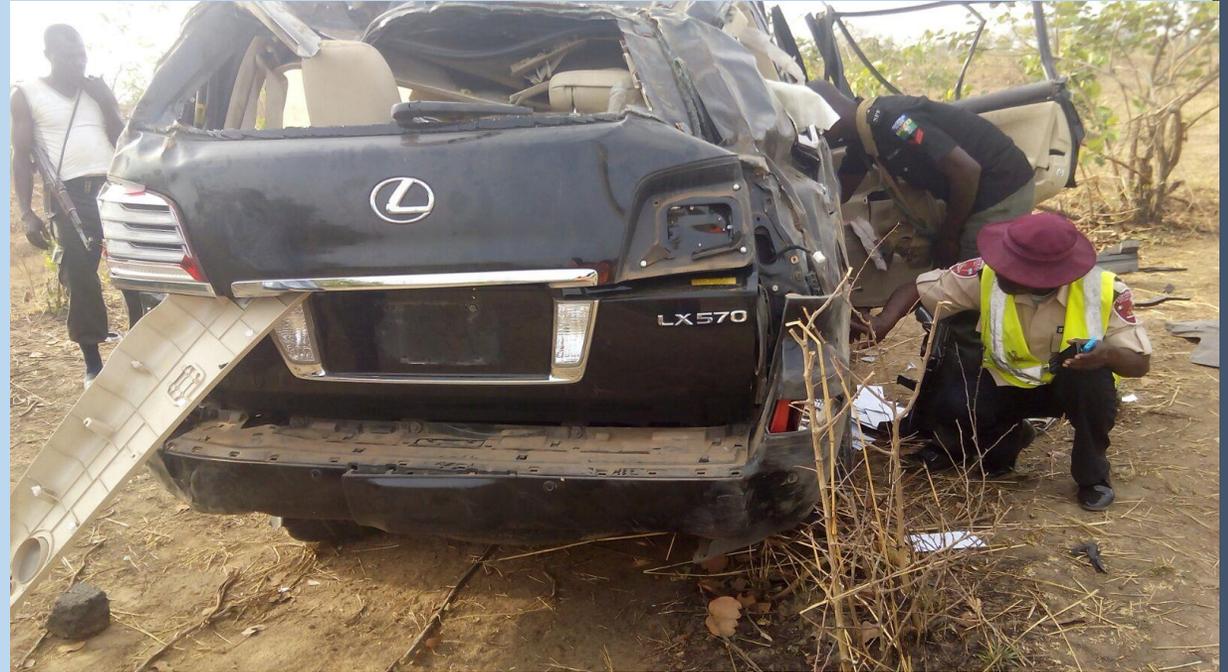
ANALYSIS OF THE CRASH IV

The Minister and his son were ejected from the vehicle while the wife was trapped by the left passenger door before sliding to a final rest position about two metres to an electric pole

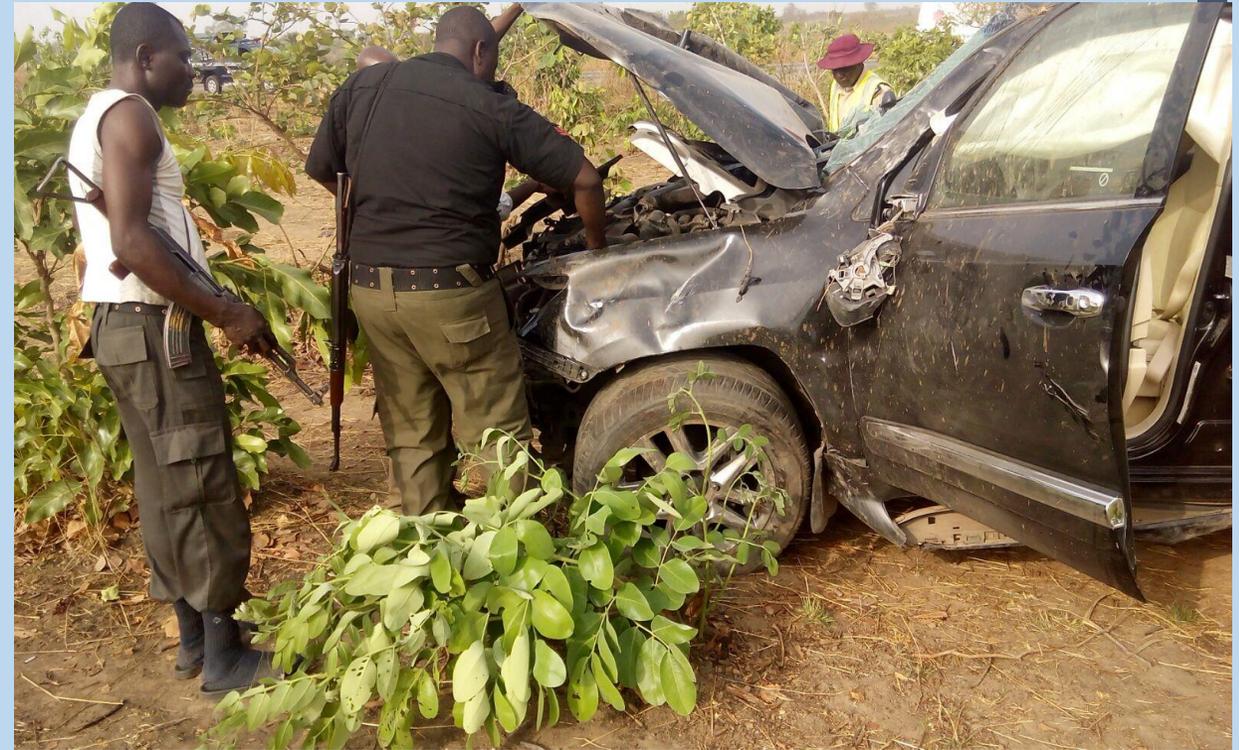
INVESTIGATION II

The driver of back-up vehicle also slammed on his brakes and held the firmly the steering which made the vehicle to skid and made 180 degree turn also ejecting two out of its five occupants before coming to final rest position on the middle of the road facing the opposite of its travel direction

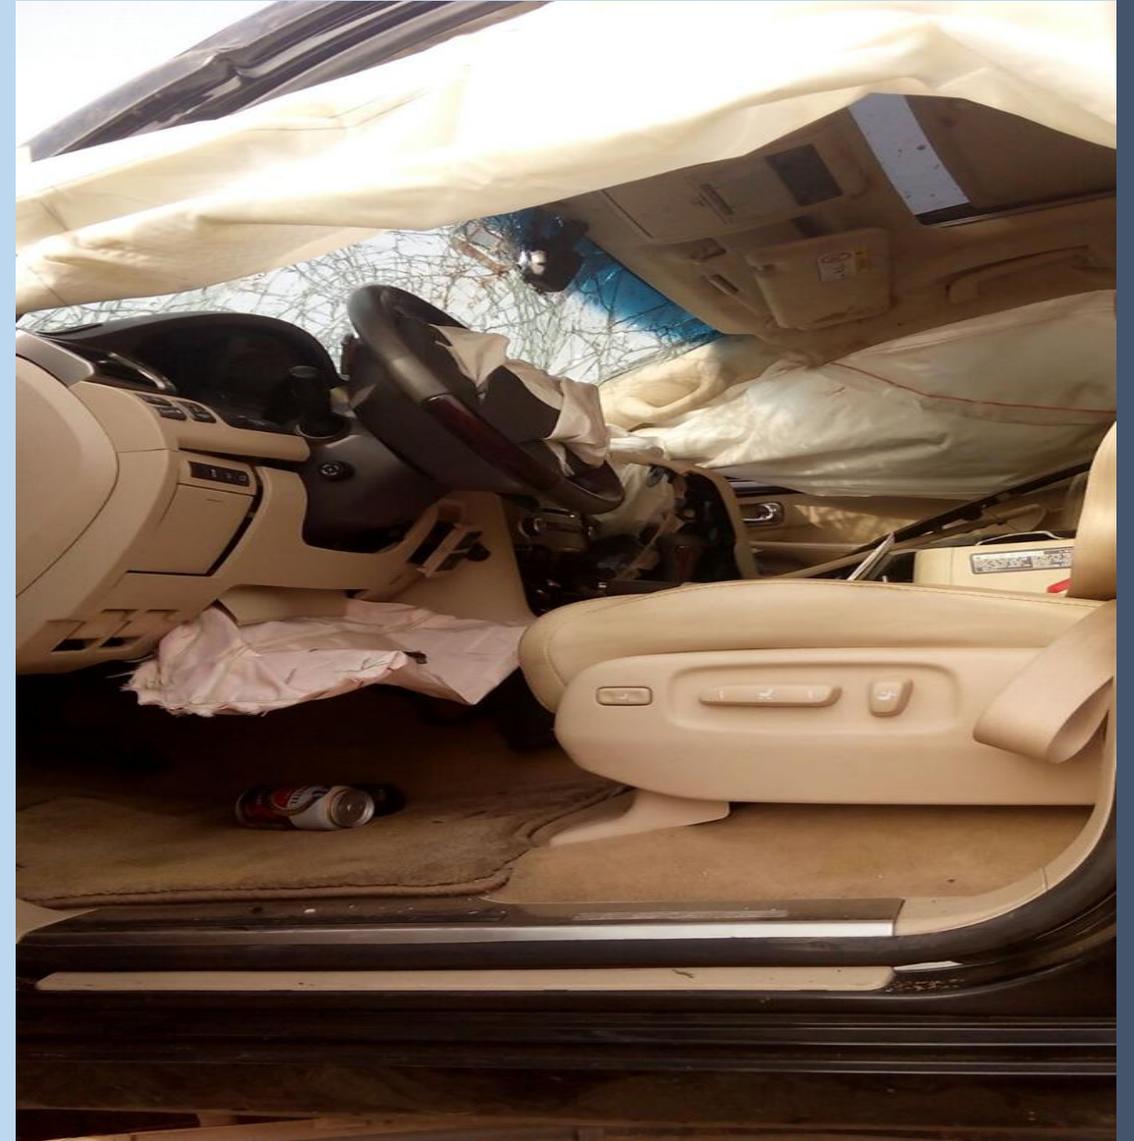
SPEED LIMIT AND SEAT BELT AVAILABILITY/USE II

The ejection of the Minister and his son who occupied the rear seat confirmed the fact that their rear seat belt were not in use and on the contrary, the driver and the orderly survived because the front seats belts were in use
