ASCE/SEI 31-03 Seismic Evaluation and Cost Estimate for
Seismic Upgrades for
Beverly Cleary Fernwood Campus
1915 NE 33rd Avenue
Portland, Oregon 97212

April 15, 2011

Portland Public Schools

James G. Pierson, Inc.
Consulting Structural Engineers

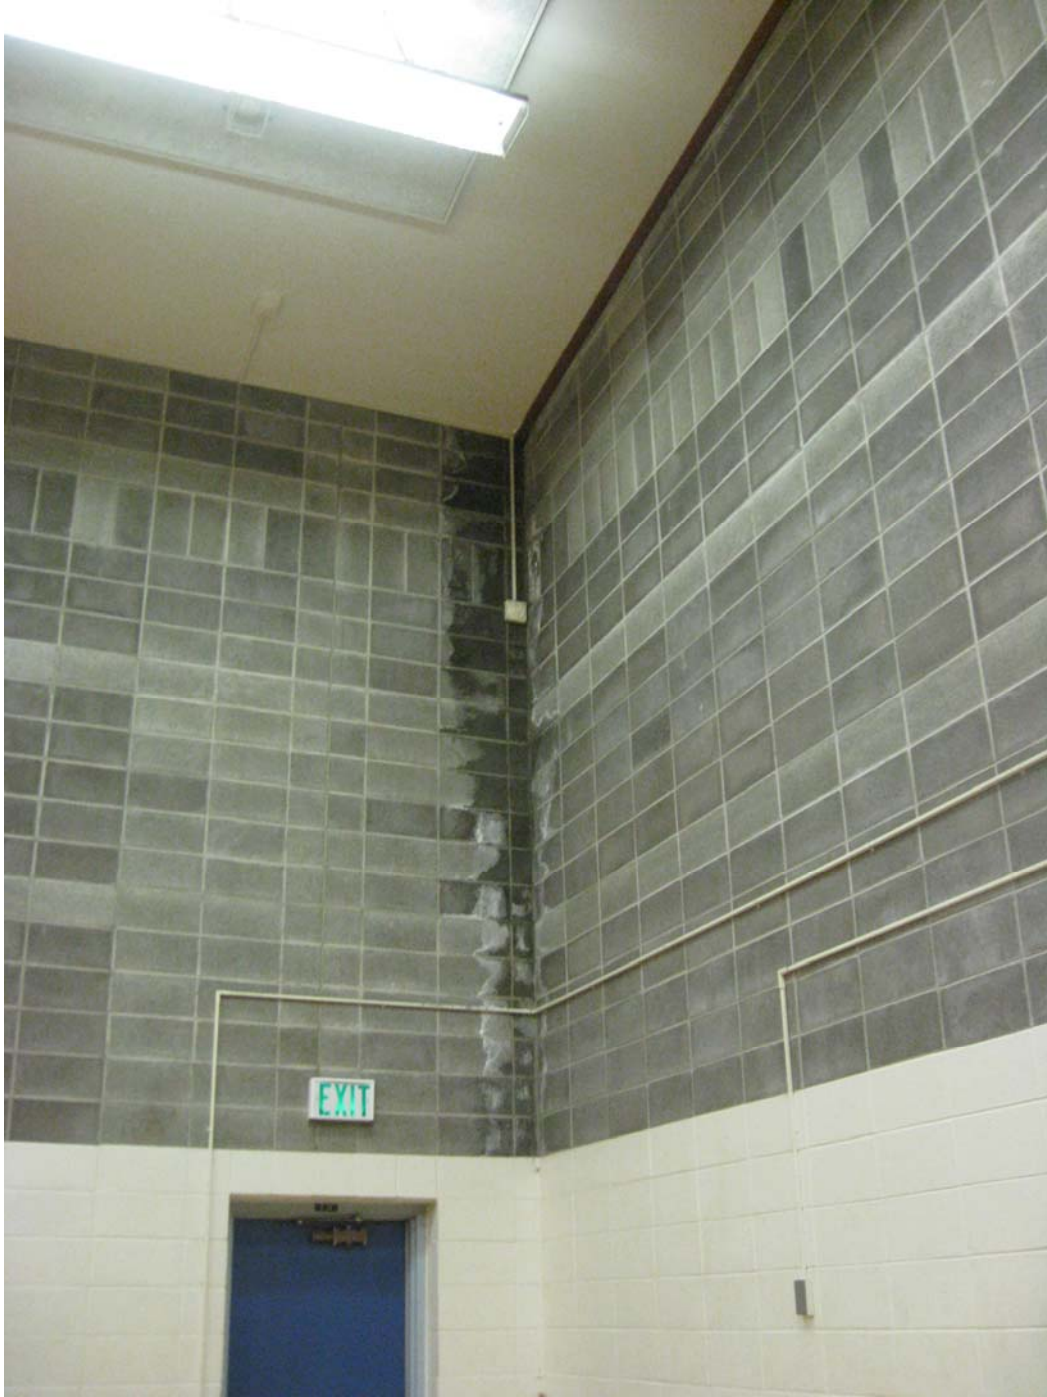
Photo 2

Generally the brick is in good condition. No cracks were observed. A white residue is present over some exterior wall areas at the Original Building. The most substantial amount of efflorescence occurs on the west face of the west wing of the Original Building. Refer to Photo 1. Efflorescence, along with water marks, occur in several locations on the interior face of the

gymnasium walls, indicating roof leaks. See Photo 2. The brick mortar appears to be well maintained and is in good condition. No significant cracks were observed. The mortar can not be scraped away by hand with a screwdriver. Differences in mortar color and tooling on wall areas of the Original Building indicates that repointing has been done in the past. The terra cotta trim on the exterior of the Original Building appear to be in good condition. The joints around the edges of these pieces appear to be in sound as there are no signs of water intrusion. No loose pieces were observed. The original drawings depict ties embedded into the adjacent supporting concrete.

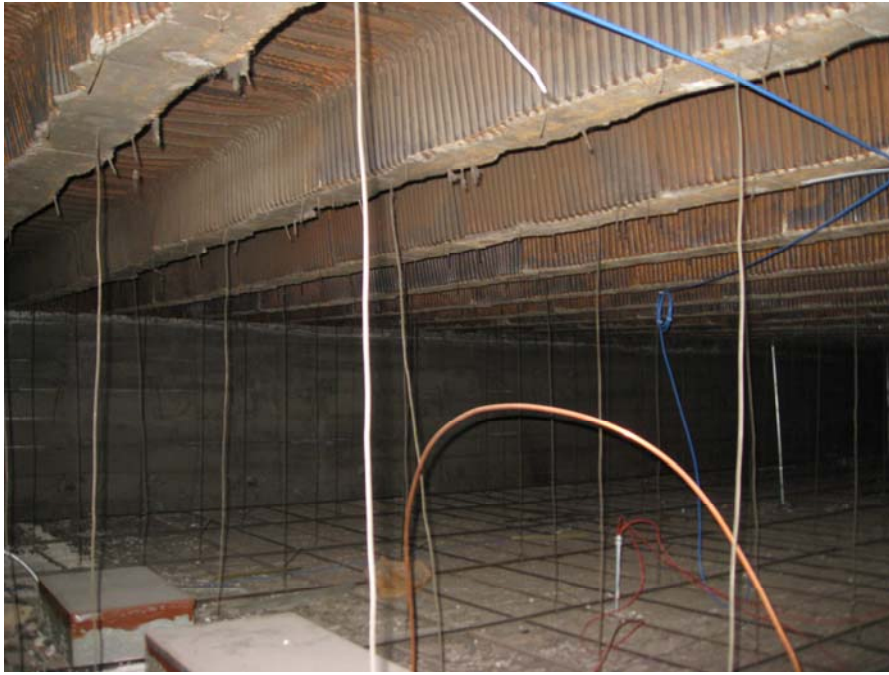
Photo 5

The construction of Unit #3 East Classroom Wing is generally the same as the West Classroom Wing; however observations during the site visit found the joists in this construction phase were formed using metal pans rather than the clay tile used in the first two Units. The bottom of this system can be seen in Photo #5.
