The structural adequacy and durability of large panel system dwellings

Part 1

Investigations of construction

R J Currie, B R Reeves and J F A Moore

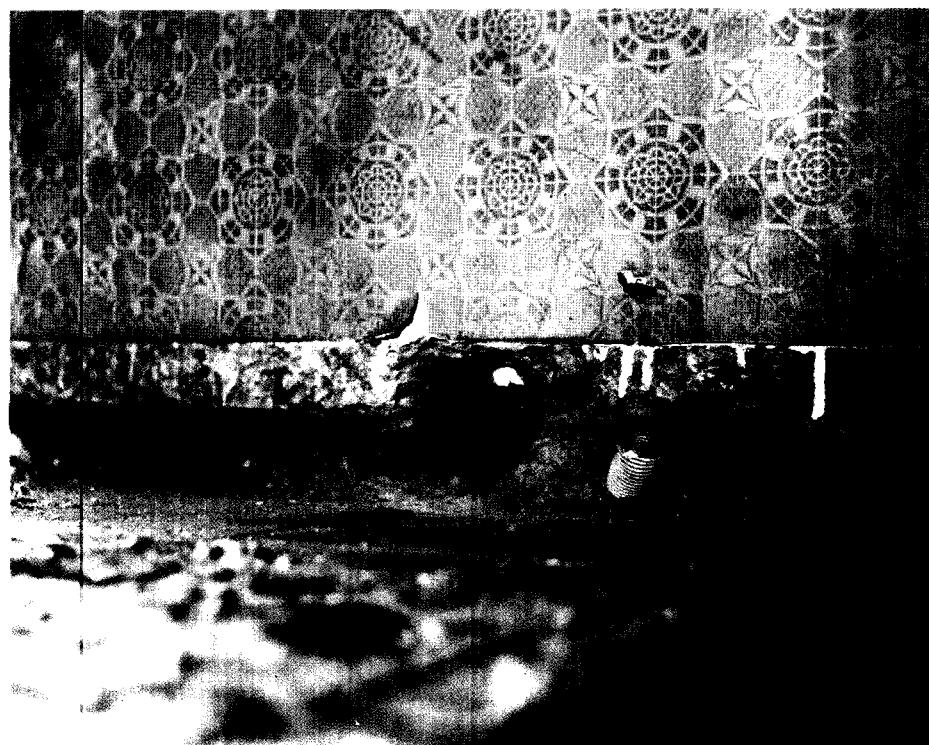
Plate 2 Bison: dry pack missing; support provided by the levelling bolts

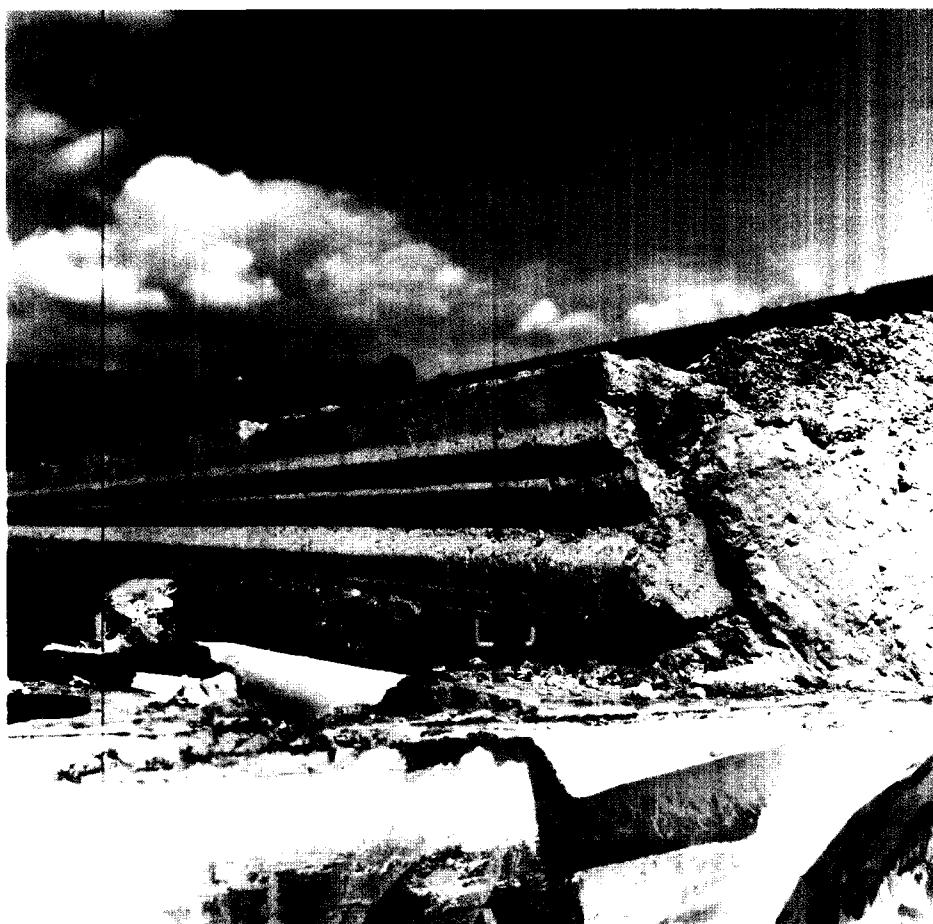
Plate 3 Bison: carbonated roof beams supported on hardboard packing

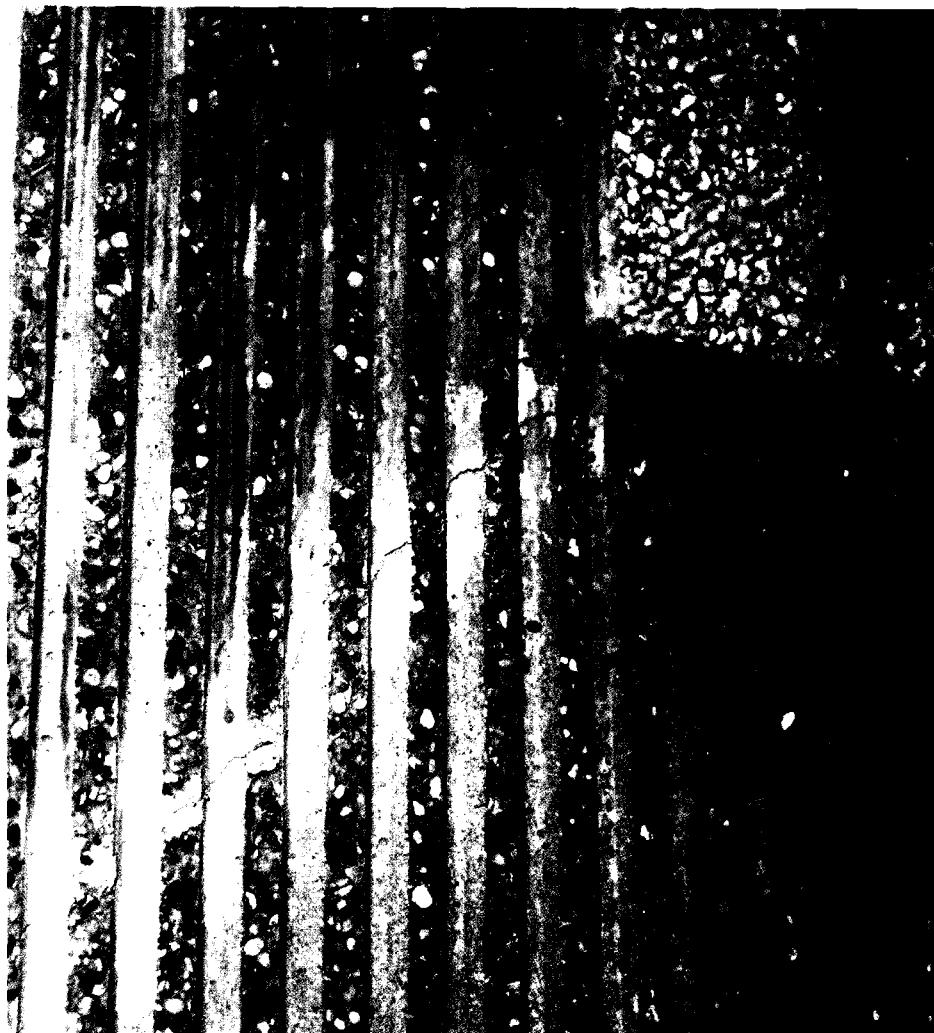
A3.25 Fine diagonal cracking was found in a number of cladding panels. The cracks originated from the lower corner of window openings (Plate 4).

Plate 4 Bison: diagonal cracking originating from corner of window opening

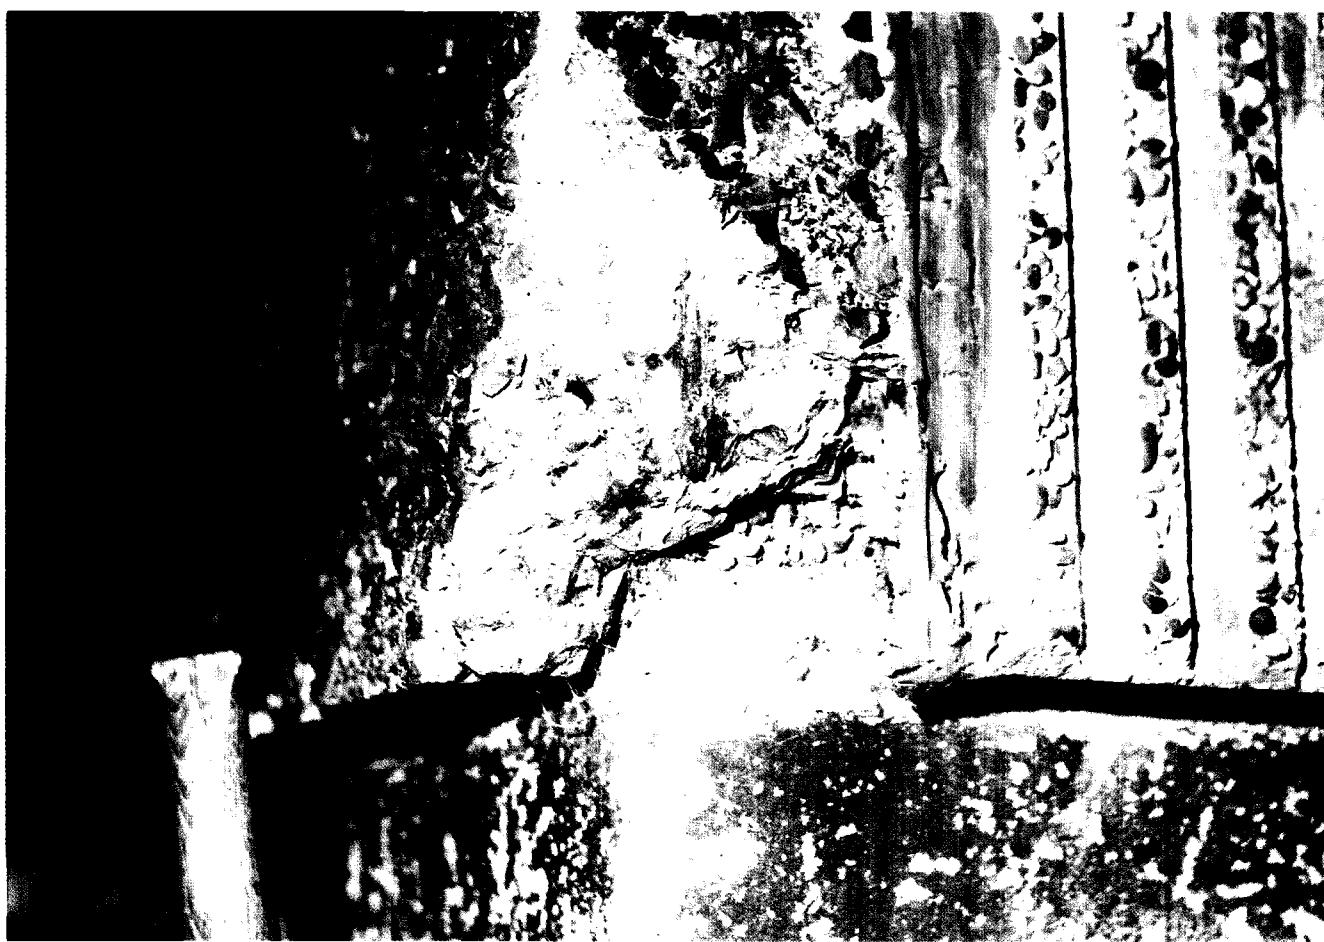
A3.26 One example of the failure of a previously repaired panel corner was found. Corrosion of underlying reinforcement had caused a crack to form along the interface between the parent panel and the repair (Plate 5).

Plate 5 Bison: failure of factory repair to panel

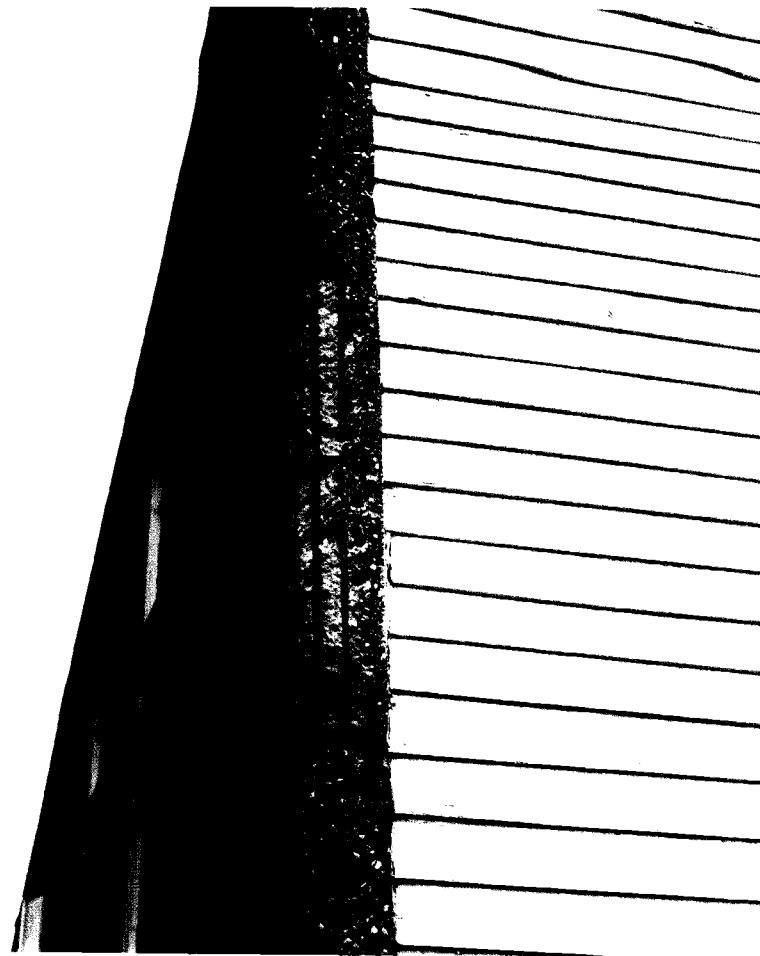
Plate 11 HSSB: spalling associated with reinforcement corrosion

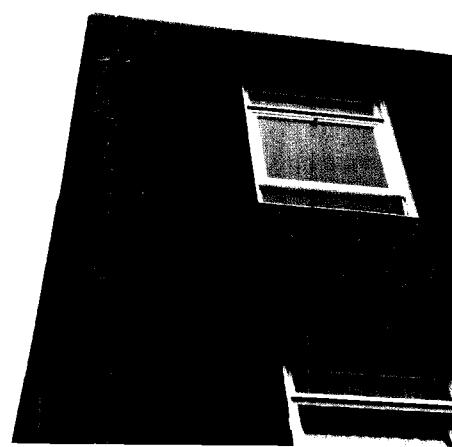
Plate 12 HSSB: movement of parapet components

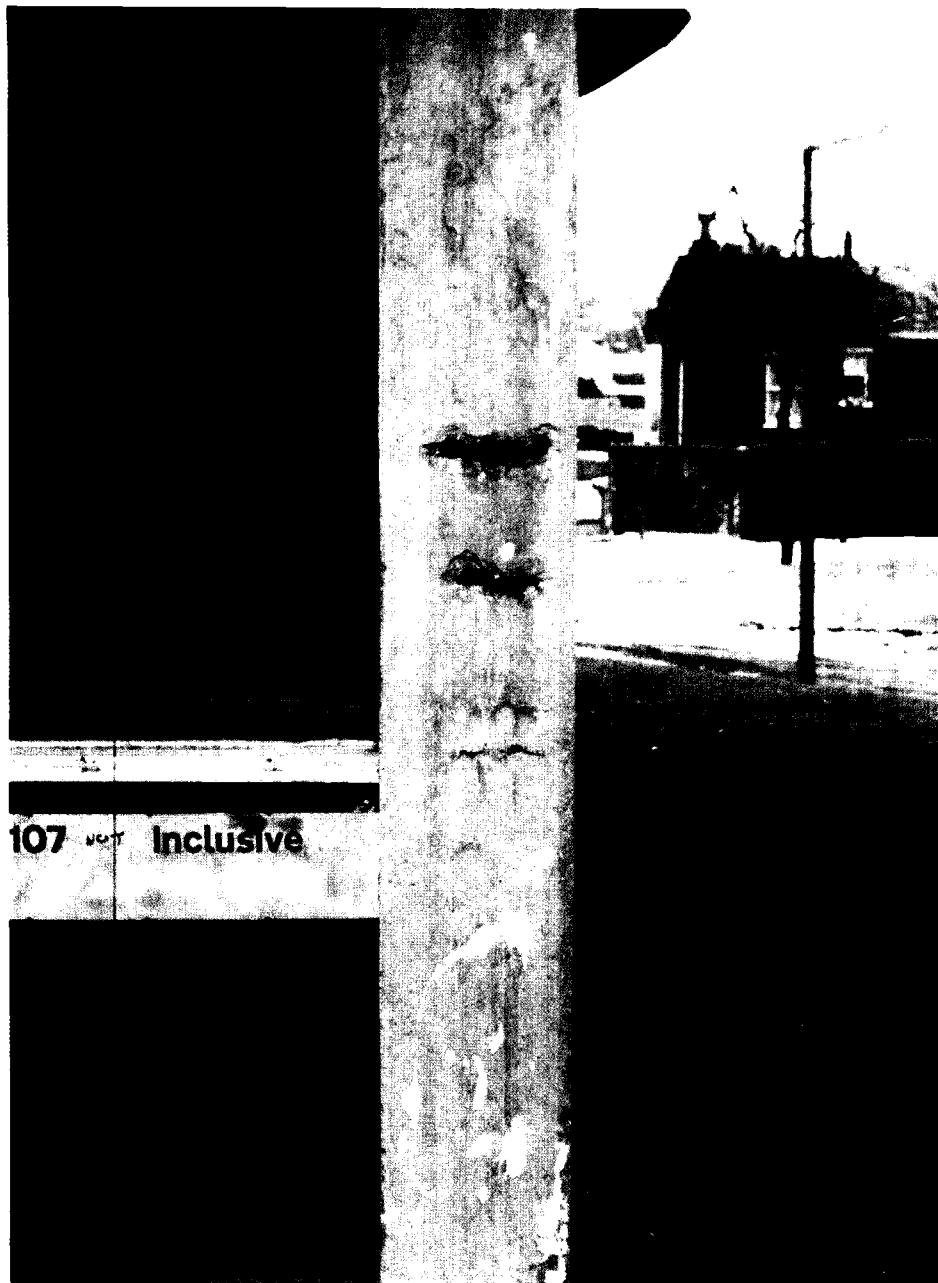
A7.9 In some columns there was spalling associated with reinforcement corrosion due to carbonation and low concrete cover to the reinforcement (Plate 14).

Plate 14 Jespersen: corrosion due to carbonation and low concrete cover to the reinforcement in columns

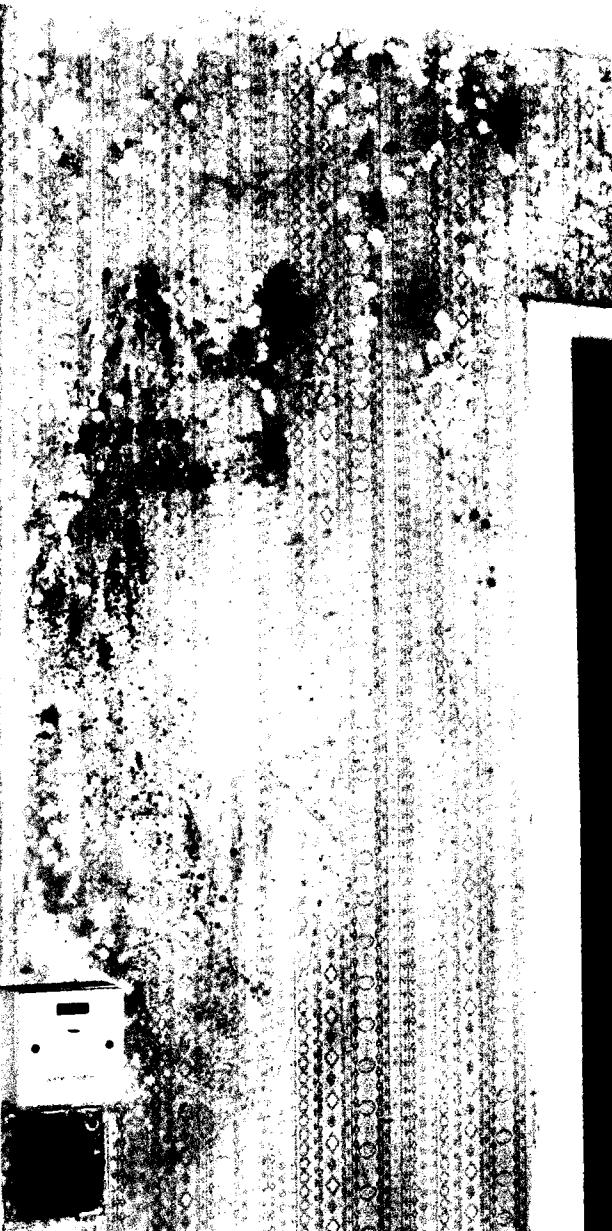
Plate 15 Jespersen: extensive mould growth on wall

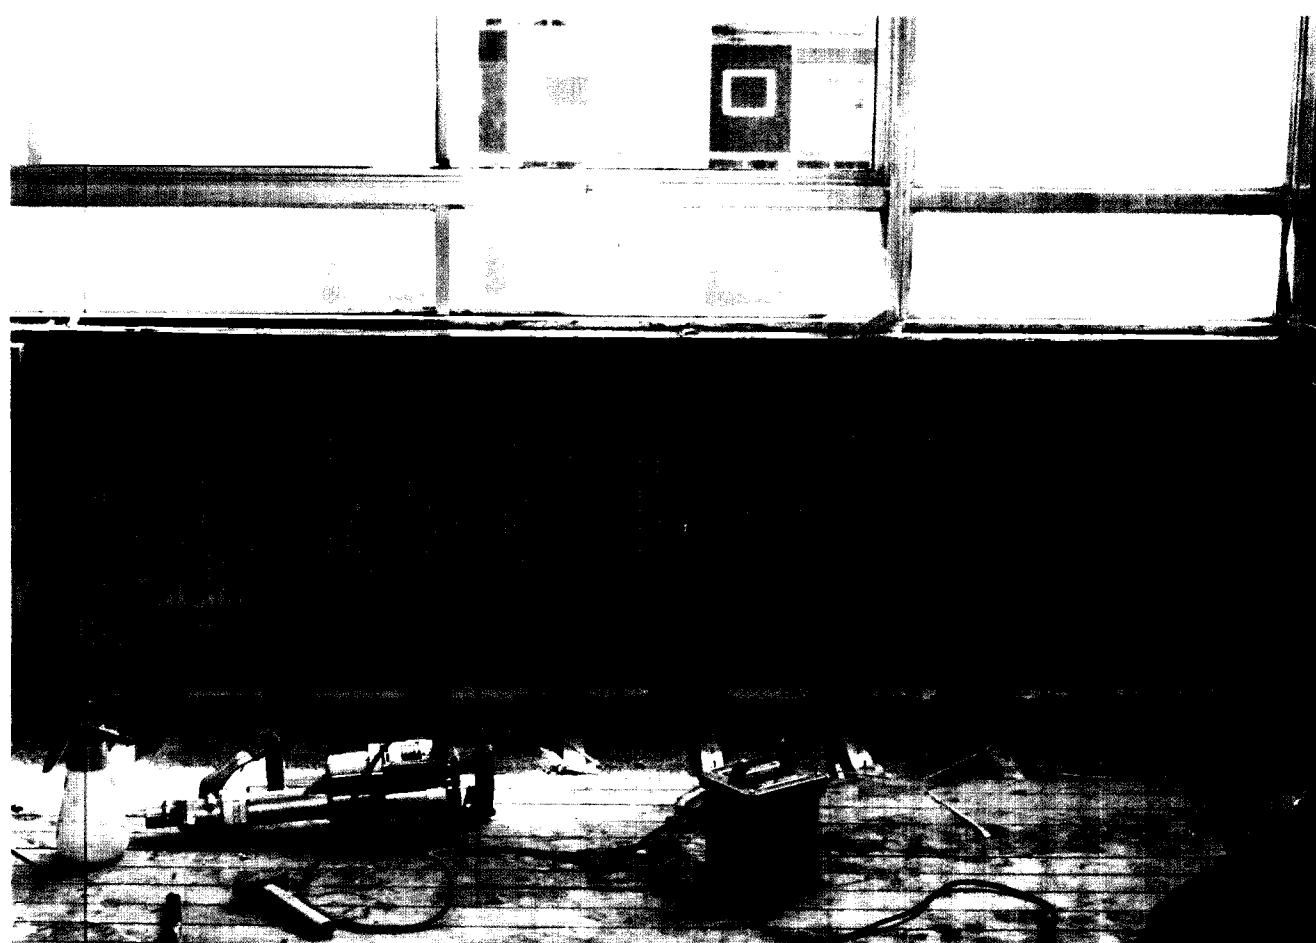
Plate 16 Jespersen: hair-line cracking in non-loadbearing cladding panels

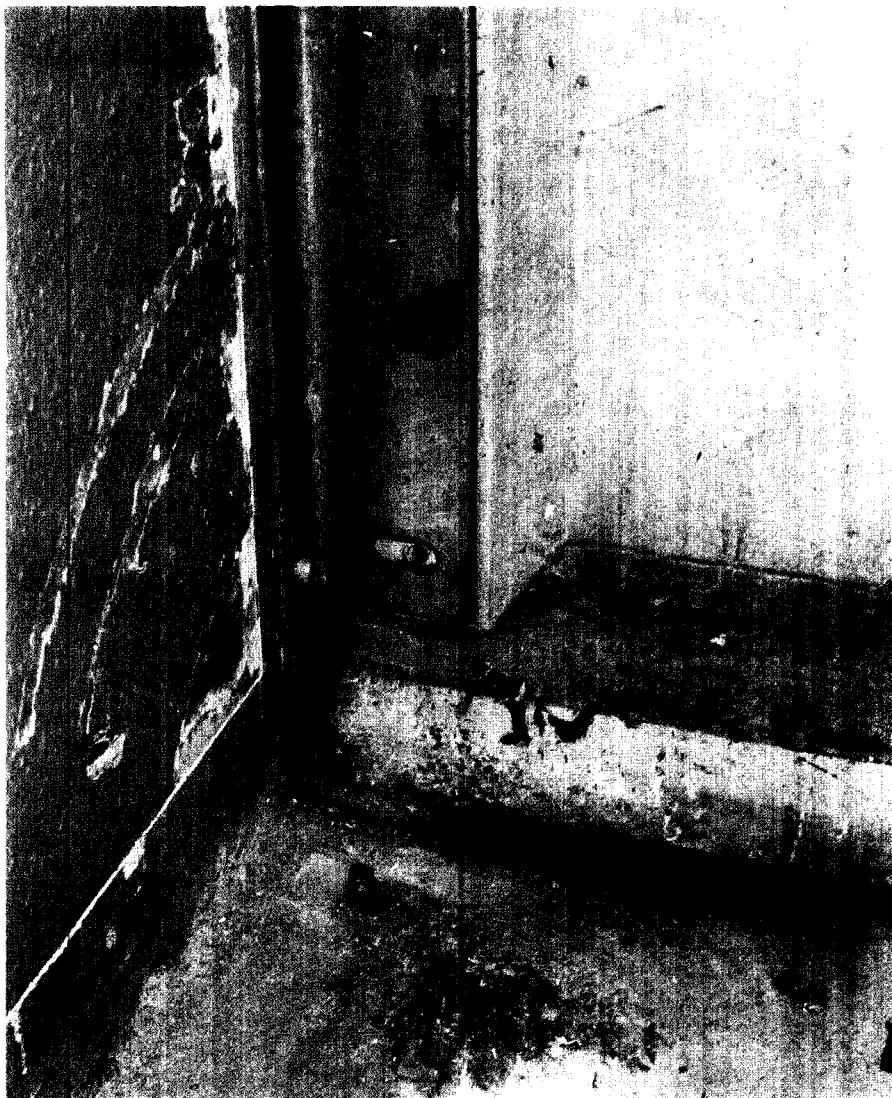
3.13 In many cases storey-height non-loadbearing panels and spandrel panels were supported by the main structural walls using metal brackets or angle connections. Little corrosion was found in this form of connection, the main faults identified being the occasional omission of bolts (as shown in Plate 18 in Appendix A) and the failure to tighten some of the bolts provided.

Plate 18 Jespersen: omission of bolts from connection plates

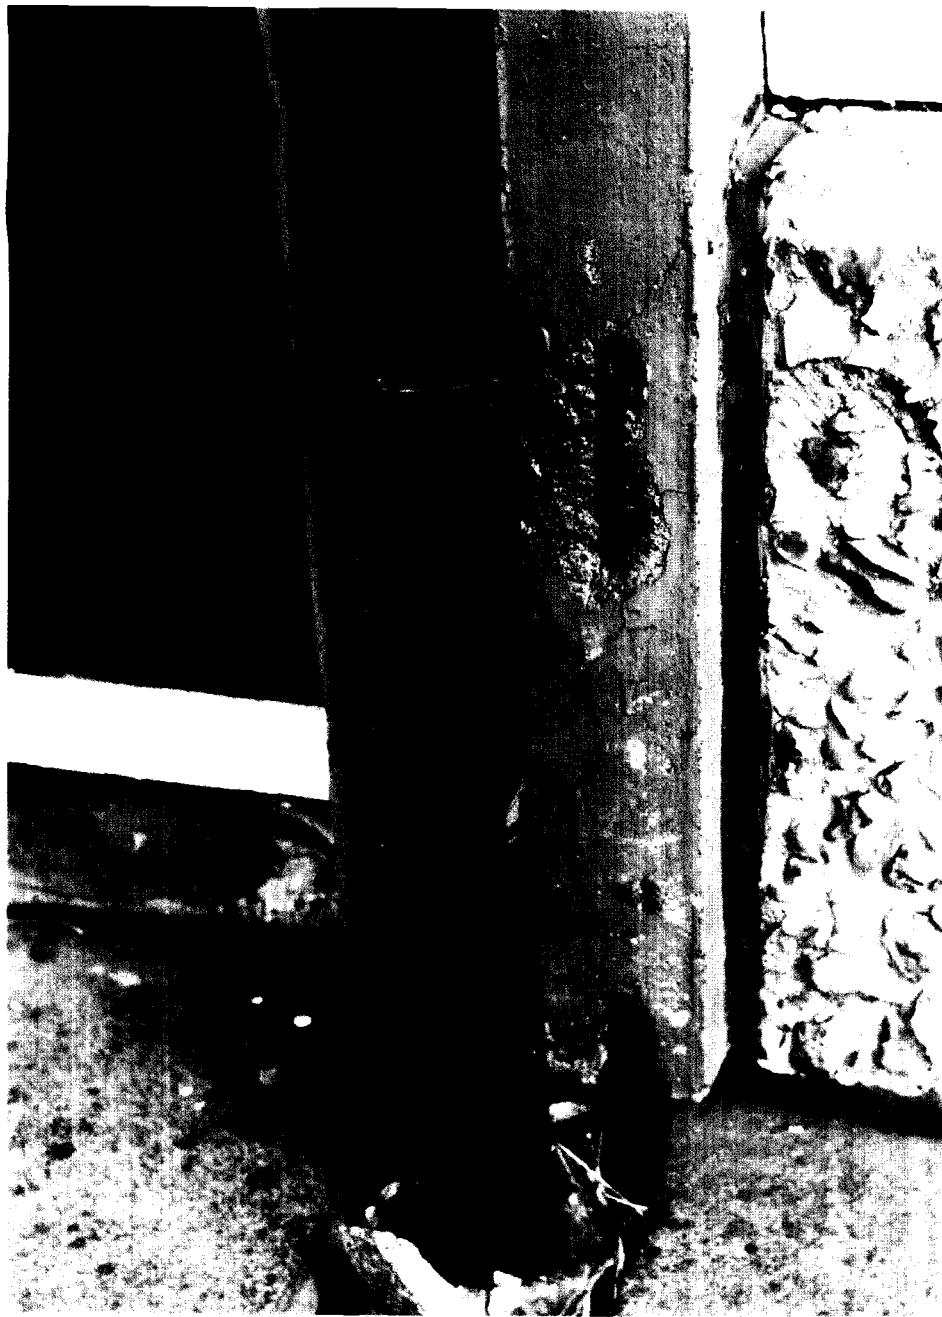
Plate 25 Shepherd Spacemaker: extensive cracking and spalling in exposed ends of cross walls

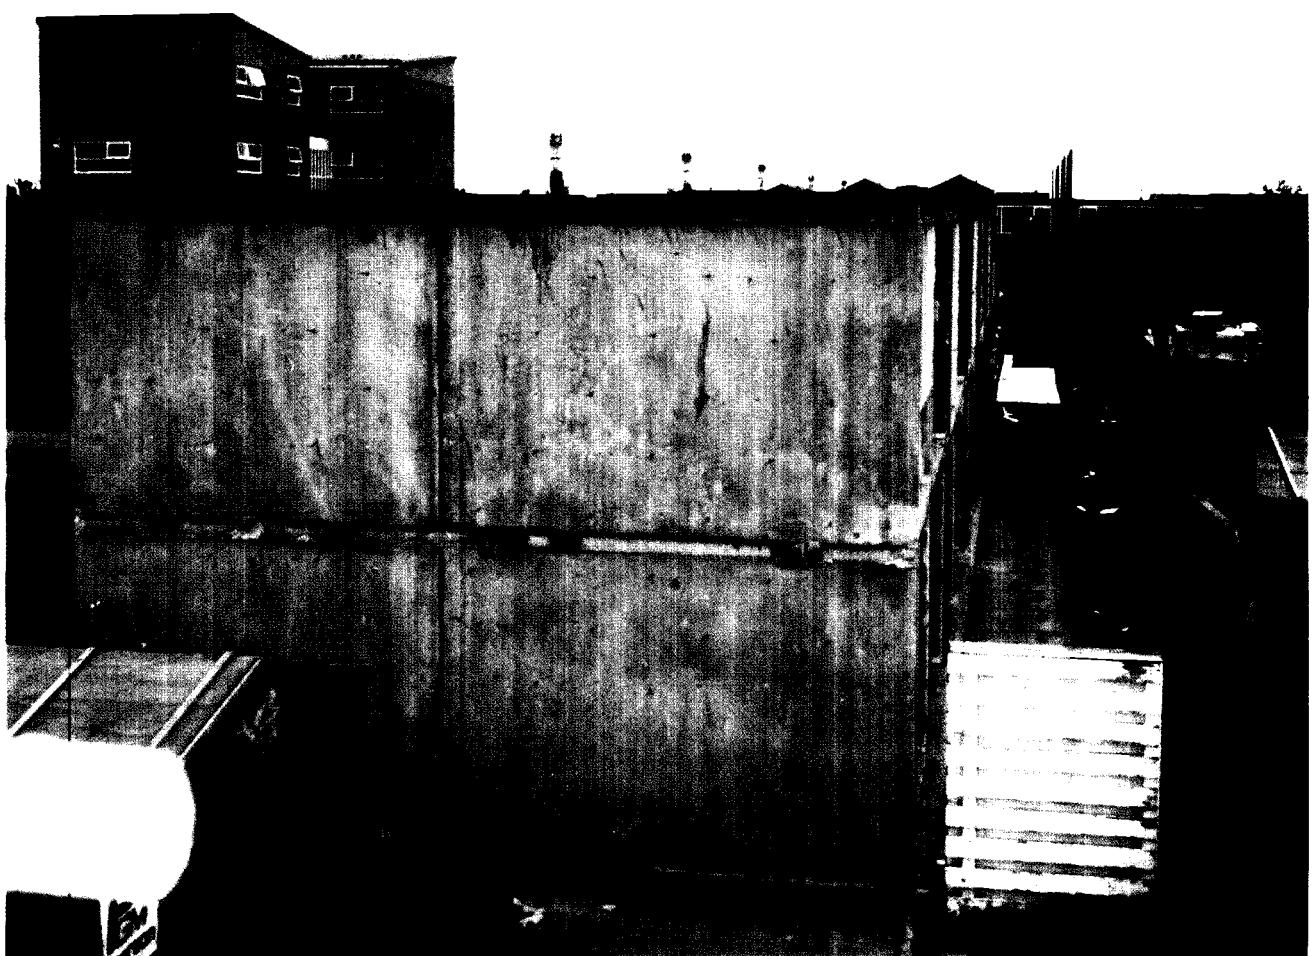
Plate 27 Skarne: removal of brick cladding from flank walls as part of renovation scheme

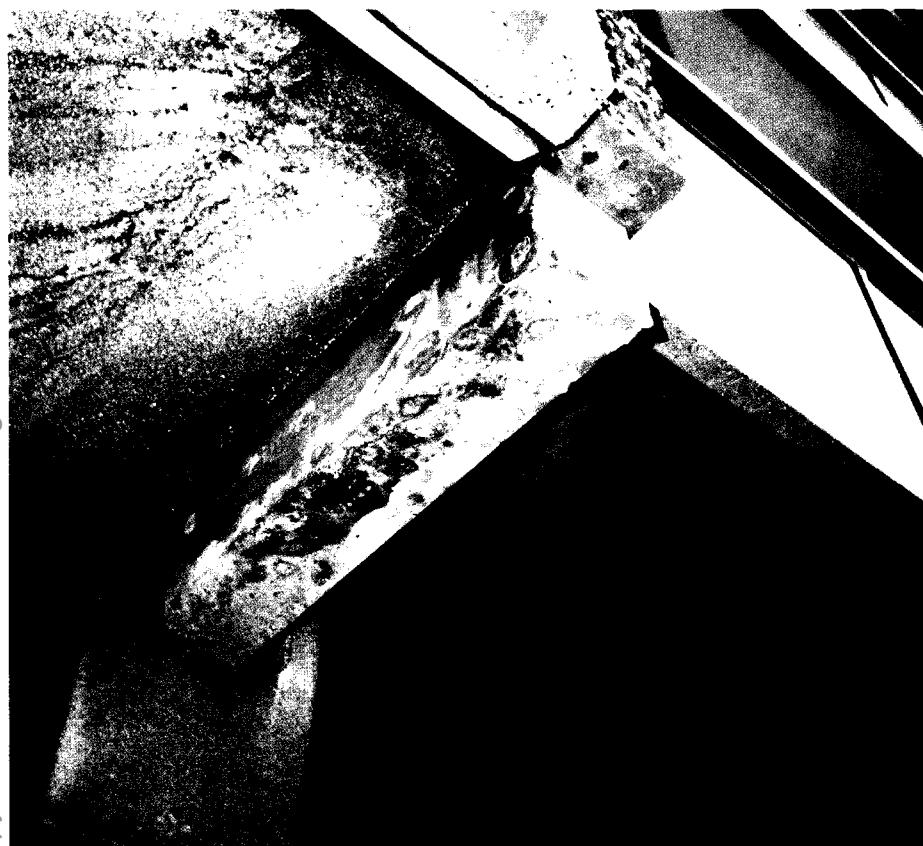
Plate 31 Wates: rusting and cracking in-situ podium cantilever
