Floods on the Llano River, Texas — Fall 2018

Llano River Watershed Alliance

Tyson Broad - January 18, 2019

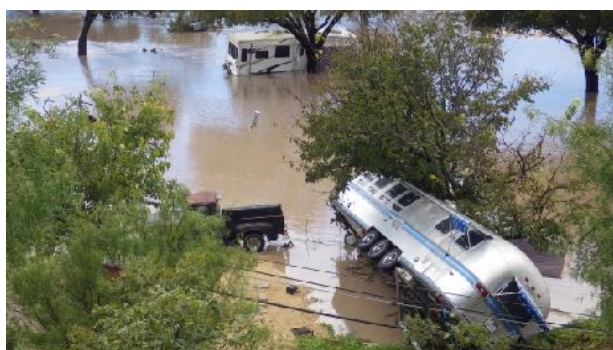
Campers at an RV Park (Figure 8), recently expanded onto a gravel bar next to the

Figure 8. Destroyed RVs on South Llano River

South Llano River, were inundated by floodwaters. Fifteen campers were rescued by boat and four by helicopter. Tragically, the bodies of four campers were recovered downstream, one as far downstream as LBJ Reservoir.

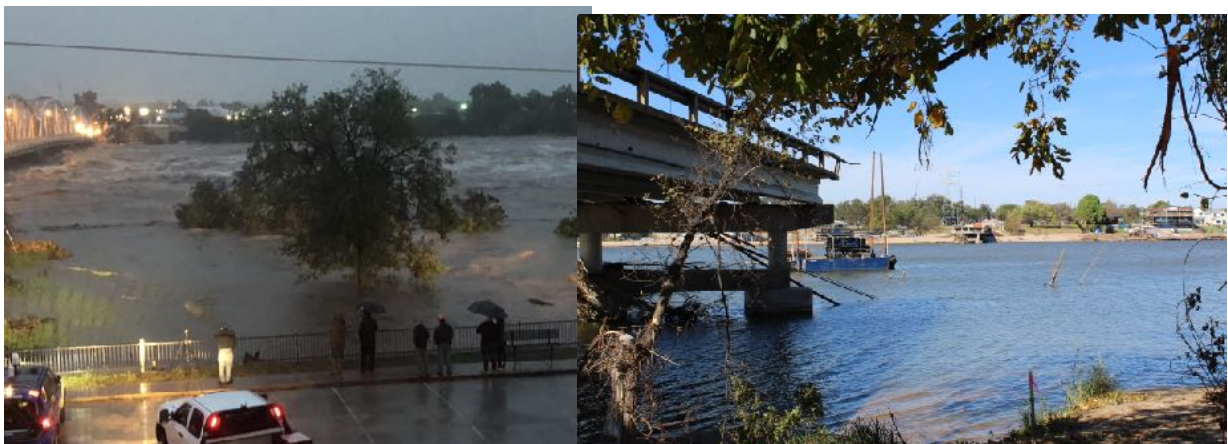
community of Kingsland. Floodwaters approached, but did not reach the bottom of the Hwy 16 bridge in the City of Llano; no damage was sustained by the bridge (Figure 13).

Figure 13. Left: Llano River at City of Llano, morning of October 16, 2018. Photo by Dana Wright. Right: Destroyed Hwy 2900 Bridge over Llano River Arm of LBj Reservoir, November 3, 2018.

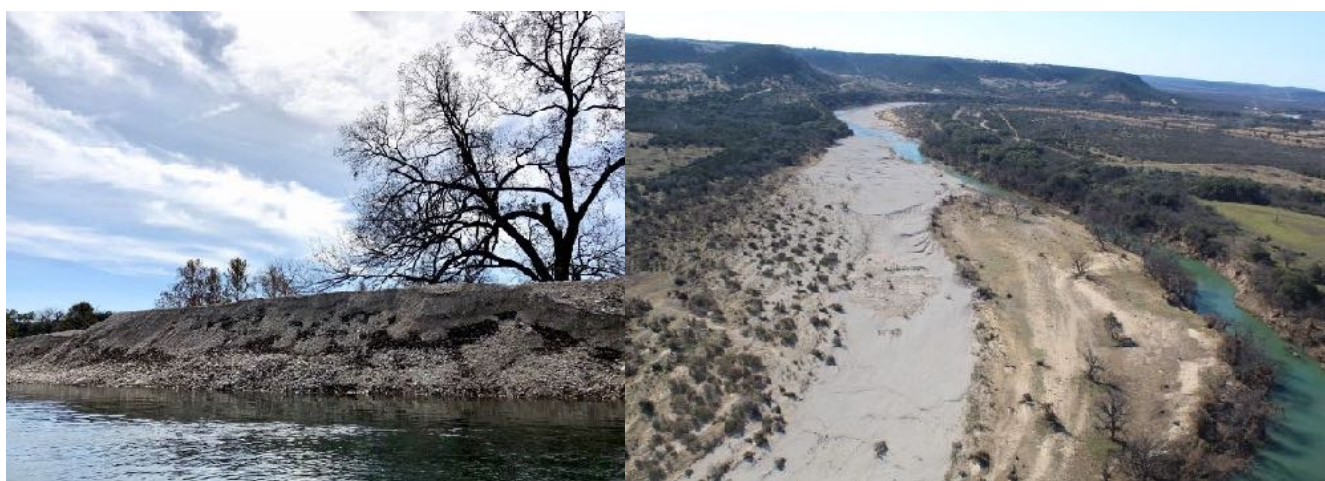
Figure 16. Left: Point Bar Deposit near South Llano River State Park (photo Megan Bean) Right: Floodwater deposits, Llano River below Junction, December 14, 2018

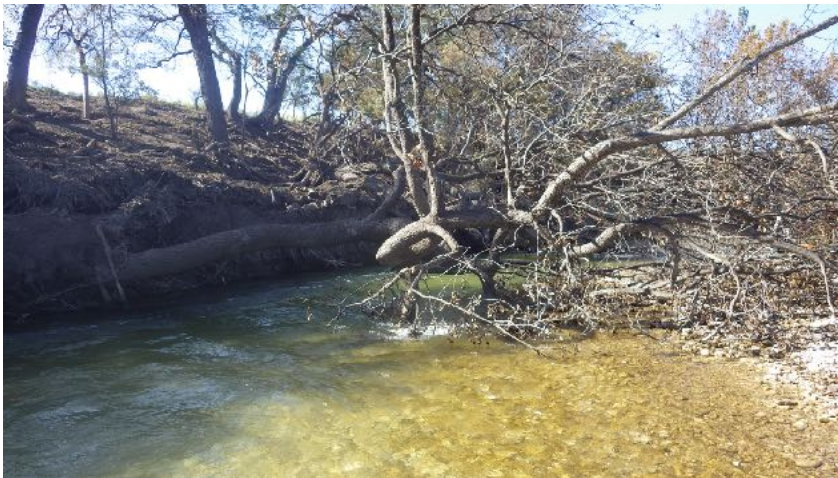
Within the channel itself, considerable scouring occurred, removing patches of aquatic vegetation. However, it is noted that certain snags remained anchored in the river, providing cover for aquatic species in the crystal clear waters of the river following from the flood. Additional large woody debris also fell into the river from eroding streambanks. While this can create a navigation hazard and decrease bank stability and potential shade along the river, it does provide additional habitat for fish and other aquatic species (Figure 17).

Figure 17. Large woody debris along South Llano River near South Llano River State Park, November 5, 2018

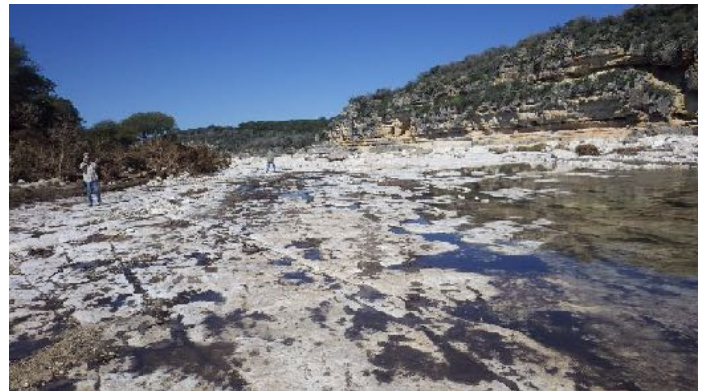
Upstream of the spring systems that form the headwaters of the South Llano River, normally dry riverbeds carried significant flood waters, resulting in the flooding of riverside homes that had not previously flooded. Those flood waters carried with them great potential for scour, in some instances removing well vegetated gravel bars completely to the bedrock (Figure 19). Some of the observed benefits of the floodwaters in the upper reaches of the South Llano River are the considerable recharge to springs that occurred from crevices in the stream bed, and the deposition of large woody debris from the uplands along stream banks.

Figure 19. Riparian habitat removed to bedrock in South Llano River watershed.

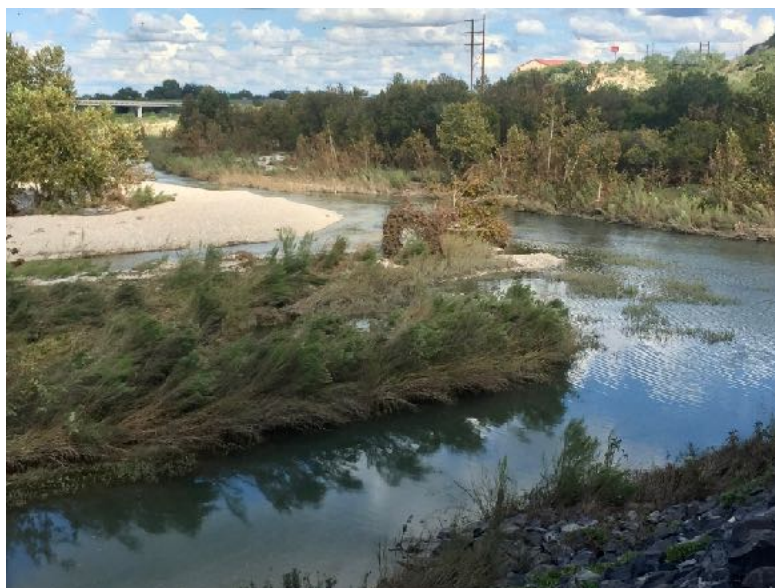
Figure 20. Confluence of North and South Llano River. Note new mouth of North Llano in background.

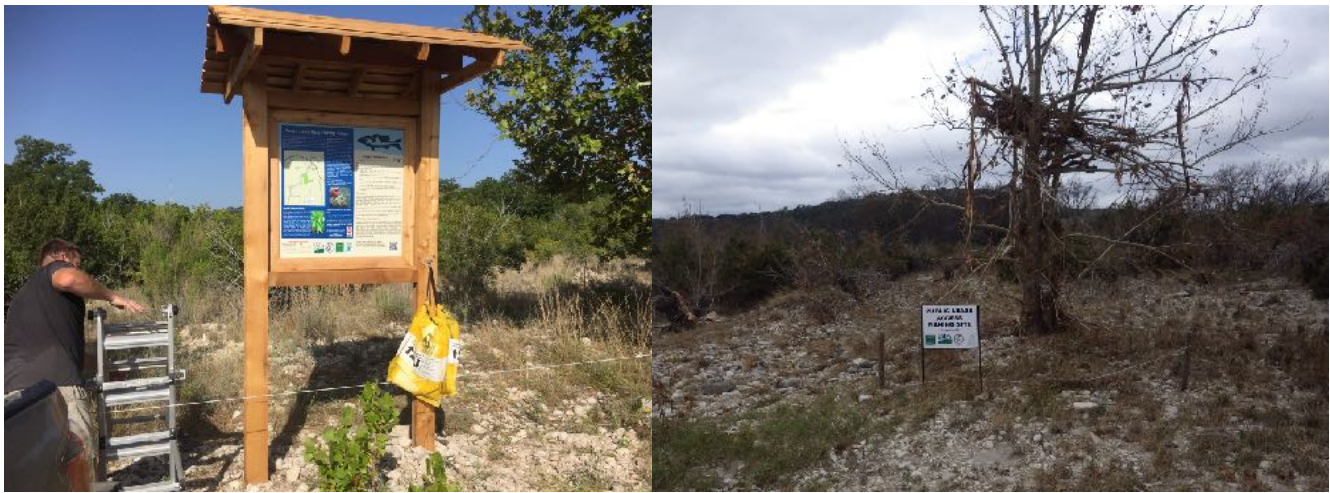
Figure 23. River Access and Conservation Area sign destroyed by October floods along South Llano River. Note: Kiosk was located to the left of tree.

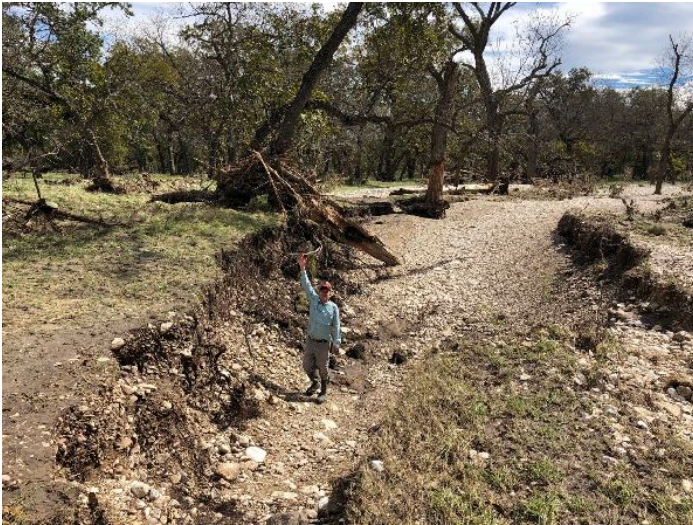
Figure 24. Scour hole along former Buck Lake Trail - South Llano River State Park. Photo: Megan Bean

There was considerable damage to the South Llano River State Park. Many signs along the river, including the South Llano River Paddling Trail sign at park bridge crossing, were destroyed. Trails along the river were severely damaged and the tubing takeout was buried under a new gravel bar. One trail between the river and Buck Lake became a temporary floodway when the river topped its

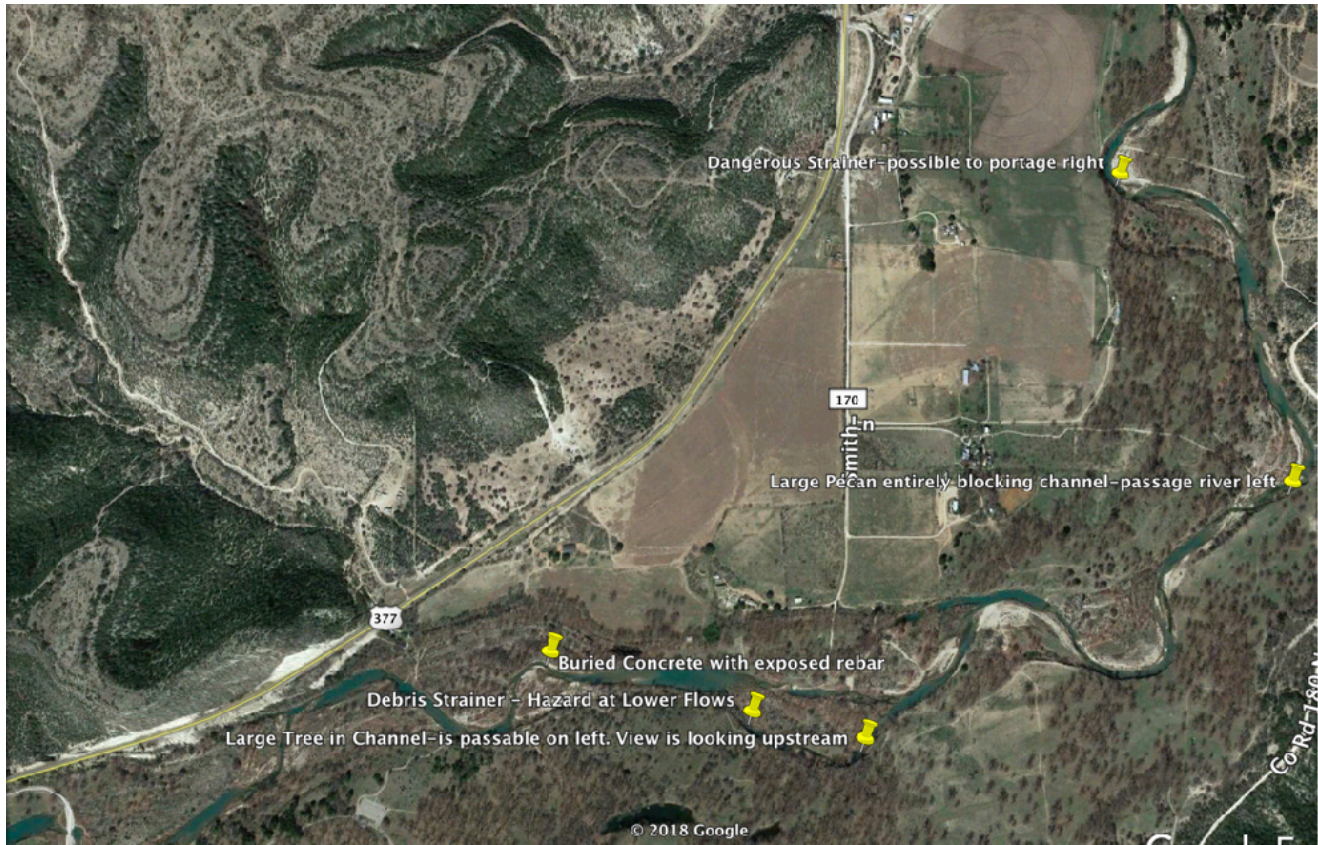
The South Llano River Paddling Trail between South Llano River State Park and the City of Junction was severely affected. The most significant impact was the damage to the Flat Rock Crossing. A crack in the surface of the bridge forced closure of the bridge and debris continues to block the arched culverts beneath the bridge, thus making the paddling trail unusable at the previously established access points at the state park, Flat Rock Crossing, and the Junction City Park. The South Llano River Paddling Trail signs at Flatrock Crossing and the Junction City Park were washed away. Some of the additional navigation hazards along the South Llano River Paddling Trail, primarily downed trees, are shown in Figure 25. There is also a downed tree 0.4 miles above the Flat Rock Crossing.

Figure 25. Navigation hazards on South Llano River Paddling Trail following October flooding.

The Alliance also recommends the removal of both natural and artificial navigational hazards on the river. The primary natural hazards are downed trees that create hazardous ‘strainers’ where boaters could potentially be pinned against the woody debris by the current. Several of these ‘strainers’ have been identified on the South Llano River and Llano River but passage can be restored by crews cutting passages through the downed trees with a chainsaw. Other natural hazards occur at the RACA sites along the river where some debris needs to be removed and parking areas, kiosks, and signage need to be reestablished.

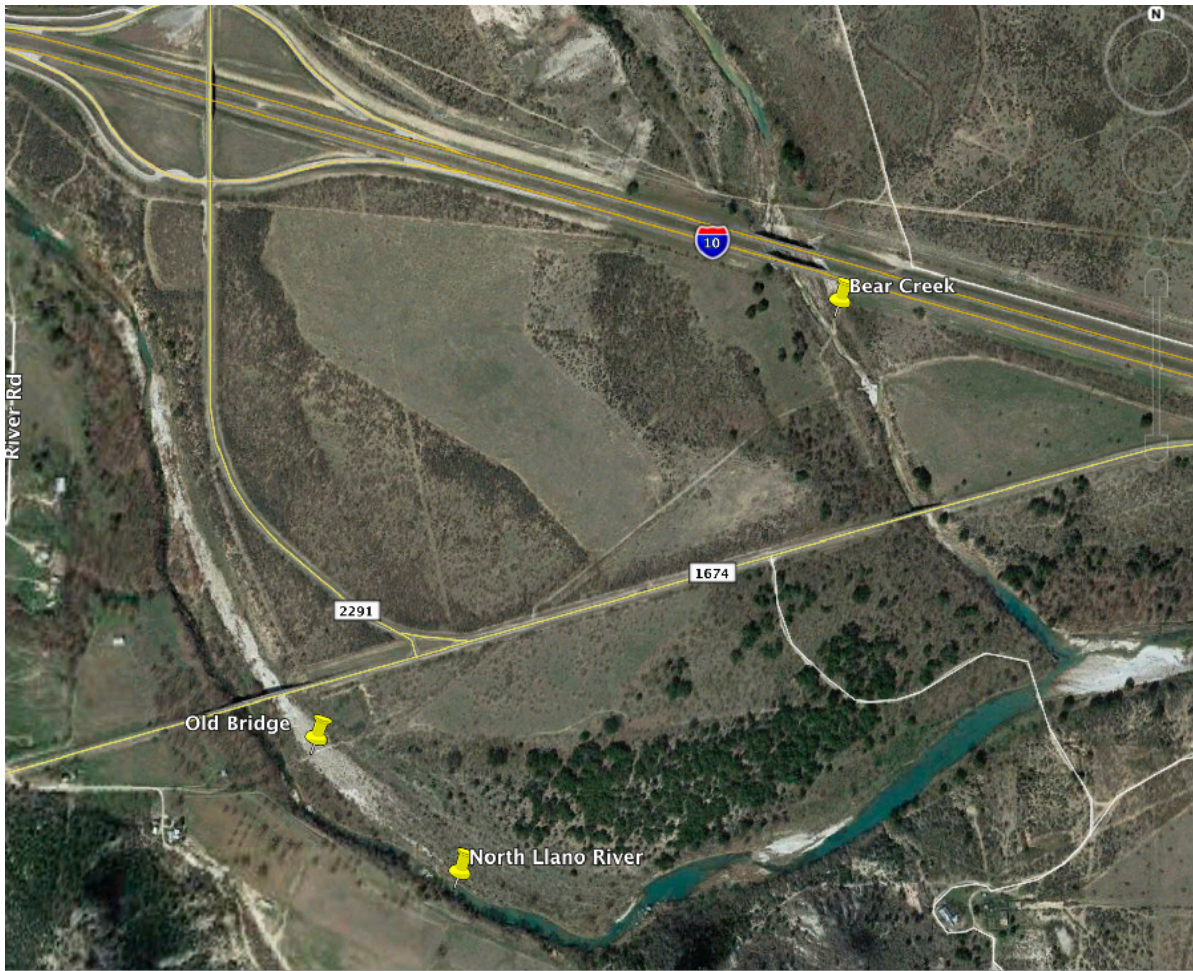
As noted in Figure 4, floodwaters on the North Llano River only reached a recurrence interval of about 1 in 5 years. Consequently, river access points at the crossings were not significantly impacted. It is not known what new navigation hazards were created along the entire river following the flood, but no hazards were noted along the lower stretch downstream of below Kimble County Road 271. An existing navigation hazard is located at an old bridge crossing of the North Llano above the confluence with Bear Creek (Figure 26).

Figure 26. Navigation hazard resulting from old bridge crossing of North Llano River above its confluence with Bear Creek.

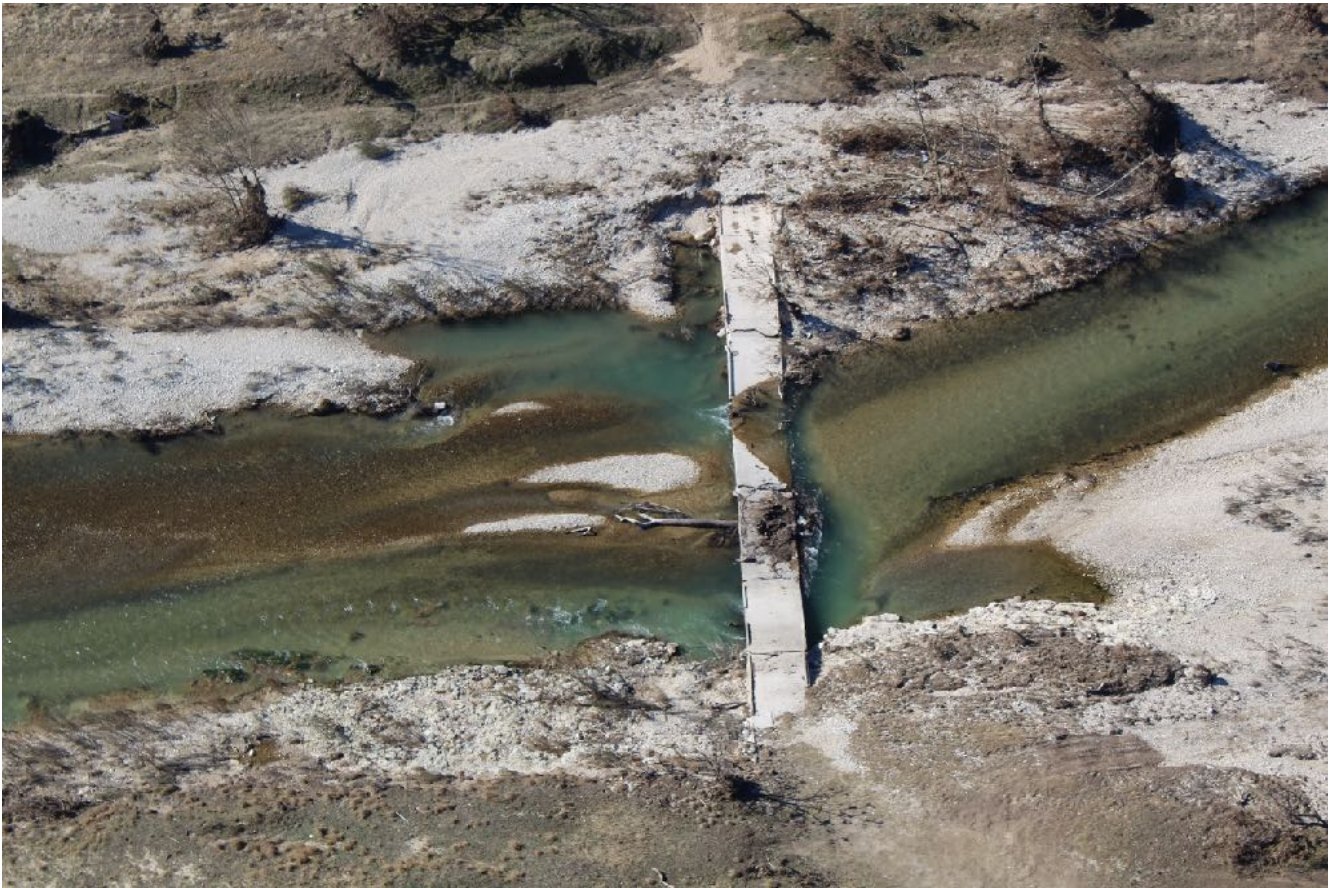
The largest navigation hazard along the mainstem of the Llano River downstream of Junction is the Kimble County Road 310 Bridge which was destroyed by floodwaters in the 1980s. As sections of the bridge have collapsed, paddlers must line their boats under the bridge in swift water. The potential for an accident is high (Figure 27).

Figure 27. Collapsed Bridge at Kimble County Road 310. Boaters must line unlined boats along swift current on river left (bottom)

The primary artificial hazards are the KC 310 Bridge downstream of Junction and the Flat Rock Crossing located just upstream of Junction. Although the KC 310 Bridge has been a hazard for some years, with flood mitigation efforts likely resulting in a temporary surge in capacity for recovery efforts in the Llano River, this is likely an ideal time to revisit and address the situation.

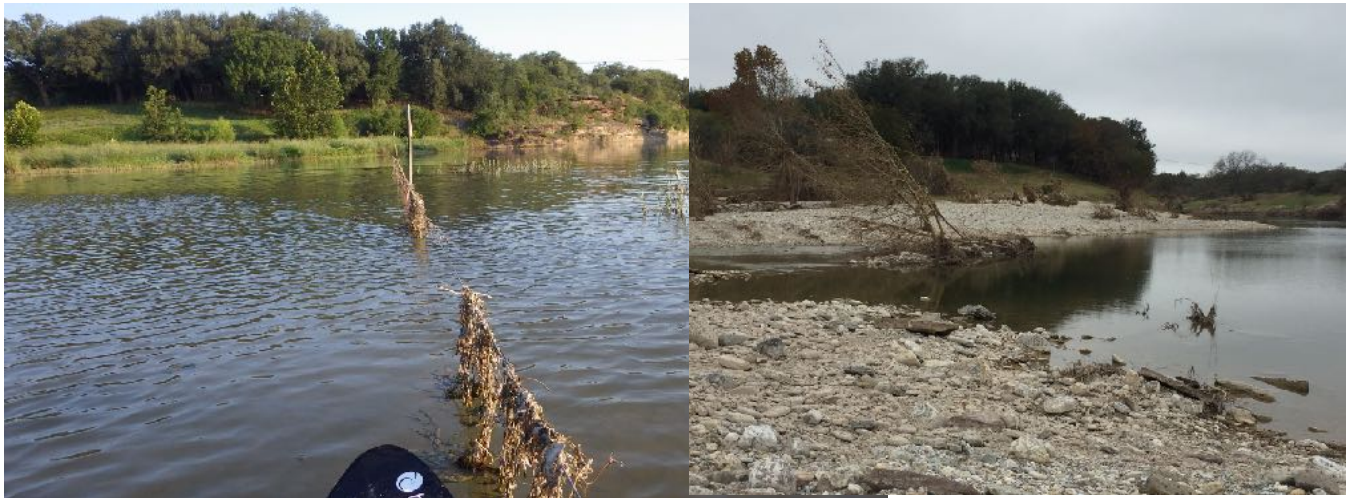
deposits of gravel from the James River inundated the island and the channels on both sides of the island were reworked and widened by the flood flows (Figure 28). Downed trees at the entrance to the north channel could cause a navigation hazard for paddlers. Riparian vegetation was destroyed or heavily damaged. The crossing has reopened but was slightly damaged with the loss of concrete slabs on the downstream side. Access to the island was impacted at first, due to the deposition of sand and gravel, but it becoming easier as the gravel is compacted by travel on re-emerging access roads.

Figure 28. Mouth of the James River, August 2017 and October 2018

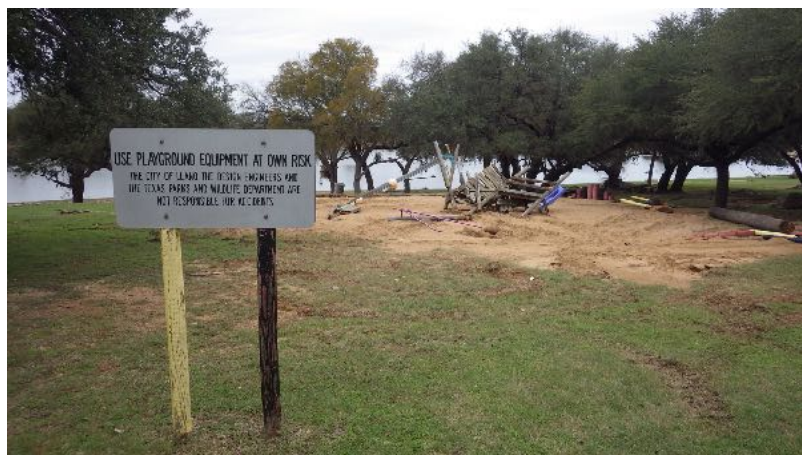
Figure 30. Damaged playground equipment, Robinson Park, Llano, Texas.

Robinson Park, Badu Park, and Crenwelge Park in the City of Llano are all located next to the Llano River, providing popular access points and recreational opportunities. All of the parks, suffered considerable damage to infrastructure (Figure 30), but have reopened for recreational access. The rock art displays in Crenwelge Park, site of the Llano Earth Art Festival, were destroyed.

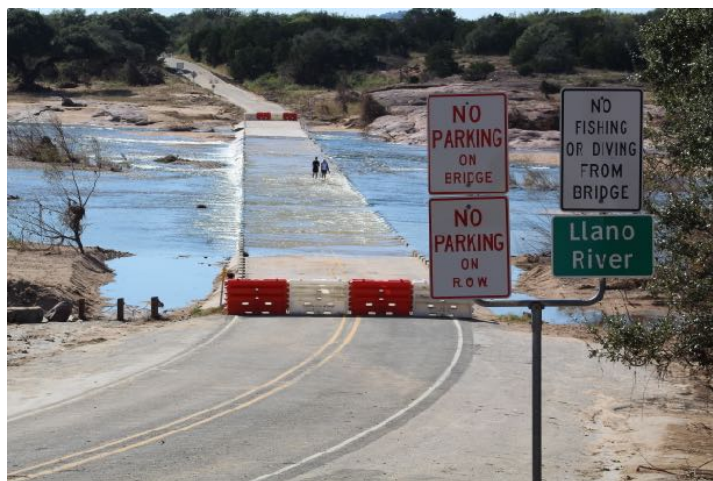
The Kingsland Slab is located just upstream of the point where the Llano River flows into LBJ Reservoir. The Slab was not damaged, but the parking areas at the Slab will require maintenance. The Slab was closed due to high water until November 13th (Figure 31).

Figure 31. Barricades at Kingsland Slab, November 4, 2018
