AIRCRAFT ACCIDENT REPORT

LOSS OF CONTROL AND IMPACT WITH TERRAIN (WATER)

PIPER AZTEC PA-23-250

N62769

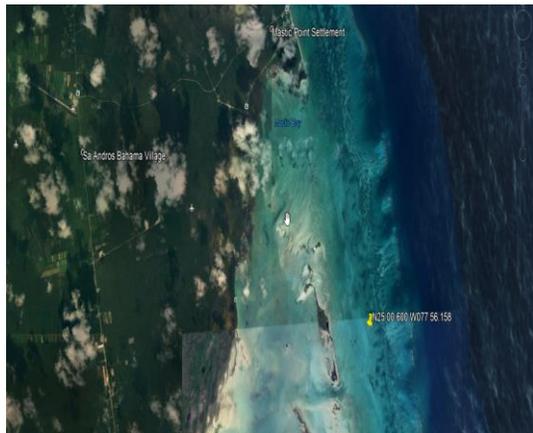
Once the local police confirmed the wreckage was in fact located, a salvage team was engaged to recover the wreckage. On 25 February 2018 the salvage team with assistance from the RBDF and other divers, recovered the wreckage inclusive of all major components and parts in approximately 6 -10 feet of water in low tide.

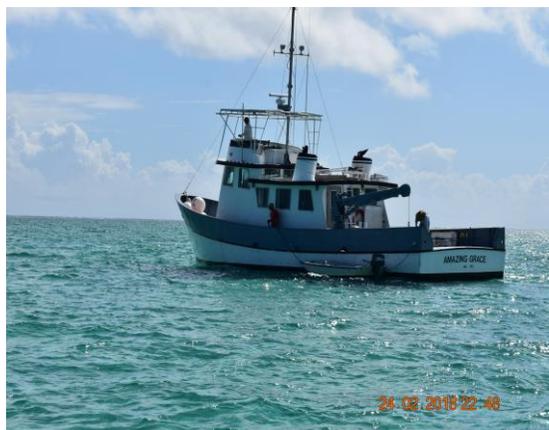
According to the divers, the recovered wreckage had been distributed in a debris field about 200 feet long and was oriented on a westerly magnetic bearing of about 280 degrees as if it was heading back to the airport of departure.

The coordinates of the bulk of the recovered wreckage was located at N25°00.600' and W077° 56.158' a distance of 0.044 miles (230 feet) south east from where portions of the aircraft were originally found on January 18, 2018.

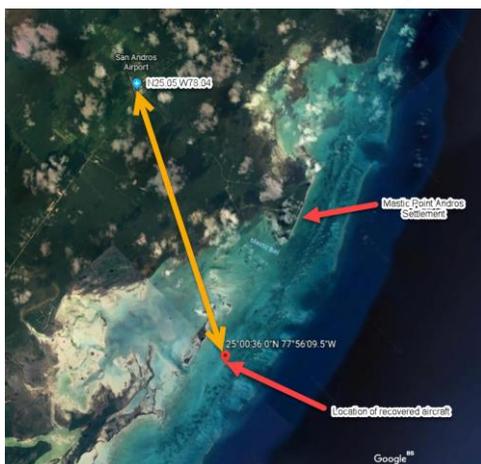
The distance from the center of MYAN runway (N25°05'38.1" and W-78°04'49.9") to the crash site where the bulk of the wreckage was located was approximately 4 miles southeast.

All indications were that the aircraft made contact with the ocean straight in, ((approximately 180 degrees), (nose, propeller and engines first, as evidenced from propeller and airframe signature

marks), before cartwheeling several times prior to stopping.
