Rasolastik Evo Case Study

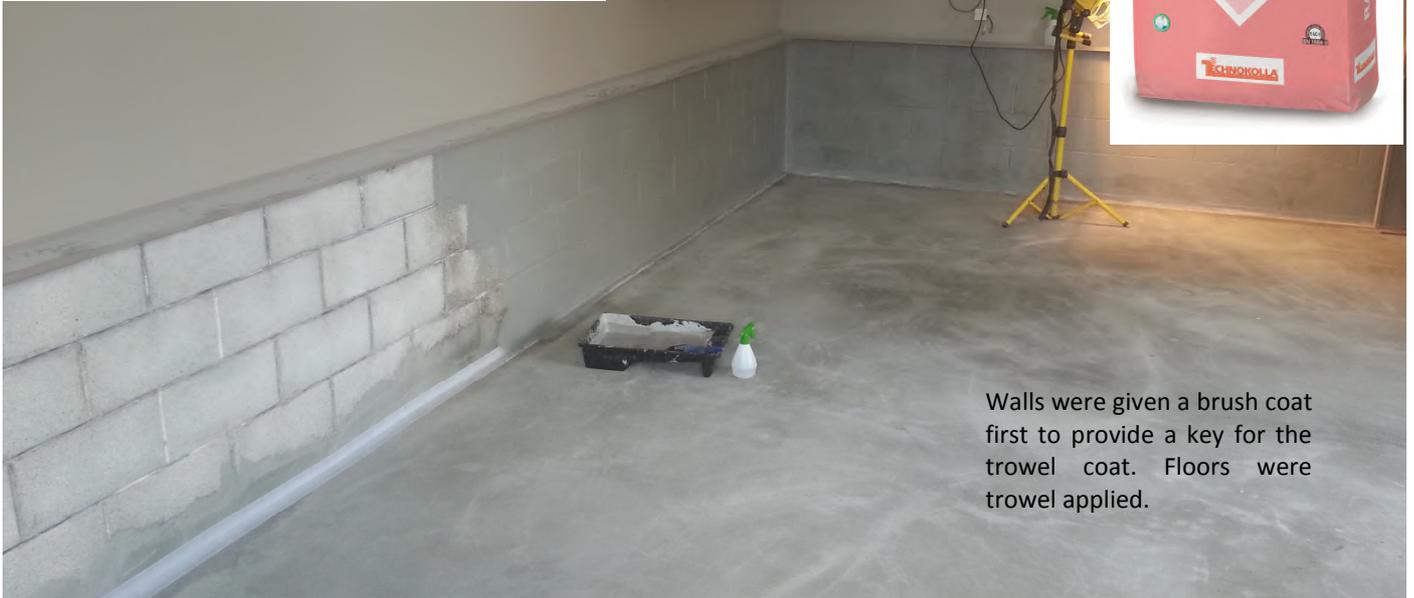
Walls were given a brush coat first to provide a key for the trowel coat. Floors were trowel applied.

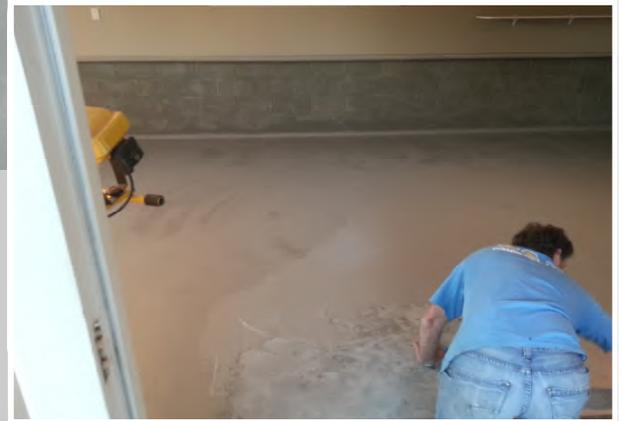
This residence in New Lynn was suffering from counter thrusting water issues. The client had spent several thousand dollars water proofing the external wall by a third party, but still had issues with water ingress.

Areas were diamond ground to remove paint and laitance. Then the entire area was washed with Fila Deterdek to ensure all free limes and salts were removed. RL80 tape was applied to all floor/wall junctions to provide water tight joints.

Technokolla Rasolastik Evo was then used to water proof the areas due to its ability to handle up to 1.5 bars of counter thrusting pressure. This ensured that the areas were totally waterproofed from future water ingress from the reverse side and negated the failure of the external water-proofing.
