Overview of Natural Terrain Hazards Mitigation Works

Don Sum
Senior Geotechnical Engineer
Ove Arup & Partners Hong Kong Limited

- An existing development at On Yam, Shek Lei, Victoria Road and Luk Keng Wong Uk is affected by Natural Terrain Landslide Hazards
- Ove Arup & Partners Hong Kong Ltd (Arup) was commissioned to undertake detailed design of hazards mitigation works for these sites

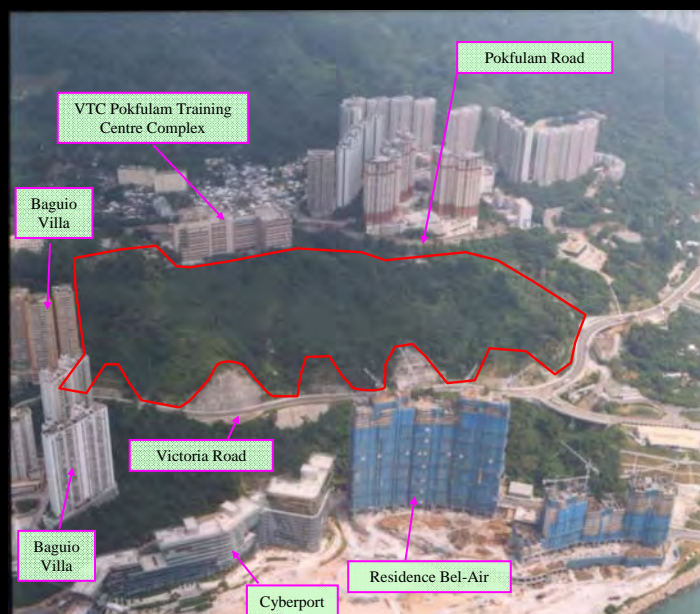
Victoria Road Site

Recent major landslides in 1966, 1994, 1999 and 2005

- **Major landslides** with volumes over 100m³ occurred in recent years
- The run-out from the failures **became channelised** in an ephemeral drainage line and reached Victoria Road, which was subsequently closed to traffic
- The hillside has a history of shallow open hillslope landslides, with over **30 natural terrain failures** identified by the API
- Other more sizeable events, such as the **Baguio Villa Landslide**, have occurred within the site, although these were triggered by failure of man-made features

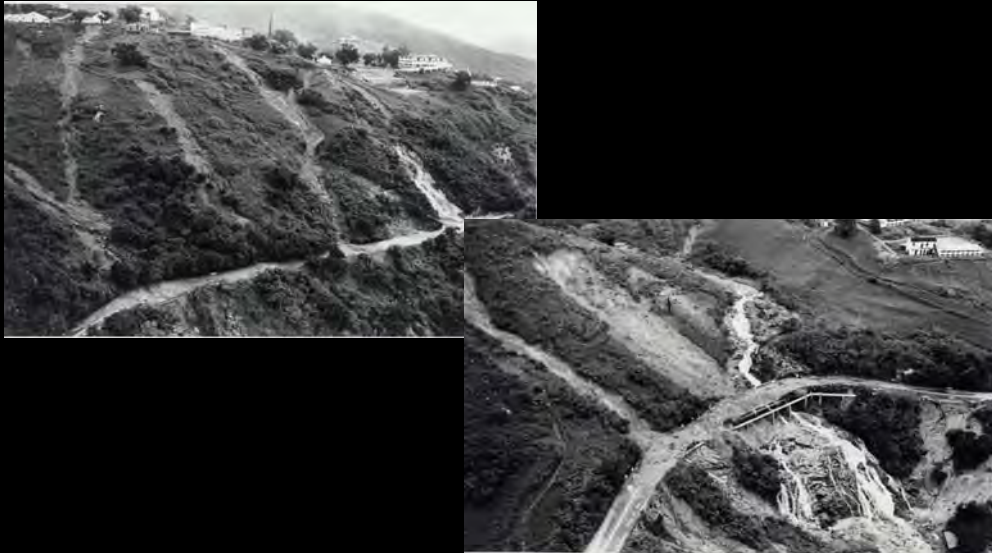
Victoria Road Site -- 1966 Landslides

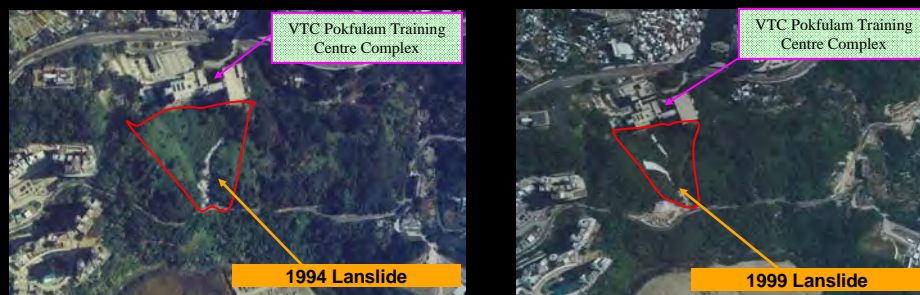
Victoria Road Site – 1994 and 1999 Landslides

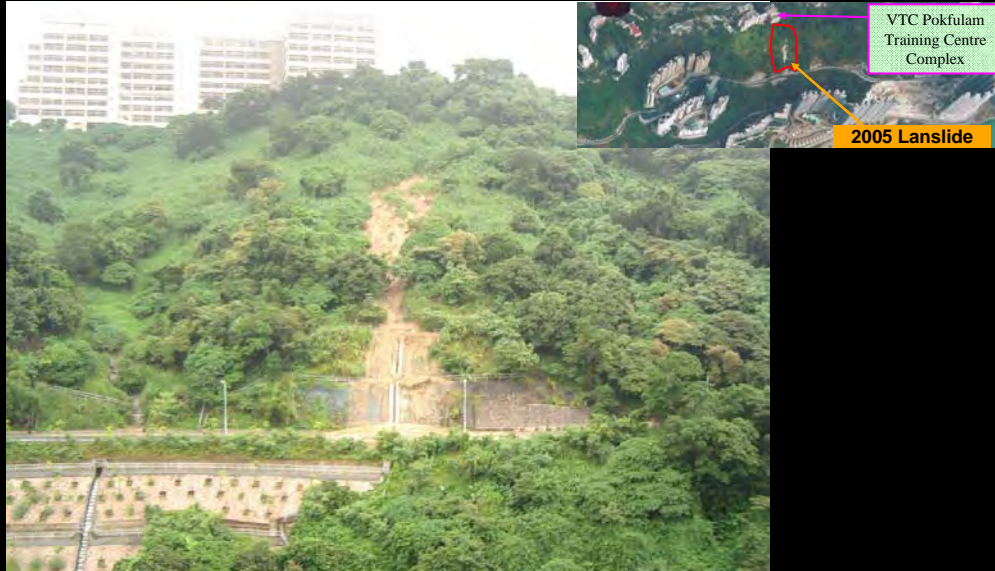
Victoria Road Site -- 2005 Landslide

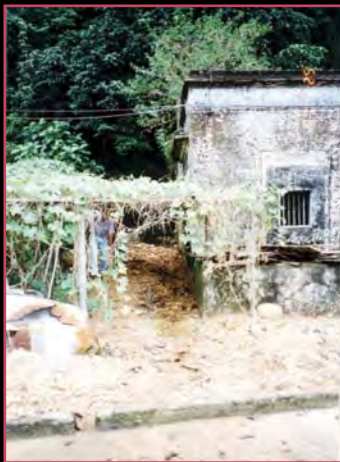
On 12 August 1997, a landslide occurred within the Study Area and some of the **channelized debris** was deposited at the rear of a village house

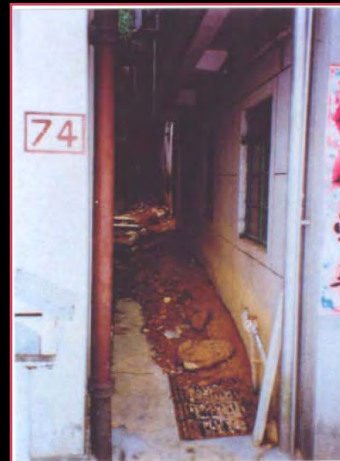
On 24 May 1998, another landslide, with a source volume of about 150 m³, occurred at about 200 m to the north of the 1997 landslide. Some of the **channelized debris** deposited in an alley between two village houses.

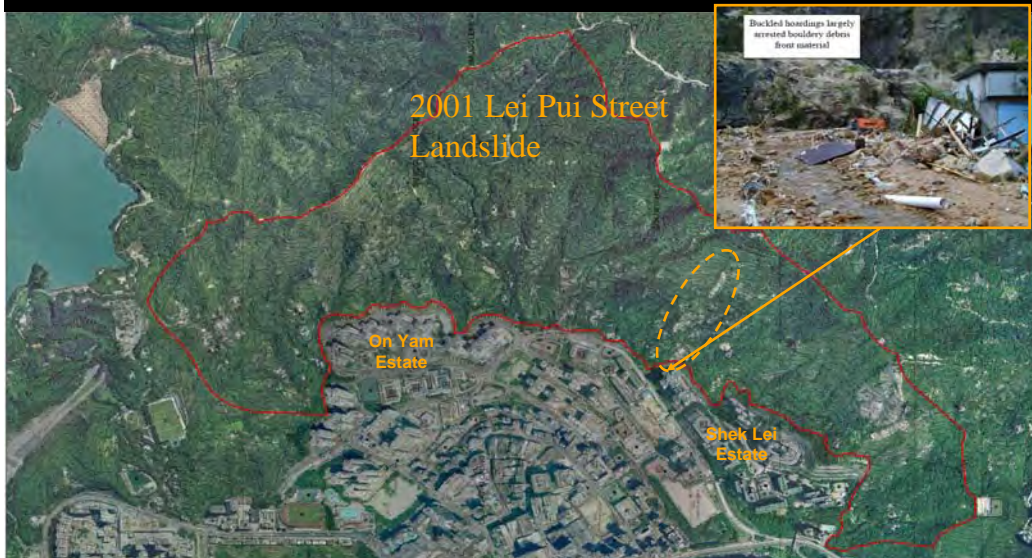
On Yam and Shek Lei

- **800m³ Channelised Debris Flow** occurred on **1st September 2001**.
- The **run-out** from the failure reached Lei Pui Street, some **350m from the landslide source**.
- Several squatter dwellings were completely destroyed by the failure.
- Over **50 other recent landslides** had been recorded within the study area.

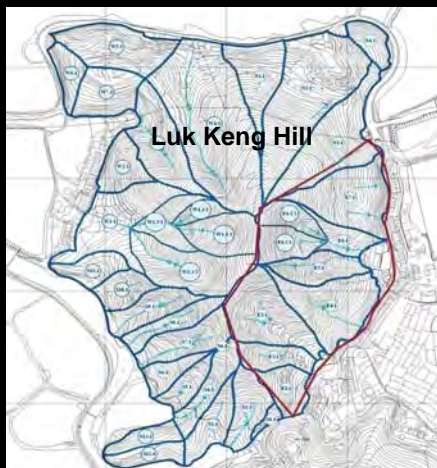
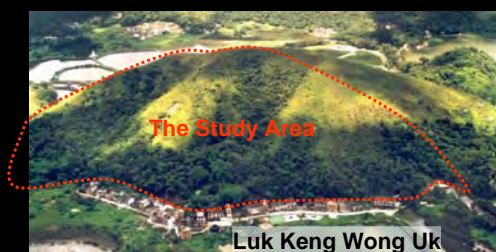
Luk Keng Wong Uk site -- Hazards Identified

Location: Above Luk Keng Wong Uk, Luk Keng

No. of Drainage Catchments: 8

Minimum Elevation: +2mPD

Maximum Elevation: +120mPD

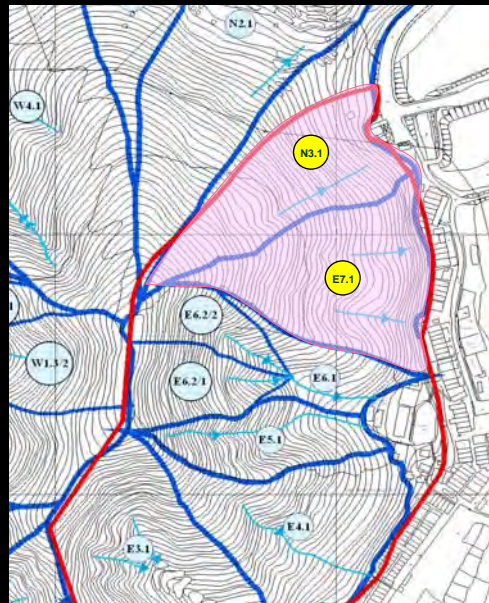
- Catchments N3.1 and E7.1 have potential landslides that could cause significant risk and NTHMM for these catchments are required.
- Catchment N3.1 – 300cu.m Open Hillside Landslide (OHL)
- Catchment E7.1 – 530cu.m Channelized Debris Flow (CDF)

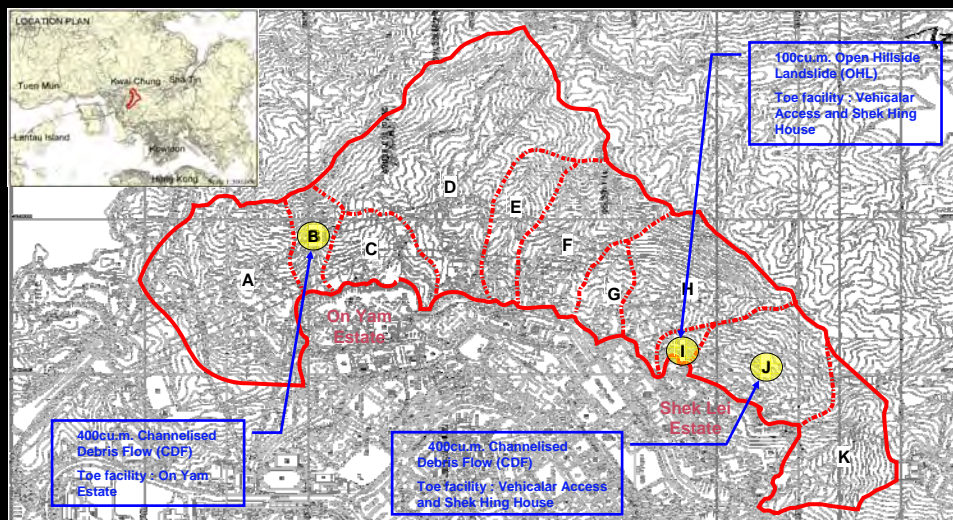
On Yam and Shek Lei -- Hazards Identified

Study Area Catchment Boundary

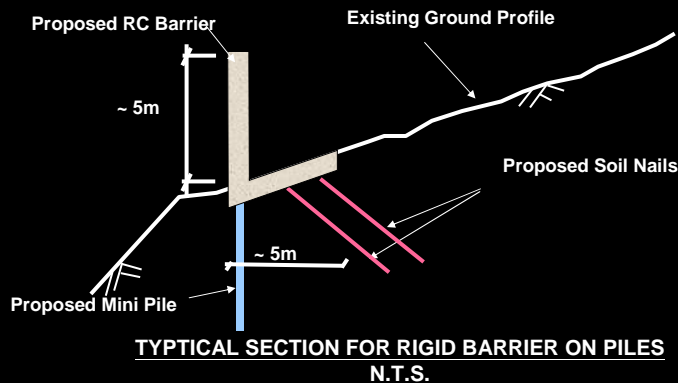
CDF in Catchments C and E

- To **RESIST** debris impact force
- Smaller on plan (~10m x 4.5m) due to the use of piles, but higher stem (~3m to 4m) to maintain containment volume
- Less excavation into hillside, estimated excavation volume
- No TTM required during construction (except mobilisation of plan / material)

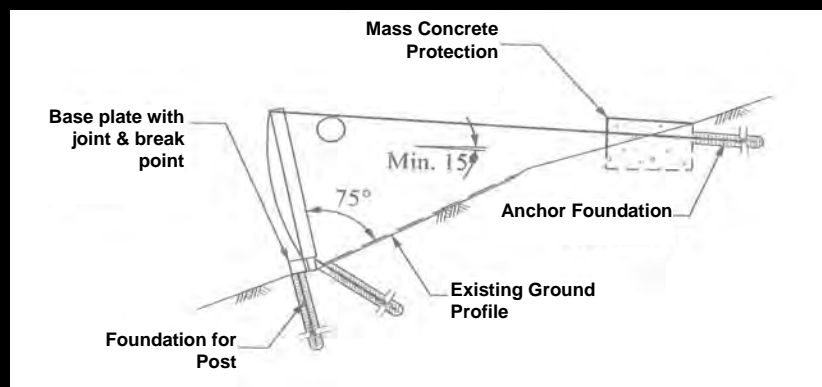
OHL in Catchments

- To **RESIST** debris impact force
- Deformation will be resulted (replacement cost), need to be set back from road
- Minimum excavation into hillside
- Less impact to Traffic

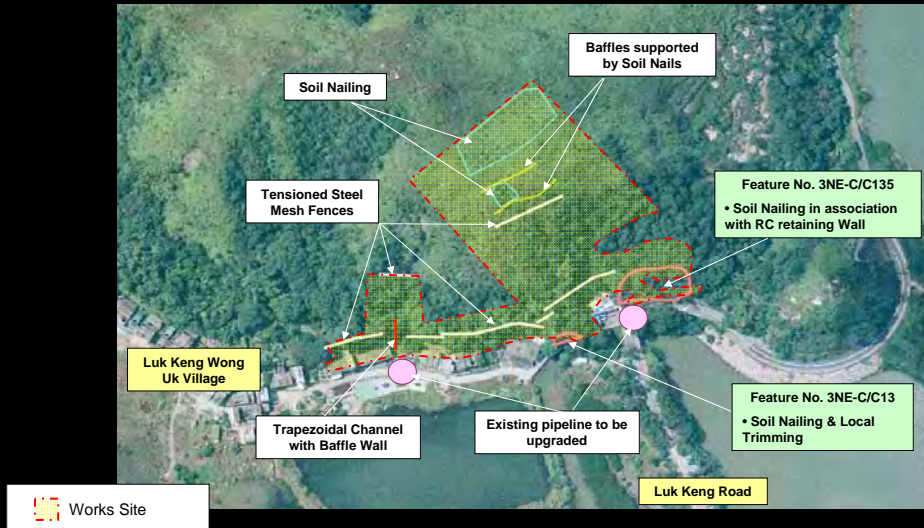
Proposed Works at Luk Keng Wong Uk

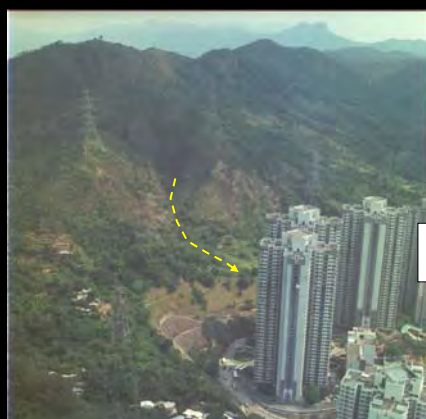
Proposed Works at On Yam

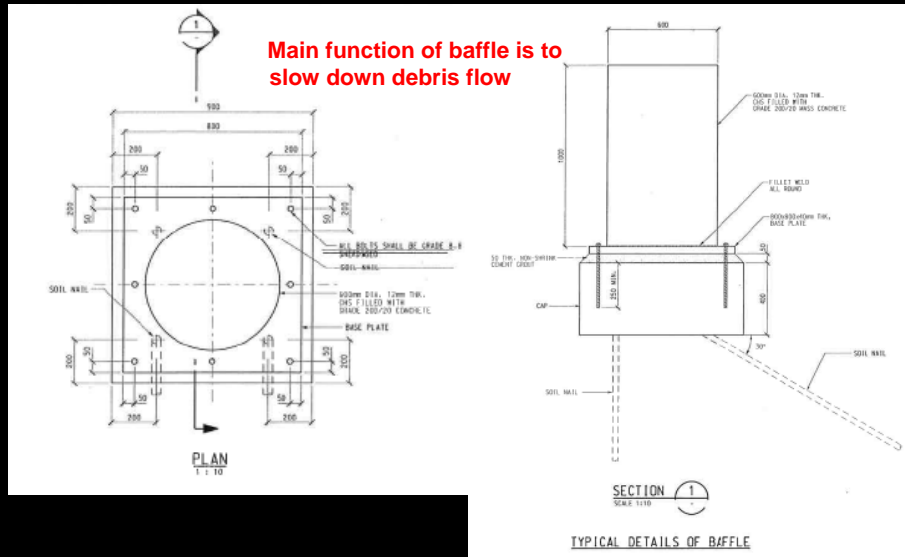
Typical Details of Baffles

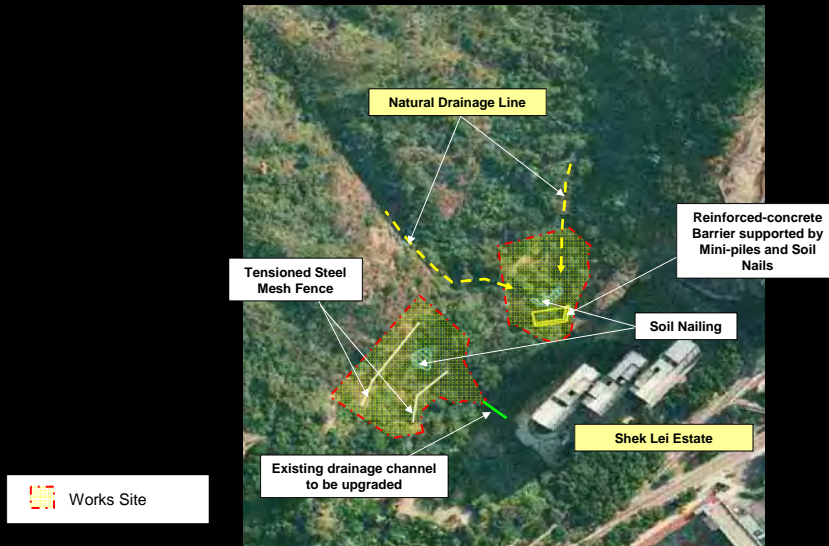
Proposed Works at Shek Lei

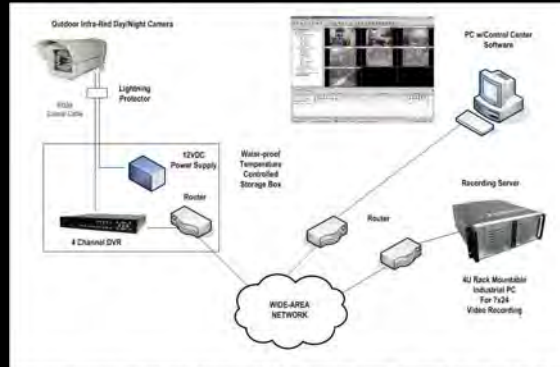
- Provide **continuous video capturing (24-hrs recording)** to the landslide resisting structures in the event of the structure being hit by landslide debris
- Clearly capture the **motion of landslide debris** and the **behaviour of the proposed structures**
- Cameras can be **remotely controlled** and monitored using the control center software through board brand network
- **Send email** to pre-defined email account, with thumbnail images of the captured pictures

Main Components of the system : Day/night Indoor/Outdoor Infra-red color Camera; Digital Video Recorder (DVR); Desktop computer; Control Center software; Routers etc.
