Site Investigations for Natural Terrain Hazard Assessments

Steve Parry (GEO)

Brief introduction to geomorphological approaches

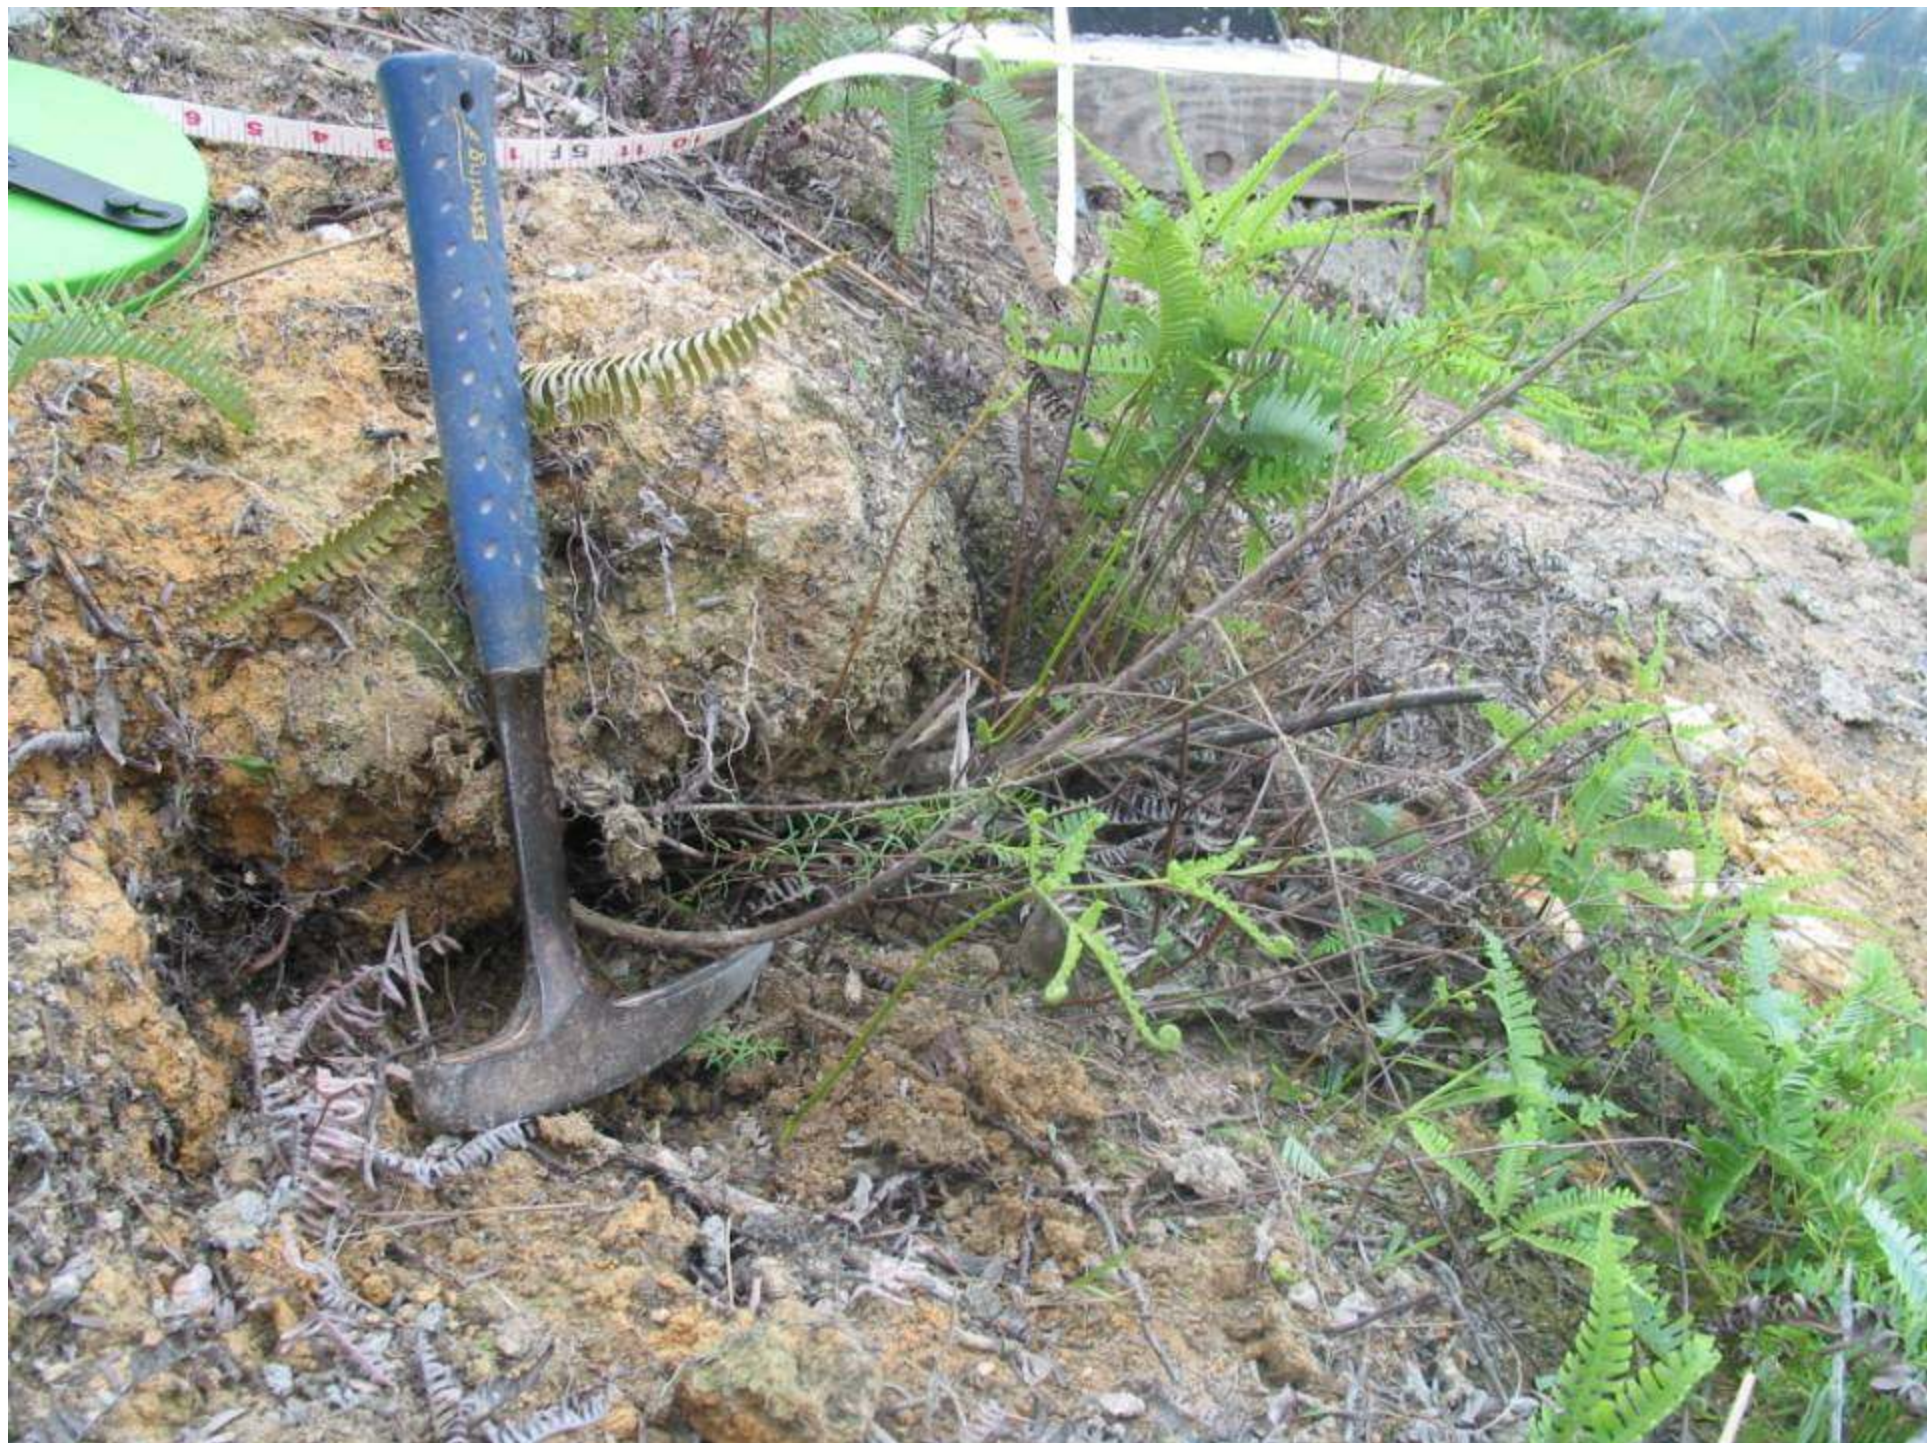
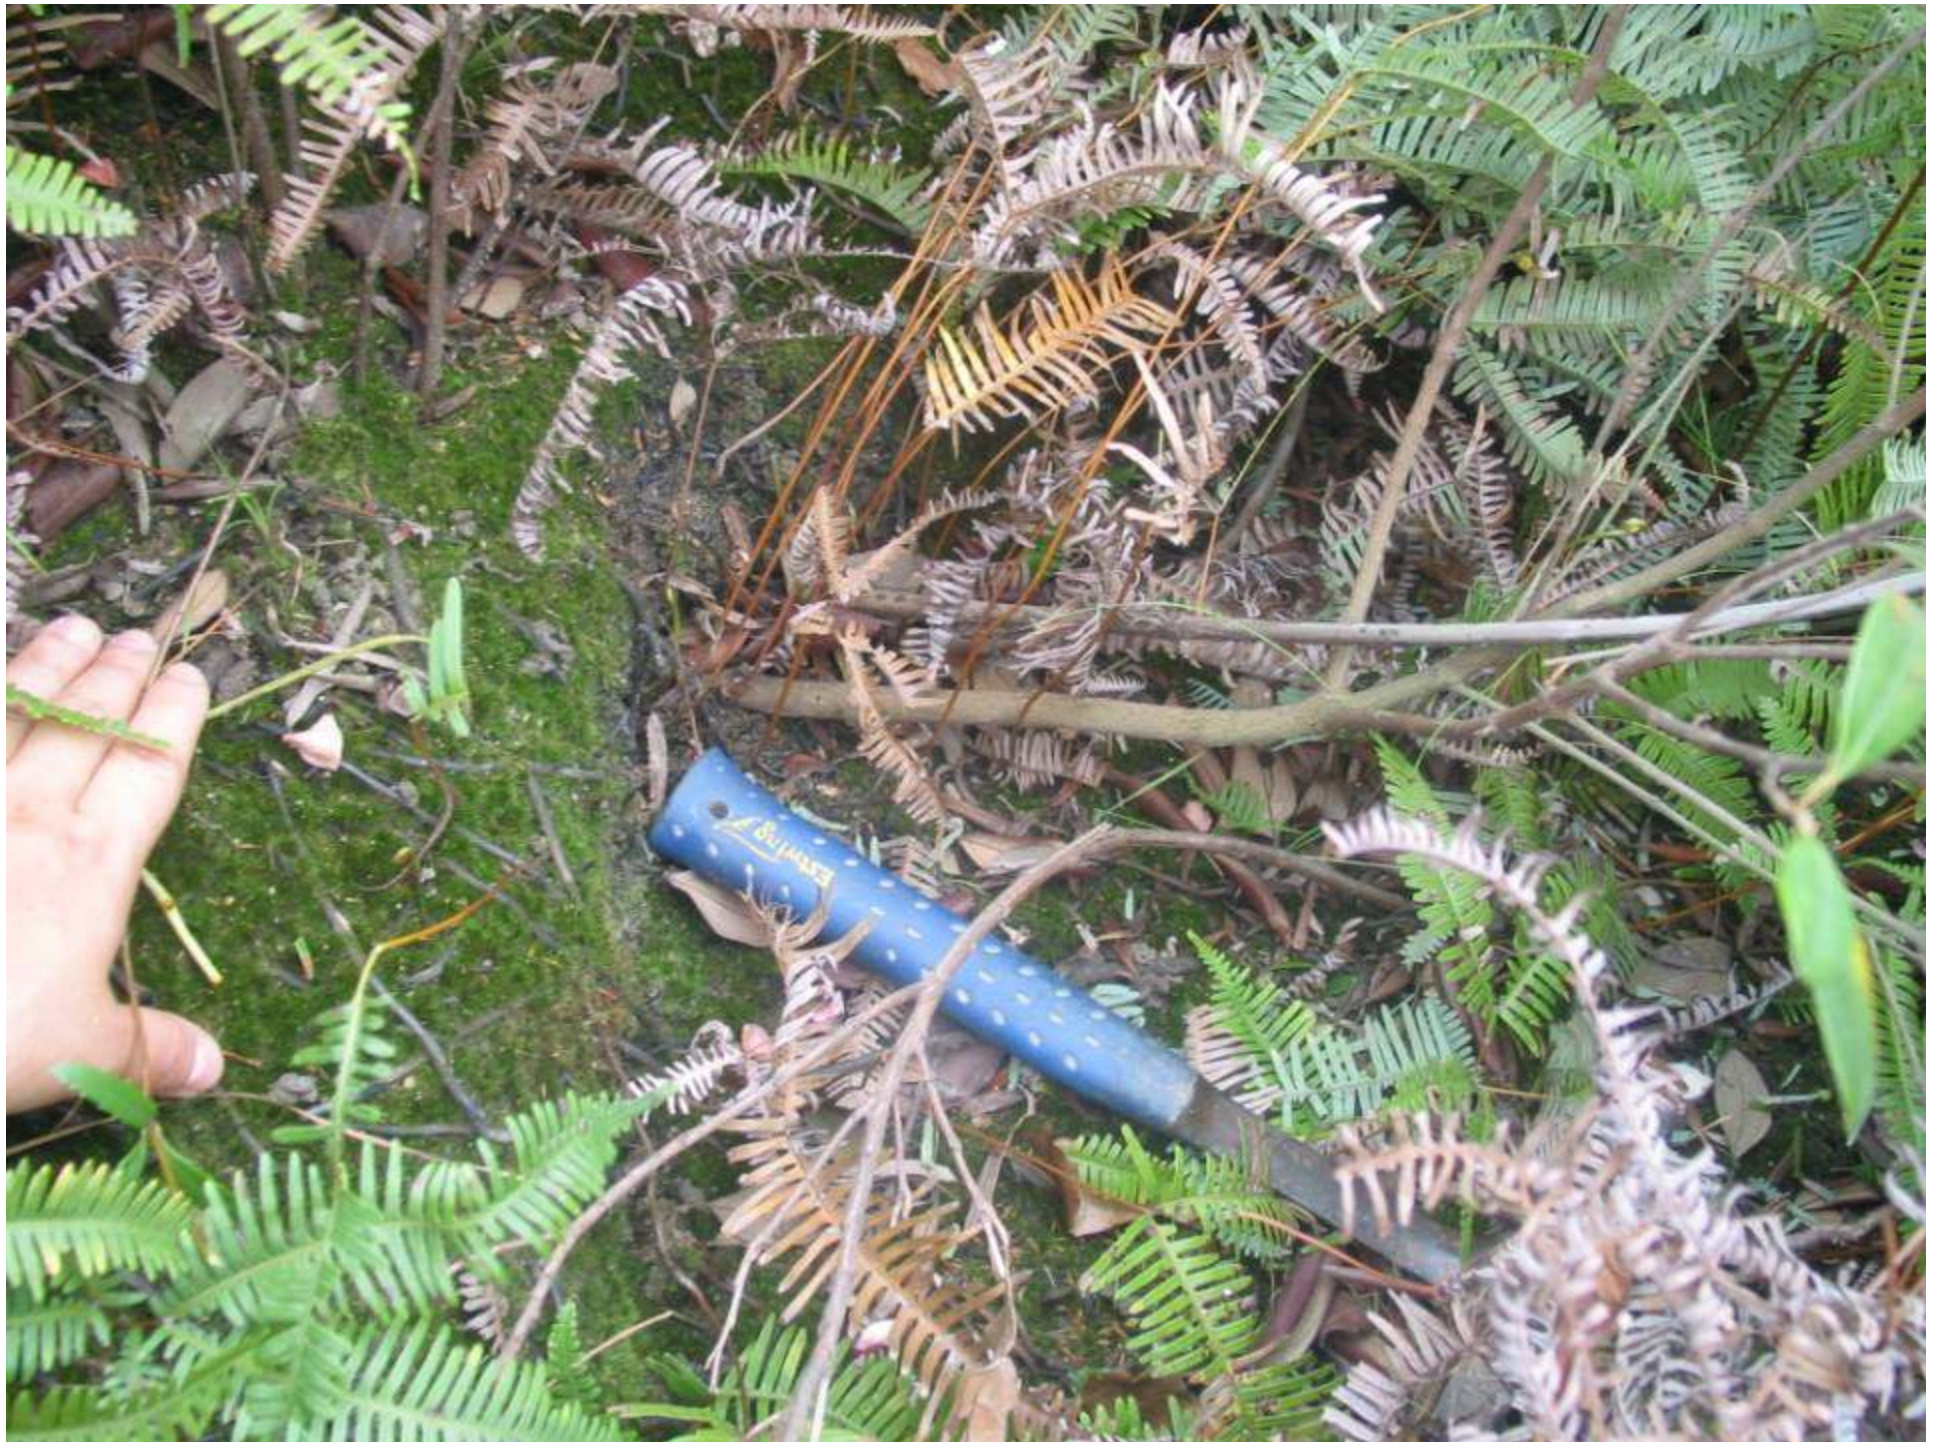
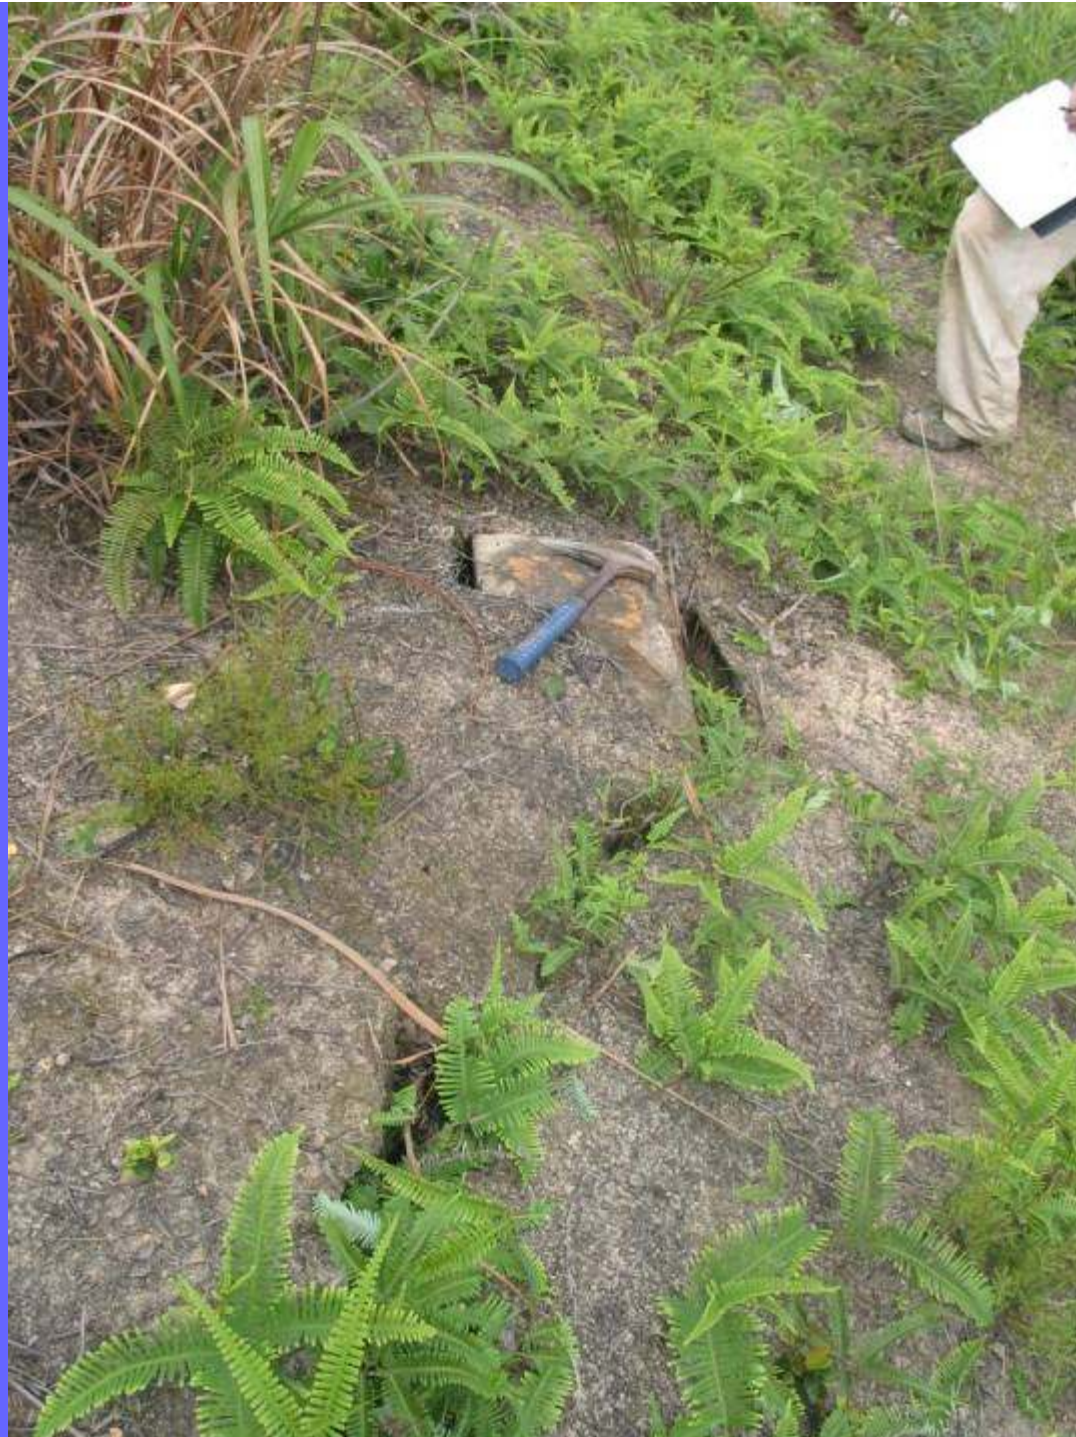
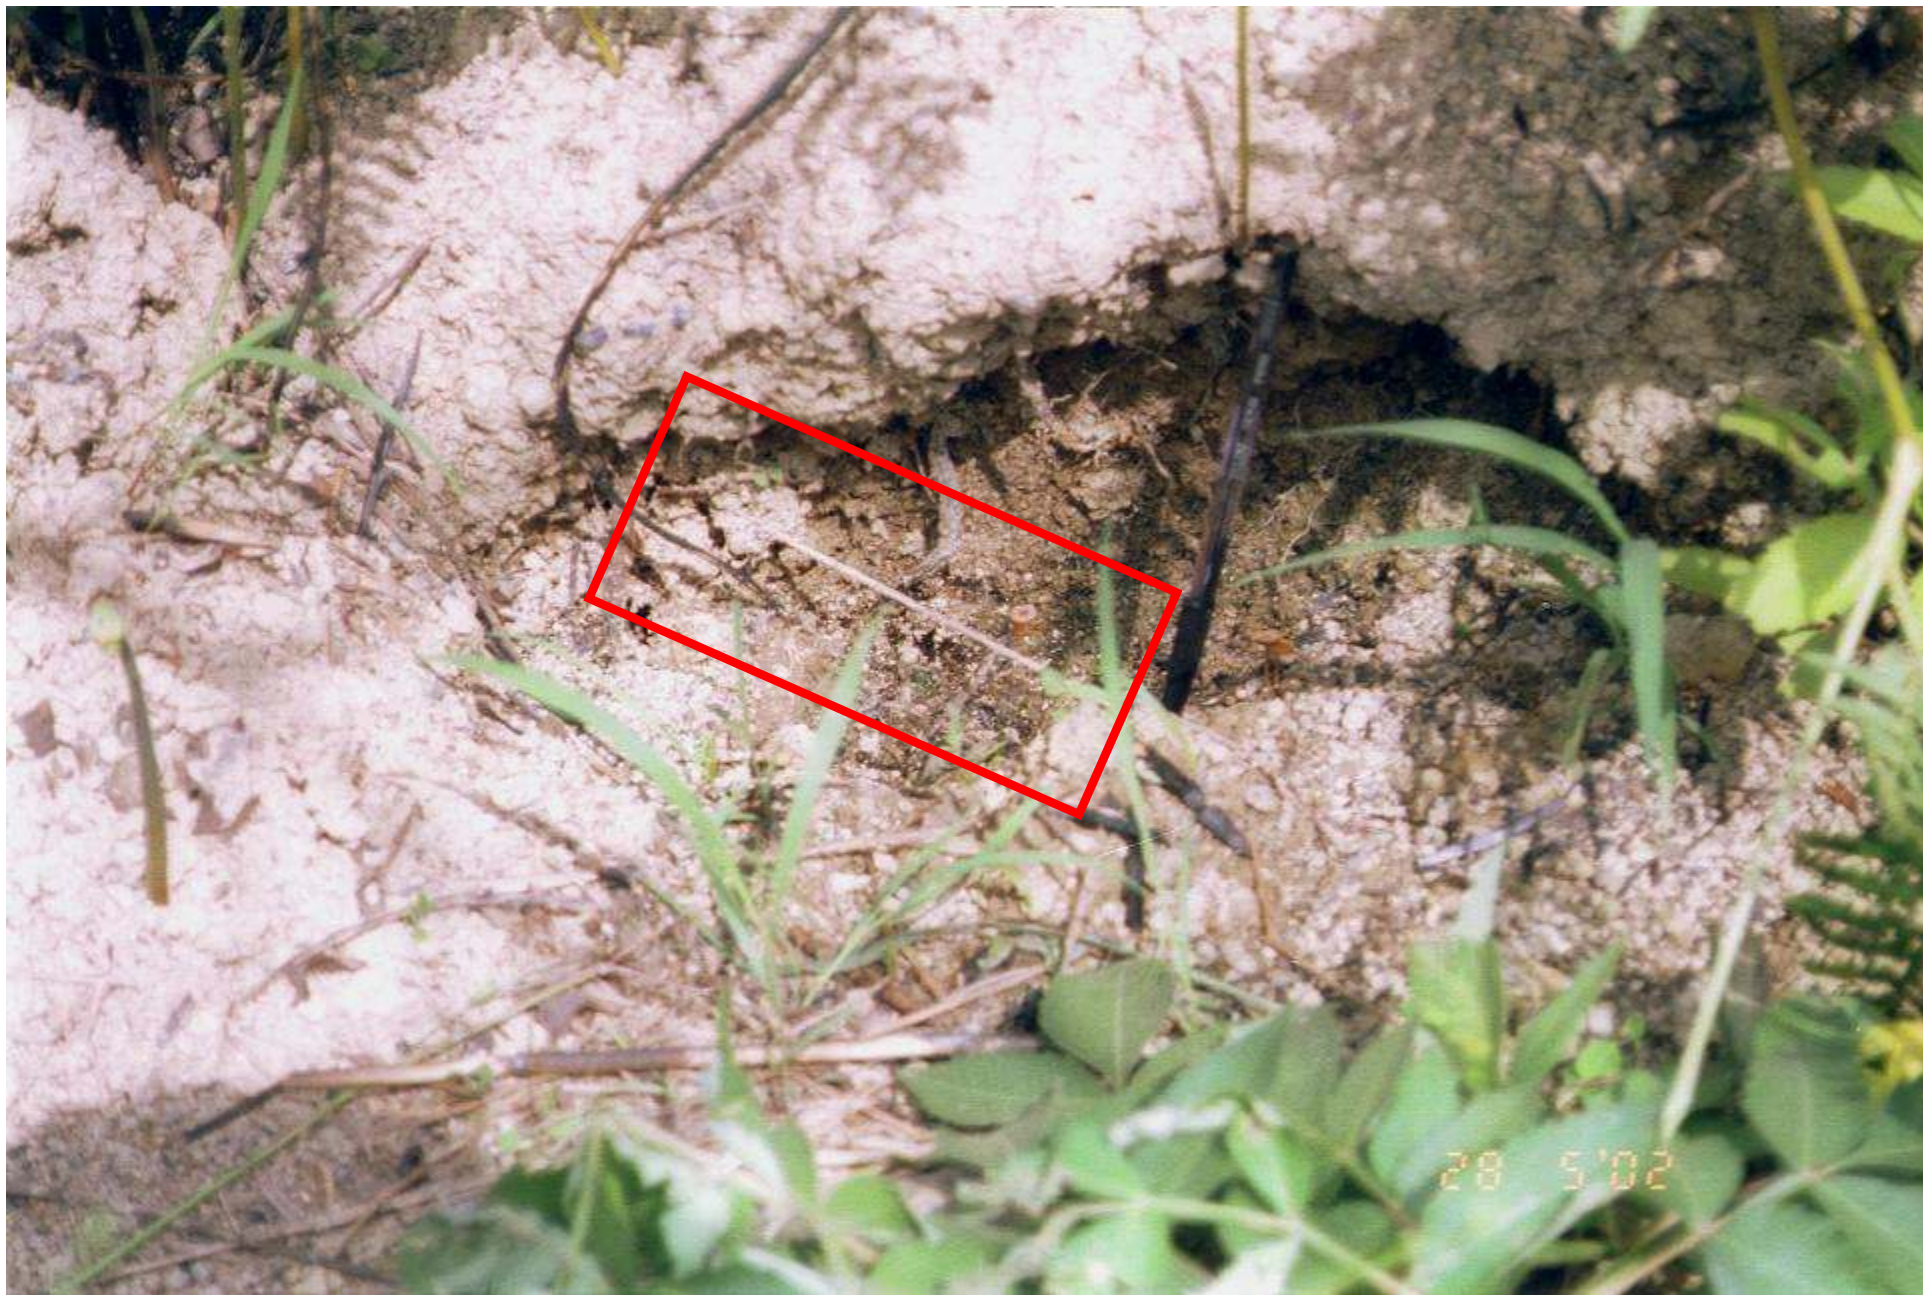
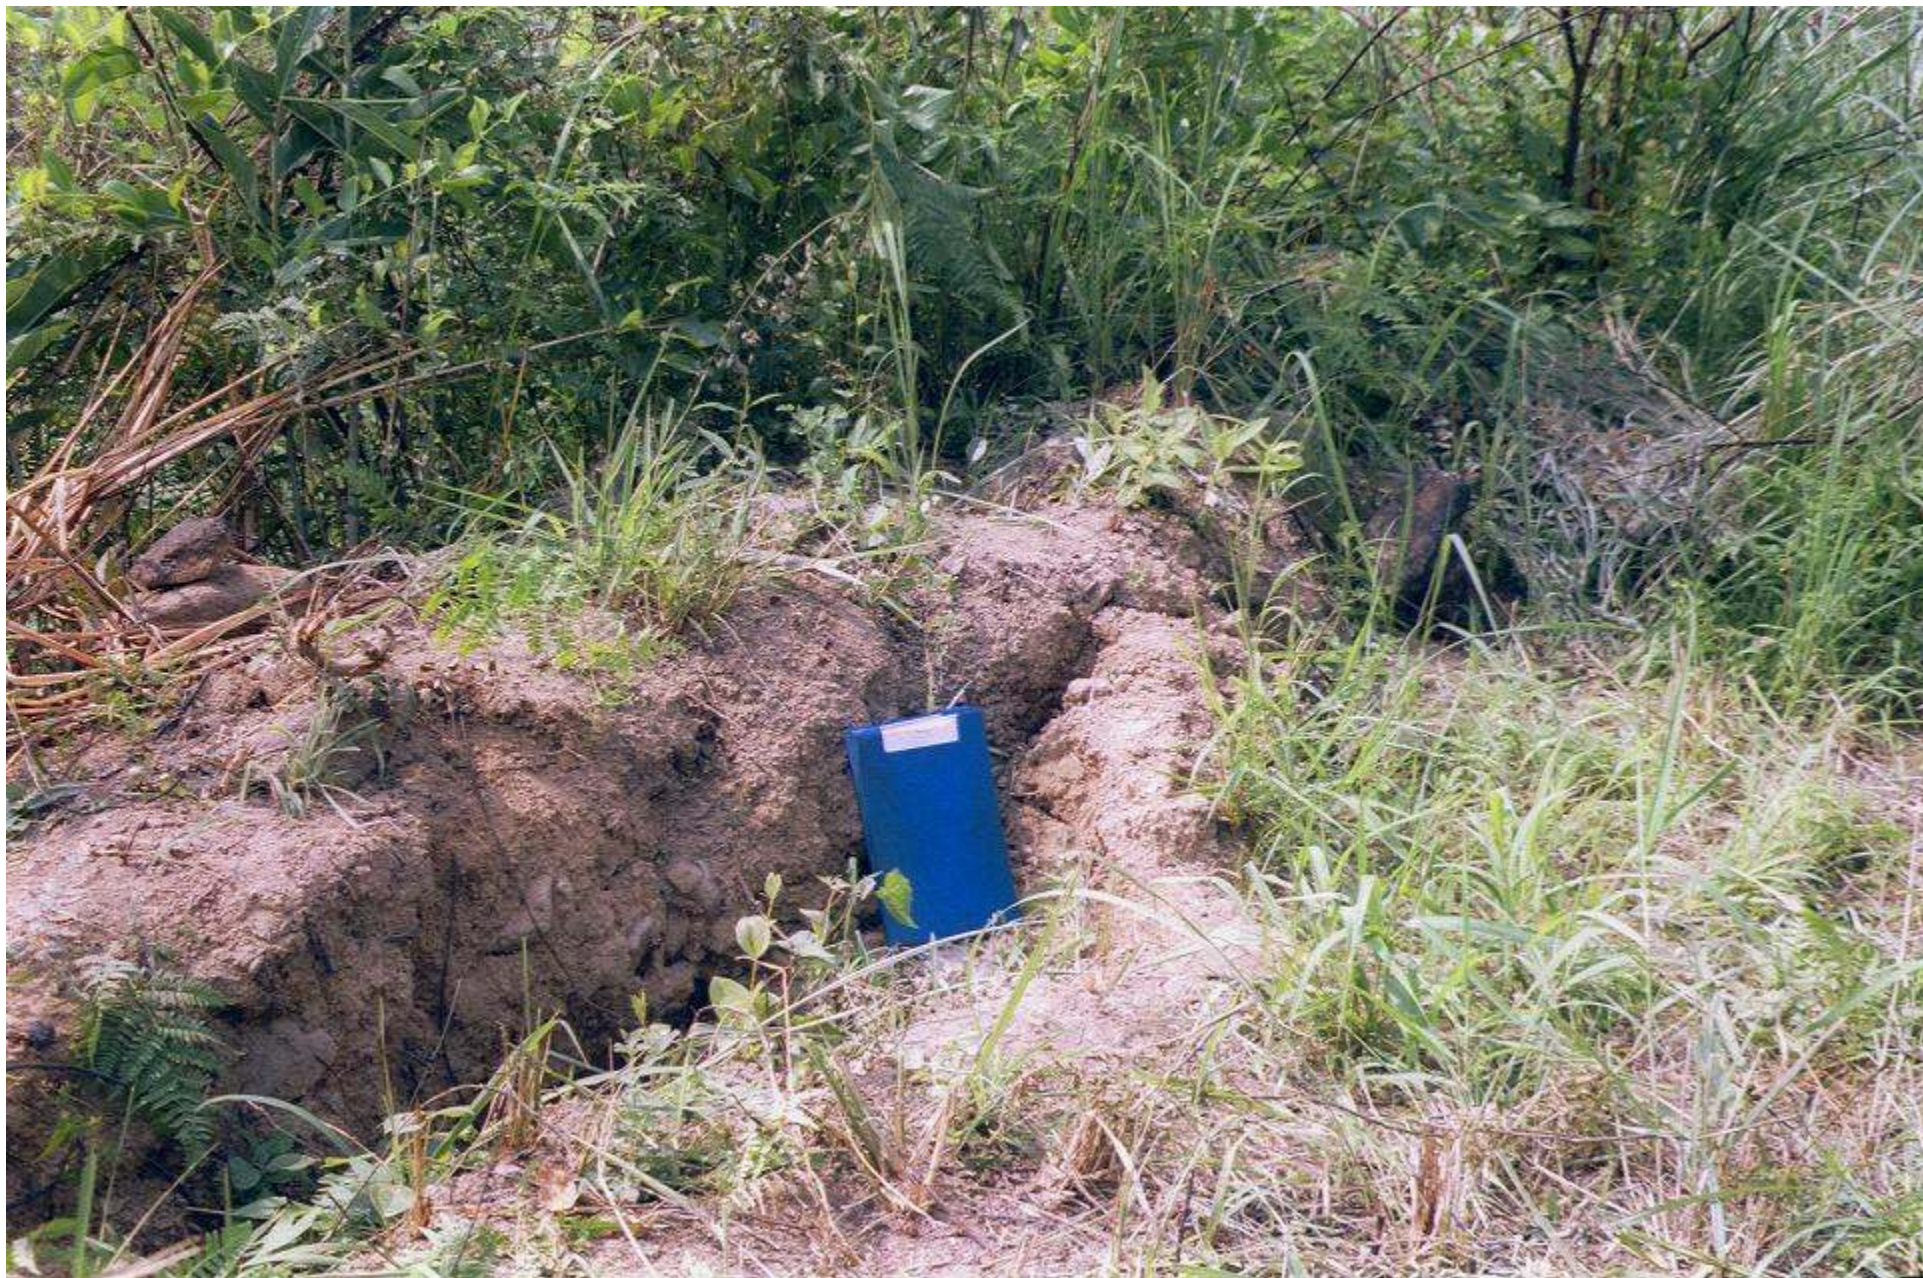
Natural Terrain Hazard Study for Tsing Shan Foothill Area
Landslide Field Proforma

(Note: based on orthorectified photograph with average thicknesses of depletion on overlay)

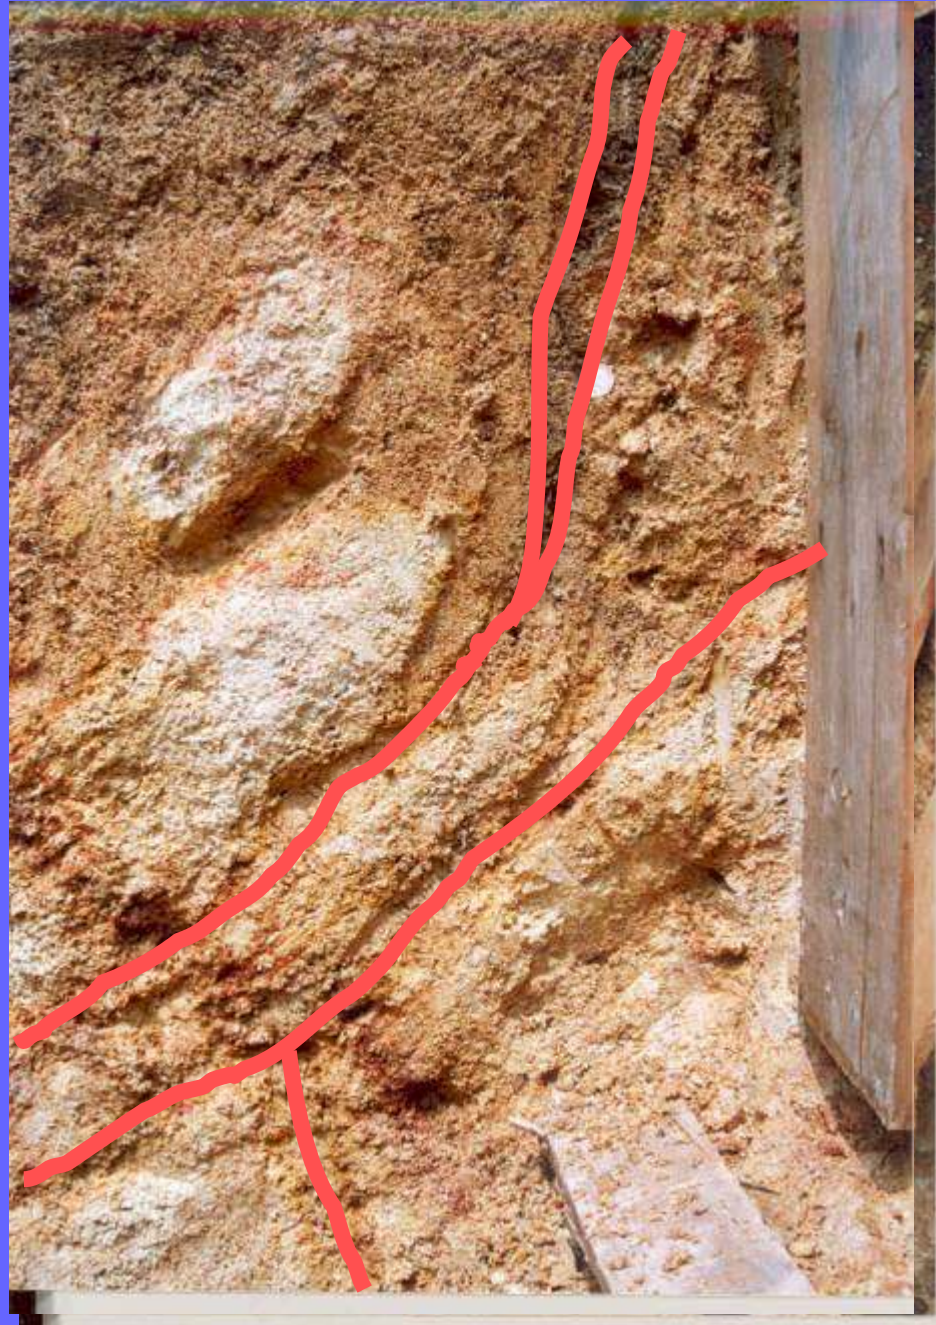
Colluvium
clayey silt

CD Tuff

Tension Crack
