1989 Suzuki RGV250

Modern tank battle

Thanks to ethanol and a wrongly applied sealing kit, Chris' RGV fuel tank was beyond home repair. Expert help was at hand, fortunately

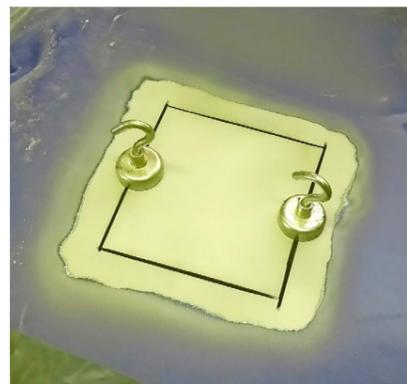
Magnets to hold new panel before it gets tacked

is free of rust and clean ready for the process. Ian then welded the hole back up, and applied his own lining. Not a difficult stage – though it's made easier for Ian, as the sealant works best if it (and the tank it's applied to) is heated to 40°C, and Ian's created a low-temperature oven specifically to pre-warm the tank and sealer.

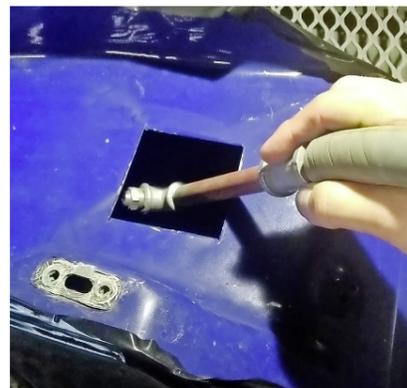
Blasting the insides right down to bare metal

My RGV's tank required a small square hole cut out – though mostly so a thick chunk of sealer rattling around that was too big for the filler hole, or to be dissolved by Ian's own chemical sealant dissolving solution, could be removed. Nonetheless, it gave Ian further access to use his array of special home-brewed blasting attachments to make sure every corner

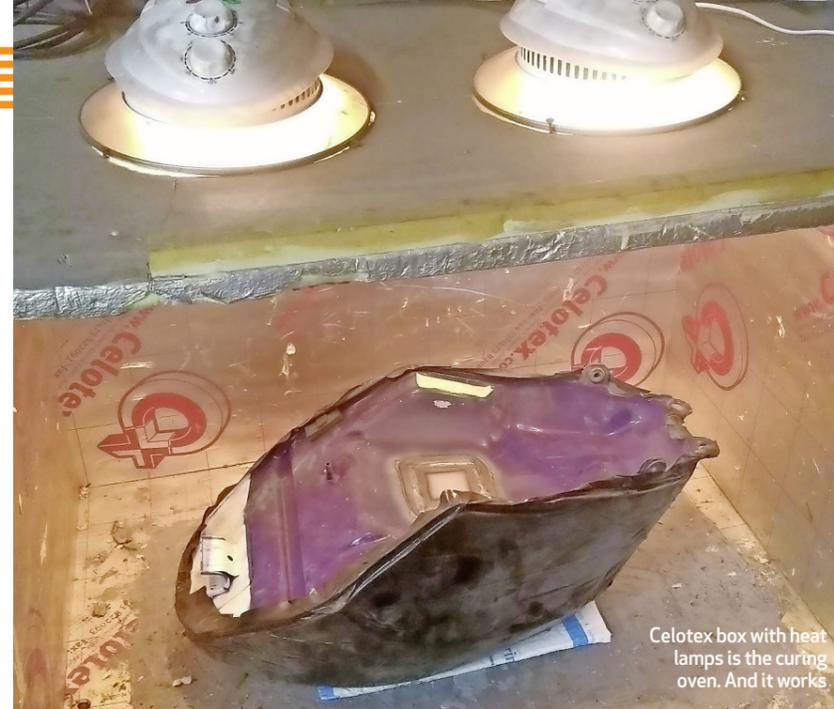
Celotex box with heat lamps is the curing oven. And it works

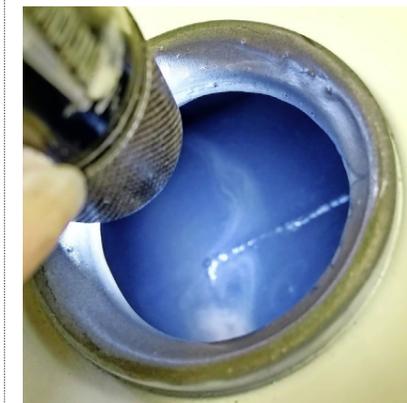
And a really good torch. And some patience

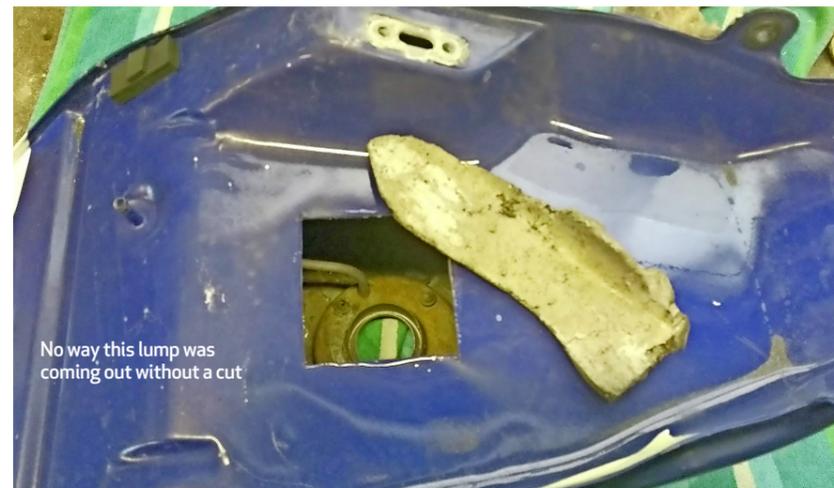
No way this lump was coming out without a cut
