EVALUATION OF
DIESEL ENGINED JEEP (JAPAN)

Job Order No. 318
Contract No. DA-20-113-AMC-08571(T)

January, 1967

Keweenaw Research Center
Michigan Technological University
Houghton, Michigan 49931

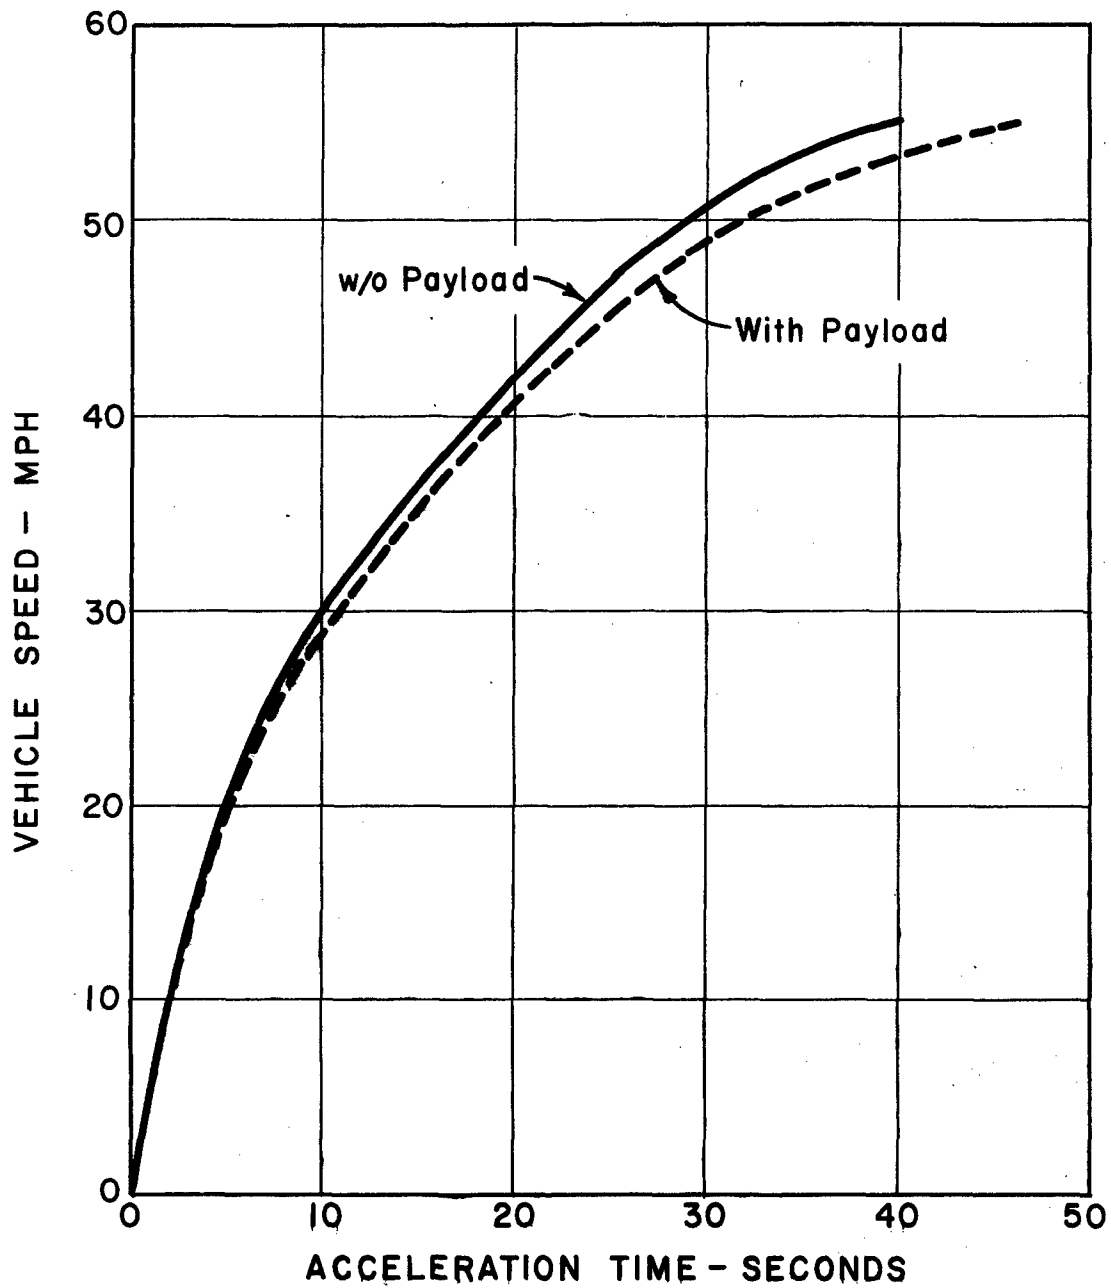
Figure 5
Japanese Jeep - Acceleration Rate

Acceleration tests conducted on smooth, level concrete pavement, showed that 40 seconds were required to reach a governed maximum speed of 55 mph, without payload, and 45 seconds for this same speed with payload. In that the engine was equipped with a speed governor the time for the last portion of the acceleration period varied considerably during the test. Possibly a more reliable comparison would be the 29 seconds to reach 50 mph, unloaded, and 32 seconds when loaded. A graph of this is shown in Figure 5.
