# Comparison of NDT techniques on a post-tensioned beam before its autopsy

By : X. Dérobert<sup>a</sup>, C. Aubagnac<sup>b</sup>, O. Abraham<sup>a</sup>

# Introduction

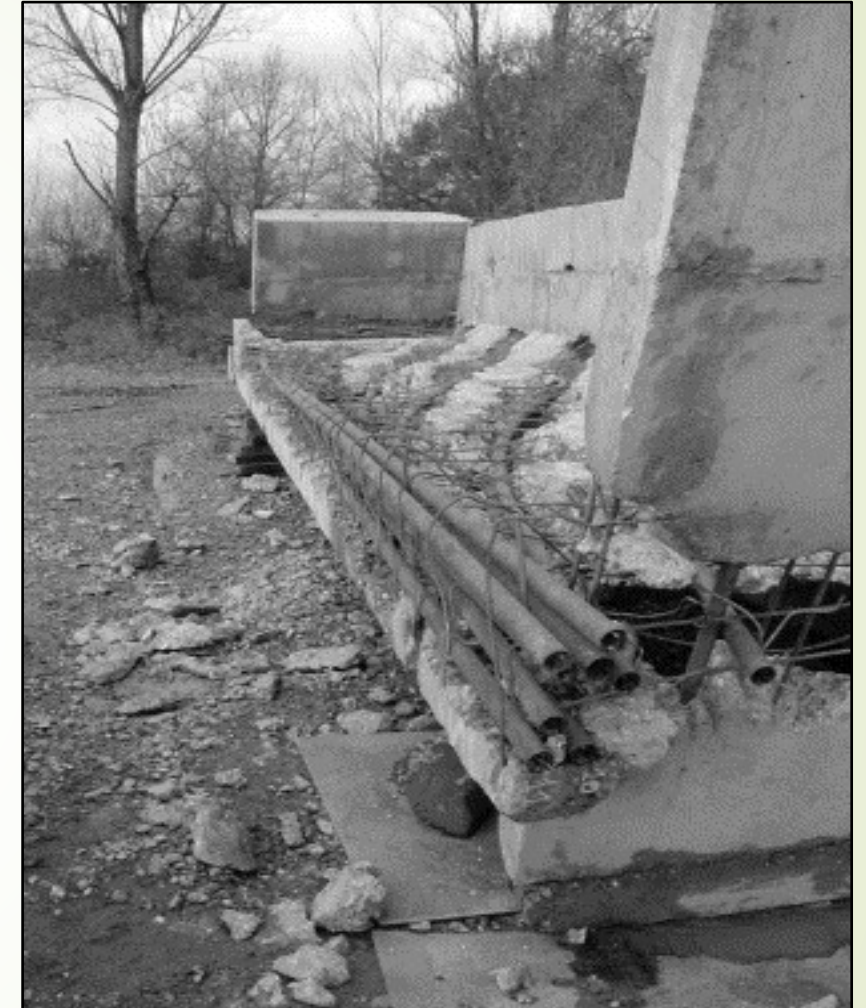
- After completion of NDT campaigns, the beam was hydro demolished with the use of high pressure spouts.
- Concrete destruction was limited to the post tensioned duct areas in order to release them along with anchorages and with the least damage to the tendons.
- Total 11 anchorages and 77m of tendons have been examined.
- Examination includes,
  1. Tendon layout identification.
  2. Opening of each metallic duct.
  3. Grout removing.
  4. Dismounting of each tendon, each strand and each elementary wire to find the corrosion and wire fracture.
  5. Chemical analysis of the grout.

**Release of tendons and anchorages from the beam after hydro-demolition**
