# Damage Due to Earthquakes and Improvement of Seismic Performance of Reinforced Concrete Buildings in Japan

Masaki Maeda and Hamood Al-Washali

**Keywords** RC existing building · Seismic evaluation · Seismic retrofit · Earthquake damage

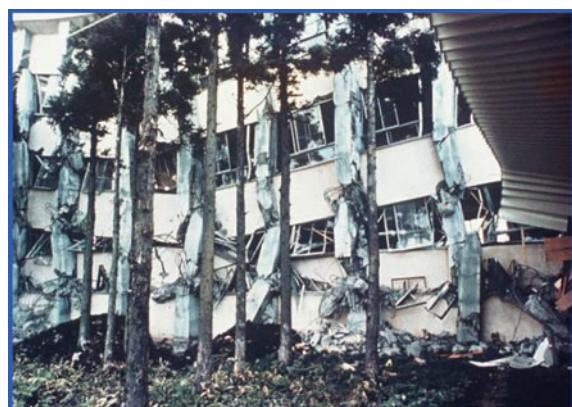
The 1968 Tokachi-oki earthquake induced heavy damage and collapse of many reinforced concrete (RC) buildings as shown Fig. 1. Brittle shear failure in columns were most typical damage and considered the main reason of collapse. Therefore, requirement of hoop spacing in columns were upgraded from 30 to 10 cm in order to prevent shear failure in 1971. At the same time, Japanese government established a national project for improvement of seismic capacity and seismic design including universities, national research institutes and construction companies. As a result of ten years project, ultimate state design was introduced to seismic code in 1981 revision. In addition, Standard for Seismic Evaluation of Existing Reinforced Concrete Buildings (Seismic Evaluation Standard) was published by Japan Building Disaster Prevention Association (JBDPA) in 1977.

**Fig. 1** Collapse of RC buildings in 1968 Tokachi-oki earthquake

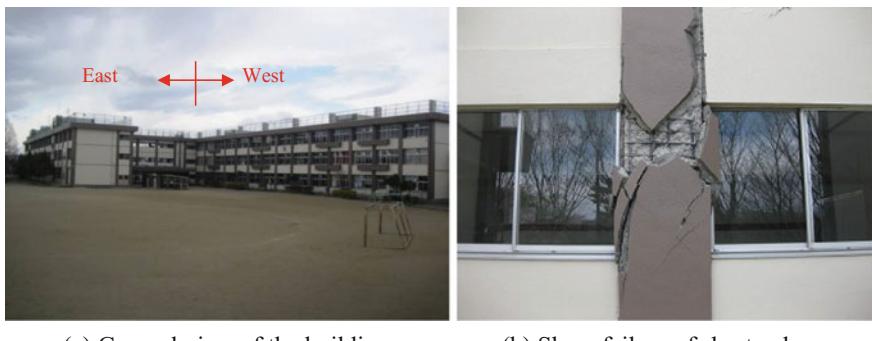
As mentioned above, most of seismically retrofitted RC buildings performed well against the 2011 East Japan earthquake. However, few retrofitted building suffered moderate damage. Figure 7 shows three storied RC building of an elementary school in Sendai city constructed in 1974. The building is divided by expansion joint into west side and east side. Seismic evaluation was carried out to both sides. According to the seismic evaluation, the East side building needed to be retrofitted and the West side was evaluated to have enough seismic capacity and no retrofitting was needed. The East side building was retrofitted by adding framed steel braces and shear walls. By this earthquake, the retrofitted building had only minor damage. On the other hand, the west side building had shear failure in its short columns as shown in Fig. 7b. Shear failure of those short columns was allowed in the seismic evaluation because axial loads could be redistributed to other columns and the building didn't collapse. However, the school couldn't continue using the east side of the building. This issue of functionality is one of important problems.

(a) General view of the building

(b) Shear failure of short columns

**Fig. 7** *Damage to RC school buildings in 2011 East Japan Earthquake*

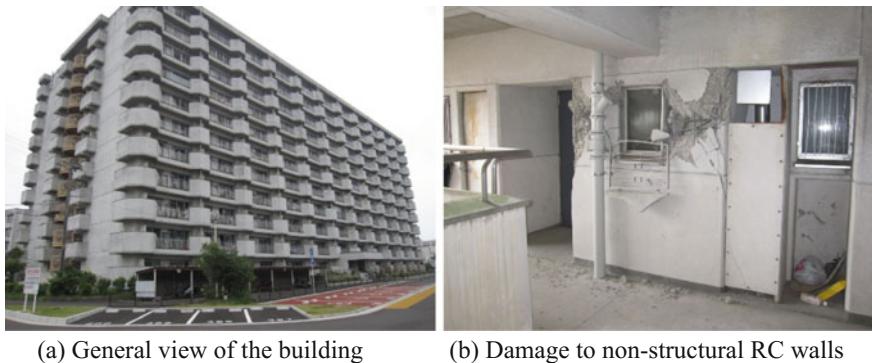
**Fig. 8** Damage to a residential building in 2011 East Japan Earthquake

Another issue was damage to non-structural elements. Figure 8a shows an overview of an eleven storied SRC residential building which was evaluated as  $I_s$ -index of larger than requirement (0.6). However, shear failure of non-structural concrete wall were observed in lower stories as shown in Fig. 8b. These damage induce problems in functions of the building. Although damage to structural elements were quite limited, inhabitants evacuated from this building because of interruption of service and the building was finally demolished. It suggest functionality is getting more important for performance of buildings structure from the resilience point of view.

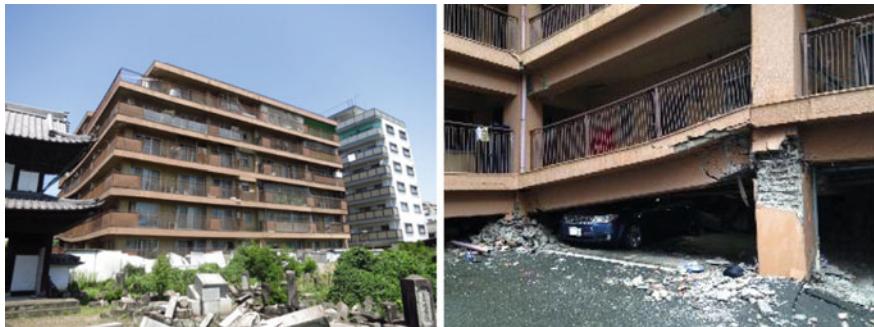
Figure 9 shows the damage of 7-story residential RC building design by old seismic code and having soft first story (piloti) used as parking lot. Such damage was commonly observed in previous earthquake in Kobe earthquake 1995.

(a) General view of the building

(b) Collapse of first story

**Fig. 9** Damage to a residential building in 2016 Kumamoto Earthquake**Fig. 10** Damage to city hall building in 2016 Kumamoto Earthquake

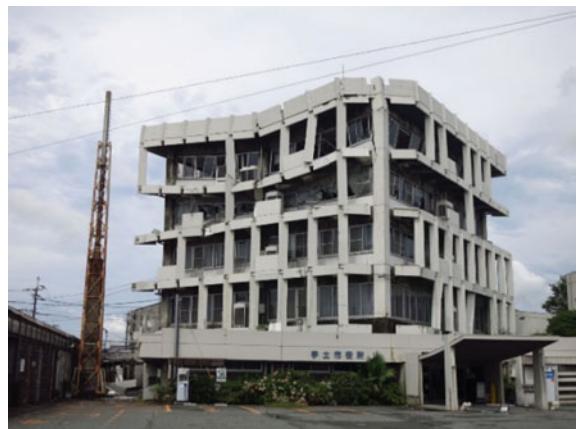
Figure 10 shows 5-story RC building used as city hall. The story collapse occurred at the 4th story. This building was also designed by the old seismic code (before 1981) and was evaluated to have low seismic capacity  $I_s$  index. Future plans of either retrofit or rebuild was under consideration before the earthquake.

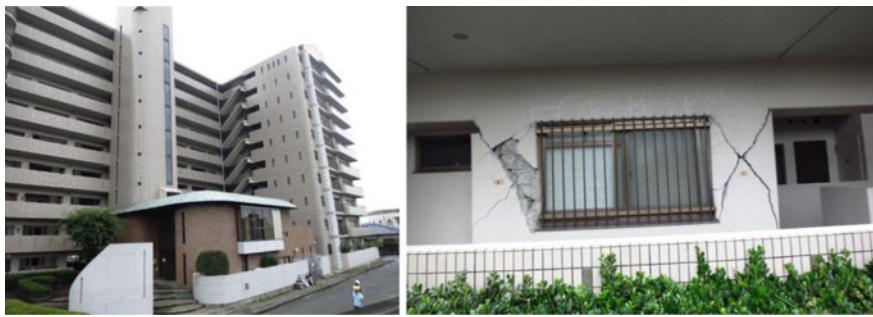
Figure 11 shows the damage of another RC building where the damage to its structure elements was slight. However, the non-structural secondary walls were greatly damaged. This repeated damage, rise the importance of reevaluating serviceability limits due to non-structural elements.

(a) General view of the building

(b) Collapse of non structural RC walls

**Fig. 11** Damage to a residential building in 2016 Kumamoto Earthquake
