Alaska Department of Environmental Conservation (ADEC) Solid Waste Program (Trisha Bower and Kit Persson) conducted a Coastal Impact Assistance Program (CIAP), Waste Erosion Assessment and Review (WEAR) site visit for the Village of Teller on July 29, 2013. Trisha Bower and Rebecca Colvin conducted a follow-up visit on July 29, 2014. Carolyn Oquilluk, the City Clerk helped coordinate our visits. The following narrative is a brief description of our findings during the 2013 and 2014 inspections.

### WEAR Sites

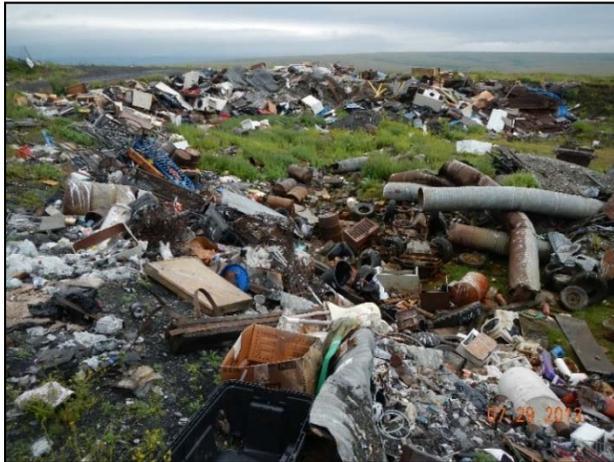
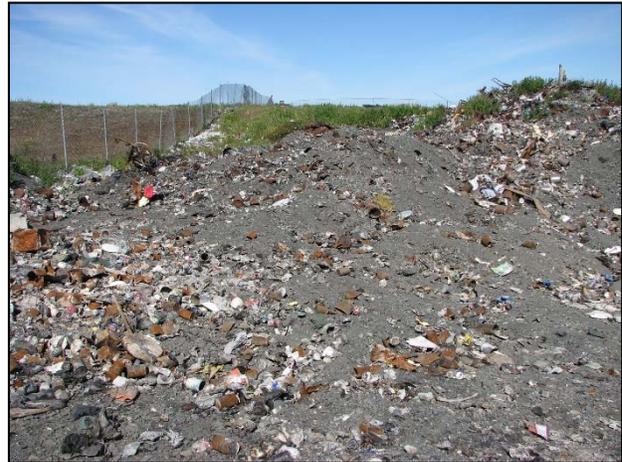
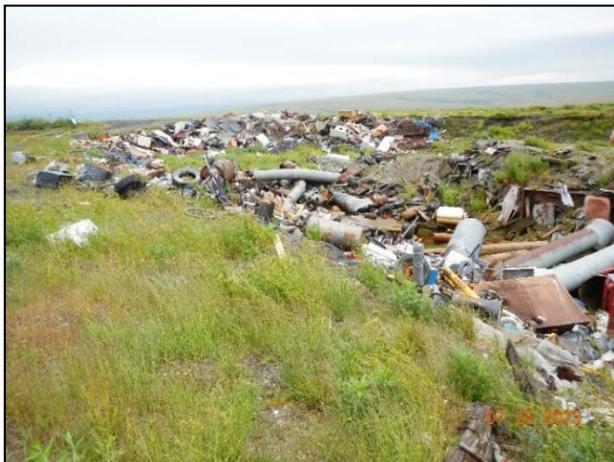
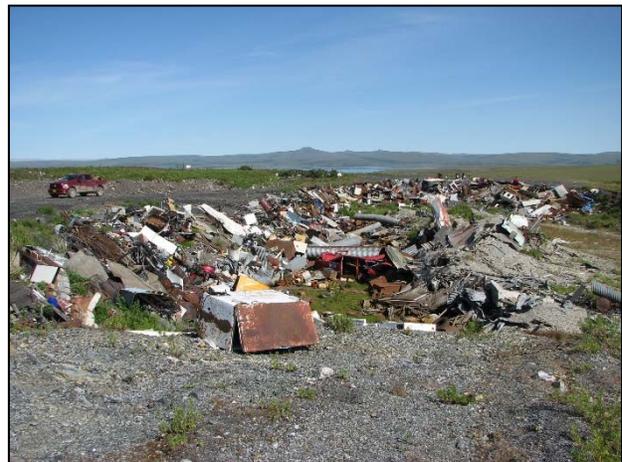
- **Landfill, 65.215301/-166.316974 (Active)** — This permitted site was constructed in 1994 and is a partially fenced area fill landfill. It is located over 4 miles southeast of the community on the Nome-Teller Highway. A Landfill Operator is hired occasionally to manage the landfill. A collection program brings the majority of the community's waste to the landfill, but self-hauling is also allowed. Open burning is conducted at the working face, which is covered on a regular basis. However, there is a large metals area in the landfill that is not covered at all. The landfill accepts municipal waste, construction and demolition debris, and there may be waste from a previous reindeer processing facility within this landfill. This landfill also includes a Construction and Demolition debris Monofill that was permitted by the Solid Waste Program in 2008. It is located more than 3 miles inland from Port Clarence in an elevated area.

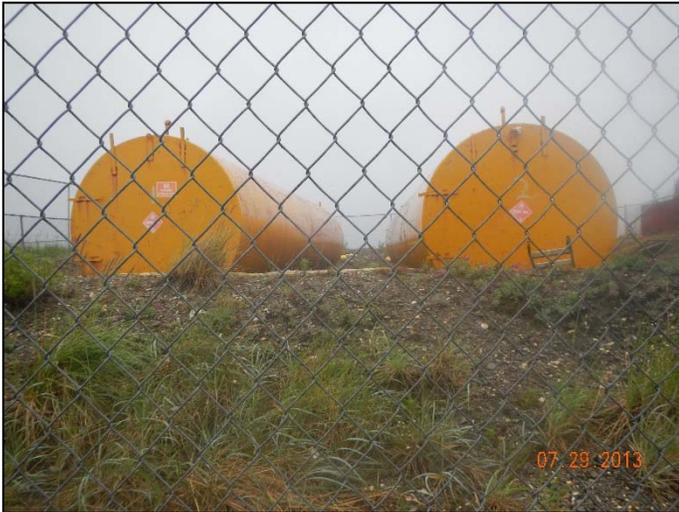
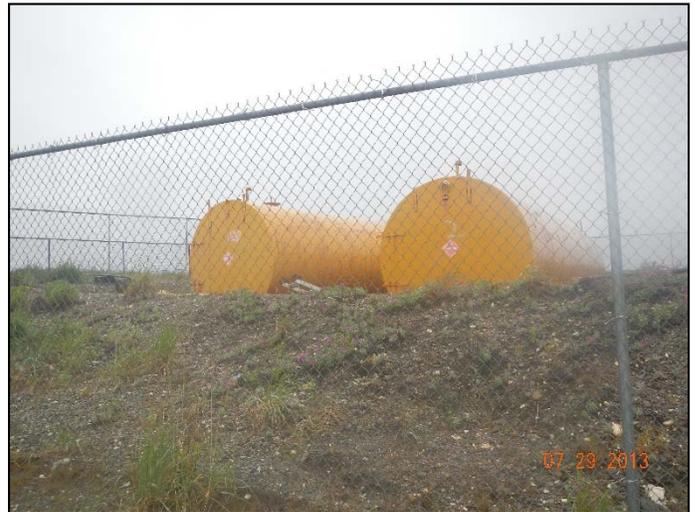
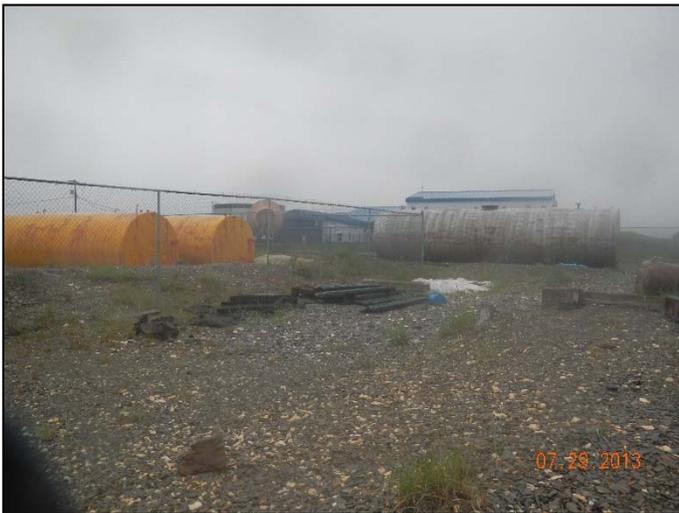
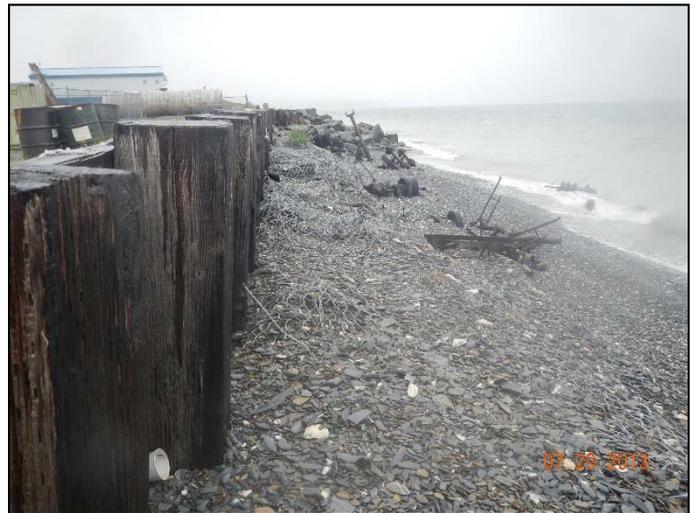
- **School Tank Farm, 65.264474/-166.366174 (Active)** – There were two horizontal, orange diesel tanks located adjacent to the school in a secured area and one grey, horizontal tank located outside of the secured perimeter. This tank farm has been in place since the 1970s. The secured tanks are active and currently serve the school. These two tanks are within earthen bermed containment. They are located approximately 53 feet from Port Clarence on the east side of the tank farm and approximately 560 feet from Grantley Harbor on the west side of the tank farm. Teller is located on a small peninsula and is surrounded by water on 3 sides. At this section of shoreline, a seawall is installed on the shore of Port Clarence.

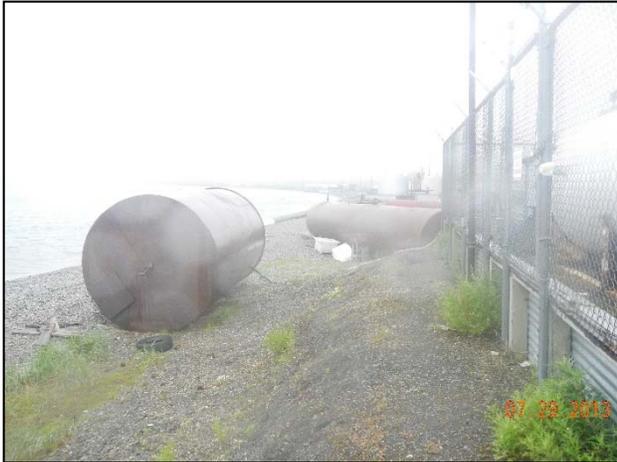
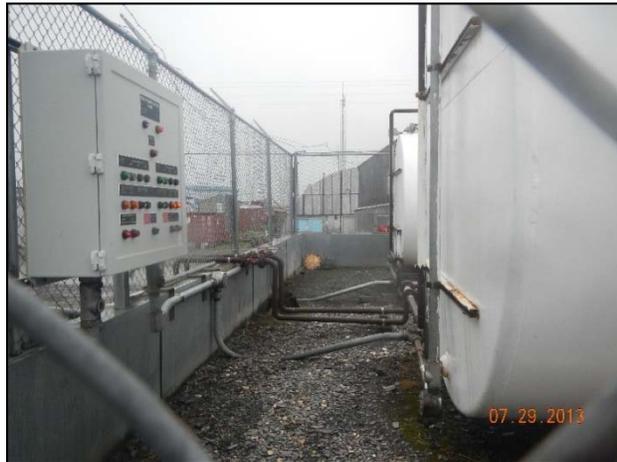
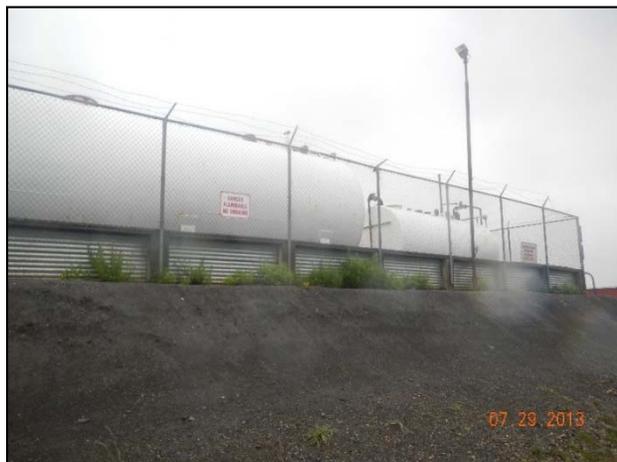
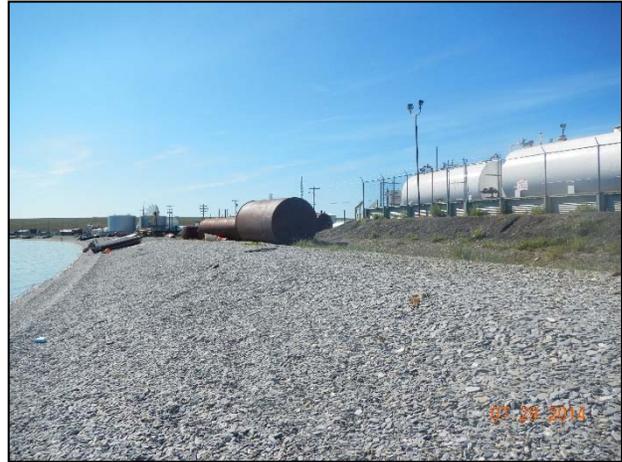
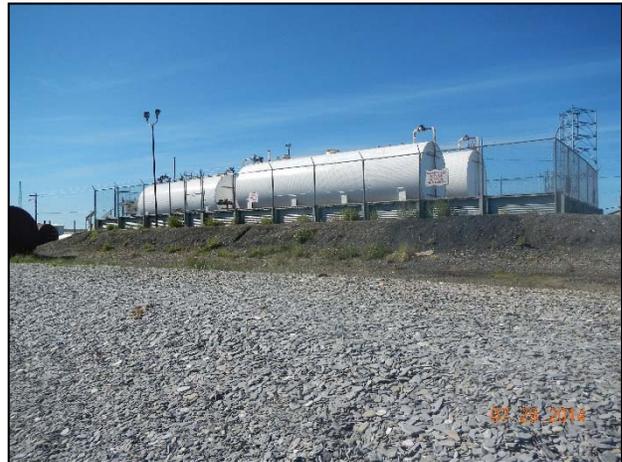
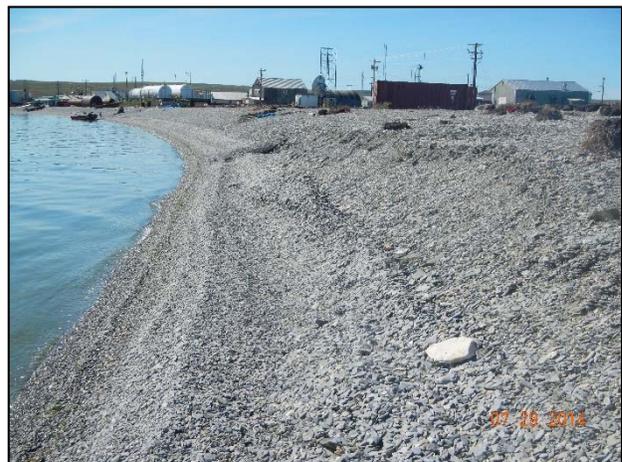
- **Community Tank Farm, 65.264785/-166.362562 (Active)** – The community tank farm in Teller is built up more than 5 feet above the surrounding grade within a steel diked and secured area. It consists of 4 horizontal tanks of varying sizes. There are some tanks outside of the locked perimeter, but they did not appear to be connected to a distribution system. This tank farm is the fuel service station for the community. It was a Denali Commission Project that was constructed by the Alaska Energy Authority and was completed in 1997. This bulk tank farm is approximately 30 feet from Grantley Harbor to the east and approximately 415 feet from Port Clarence to the west. Teller is located on a small peninsula and is surrounded by water on 3 sides. There were no changes noted from 2013 to 2014.

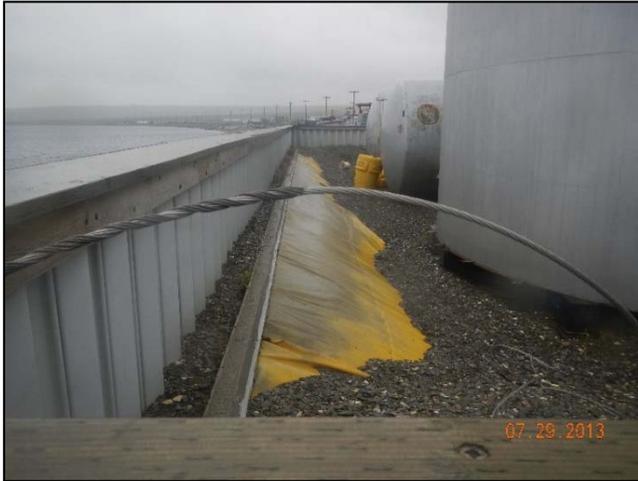
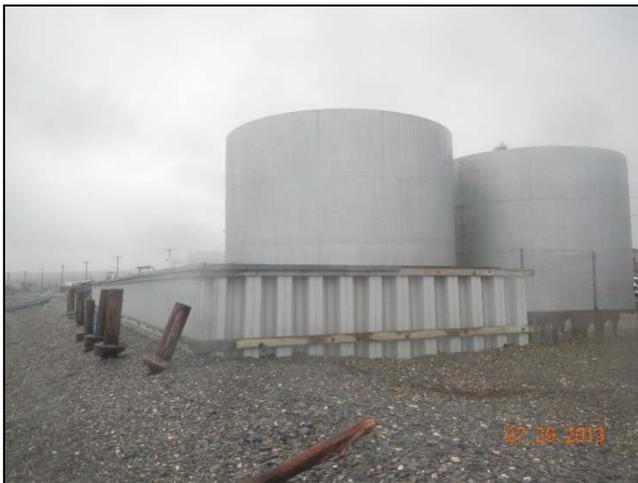
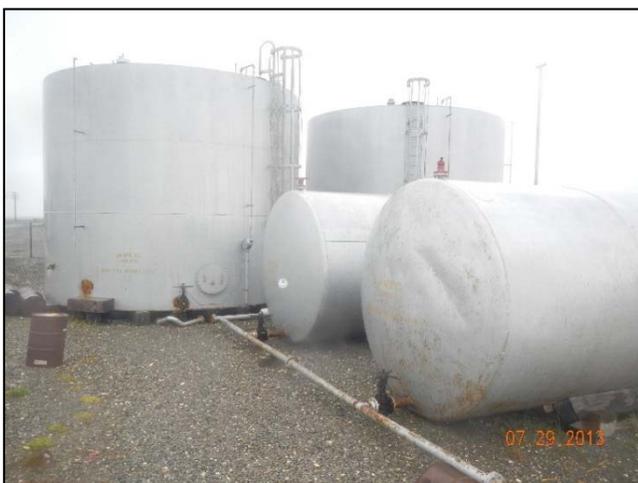
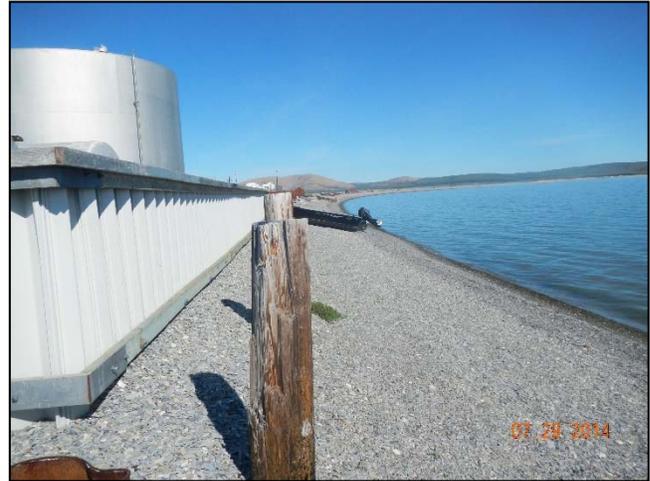
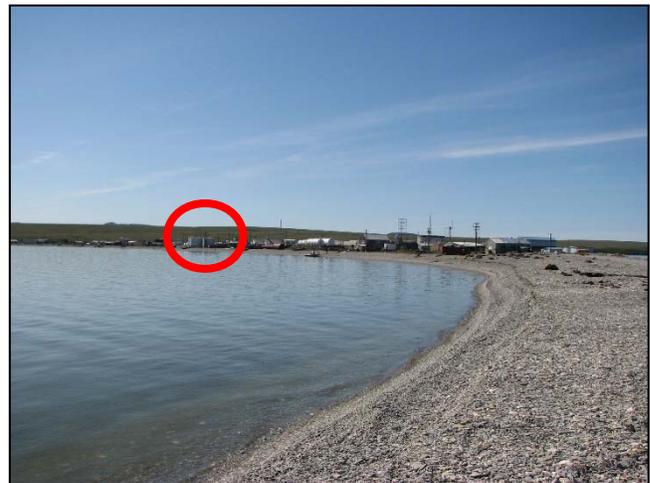
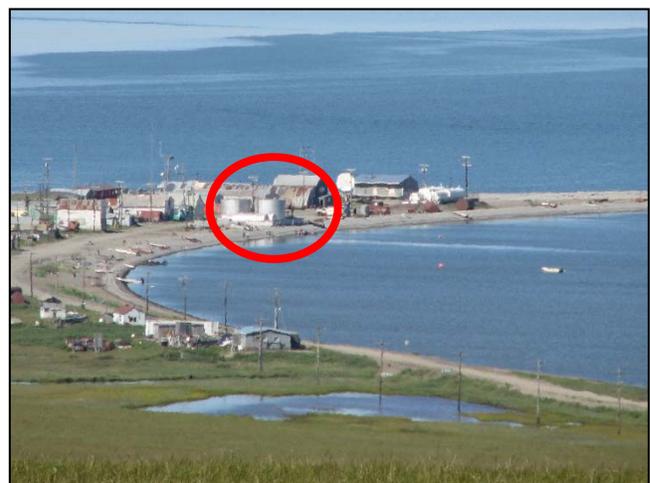
- **AVEC Tank Farm, 65.263582/-166.362045 (Active)** – AVEC is the local power utility and maintains a tank farm to supply fuel to the power generation system in Teller. There has been a tank farm in this location since the 1970s. The current tank farm consists of 2 vertical and 2 horizontal fuel tanks within a diked secondary containment with no fencing. The total capacity of the site is 185,759 gallons of diesel. A corrugated plastic seawall is constructed around part of the facility. This tank farm is approximately 10 feet from Grantley Harbor to the east and approximately 740 feet from Port Clarence to the west. Teller is located on a small peninsula and is surrounded by water on 3 sides.

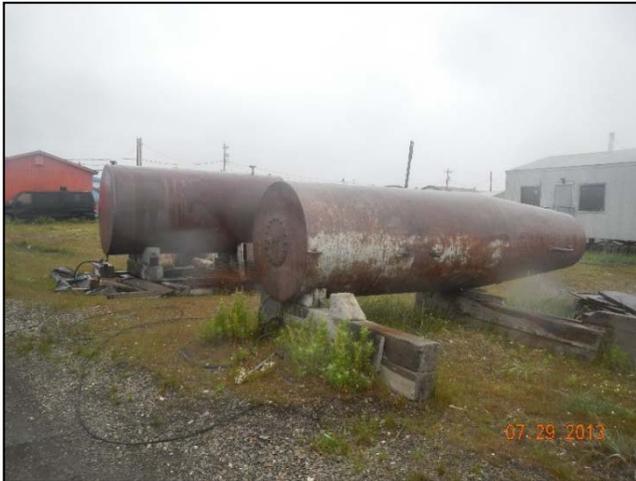
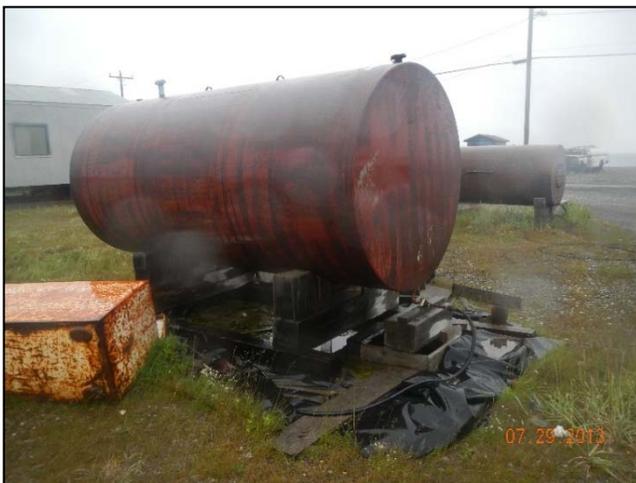
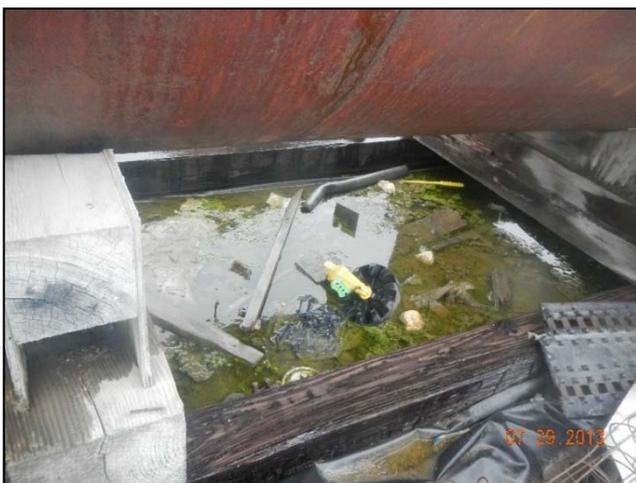
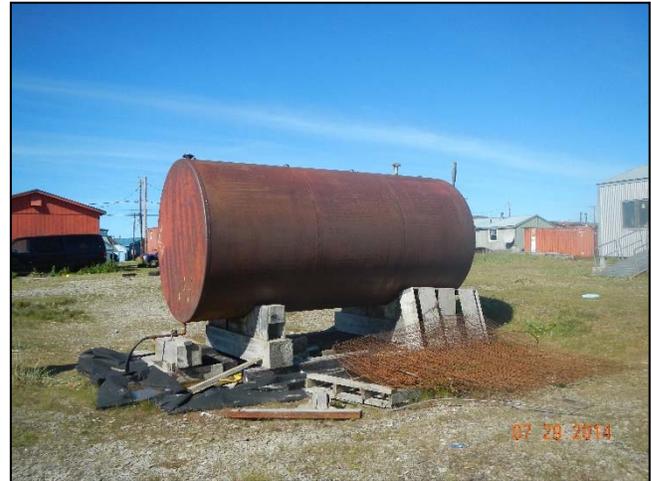
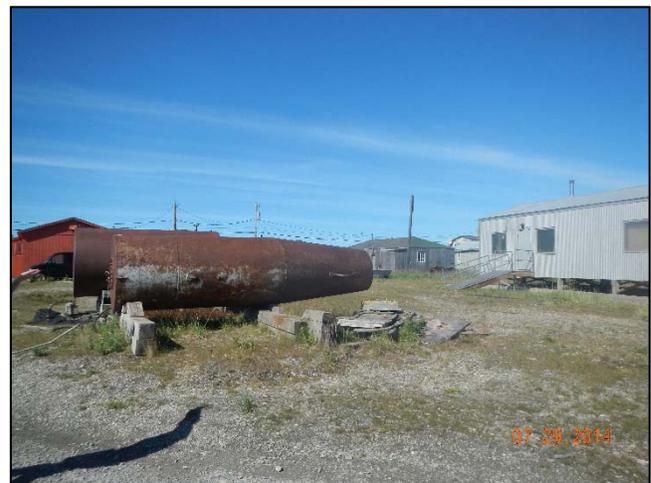
- **Fuel Tanks, 65.264090/-166.363172 (Abandoned)** – This site consists of 2 horizontal fuel tanks on wooden blocks. There is black plastic sheeting under one tank that was full of water. There is no fencing, and the site is accessible to the public. The tanks were reported to be empty and not in use. The owner of the tanks is unknown. It is located beside the road between the Lutheran Church and the National Guard Armory. This tank farm is approximately 170 feet from Grantley Harbor to the east and approximately 540 feet from Port Clarence to the west.

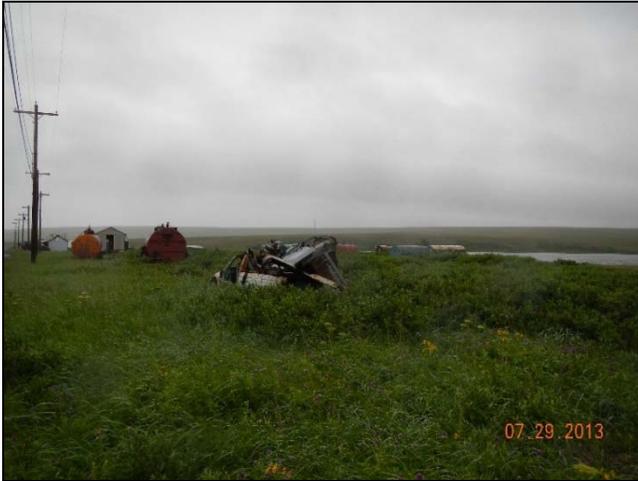
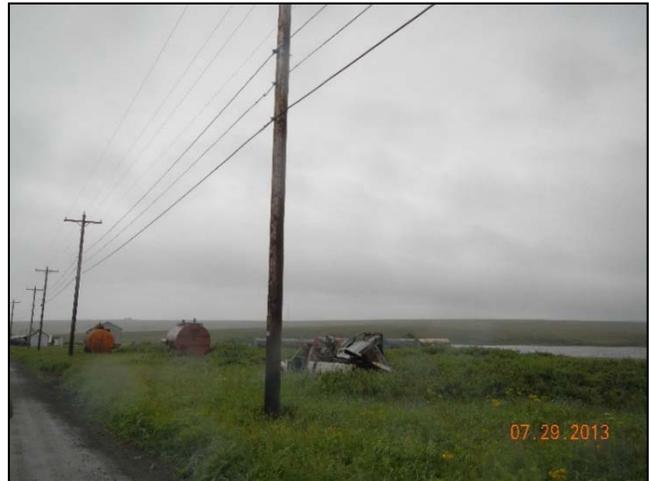
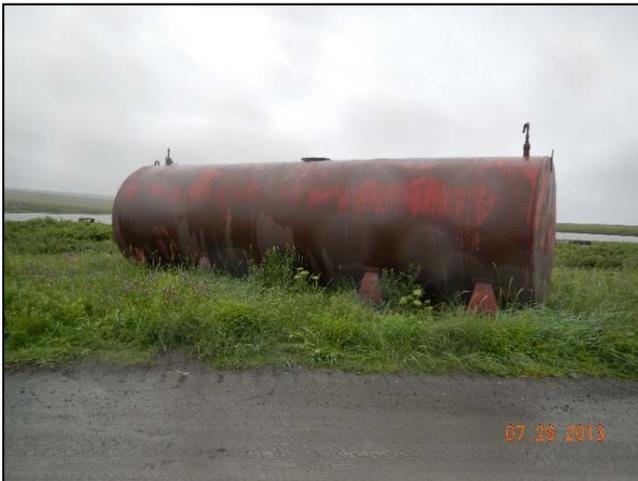
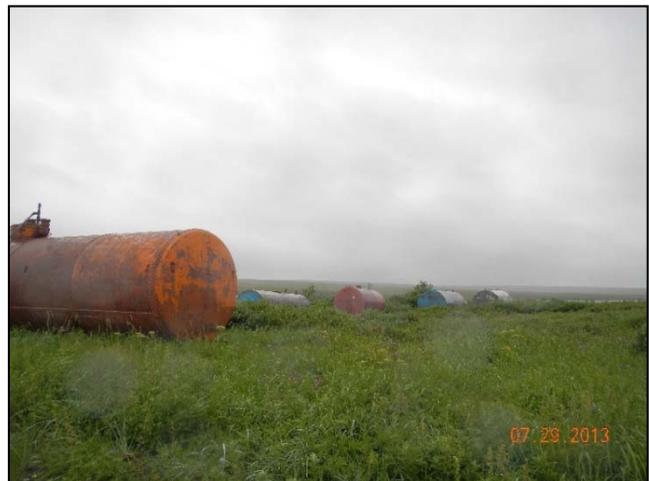
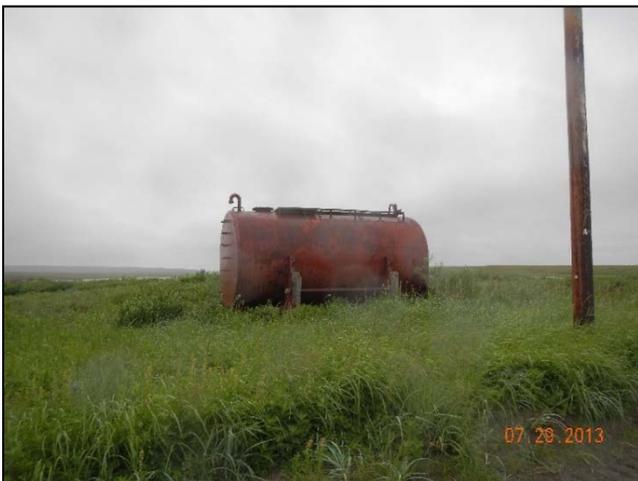
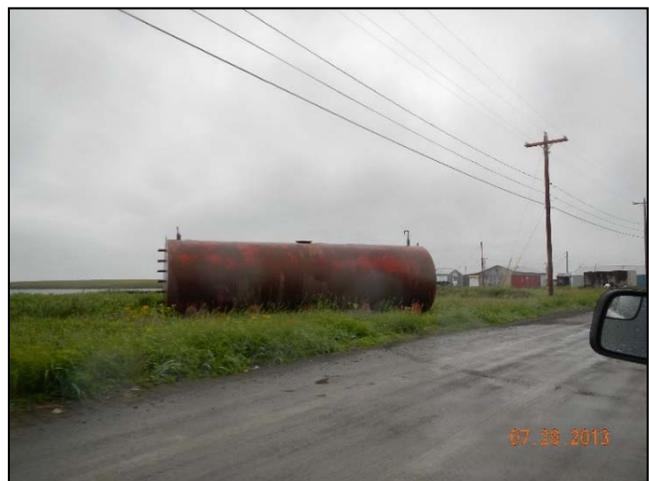
- **Abandoned Tanks, 65.25131/-166.356656 (Abandoned)** – This was a field that contained numerous abandoned tanks. There were seven tanks observed during this inspection. There were no indications that any of the tanks were in use, but they had not been labeled as inactive or decommissioned. They date from the 1980s-1990s as are not on the Division of Community and Regional Affairs (DCRA) 1980 map, but they are on the 1996 map. The closest tank is approximately 50 feet from Grantley Harbor to the east and approximately 150 feet to Freshwater Lake.

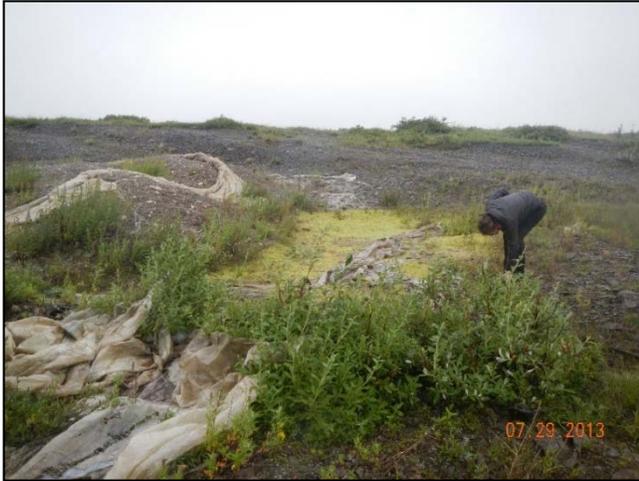
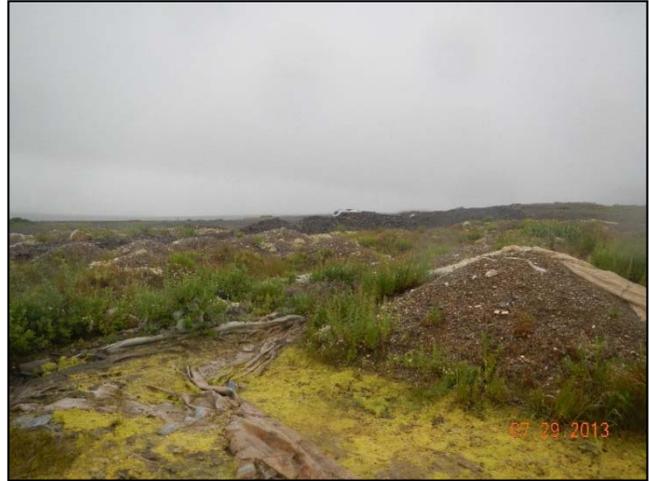
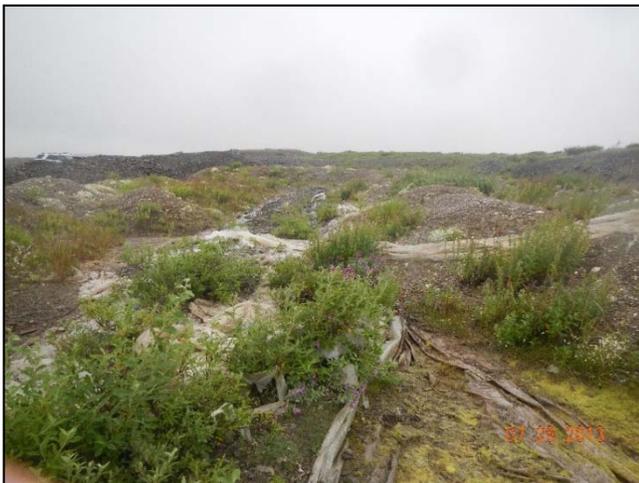
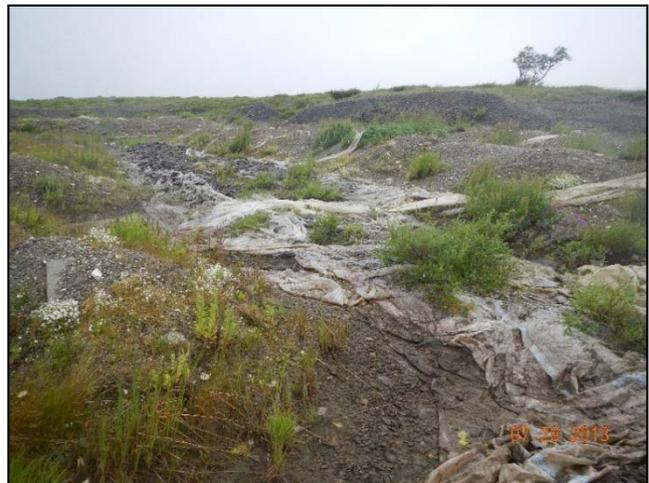
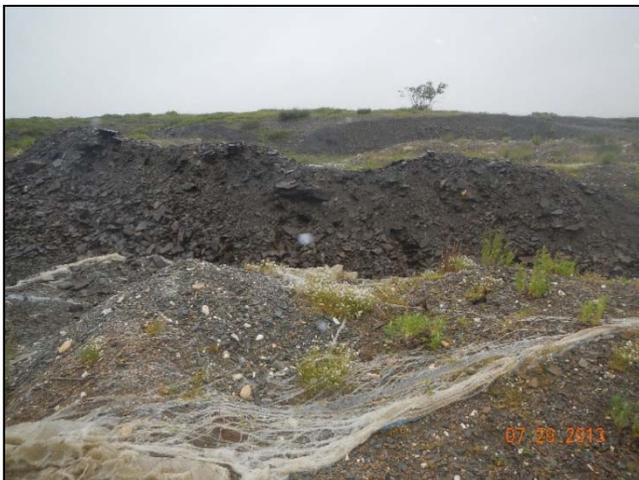
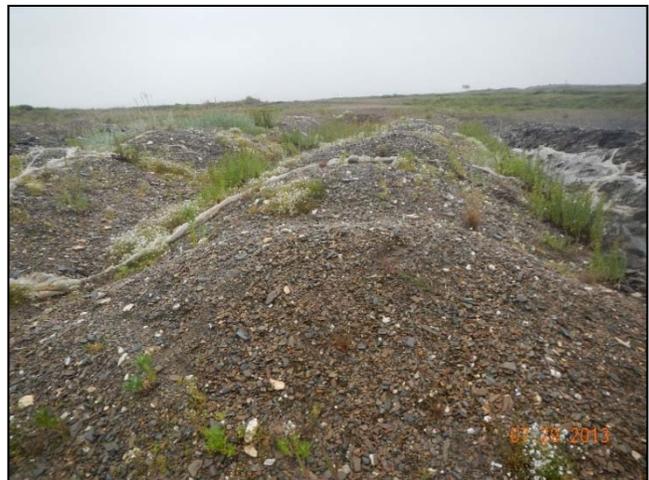
- **Contaminated Soil Site, 65.201752/-166.302947 (Abandoned)** – There is a large area with windrows of soil on plastic outside of Teller on the Nome-Teller highway. This site is located approximately 2.7 miles south of the Teller airstrip. Although it is not listed in the Contaminated Sites Program’s database, polluted soil is normally stored in berms and with plastic such as this site. The responsible party and landowner is unknown, as is the age of the site. However, this site has been in place long enough for the plastic sheeting to begin degrading. This site is approximately 4.5 miles from Port Clarence to the west and approximately 3.6 miles to Grantley Harbor to the north.
