Structural Performance Monitoring Technology and Data Visualization Tools and Techniques – Featured Case Study: UBC Tallwood House

Abstract:

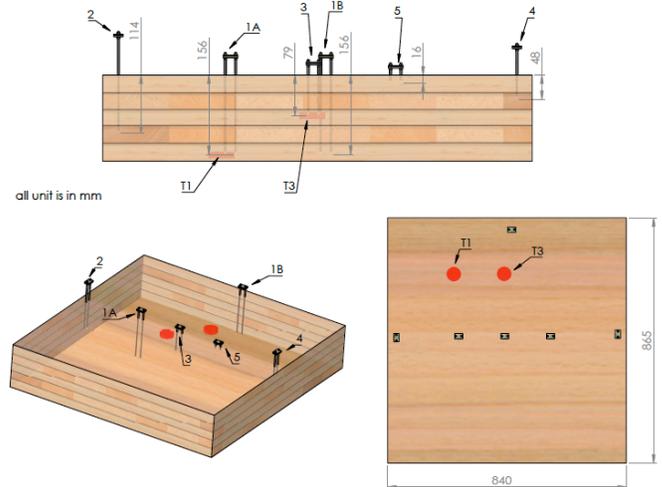
Detailed in Figure 2 a number system corresponding with drill depth was developed with #1 being the midpoint of the topmost layer and #5 being the depth of the bottom ply. Depths 1 and 2 utilized 200mm probes, depths 3 and 4 110 mm probes, and 5 a 40mm probe. Thermistors were installed to depth 3 at the center of the panel, and to depth 1 at the top face.

The CLT panel grain orientation changes with each layer. Probes were installed parallel to the grain of the testing layer to gather consistent data.

Figure 2. Probe Locations and Orientation

Moisture probes were installed into the CLT panels in the Tallwood House onsite at UBC. Point Moisture Measurement Sensors (PMMs) were installed in alternating East-West and North-South panels on every second floor. The orientation of the PMMs and their depths were installed identically to the transportation study as illustrated in Figure 2.

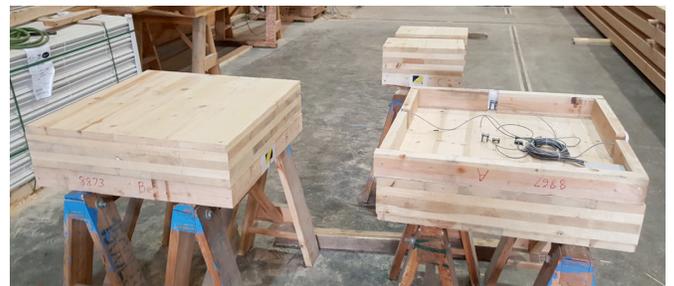
Figure 3. Instrumented Off-cuts May 7th, 2016

During the first trip, 2 large offcuts were outfitted with sensors, as well as 2 smaller CLT blocks. During the second trip, 6 large offcuts were instrumented and stored. All offcuts were coated with the same products and in the same manner as the full-size floor panels. The offcuts were then wrapped in plastic, stacked and stored alongside the full-size panels. Wood slats were placed in between each panel to increase airflow to the panels and prevent any potential moisture buildup, similar to how the full-size floor panels were stored.

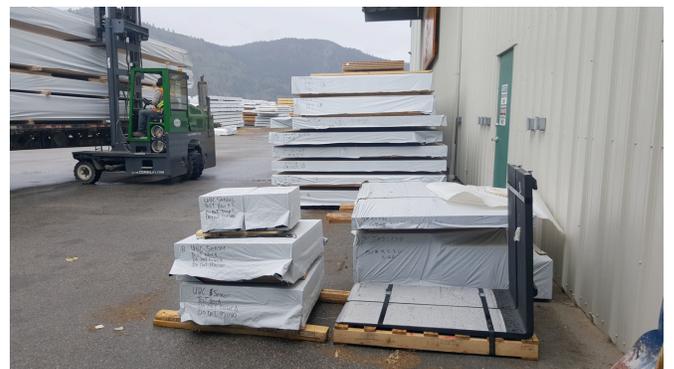
Figure 4. Off-cuts Stored outside next to Full Size CLT Panels

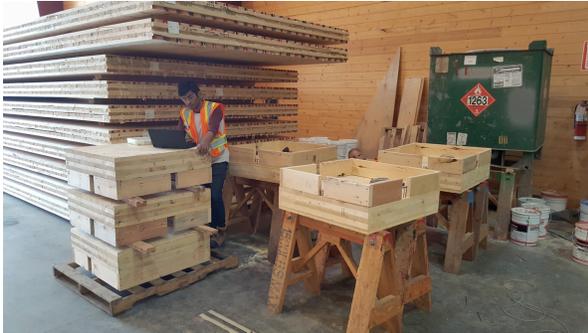
Figure 5. Six Additional Off-cuts Instrumented on May 27th, 2016

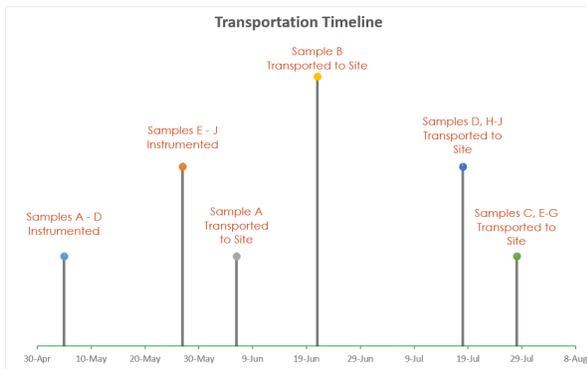
Figure 6. Transportation Timeline of Samples

The timeline and path of travel for the transportation CLT samples are as shown Figure 6 and Figure 7. Samples were shipped with different floor panel shipments to create a diverse set of data with the possibility of varying environmental and logistical conditions.

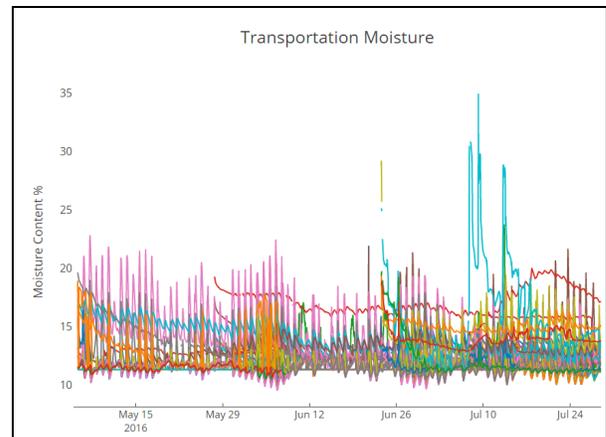
Figure 8. Transportation Moisture Data

Moisture and Temperature data were collected by the wireless data loggers connected to each panel. These devices stored data regardless of where the sample was located and transmitted the data to the Internet upon arriving on-site. Results from 60 moisture content sensors at varying depths and 20 temperature sensors are shown in **Error! Reference source not found.** and Figure 9.

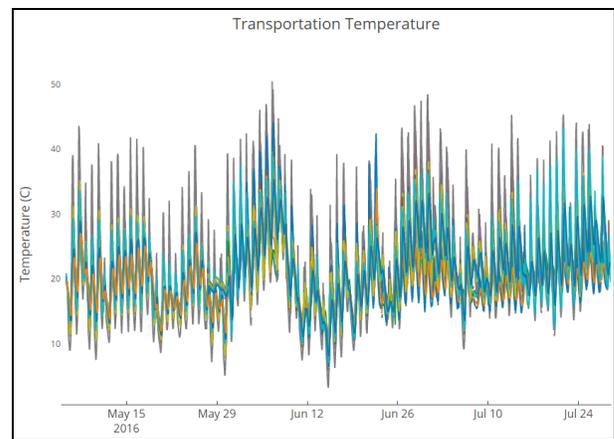
Figure 9. Transportation Temperature Data

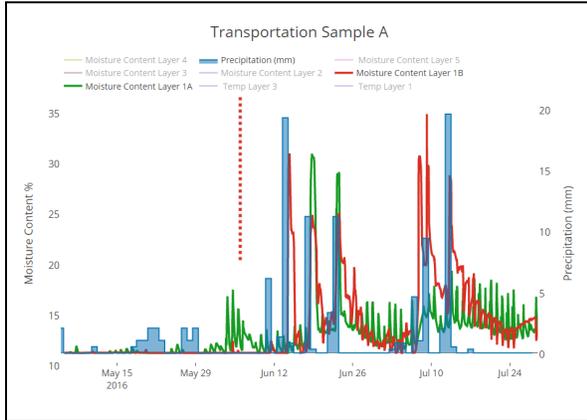
Data from Transportation Sample A which arrived and was uncovered to reflect the conditions of the CLT of the structure showed the effectiveness of the processes the CLT manufacturer implemented while storing and transporting the CLT panels for this project. As seen in Figure 10 prior to shipping, moisture levels in the CLT samples stayed very consistent and were did not appear to be exposed to moisture

Figure 10. Analysis of Sample A During Transport

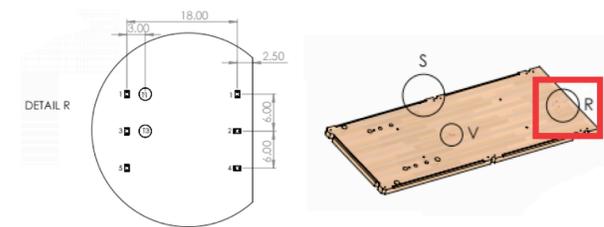
Key considerations taken in the building study were that MC1B probes are in the plywood spline of non-edge locations. In edge installations MC1B measures moisture at the surface level as close to the edge of the panel as reasonably possible. These layouts are documented in the figures below

Figure 13. Edge Panel Mount Probe Locations

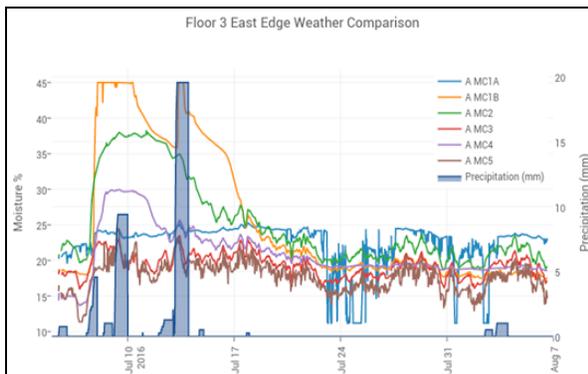
Figure 15. CLT Moisture Performance After Exposed Precipitation Event

As discussed in the transportation study and the previous section, the CLT panels within the building dried to acceptable moisture levels during the year-long monitoring. While collecting data during construction the data-collection units had to be removed and reinstalled several times to work within the schedule of other contractors. This process can be refined in the future with increased conversation between contractors and involvement with the sequencing schedule. In Figure 15 CLT moisture performance after an exposed rainfall event is shown

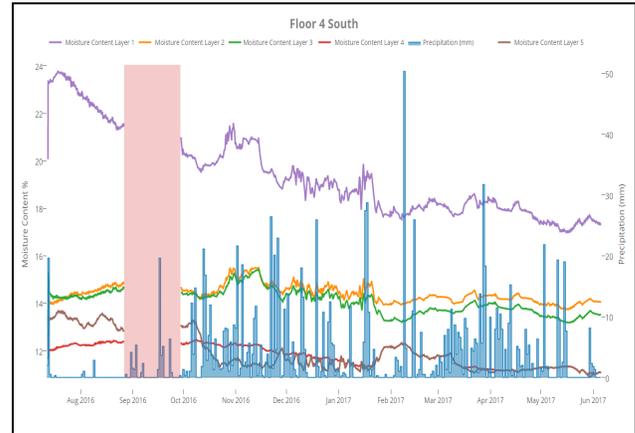
In Figure 16, moisture data collected over the course of a year is shown with precipitation as represented by the blue bars. Despite periodic precipitation, the CLT continued to dry during construction and after

the building had been closed. The red area is a gap in data due to removal and reinstallation of the data collection unit to work around other contractors.

Figure 16. Year Long Moisture Performance

Moisture performance of the CLT panels was analyzed with respect to these events as it was theorized that the CLT panels moisture levels would rise with the completion of the concrete floor topping. However, unless direct precipitation was in contact with the panels, the moisture levels did not change substantially. In event of direct moisture contact CLT panels would then quickly dry to acceptable levels. With the completion of the on-site water sealer used to improve the moisture protection of the CLT panels on-site and envelope panels, the overall moisture performance of the CLT panels became much more resilient to moisture. Year-long moisture performance of one location of the CLT is detailed in Figure 16.

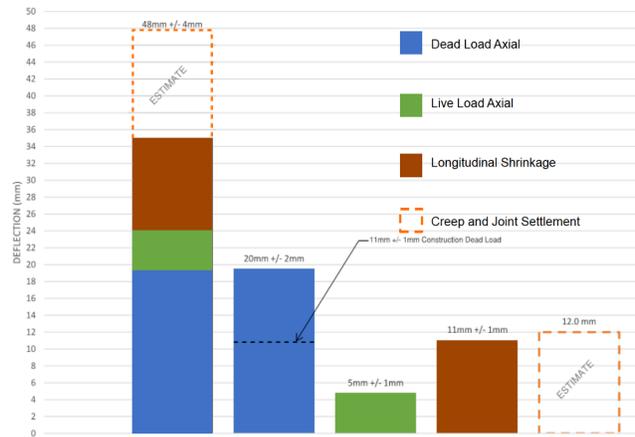
The axial column shortening was calculated to be 48mm. Of this, an estimate of creep and joint settlement is 12mm as shown in Figure 17. (Jackson, 2016)

Figure 17. Column Shrinkage Estimation Calculated (Jackson 2016)

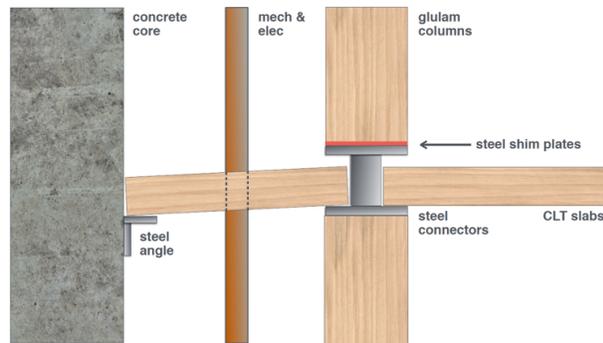
The difference between the axial concrete core shortening and the timber shortening is calculated to be 24mm. Provisions for axial shortening were mitigated by offsetting the connections for the CLT slabs so that they will naturally align after the building settles. (Jackson, 2016)

Figure 18. At Time of Construction

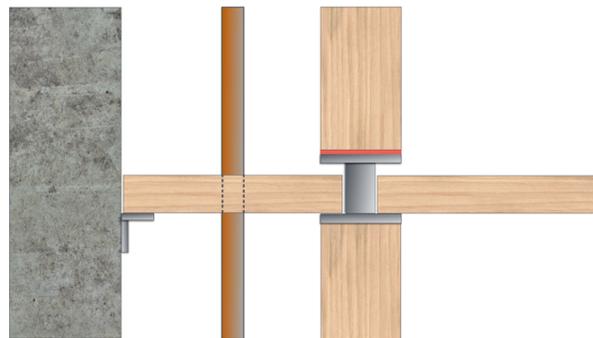
Figure 19. At a Later Date

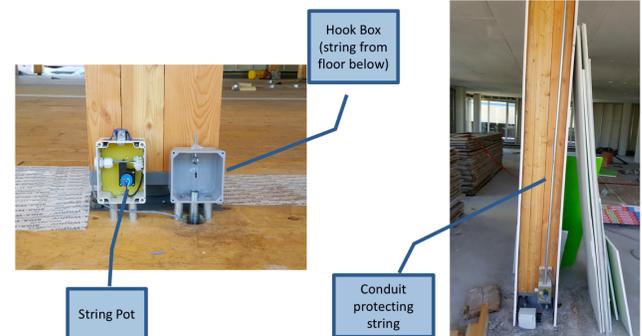
The measurement method consists of using a string pot sensor that contains a cable actuated position sensor connected to a spring loaded spool. The string is elongated using downrigger stainless steel non stretch cable and connects from the base of a selected column to the top of the floor above capturing the compression of the CLT and wood column.

Figure 20. String Pot Installed in Structure

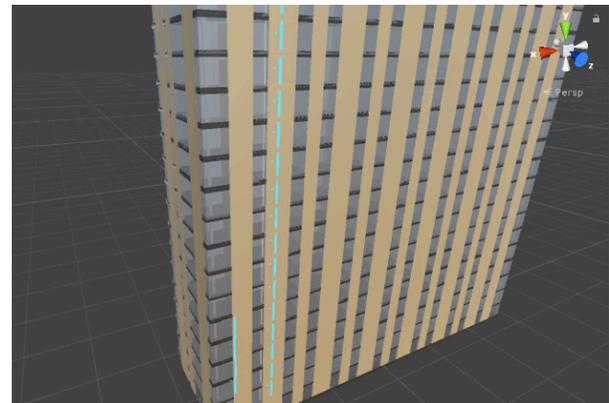
CLT columns from the base to the floor above were instrumented on the lower four inner floors and an all exterior columns extending up all 18 floors. The locations are shown in Figure 21 and Figure 22.

Figure 21. String Pot Locations along side and corner

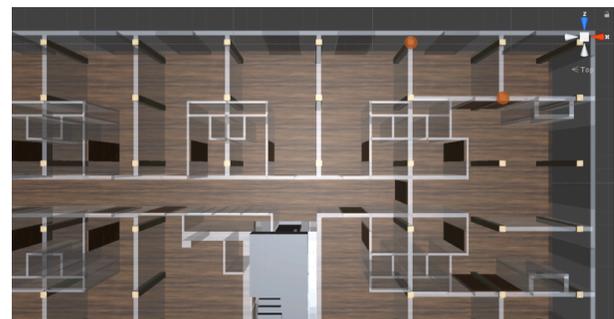
Figure 22. String Pot Locations

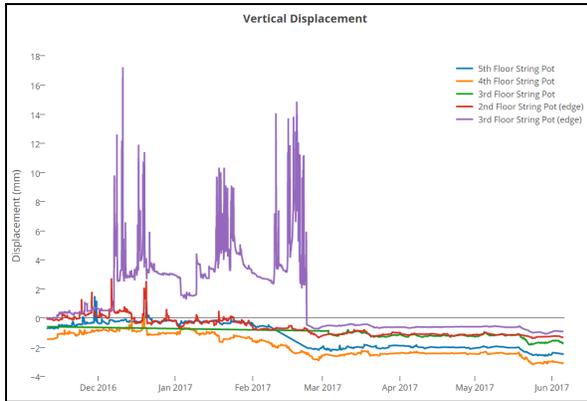
Upon commissioning, the sensors started at 0 mm displacement; positive displacement indicates there was an expansion, most likely due to the shoring; negative displacement represents vertical compression. Figure 23 shows the vertical displacement of selected string pot sensors during construction. Vertical displacement sensors were disturbed by shoring used to support outriggers during construction.

Figure 23. Vertical Displacement Sensor Data

The shoring adversely affected the string pots while it was installed however after it was removed it did not appear to offset or skew the measurements. The edge columns and inner columns tracked each other as expected and the displacement on the outer column was less than the inner column as expected. Approximately 1mm displacement was observed on all floors in May 2017, this occurred when the window and façade details were completed on the end units after the outriggers were removed.

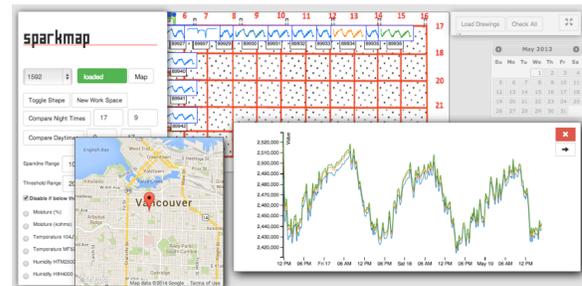
Using standard data analysis tools such as sensor overlays and graphing tools, areas of interest can be easily identified and data trends pertaining to these areas further analyzed using standard graphing tools as shown in Figure 24.

Figure 24. Analytics Graphing Interface

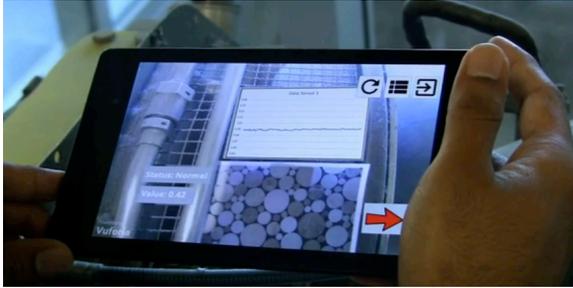
Using a custom Smartphone app, data can be extracted from embedded sensors and overlaid over the image in a smartphone display. Once the app recognizes a unique identifier in the camera viewfinder, data pertaining to the sensor location is accessed from the cloud based server and populated

on the image, displaying real-time data over the view shown on the camera. This creates a highly interactive environment for educators, students, and visitors of the space. Being able to tangibly associate building assemblies with real-time data with a mobile device also creates an opportunity to very easily investigate the surroundings of the instrumented areas.

Figure 25. Augmented Reality Interface

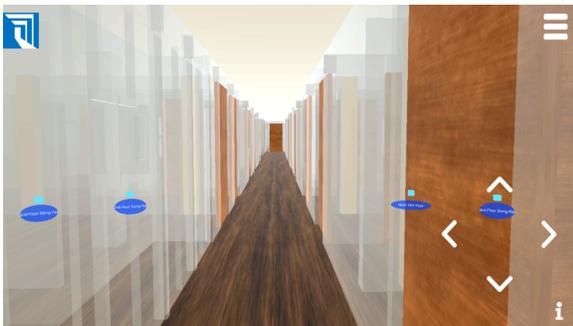
The BIM model for UBC Tall Wood House was ported into a gaming software engine, Unity. Sensors were populated throughout the 3D model. Using common gaming controls, users are able to virtually walk through the building and select sensors to view their data. Multiple sensors can be selected, graphed and compared while walking through the building in a virtual environment. Creating a contained environment marrying the real-time sensor data and the BIM model allows for on site and remote exploration of the structure. This allows students and visitors to interact with sensors in restricted and hard to reach areas from a centralized dashboard. For researchers and Building Scientists, this creates an environment to visually investigate both the 3D model, and its corresponding data in a singular analysis ecosystem.

Figure 26. Virtual Reality View of Hallway at Tall Wood House

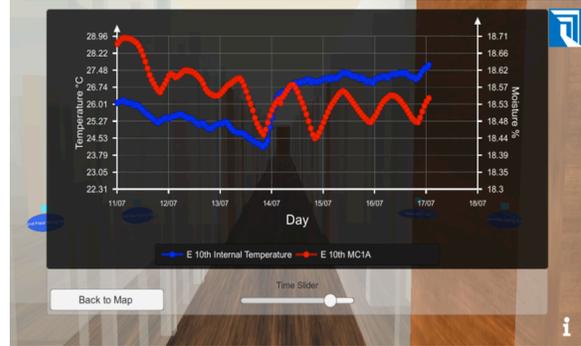
Figure 27. Sensors can be Selected and Graphed
