## Building a Bridge with a House Slab

Design & Investigation / MidCoast Council

### ABSTRACT

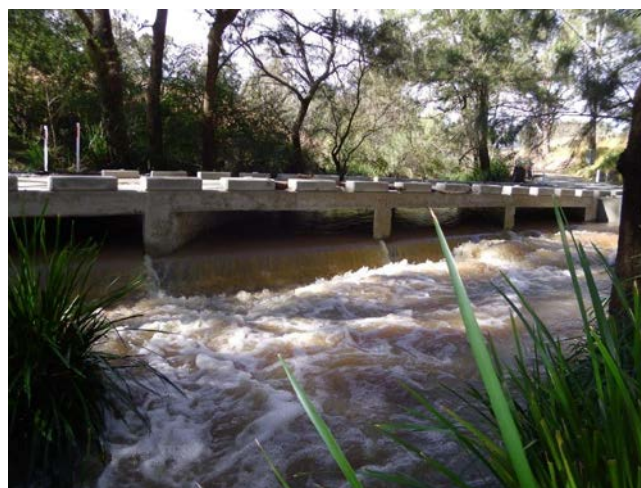
This paper outlines the journey of the Greater Taree City Council design team in dealing with a small concrete causeway on Belbora Creek Road, in rural NSW. The solution involved residential house slab technology (waffle pods), and we believe this was the first time this system has ever been used to create an in-situ concrete box culvert (Figure 1).

Figure 1: Looking upstream over the new Belbora Creek Road causeway during a freshet.

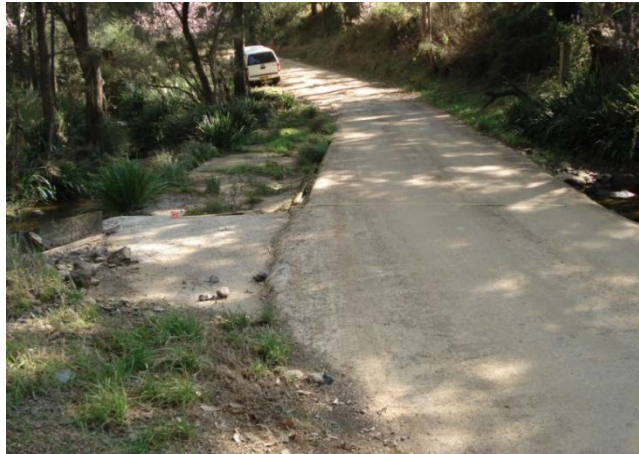
According to the English Oxford dictionary, a causeway is “a raised road or track across low or wet ground” (Oxford University Press, 2017). In this instance, the causeway acts as a road crossing Belbora Creek. As shown in Figure 3, Causeway #1 was a concrete slab near the level of the creek. A small Ø375 mm pipe is installed adjacent to the southern shore.

Older generations of the causeway can be seen off to the left of the current roadway. For many years and a number of generations of slabs, these low level causeways were considered ‘fit for purpose’ and provided the appropriate ‘level of service’ for this road. In this context, the level of service can be defined as “a qualitative measure representative of the operation of a road for a given traffic flow that takes into account a group of factors (speed, manoeuvre, safety, comfort and cost) that take place on it.”

Figure 3: The original Causeway #1, looking north.

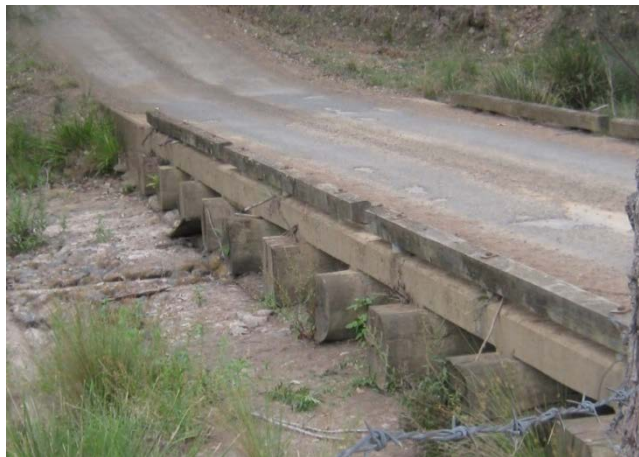
Belbora Creek Road meanders from side to side across Belbora Creek, crossing the creek 10 times between The Bucketts Way and the rural area of Bundook. The road also wanders across the Local Government Area boundary passing between the former Greater Taree City Council and neighbouring former Gloucester Shire Council. However, Gloucester Shire Council had a higher priority on causeway upgrades in the early 1990s and upgraded all its causeways further along Belbora Creek Road, installing low-level bridges across the creek

Figure 4: One of Gloucester Shire Council's upgraded causeway bridges (downstream side showing girders and mass concrete abutment).

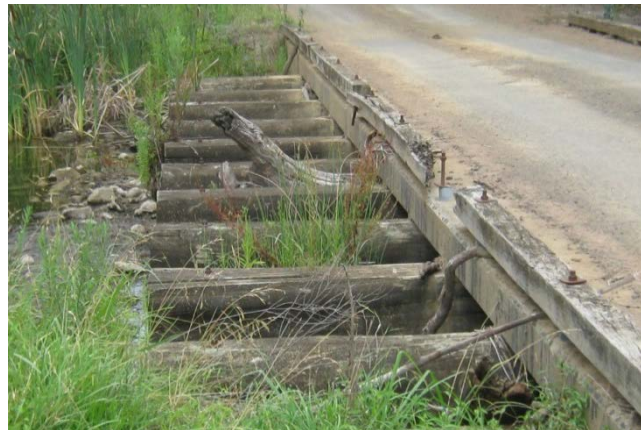
The design of these Gloucester Shire Council bridges was simple in structure, very cost effective at the time, required no specialised skills of the workforce and could easily be done using the machinery available at Gloucester Shire Council's disposal. As evident in Figure 5, the structure is made up of a series of bridge girder logs, of about 450 mm diameter, laid across the existing concrete causeway parallel with the flow of the stream. The logs are spaced at 1.5 m centres. This spacing enables a standard sheet of 19 mm form ply to be fixed between the logs and a 250 mm concrete slab to be poured over the logs. The form ply was simply left to rot and be washed away. The girders extend upstream and are fixed to a small series of piers installed in the stream bed. This tie-down on the upstream side of the structure prevents overturning of the entire structure in times of flood.

Figure 5: One of Gloucester Shire Council's upgraded causeways (upstream side showing extension of girders bolted to piers to prevent overturning).

The load of the structure and traffic is spread across a significant area under the girder logs, so the structural integrity of the original concrete causeways was not compromised. Clearly, these structures do not cater for runoff from any significant rainfall events in this catchment. They do, however, provide the locals with a 'level of service' that they are satisfied with. The structure does catch some debris as it floats downstream. However, apart from some rot or damage to the timber kerbs, these structures have stood the test of time to the satisfaction of the nearby residents and road users.

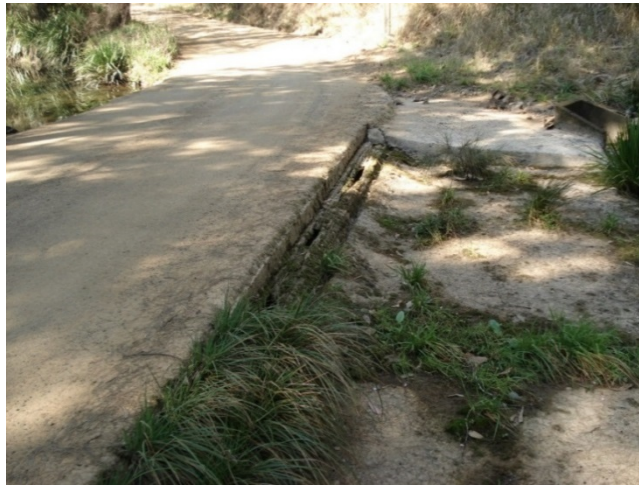
The old causeway was found to consist of a number of concrete slabs separated by gravel cobbles with the edges held in place by old timber (Figure 8).

Figure 8: Original causeway and edge timbers.

The design called for the removal of these old timbers. The voids left were replaced with concrete beams. These edge beams also gave the opportunity to widen the causeway so it would no longer be limited to the current width of causeway. The legs of the skew culvert rested on the old causeway. At these points, holes were drilled through the various slabs, shear connectors installed and grouted into the cobbles below.

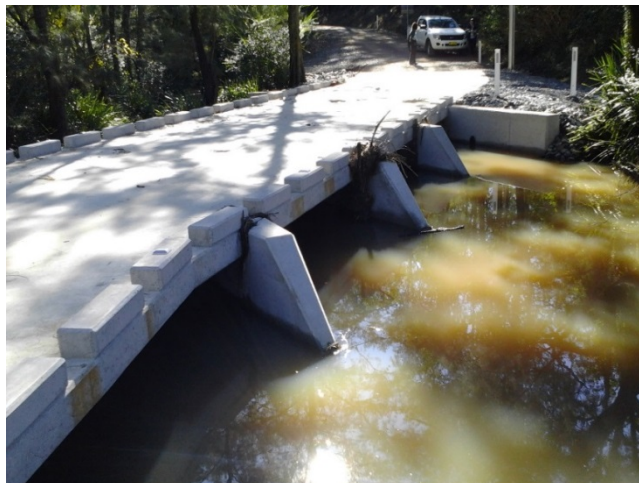
The potential for overturning of this structure was similar to the Gloucester Shire Council causeway bridges. This was overcome by extending the legs of the culvert upstream and fixing them to the bedrock below. In order to ameliorate the debris problem noted previously on the downstream structures, these extensions were designed with a sloping face to act as deflectors channelling debris through or over the boxes (Figure 9). The debris is indicative of a flood that over-topped the causeway.

Figure 9: Upstream debris deflectors and northern approach slab.

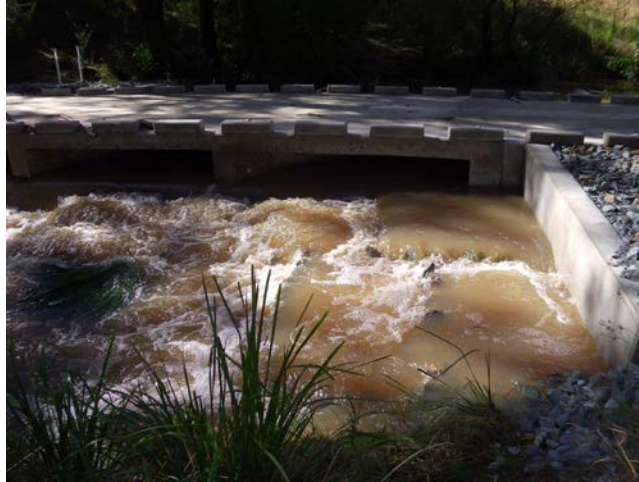
The site conditions, once the downstream headwall was removed, led to an on-site design change of the fish ladder. As can be seen in Figures 12 & 13, Pool 1 on the right back drops into Pool 2 right foreground and Pool 3 in the middle foreground before flowing back toward the causeway into Pools 4, 5 and 6 to the back left of the photographs and eventually flowing into the downstream environs in the lower left of the photographs.

Figure 12: Fish ladder in high-flow scenario.

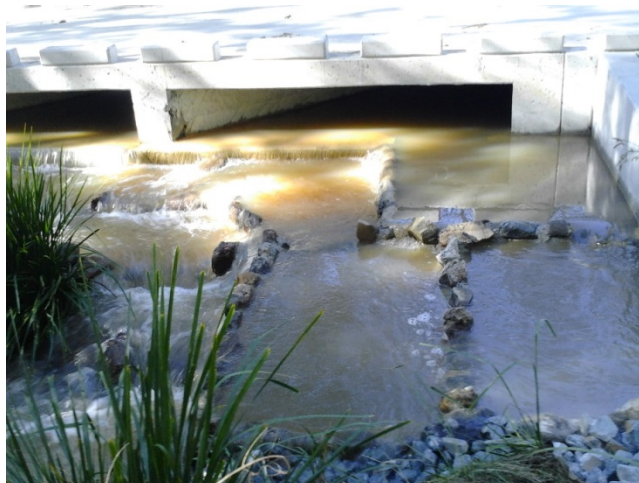
Figure 13: Fish ladder in low-flow scenario.
