Changes in the Narrow River Estuary Channels Over Time.

APPENDIX B
Saltmarsh Habitat Information in the Narrow River Drainage
John H. Chafee National Wildlife Refuge
Towns of South Kingstown and Narragansett
Washington County, Rhode Island

Sea Level Rise Projection in the Narrow River Estuary

ESSENTIAL FISH HABITAT ASSESSMENT

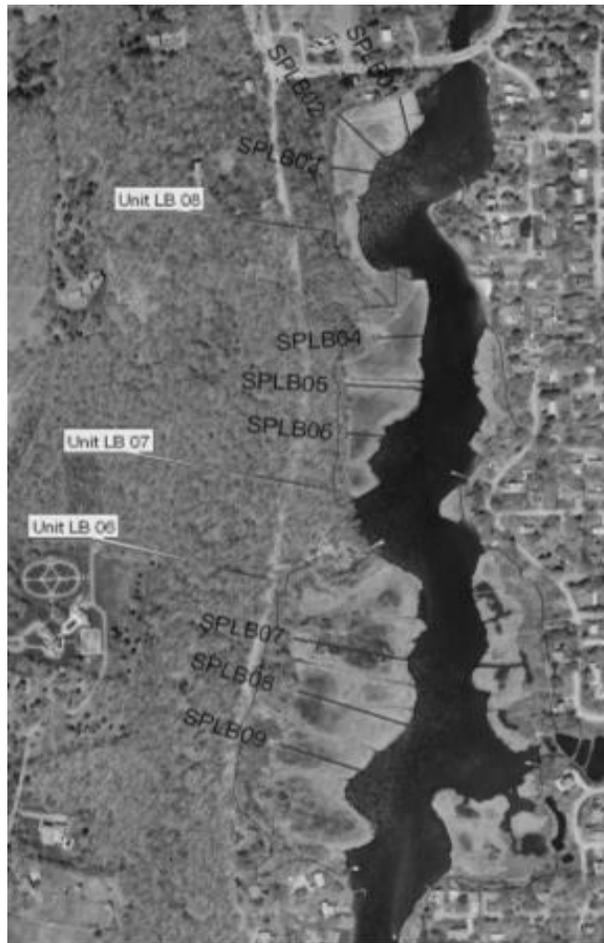
VI. Representative Saltmarsh Surface Profiles:

NOTE: Data not tied to known elevation. Reported elevations relative to each other, not to a set elevation in the field. See Appendix A for specific profile data.

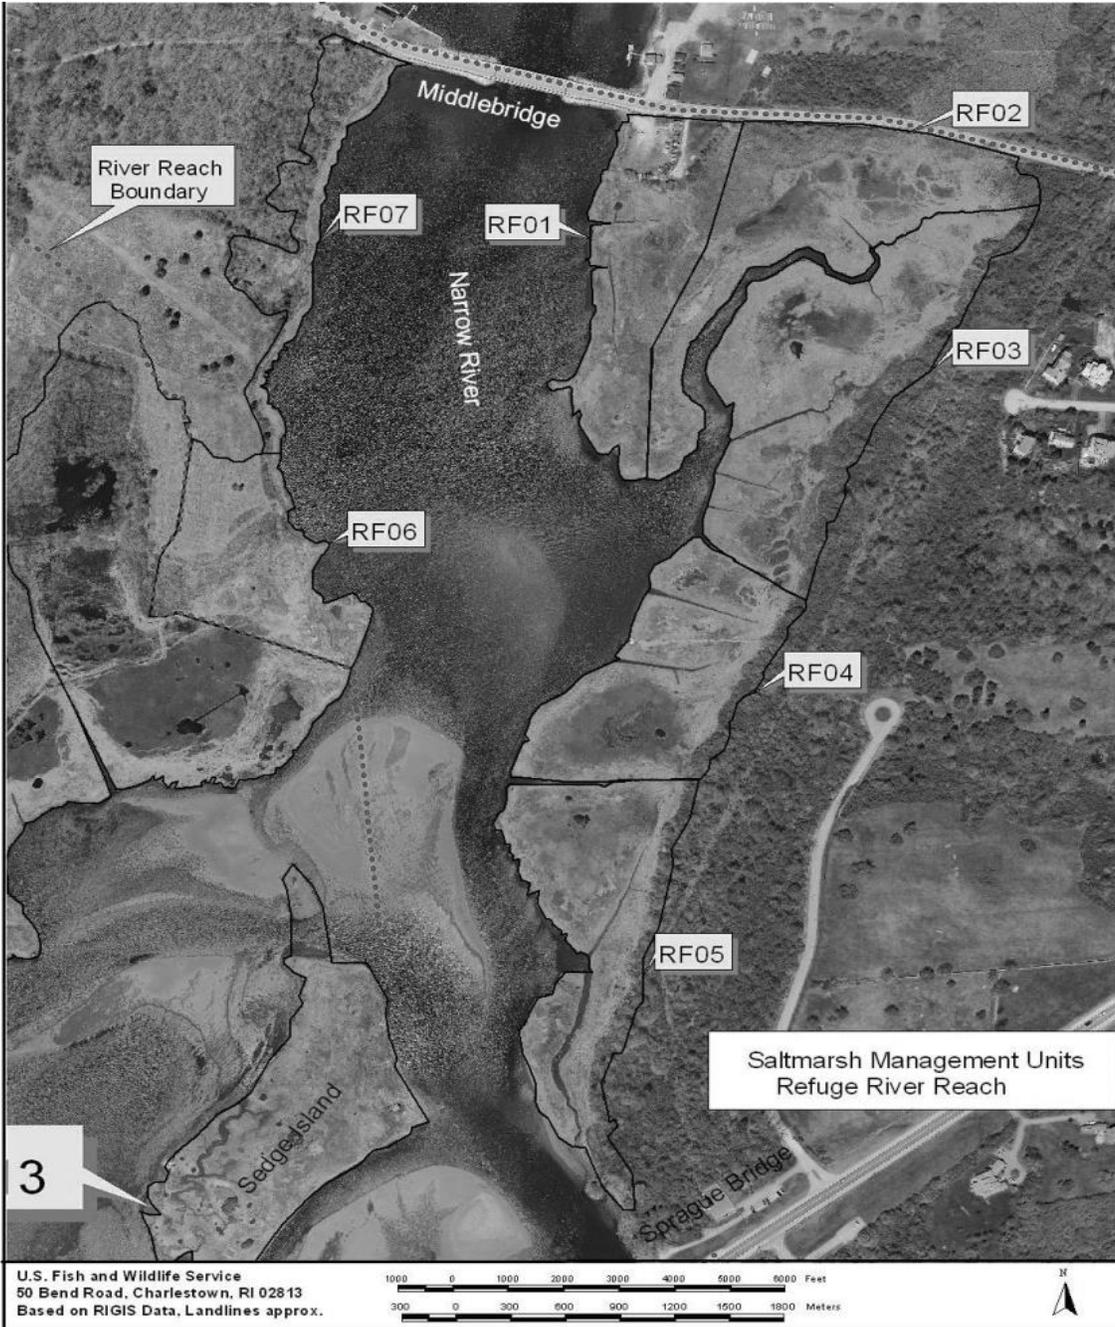
II. Saltmarsh Management Units:

A high energy river reach with substantial shoreline erosion and moderate to high boat wake impacts and wind driven waves (accelerated/aggravated rates of erosion). Much of the RF01, RF04, and RF05 shoreline is actively peeling and eroding. The peninsula at RF01 will be lost in near future without intervention. RF05 island has large blocks of marsh eroding, propeller scars have increased susceptibility to erosion. High use by saltmarsh sparrows in RF01-RF03. Fringe marshes on West side have public trails on marsh surface. Several distinct layers of peat deposition apparent. Profile data suggest the marsh surface in the Eastern slough (RF02, RF03) are two to three inches lower than in other portions of estuary.

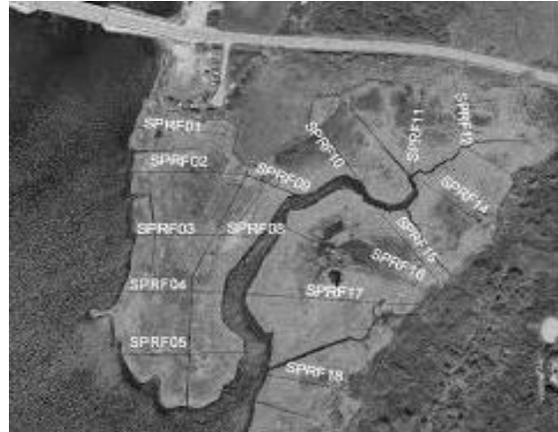
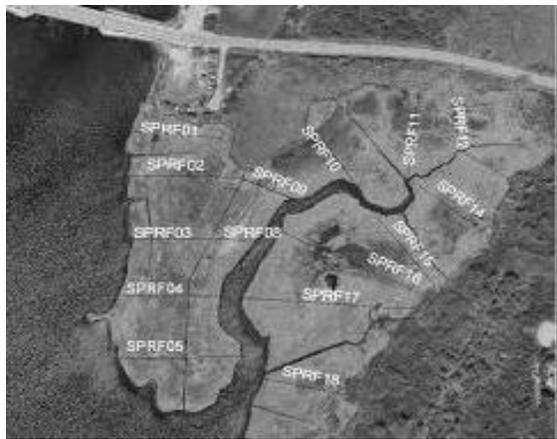
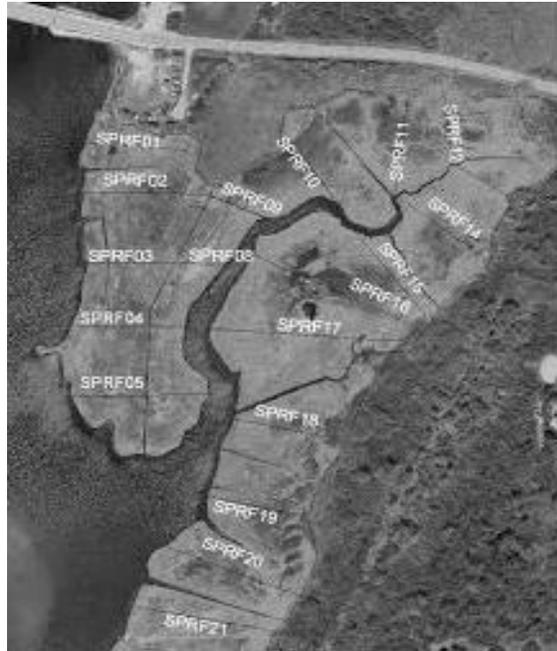
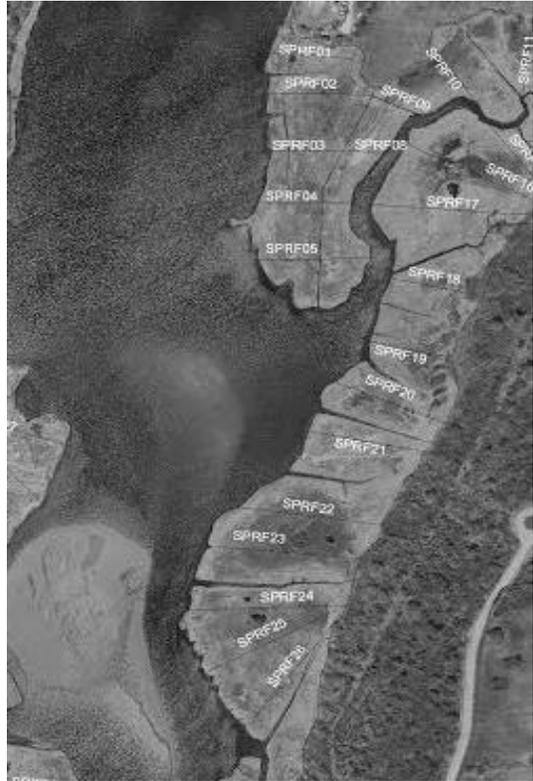
VI. Saltmarsh Profiles

NOTE: Data tied to known elevation of survey marker located in SMU RF02. Expand graph to view details.

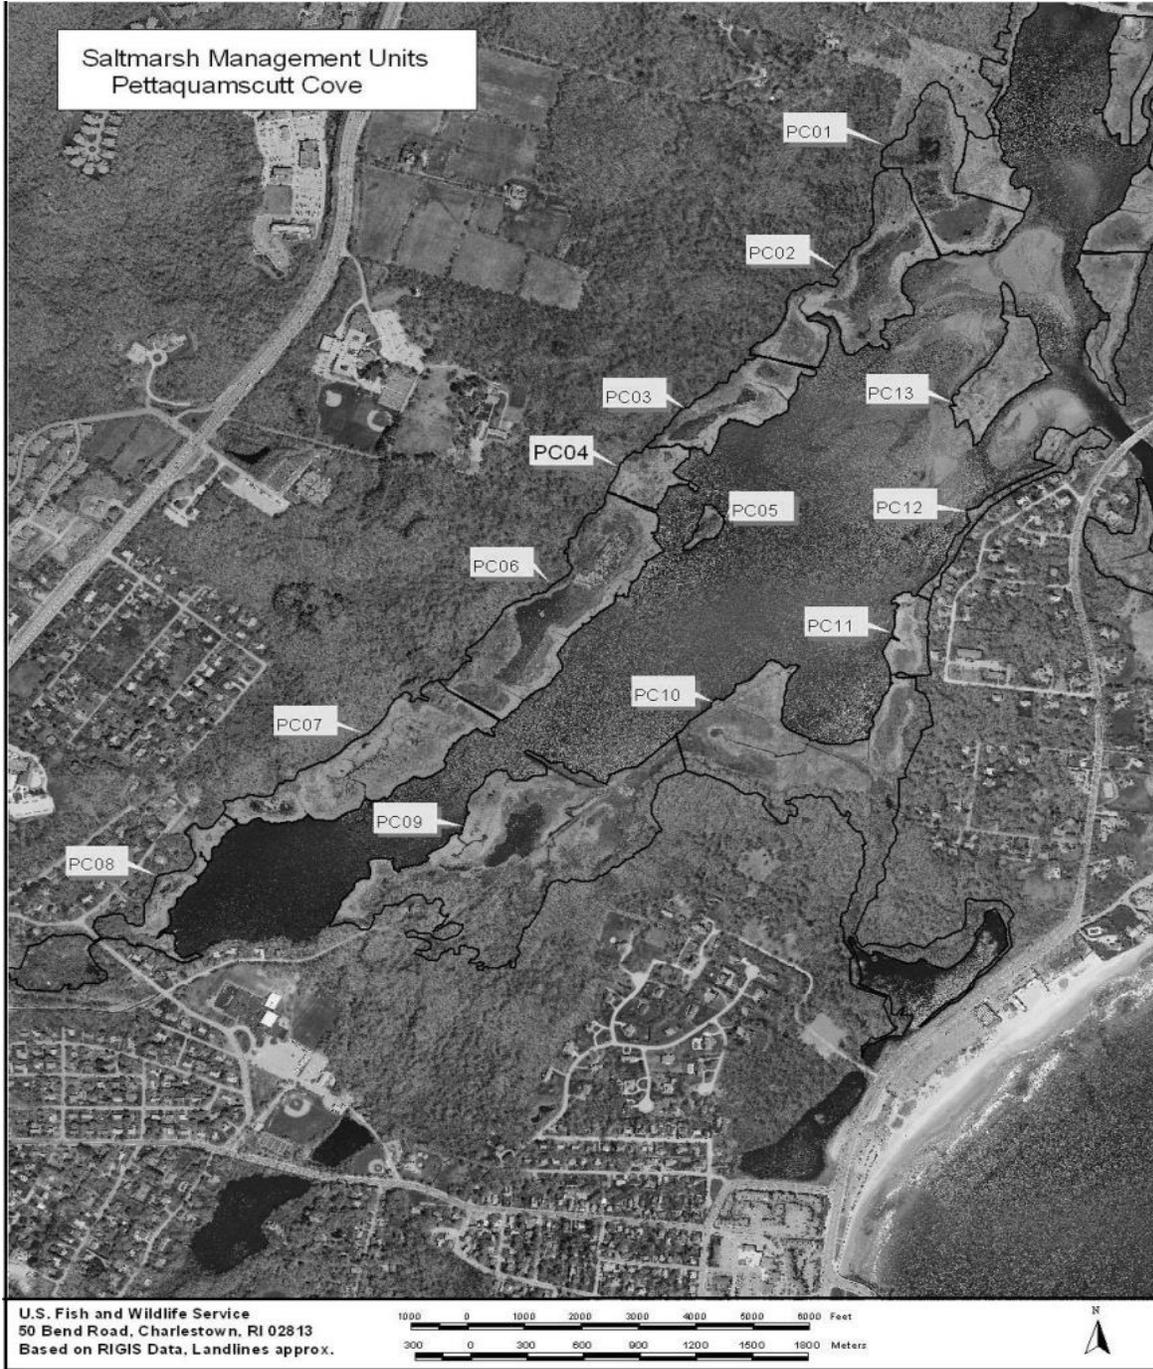
II. Saltmarsh Management Units:

This reach contains the bulk of current saltmarsh habitat in the estuary. Brackish marsh dominated variably by phragmites, cattail, sciurus. Stone walls along the side of the marshes either focus freshwater into channels, or disperse the water into tidal wetlands directly onto saltmarshes. Most pre-1939 ditches nonfunctional. Possible migration areas on NRLT and Audubon Society lands, Town of Narragansett lands at Canonchet farms, and the Mumford drainage on the Refuge. Boat wake impacts low in the cove, but wind driven waves of concern. Bank stability rated moderate in most areas, but low in vicinity of Gooseberry Island and the Starr Drive Cove.

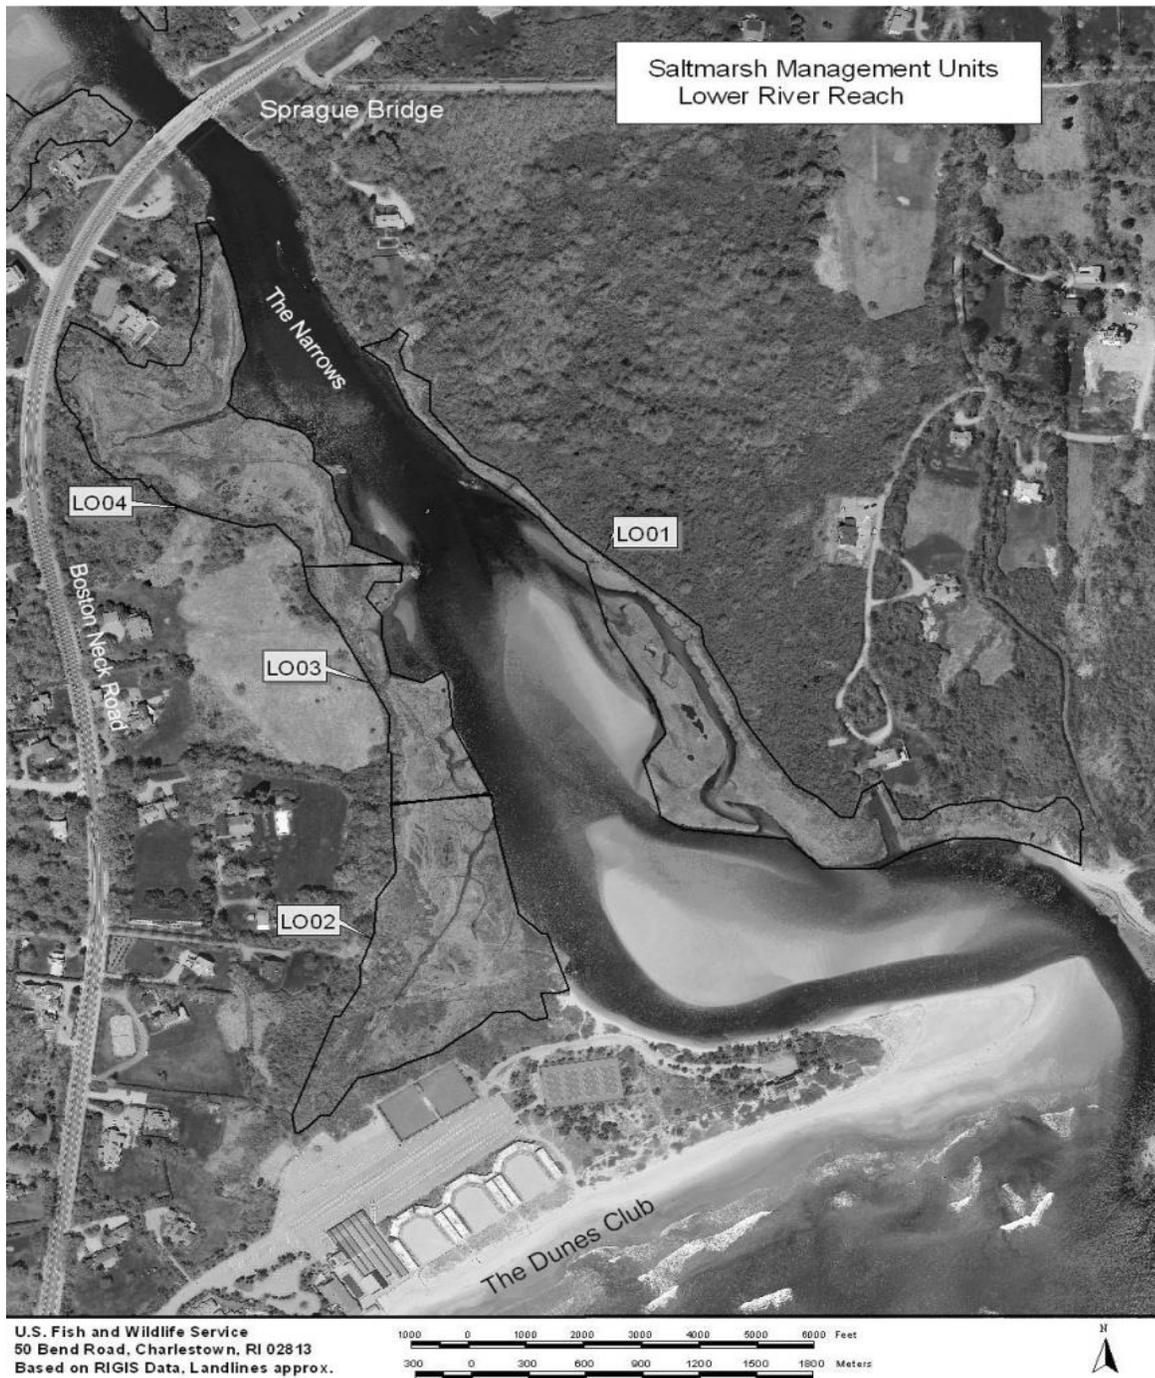
II. Saltmarsh Management Units

Saltmarsh in this reach is typified by very high (1 meter +) banks with deep undercuts which appear relatively stable. The marsh surface is typically coated with algae. Shallow tidal flats limit wave action on saltmarsh shorelines, although the shore at LO02 is failing. Heavily used fishing trail on LO04. Fringe marsh on Northern shore moves up and down with wave action.

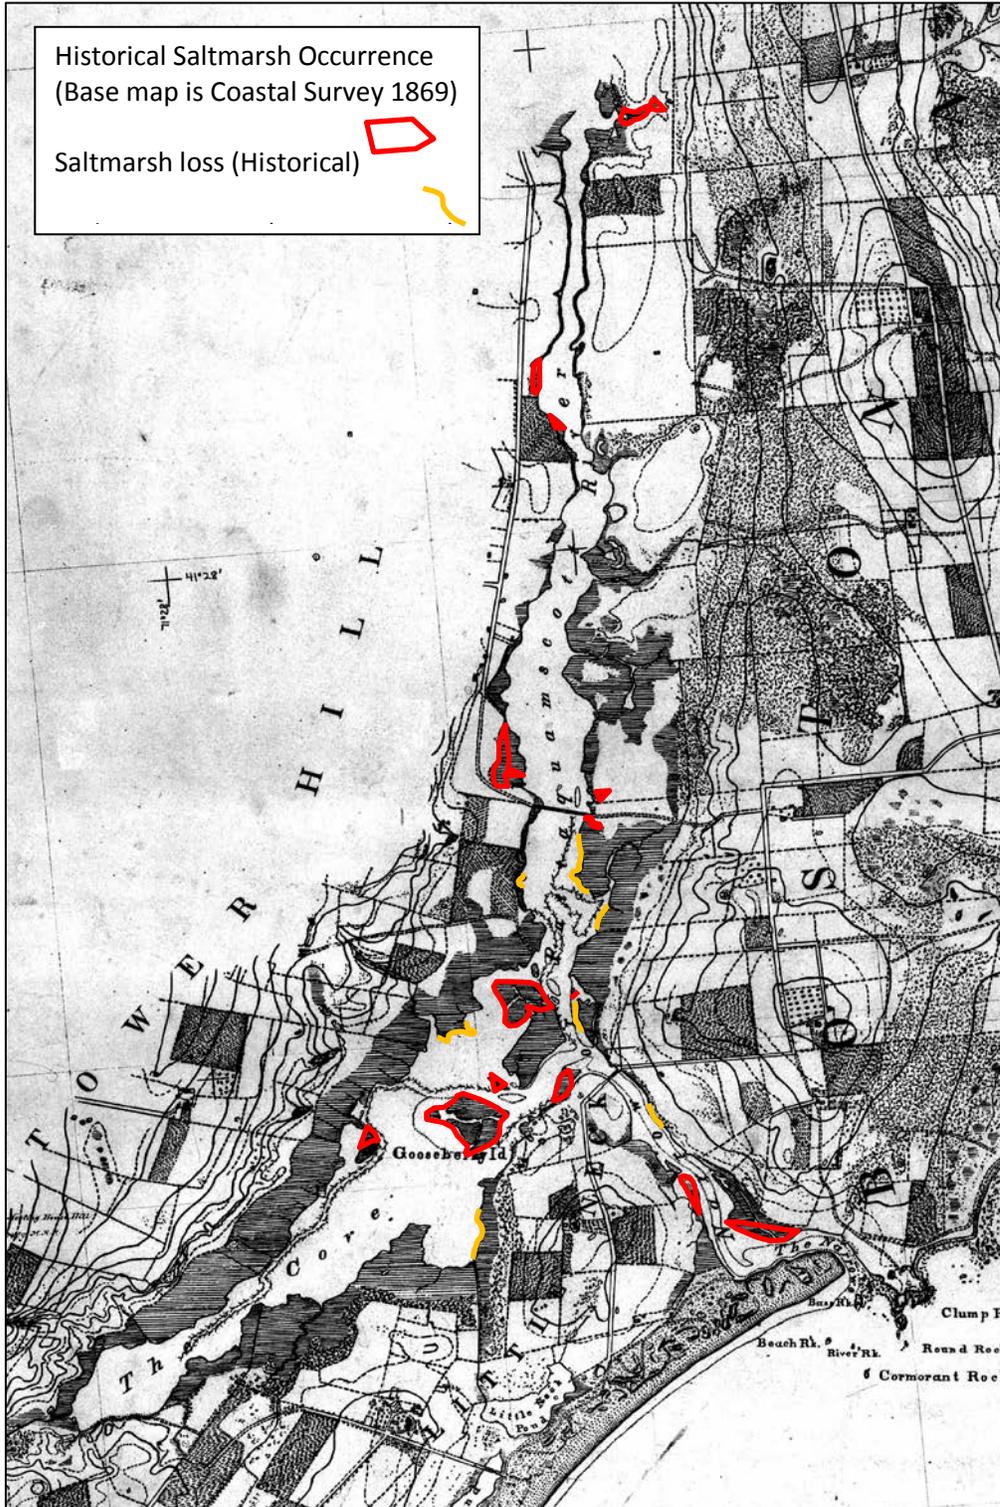
SALTMARSH HABITAT - LOSS OVER TIME

PRIMARILY RESULT OF CHANGES IN CHANNELS/DRAINAGE AND POOR TO NO RECRUITMENT

ESTIMATED LOSS FROM HISTORICAL LEVEL: 12 ACRES

Salt marsh habitats have declined over time in both abundance and health. We estimate that over 12 acres have been lost to development of bare pans and mud flats on the salt marsh surface from waterlogging and entrapment of water on the salt marsh surface. Shoreline erosion continues at a rapid pace in some portions of the estuary. In combination with the natural undercutting of banks and accelerated erosion from boat wakes in some areas, large lengths of shoreline are failing, with little, if any recruitment of salt marsh areas apparent in the watershed (USFWS 2009; 2012). In 2014, most of Sedge Island's Eastern shore has failed with two feet or more of the marsh bank lost due to channel erosion.

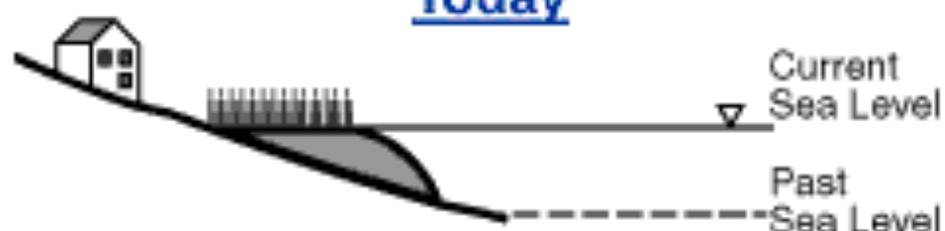
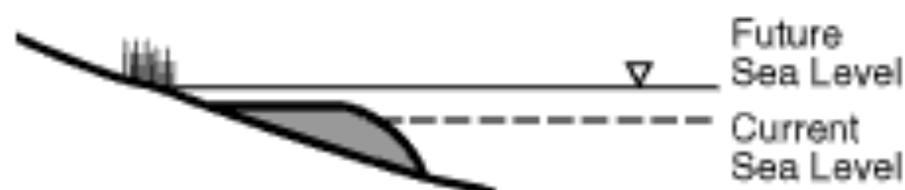
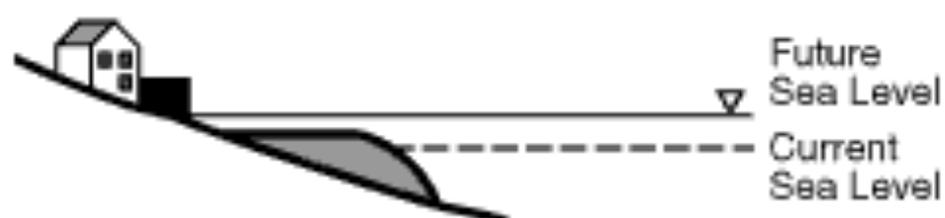
Today

Substantial Wetland Loss Where House is Moved or Upland is Vacant

Complete Wetland Loss Where House is Protected with Bulkhead in Response to Rise in Sea Level

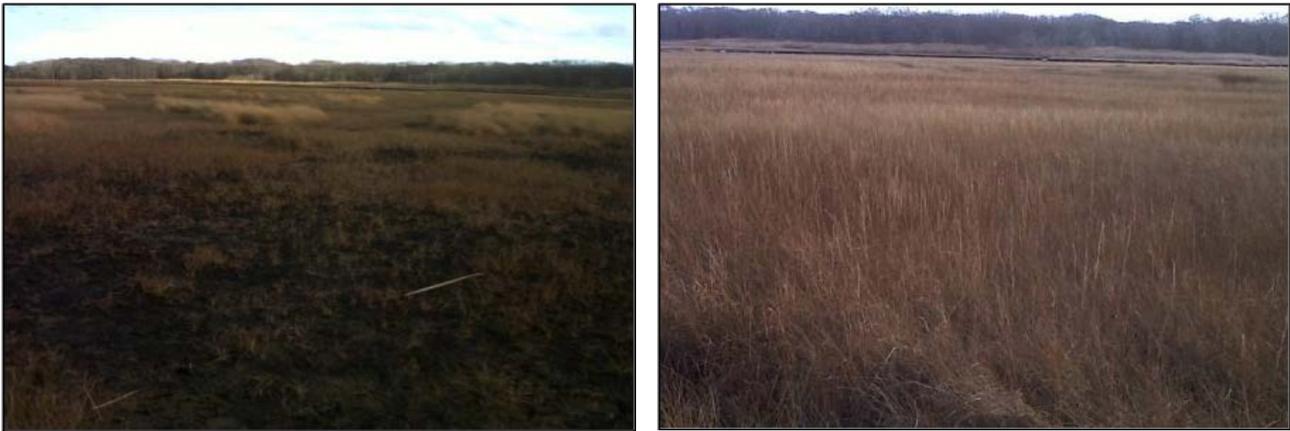
Figure 2a and 2b. Degraded Salt Marsh Conditions; Healthy Salt Marsh Conditions.

In areas where excess water is entrapped on the salt marsh surfaces, vegetation shows evidence of stress. Degraded marsh is typified by the presence of bare areas, and where glasswort (*Salicornia spp.*) and short forms of smooth cordgrass (*Spartina alterniflora*) are dominant with fringes of saltgrass (*Distichlis spicata*). In many cases, *S. alterniflora* is less than 4" high and frequently shorter with a low density (Figure 2a).

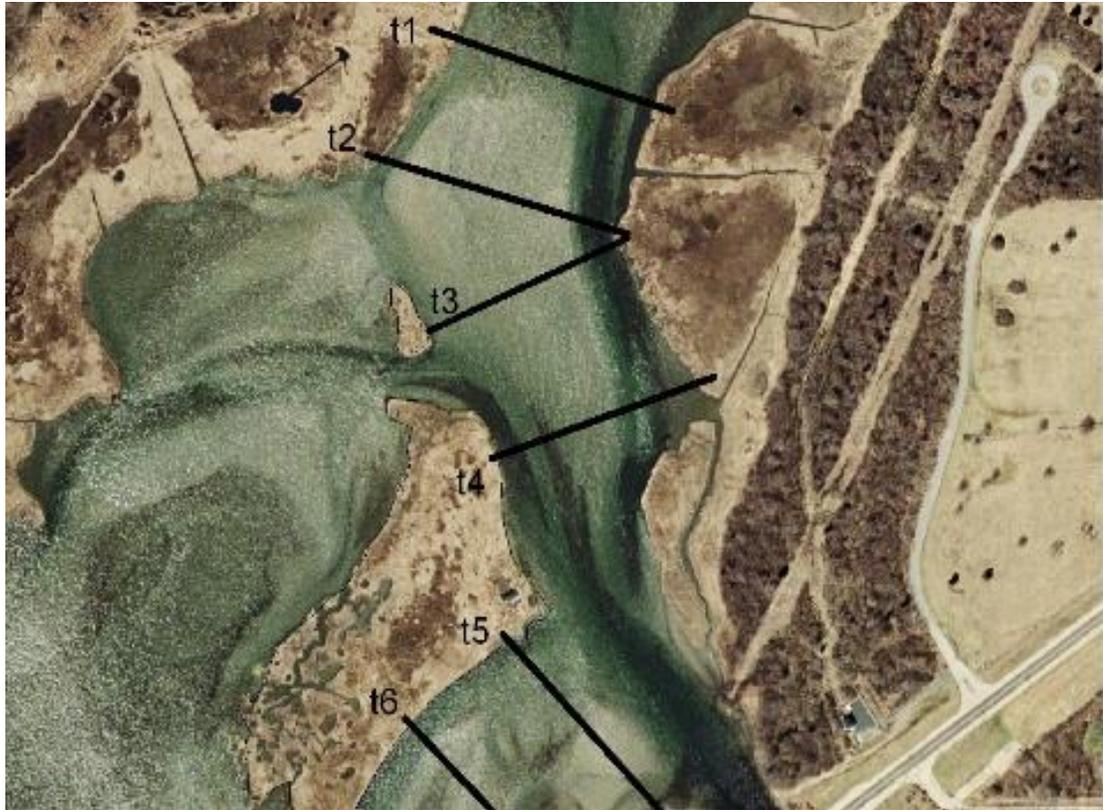
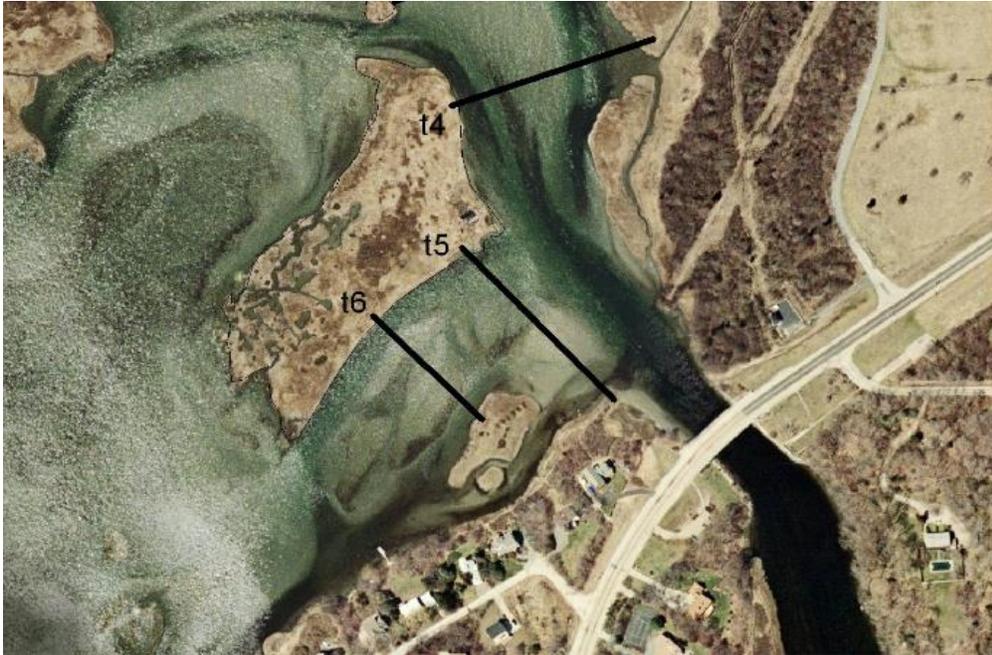
Figure B1. Excavation, fill, and Thin Layer Deposition Units under the Proposed Action. Figures B2a-B2f. Sample Profiles in Areas Excavated for Eelgrass Improvement (note: T1 not in proposed excavation area). Final designs may differ from shown here.

As shown in Appendix G, 35,629 cubic yards of material will be excavated. As existing eelgrass beds provide a ready seed source, no planting or seeding of eelgrass is proposed. Sediments removed from restoration areas will be repurposed for beneficial re-use in restoring degraded and lost salt marshes (Actions D and E, below). Sediments in

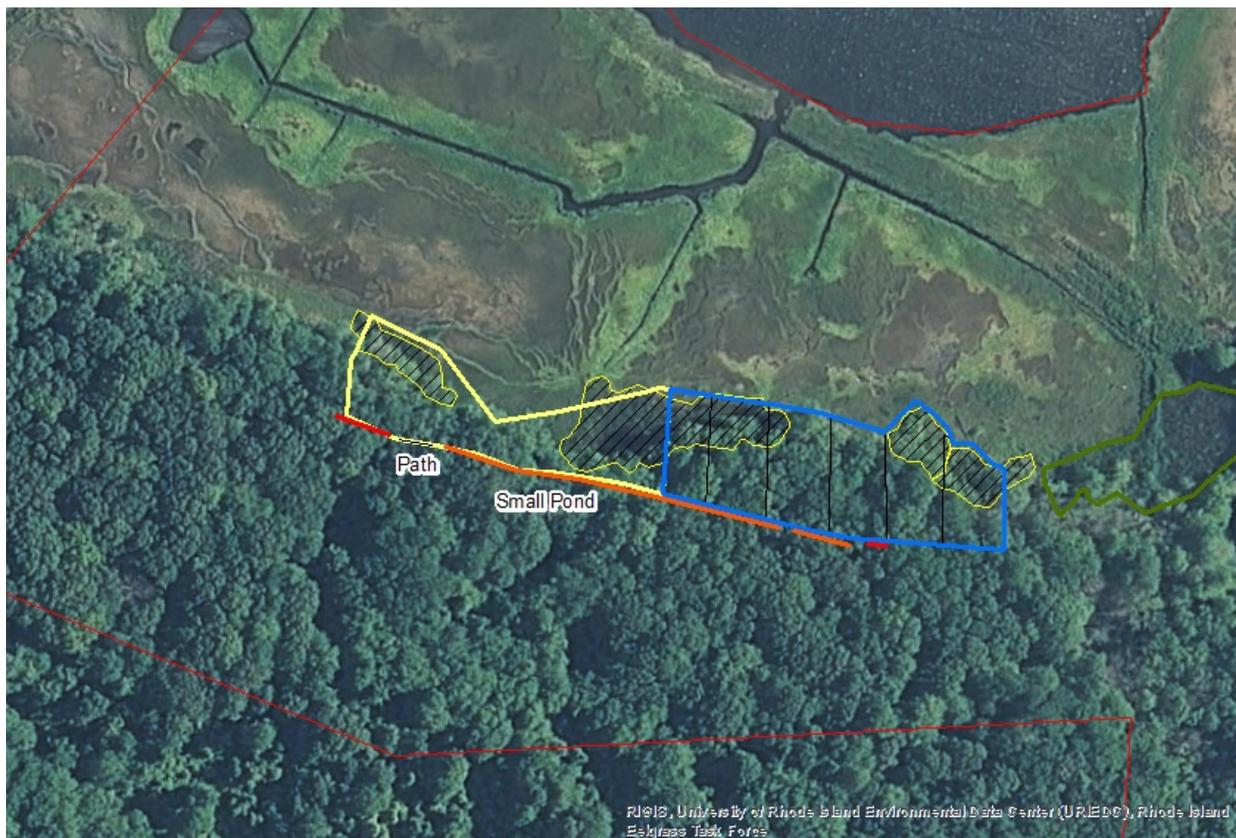
TEST TREATMENTS TO ENHANCE MARSH MIGRATION

Within a two-acre site currently comprised of an oak forest overstory near salt marsh transition zones, trees will be girdled to stimulate shrub production in the understory. Adjacent control sites in untreated oak forest near the salt marsh transition zone will be evaluated and compared to determine whether this treatment has the potential to enhance conditions for salt marsh migration. Within areas in blue in the figure below, approximately 24 trees will be girdled to allow understory release and determine whether this action facilitates marsh migration.
