## MONITORING OF VARIOUS NON-VENTED AND VENTED VAULTED ROOFING SYSTEMS IN A VANCOUVER HOME

**Jason Teetaert, P.Eng, SMT Research Ltd.**

### EXTENDED ABSTRACT

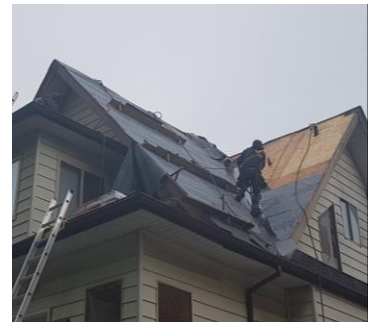
Figure 1: Sample Shingles only re - Roof Project Vancouver 2017

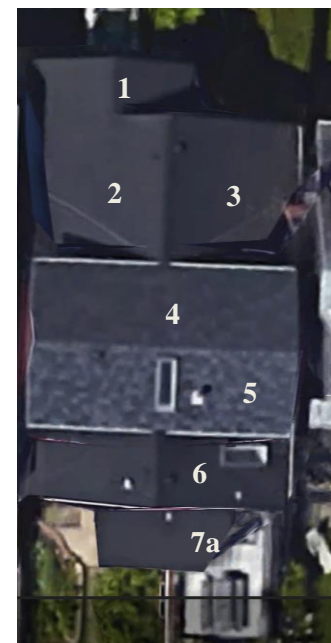
Figure 2: Existing Assemblies  
 Area 1, 2, 3 & 6: Unvented Vaulted Ceilings  
 Area 4 & 5 : 2006 Dormer Extension: Area 7:-  
 Open to below – no insulation **Page 1 of 6**

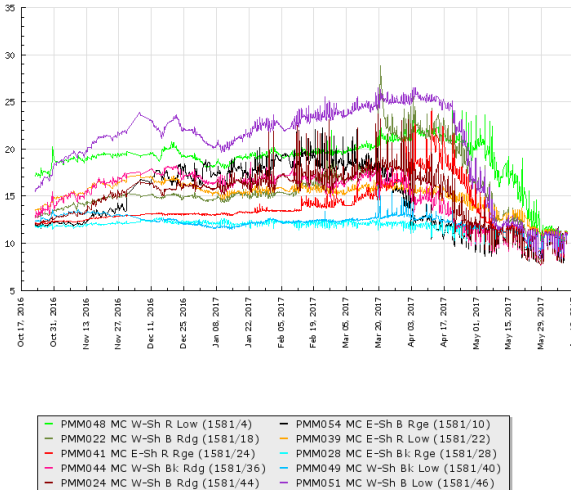
Figure 9: Moisture Content of existing roof areas 2 & 3 with no venting, limited air barrier

The moisture content measurements taken from the Point Moisture Monitoring sensor includes the un-insulated screws of the sheathing and truss below the insulation layer. All moisture content readings are in wood moisture % and temperature compensated.

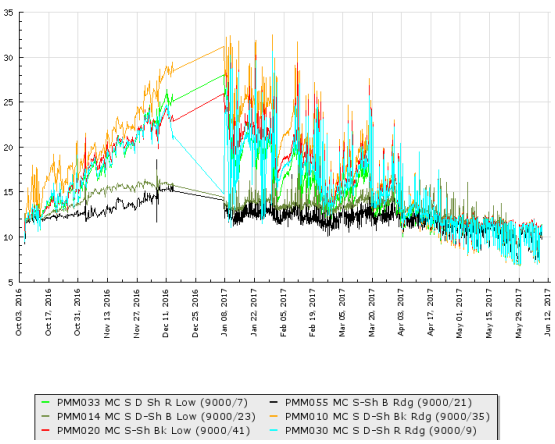
Figure 11: Moisture content of roof sheathing in ventilated attic dormer roof area 5 - South Facing Roof

The moisture content of the ventilated attic space sheathing at the lower eave vent areas are well over the desired 25% moisture content for wood products to remain healthy long term. The roof sheathing on the 2006 vented dormer expansion did show signs of minimal mould growth, which was only on the underside of the sheathing. The top side of the sheathing was in pristine condition. For the Nov 2017 CCBST presentation, there shall be further analysis of the moisture and temperature data in comparison to condensation related events to night sky radiation, external weather sources, and related information.
