## REAL-TIME MONITORING FOR LEAK LOCATING WITH WIRELESS MOISTURE CONTENT SENSORS IN NON-COMBUSTIBLE CONSTRUCTION

Jason Teetaert, P.Eng, SMT Research Ltd.,  
Brennan Vollerling, M.A.S.C., P. Eng., LEED® AP, Sense Engineering

### EXTENDED ABSTRACT

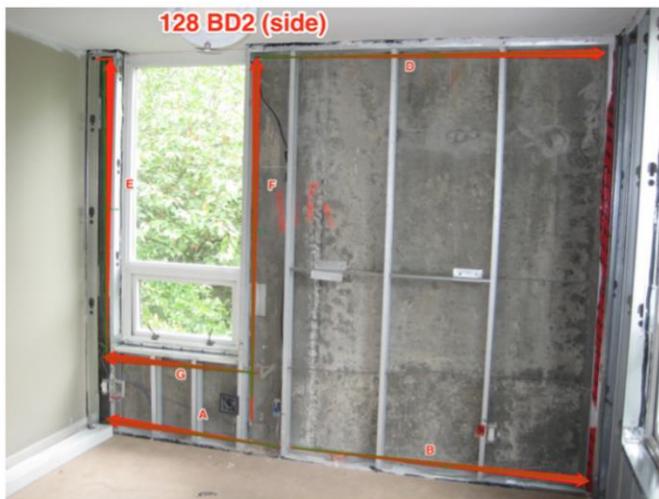
The material with-in this presentation will focus on wall assemblies of mid-rise construction lower town-home section in which original construction was completed in 2004, with interior renewal repairs completed in 2012 to 2014. The renewal work included, but was not limited to, foam insulation on the inside of the concrete exterior wall and supply and exhaust air system to improve ventilation to reduce the amount of condensation forming on the interior surfaces of the exterior walls and windows. Moisture detection tape sensors were installed on the inside surface of the concrete walls in separate zones to check if moisture continued to form in concealed parts of the exterior walls after the interior renovation was complete. The monitored data showed that the concrete wall was still experiencing wetting events after the interior air/moisture barrier was renewed with spray foam.

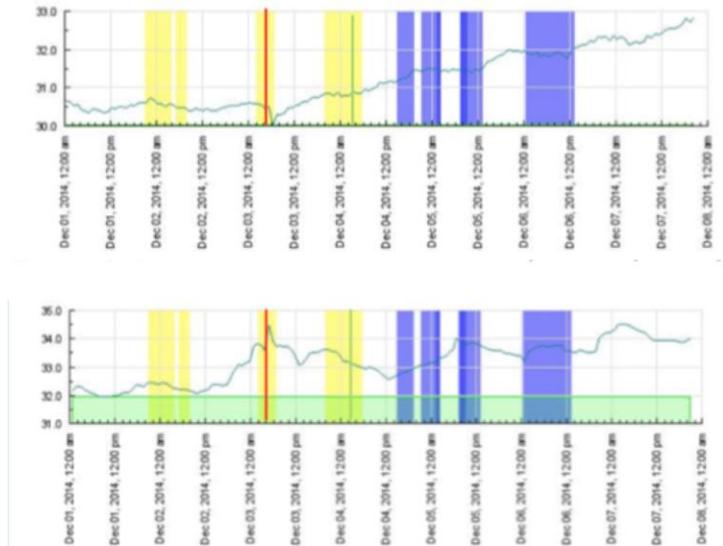
Figure 3: Sensors having elevated moisture content in the 2<sup>nd</sup> floor of Townhouse 108.

Red line indicates the approximate time of the wall water test.  
The green line indicates the approximate time of the roof planter test.

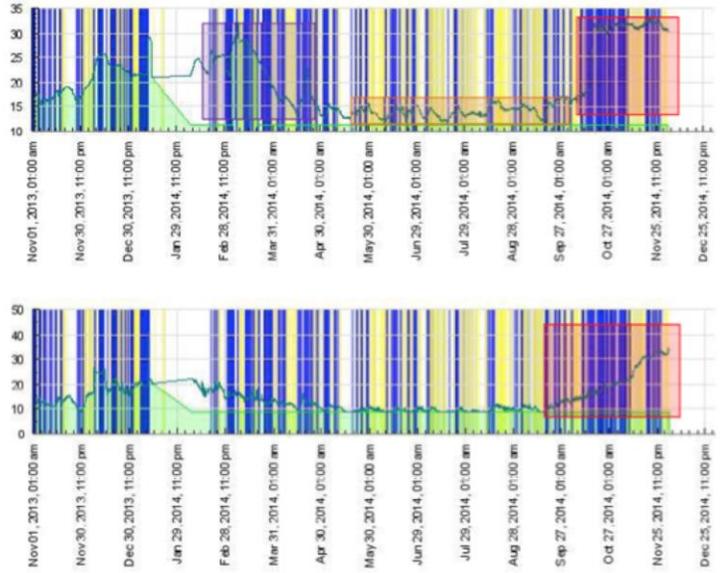
Figure 3: Sensors having elevated moisture content in the 2<sup>nd</sup> floor of Townhouse 108.
