# **Fluvial Geomorphology**

**GEOB 309**

This assignment focused on studying fluvial geomorphological effects along three different locations of the Cheakamus River. These three locations included the Cheakamus above the Cheekye, at the Cheekye (from the point of confluence between the Cheekye and Cheakamus river), and the Cheakamus below the Cheekye. From the data we collected we were able to draw conclusions about the three areas that were studied.

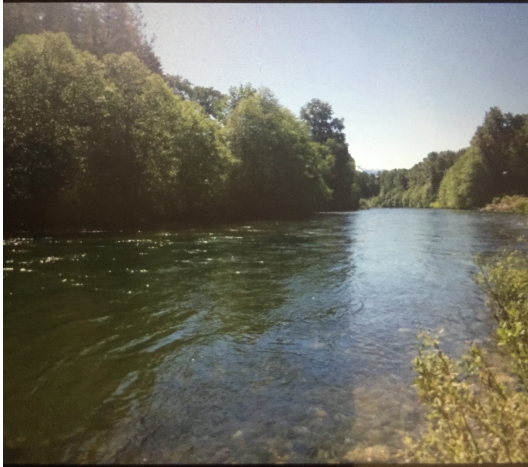
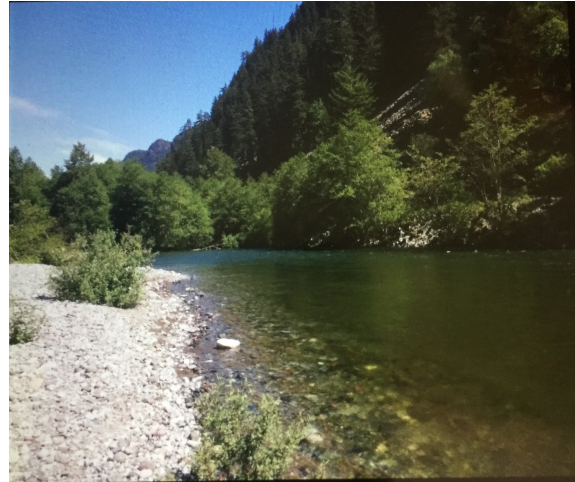
Figure 1: Cheakamus River Downstream View

Figure 2: Cheakamus River Upstream View

This area of the river has a low gradient and is described as a riffle pool. Looking at the stream, we viewed sections that flowed faster (riffle) and slower (pool) in velocity. The material found in this area was medium coarse, forming bars along the outer edges of the river.

Another difference noted between the two streams is that the Cheekye River is unregulated, therefore there is more active mass wasting processes such as debris flows occurring down the channel. The Cheakamus River is regulated by a dam upstream which can reduce and prevent effects of mass wasting. The dam would also reduce discharge and sediment supply downstream of the dam allowing for less rapid waters which could explain the riffle-pool morphology at the Cheakamus River above the Cheekye.

At the upstream location (Cheakmus above Cheekye), we would expect to have steeper slopes and a more rapid flow of water than downstream, but the data shows this is not the case. Instead, the water is calmer and represents a riffle-pool structure. At the Cheekye, the gradient is high as there are large boulders in random distributions along the sides and in the middle of the flow. The large boulders act as steps and create a boulder cascade. This eventually causes higher velocity flows feeding into the Cheakamus River at the point of confluence. At the downstream location (Cheakamus below Cheekye), the river flows as a plane bed. This area of the river has been fed by the high gradient Cheekye River, which brings medium-coarse grained sediment to the Cheakamus River. This raises the gradient of the river from the increased sediment supply and is a reason of why the gradient is higher downstream versus upstream. The observed pattern of stream gradients do not follow the standard conceptual model because the Cheekye is unregulated and is known to have mass wasting events. The mass wasting processes has steepened the river channel at the merging of the Cheekye and Cheakamus as well as below the Cheekye River.

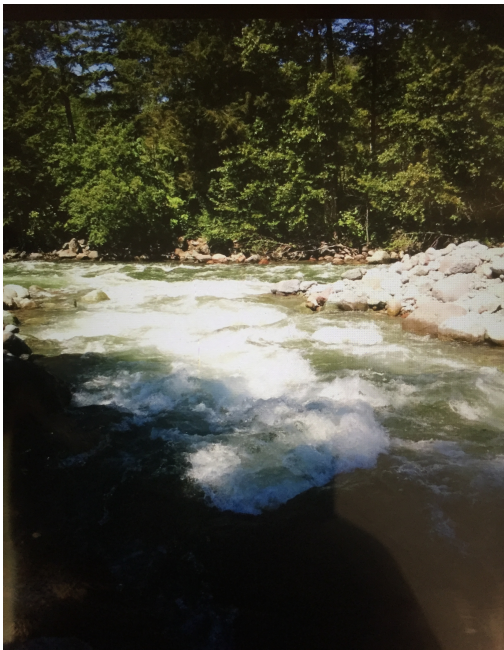
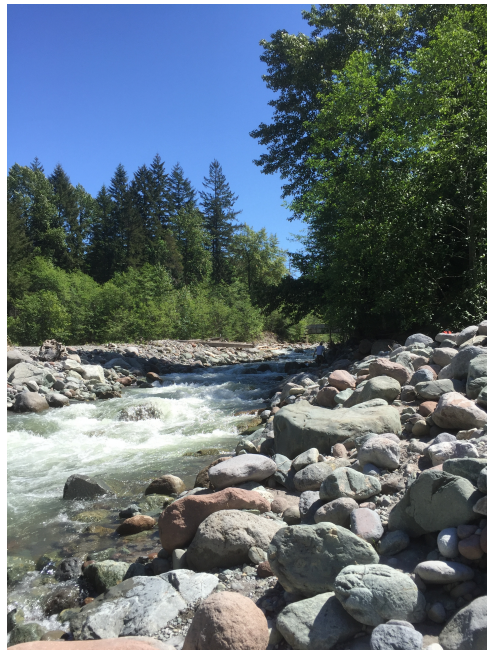
Figure 3: Cheekye River Downstream View

Figure 4: Cheekye River Upstream View

This river merges with the Cheakamus River and has a steep gradient. Large boulders and material from mass wasting events form step like features that cause the water to flow from one elevation to the other. It is described as a boulder cascade. Due to observations noted it is difficult to classify this stream as a step pool because the steps are not fully formed.

Due to the Cheekye River being unregulated, this allows for mass wasting events and the subsequent creation of active debris flows. Large boulders and fine sediments are deposited downstream at the confluence point of the Cheekye and the Cheakamus River. This creates a debris fan and consequently narrows the Cheakamus River, causing higher velocities at this area. Further downstream, some boulders are carried and deposited in the Cheakamus. The degree of scour at the merge point of the two rivers is also controlled by the large boulders around the bed, reducing the velocity at which the currents travel at.
