A DESCRIPTIVE STUDY OF THE RADIOGRAPHIC DENSITY OF IMPLANT RESTORATIVE CEMENTS

Chandur Wadhvani, BDS, MSD,^a Timothy Hess, DDS,^b Thomas Faber, DDS, MSD,^c Alfonso Piñeyro, DDS,^d and Curtis S. K. Chen, DDS, MSD, PhD^e
University of Washington, Seattle, Wash

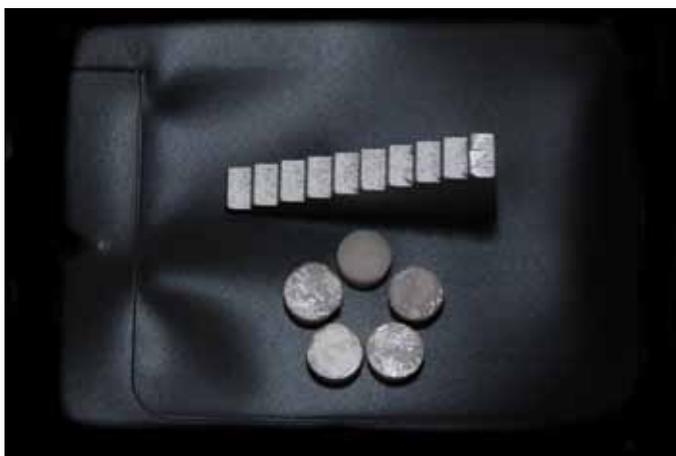
**1** Specimen disks with modified step wedge.

Melville, NY). A 98% pure aluminum step wedge (DHEF, Inc, Taipei, Taiwan) was placed adjacent to the specimens, near the center of the PSP image plate (Fig. 1). The wedge increased in incremental, millimeter-thick steps from 1 mm to 10 mm.

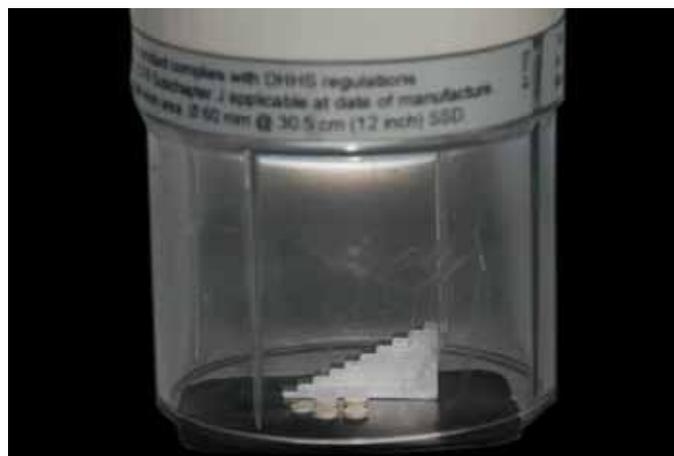
**2** Radiographic unit and image plate.

A single intraoral x-ray machine (Focus; Instrumentarium Dental, Tuusula, Finland) was used. The x-ray exposure was set at 70 kVp, 0.32 seconds, and 7 mA, and a 300-mm focus film

distance (FFD) was used for all specimens. The x-ray beam was maintained perpendicular to the specimens, which were placed on the imaging plates²² (Fig. 2). Radiographic images were made of each cement (Fig. 3). Following exposure, the PSP image plate was immediately placed in the digital reader (ScanX; Air Techniques, Inc), and the images were scanned at an average resolution of 21 pixels/mm. Images with 8-bit grey

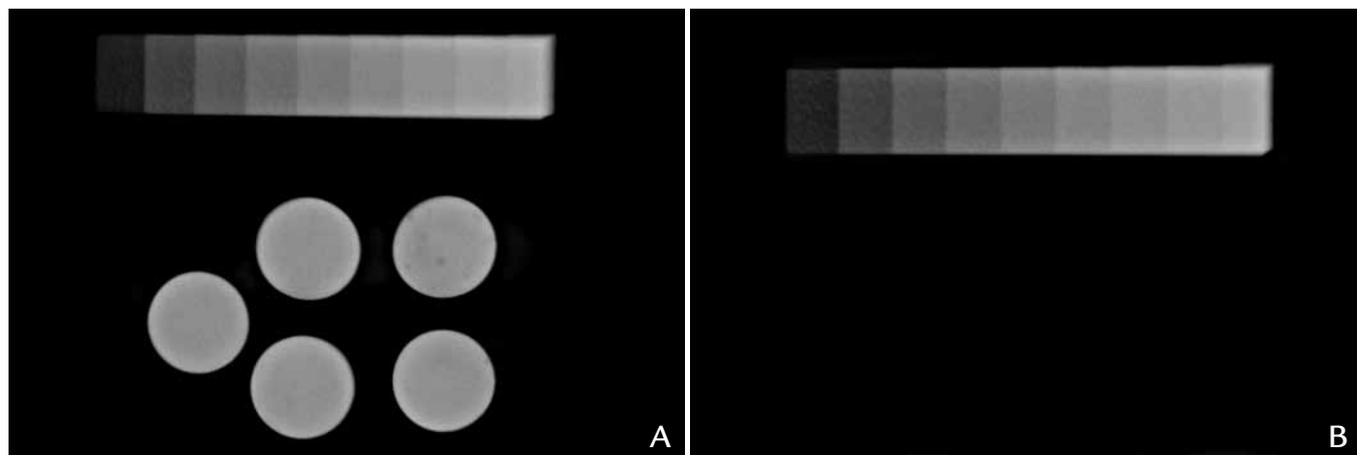
3 A, TempBond Original, 2-mm specimen image at 70 kVp. B, Premier Implant Cement, 2-mm specimen image at 70 kVp.

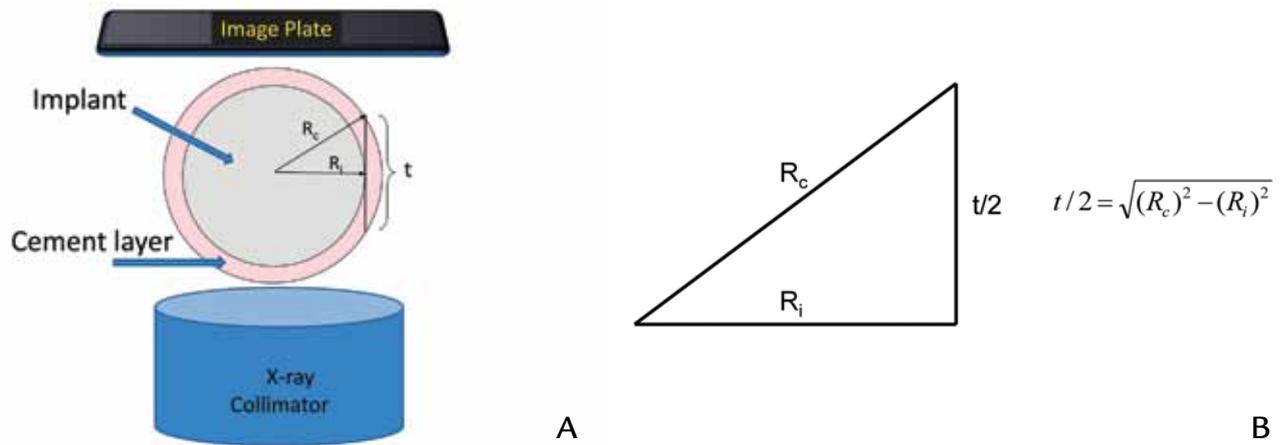
4 A, Schematic and calculation for tangential thickness of cement. B, R_i : Implant radius; R_c : Implant plus cement layer; t : tangential depth.

TABLE III. Tangential cement thicknesses for different implant diameters and cement film thickness

Implant Diameter (mm)	Implant Radius (R_i) (mm)	Cement Film Thickness (R_c) (mm)	Tangential Cement Thickness (t) (mm)
3.5	1.75	0.1	1.20
3.5	1.75	0.2	1.72
3.5	1.75	0.3	2.14
3.5	1.75	0.4	2.50
3.5	1.75	0.5	2.83
4	2	0.1	1.28
4	2	0.2	1.83
4	2	0.3	2.27
4	2	0.4	2.65
4	2	0.5	3.00
5	3	0.1	1.43
5	3	0.2	2.04
5	3	0.3	2.52
5	3	0.4	2.94
5	3	0.5	3.32
