LONG-TERM TESTING OF HIGH PERFORMANCE CORROSION INHIBITING SPRAYABLE THERMOPLASTICS (CIST)

ABSTRACT

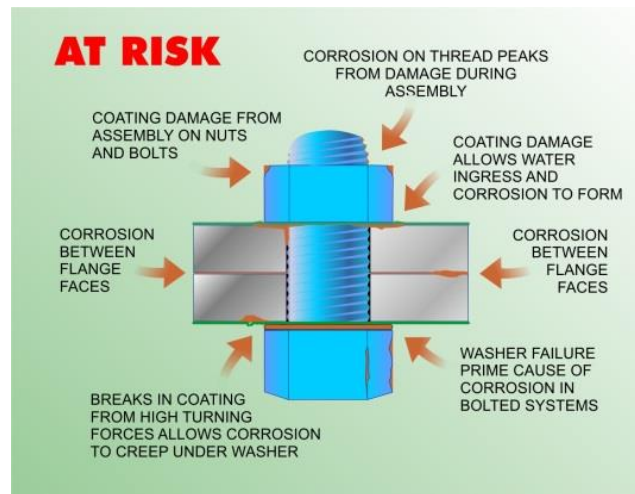
Fig 1 - coating damage during assembly

Unfortunately, even for new equipment, coating problems arise in many ways. Coating choice is often inappropriate with single-pack light-duty coatings on components failing in weeks or, even if the coating is well-chosen and well-applied, damage during assembly can leave bolt threads and nut edges devoid of protection and over-compressed coatings cracked and compromised.

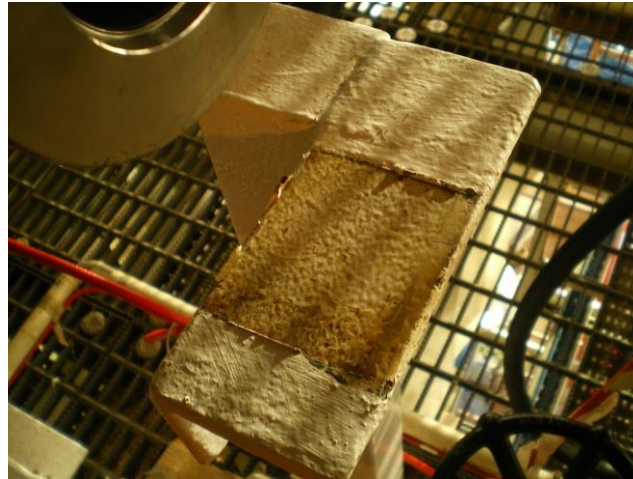
Fig 2 - Over-painting covering rust

Without complete disassembly, some corrosion will remain between bolts, washers and substrate and, in the case of flanges, between the flange faces. No amount of blasting and cleaning will remove corrosion from these areas. So, painting will always be over-coating some rust, which will soon reappear.

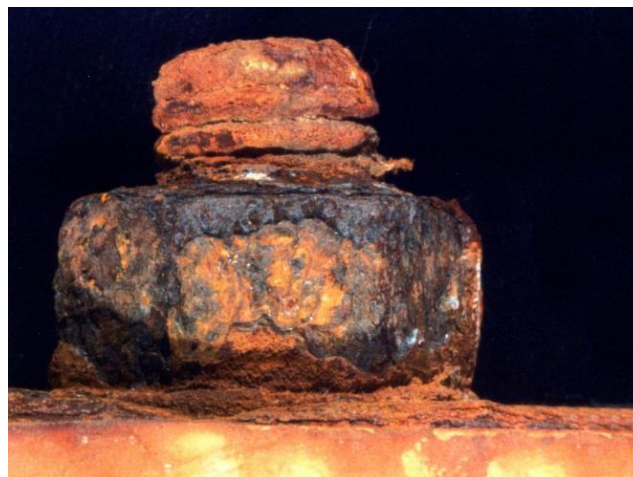
Fig 3 - PTFE/zinc coated bolt failure after 18 months in the splash zone

Other factors also have an impact on corrosion in bolted assemblies, particularly galvanic effects where, for example, a carbon-steel bolt in a stainless steel flange will become a sacrificial anode and may completely fail within 18 months - even if protected with zinc and PTFE.

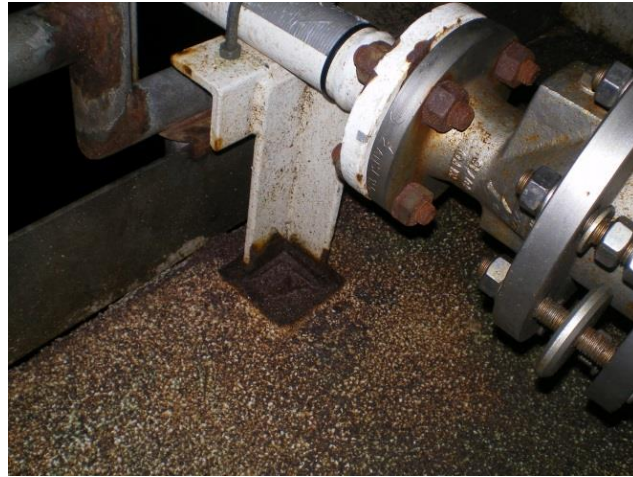
Fig 4 - rusting carbon bolts in stainless substrate

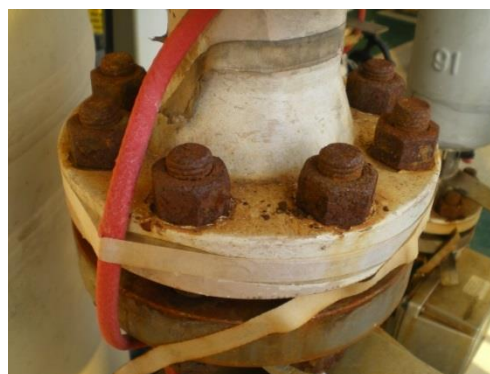
Fig 12 - Bolt corrosion after 18 months offshore North Sea

The most common weathering test is ASTM G154, in which samples are exposed to 42 cycles of 8 hours of UVA-340 ultra-violet light at a temperature of 60°C followed by 4 hours of condensation at 50°C for a total of 21 days of exposure. Like many other standard tests, this may provide a benchmark for comparison but does it has very little to say about what will happen in the real world. Other tests such as ASTM 4587 and G 155 provide for a similar combination of UV irradiation, heat and water while ASTM B117 focuses on a combination of water salt and heat. Both tests are widely accepted in assessing suitability of materials for outdoor use but, for example, a 1000 hrs of UVA exposure is only the equivalent of 1 year in South Florida and a bolt that has passed a 1000 hrs hot salt fog test may be completely unserviceable within 18 months in some environments.

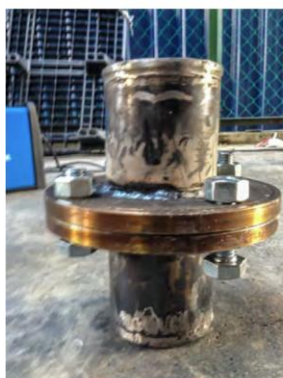
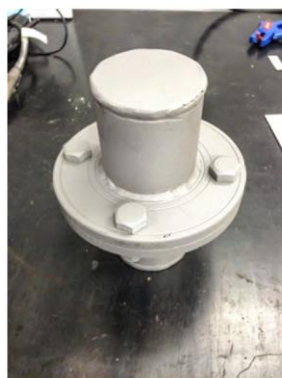
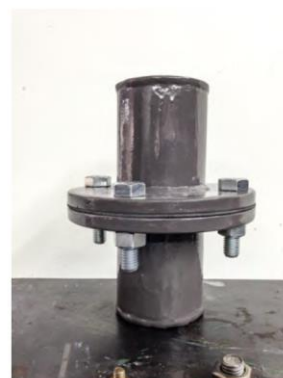
The samples were prepared using carbon steel test pieces, blasted and coated with a single coat of epoxy and fastened using standard nickel-plated B7 bolts. They were then coated with CIST using 2 coats at 2mm per coat, with edges sealed using standard cable ties and the pipe ends left unprotected.

Fig 15 - sample preparation

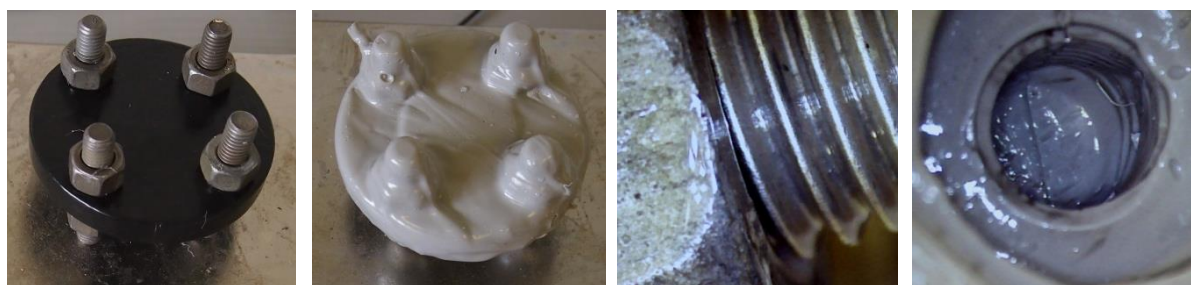
Fig 28 - Test piece before & after coating, close up of bolt thread and removed CIST after test completion

Over the six-month period there was no significant change in weight nor any escape of oil on to the tray. Initially weekly measurements were taken but, with no changes found, the interval was increased to monthly. At the end of six months, the material was removed and examined. Good oil deposits were found within the encapsulation, on bolt threads, metal and CIST interior surfaces. Other than some soiling from handling, no surface effects were found on the CIST exterior.

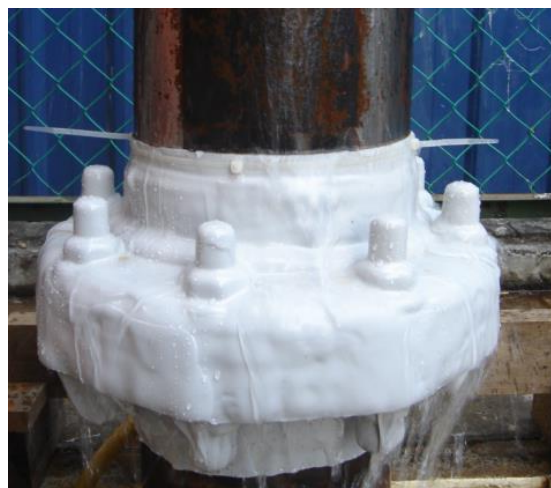
Fig 31 - Test substrate at commencement of test

A 20% saline solution was cycled at approximately 400 litres an hour for 11 hours a day, 5 days out of 7 for 6 weeks. Ambient temperatures were between 24°C and 38°C. The steel pipe substrate and flange were new and uncoated low-carbon steel, a section along the length of the pipe was abraded prior to coating with CIST to provide the best potential conditions for corrosion. The CIST encapsulation was sealed using a standard tie-wrap technique.

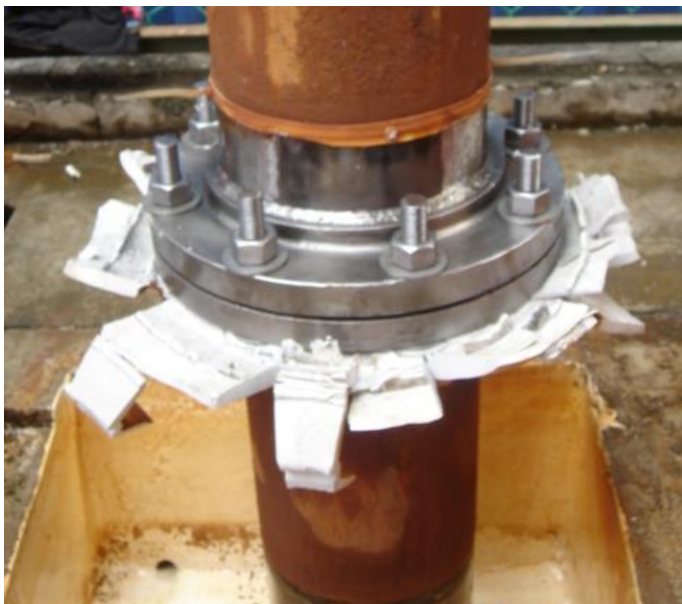
Fig 34 - Complete removal of the material shows no corrosion on substrate

At the end of the test the CIST was cut away to reveal the substrate. No corrosion of any kind was found within the CIST encapsulation, whereas significant corrosion occurred along the length of the exposed, unprotected pipe.
