# SCOUT Projects: *Additional Holding Tank Vent*

*m/v SCOUT (Great Harbour N37)*

An additional 1-1/2" vent line to the holding tank, using an existing (plugged) tank fitting.

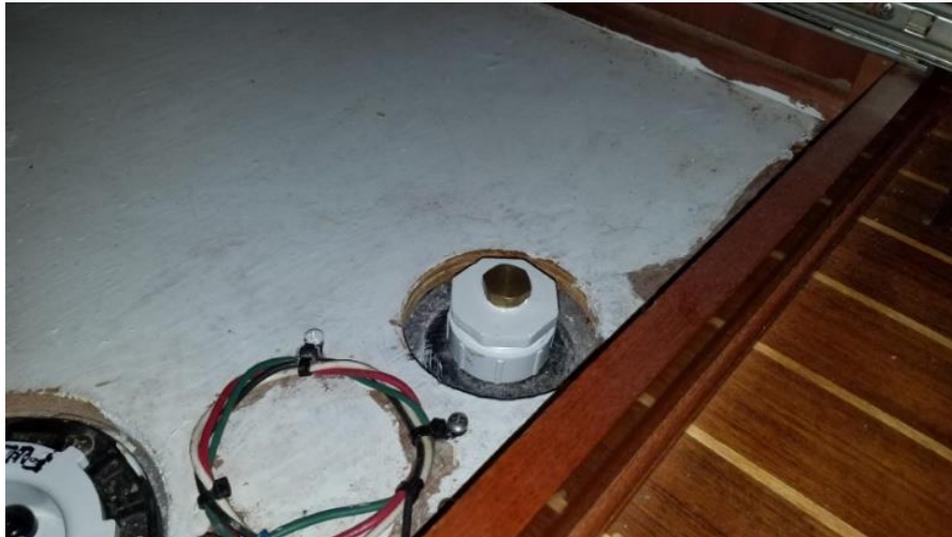
There are some ports on the holding tank underneath the aft end of the bed. Removing the drawers gave pretty good access. I noticed that the since-removed Sweet Tank fitting had a dummy plug in it, I could probably get a skinny elbow fitting to go into the 1-1/2" threaded insert and still clear the drawer bottom. This would eliminate having to cut a new opening in the top of the tank for the vent.

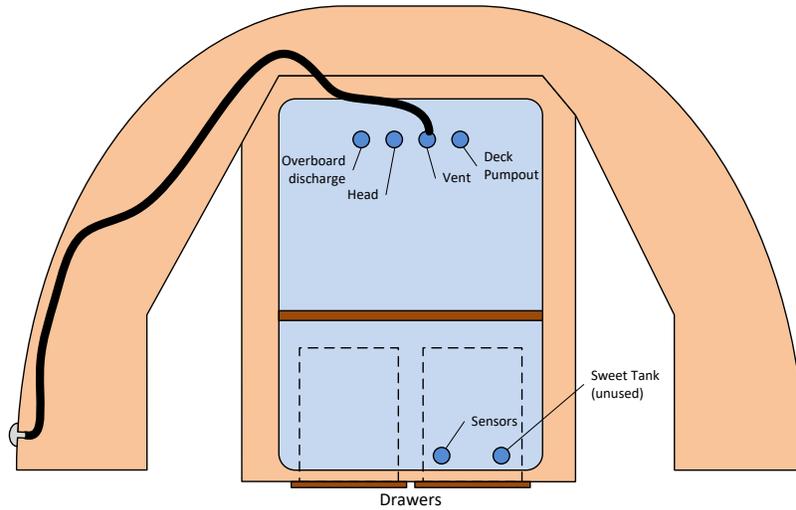
The plan was to re-route the existing forward tank vent fitting to a newly cut in starboard bow thru-hull, and then to connect this aft-end sweet tank fitting to the existing port site thru-hull. Here is what the original state of the vents was:

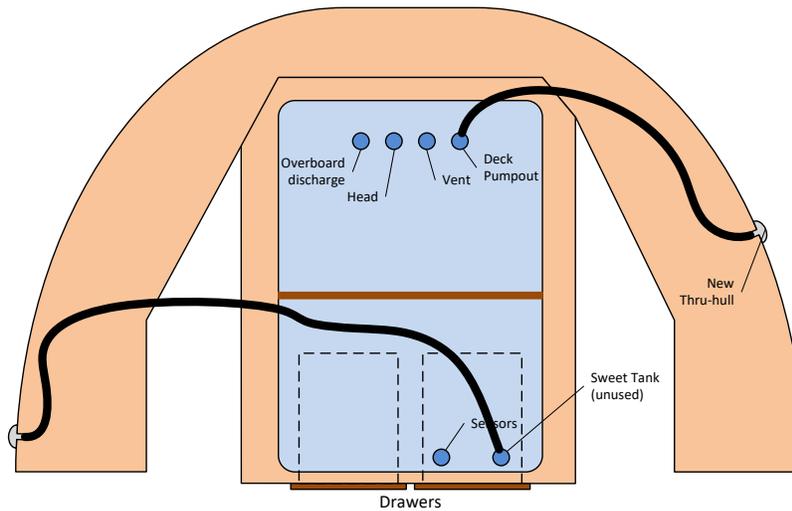
And the plan was to change it to this:

I didn't want to use the \$7/ft hose for the new connections because a)it is expensive, and b)they invariably get low spots in them and collect "things". Where I could, I used the PVC pipe with gentle slopes and joined it to the Trident hose at the end sections for flexibility.

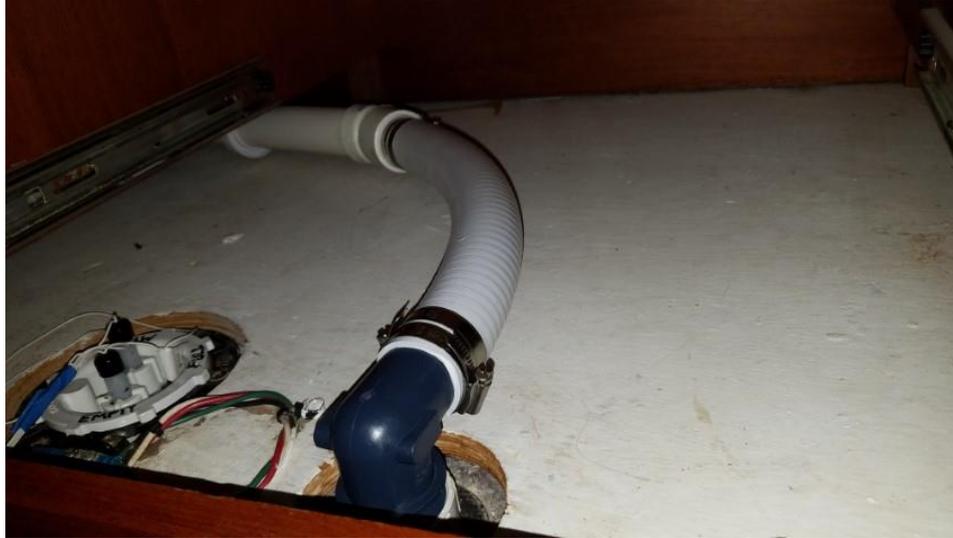
Here is what the area under the drawers looks like. The “tight elbow” was a life saver and prevented having to change the drawer arrangement. I used hose for flexibility, then transitioned to the PVC.

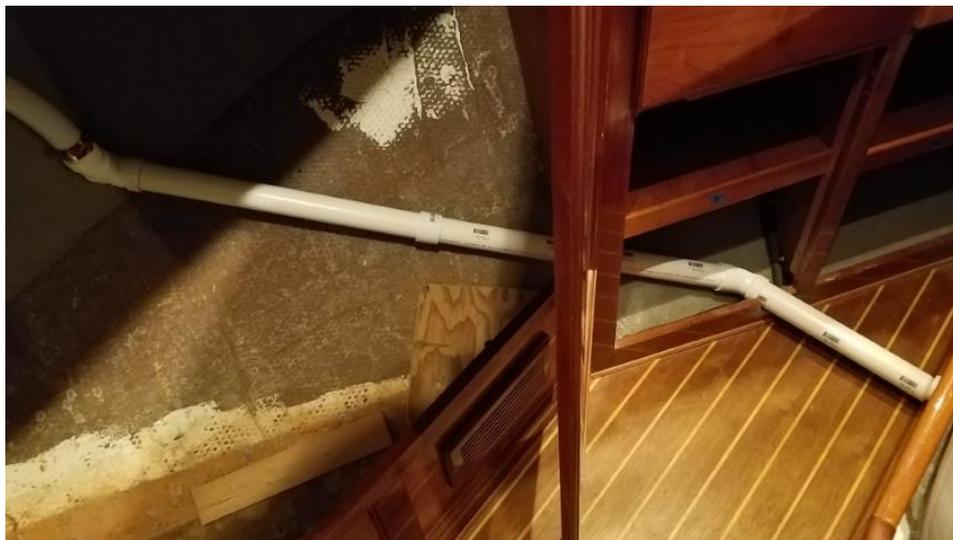
The PVC continued through the side wall of the bed riser. Across the floor space (more on that later). And then into the portside closet area. There is a very gradual slope across the floor, down into the drawer cavity under the bed.

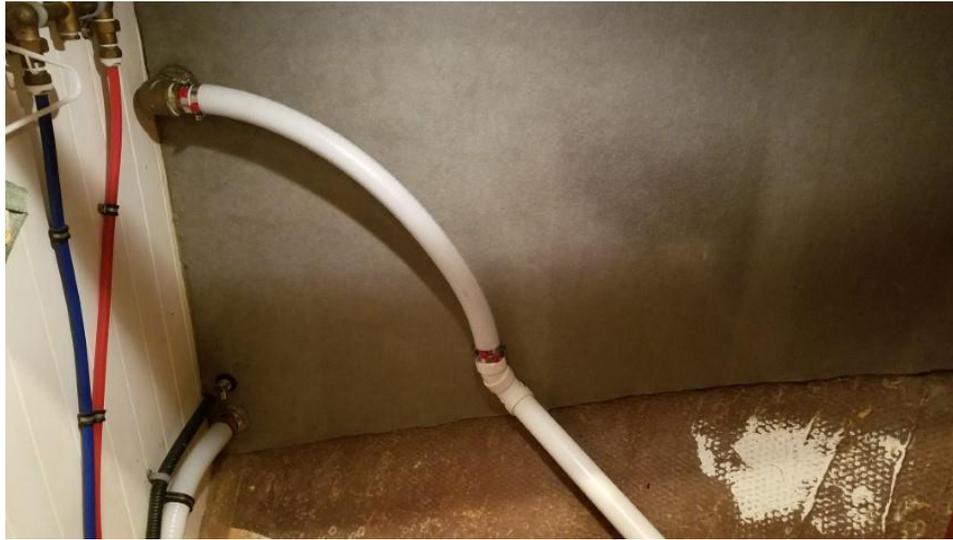
Once again, the “last mile” was a connection with flexible hose to prevent any problems with the rigidly-mounted PVC pipe. This is the existing port side vent thru-hull in the closet on the port side.

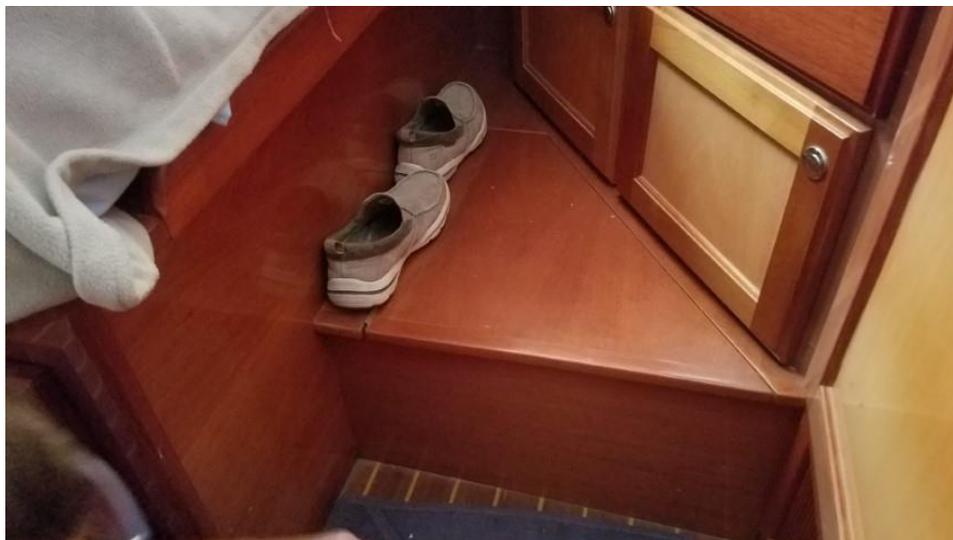
Well, it's not quite complete – I still have to cover up the PVC that crosses the sole with some riser steps that I had planned on making anyway. I will also need to cut the cabinet doors off shorter to accommodate the step. Starboard side version of a step shown below (Photo courtesy of *Tanuki*).
