Decontamination Is Key to Prevention

Corrosion control begins from Day 1:

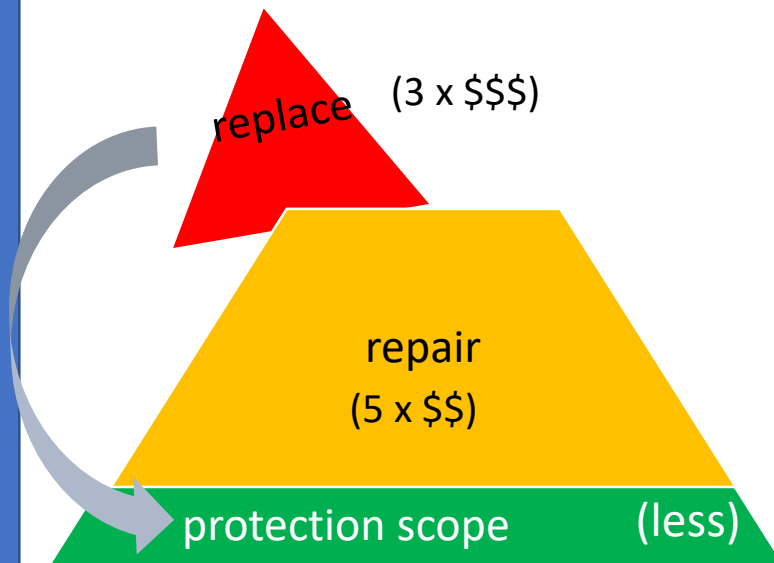
Component incidents & costs over service life of a facility or major industrial asset

maintenance-focused
corrosion control

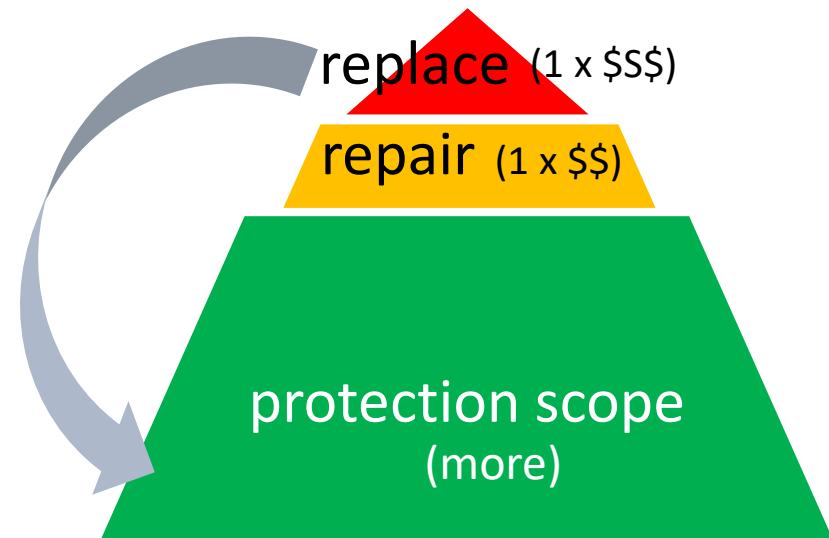
prevention-focused
corrosion control

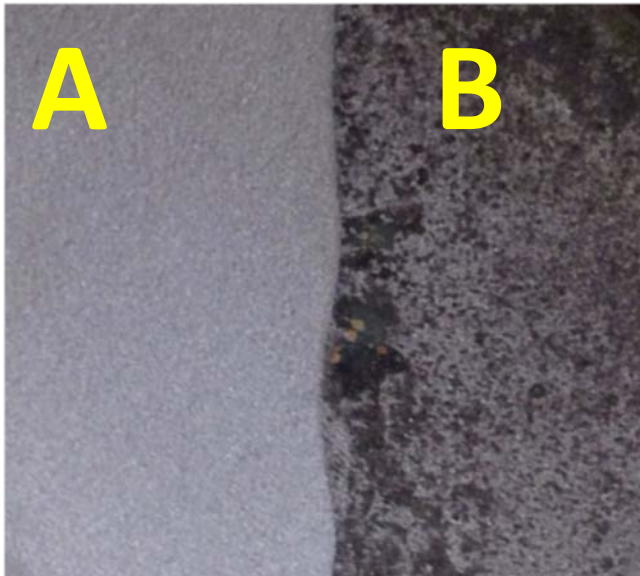
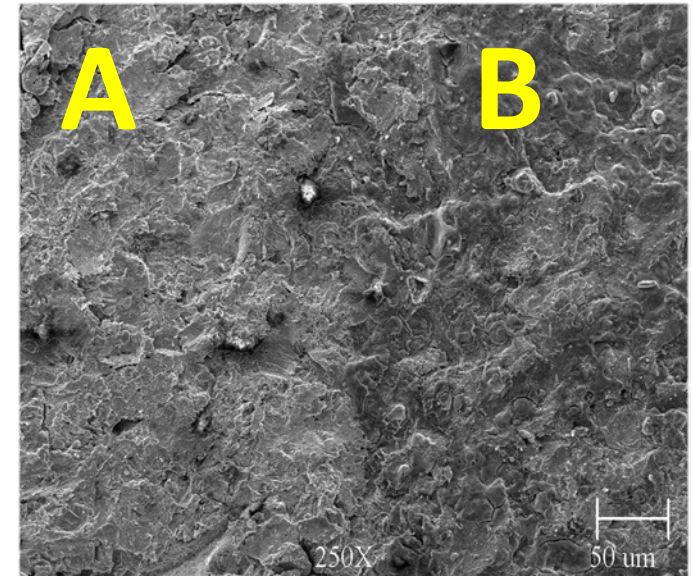
Steel Plate Blasted to NACE #1 / SSPC-SP 5 Standard, then exposed to ambient conditions for 5 hours.

A: CleanWirx Surfactant Decontamination
B: Control (blast only)

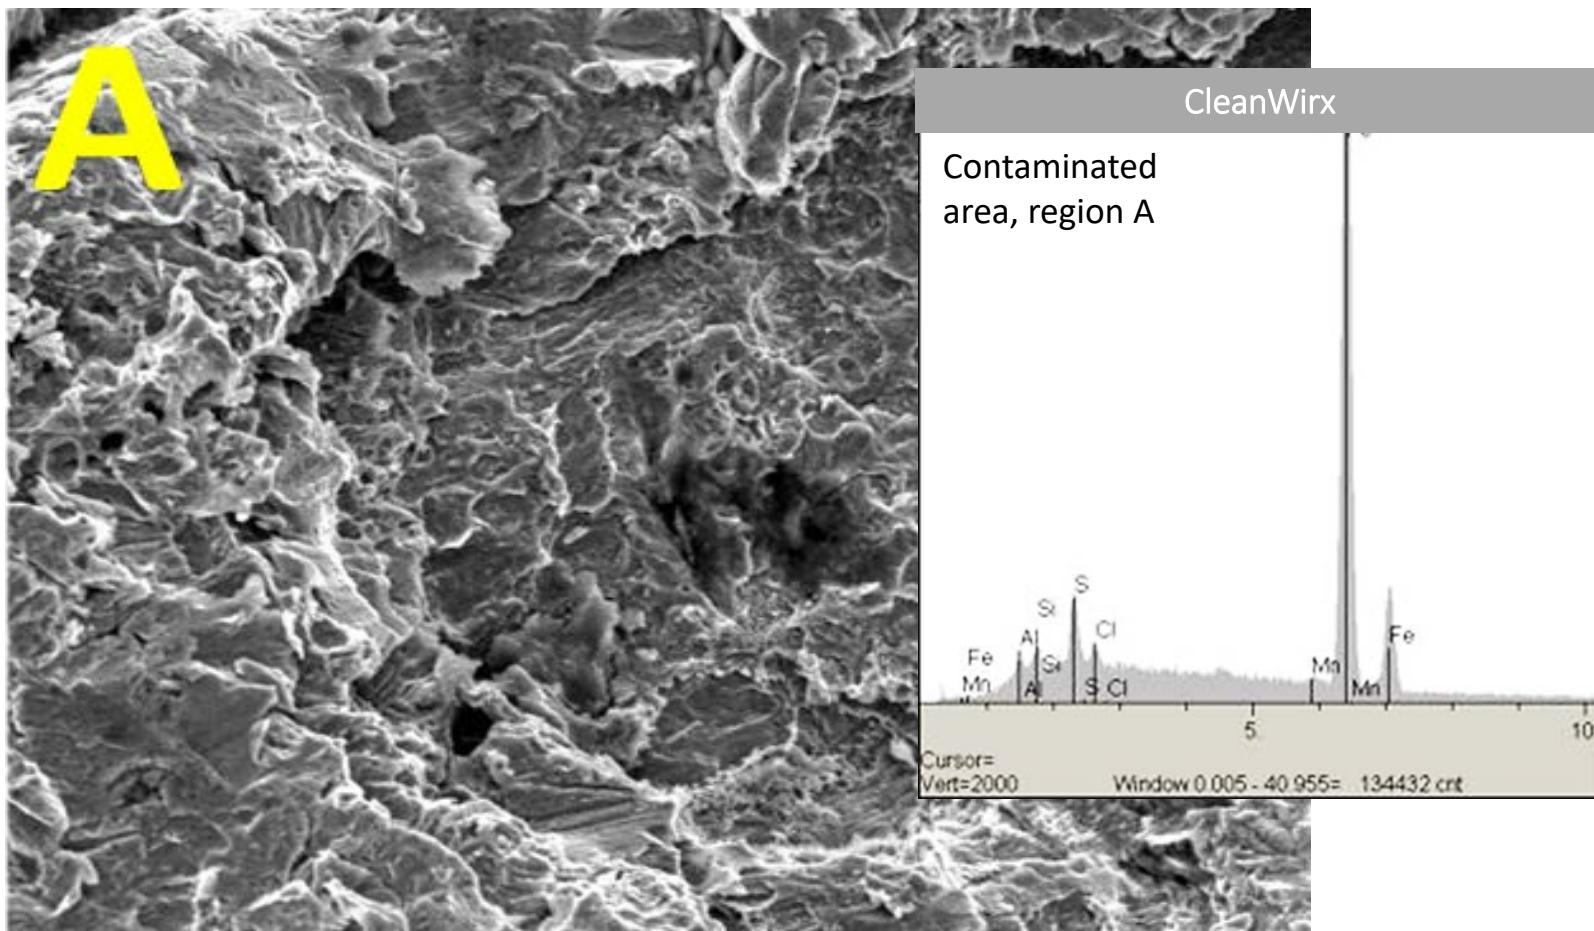
ZERO Detectable Visible & Non-Visible Soluble Salts

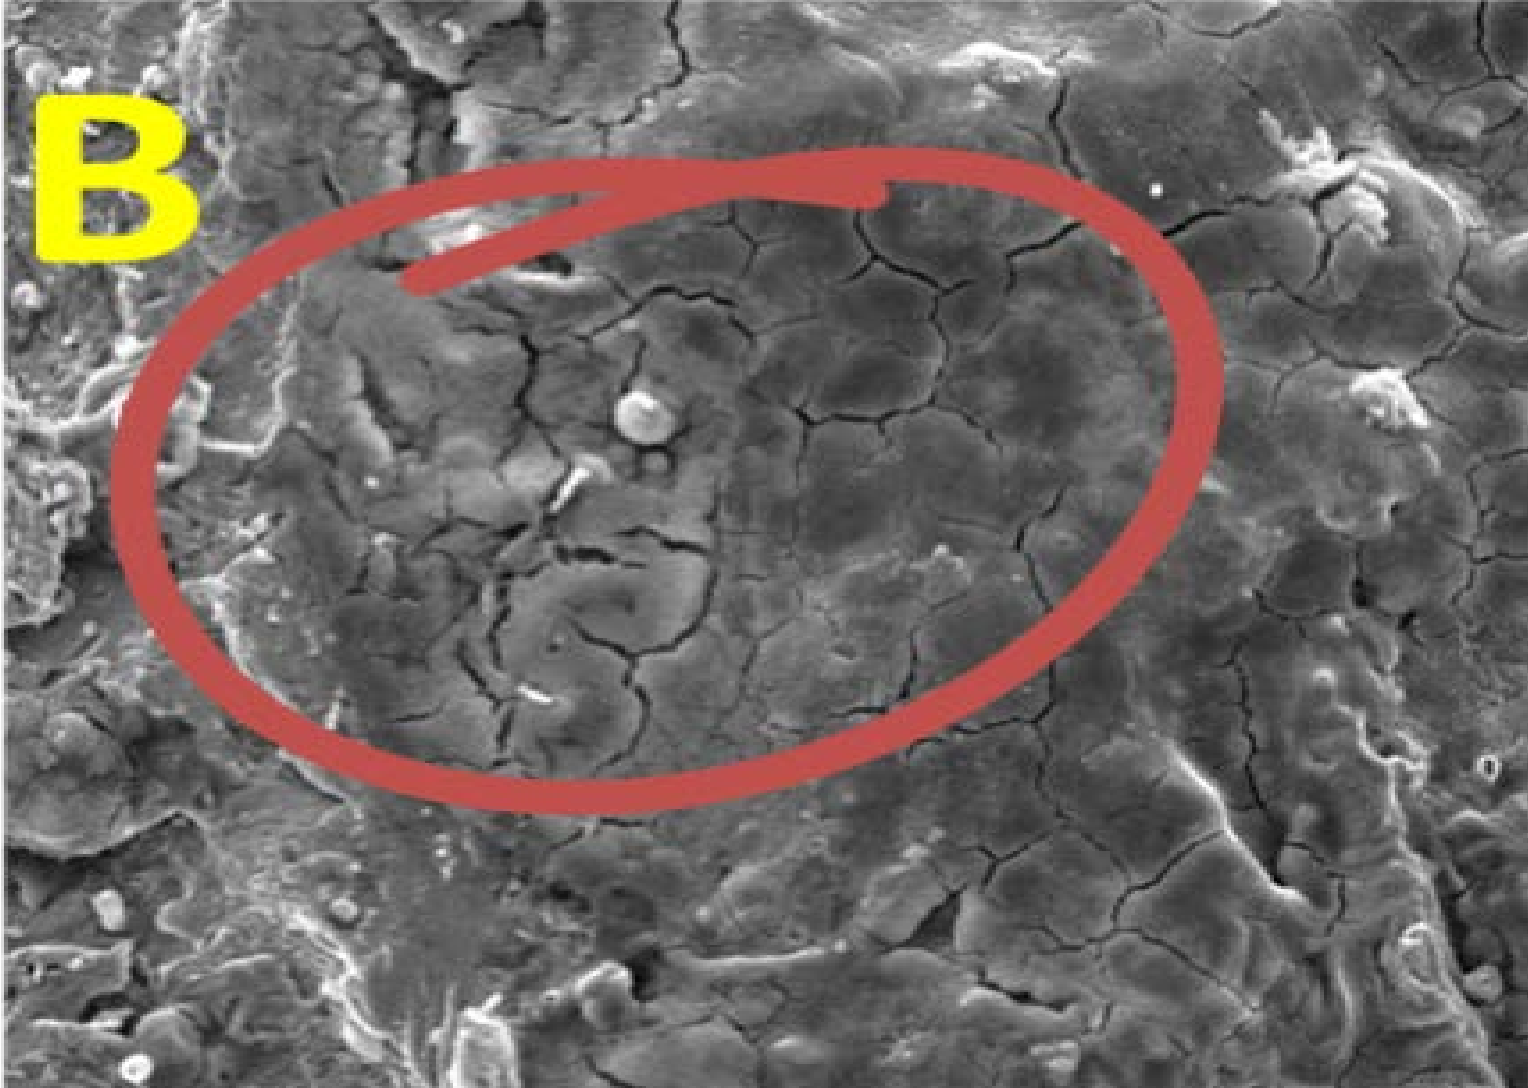
What Conventional Methods Leave Behind:

Detectable Soluble Salts & Microcontaminants

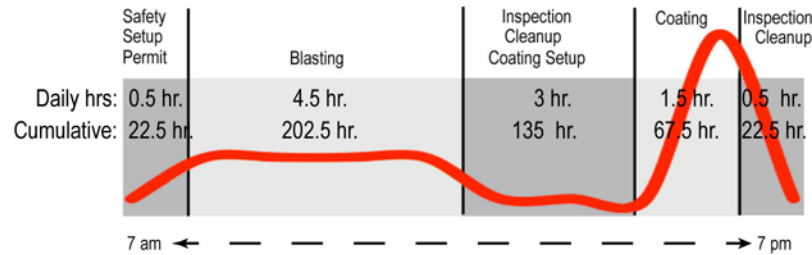
36,000 sq. ft. @800 sq. ft./day blasted and coated = 45 days to complete project

Traditional Method

Daily Blast & Coat Productivity Curve

45 Days

Start/Stop Process
Cycles Interrupted
and Repeated DAILY
Until Completion. 45x

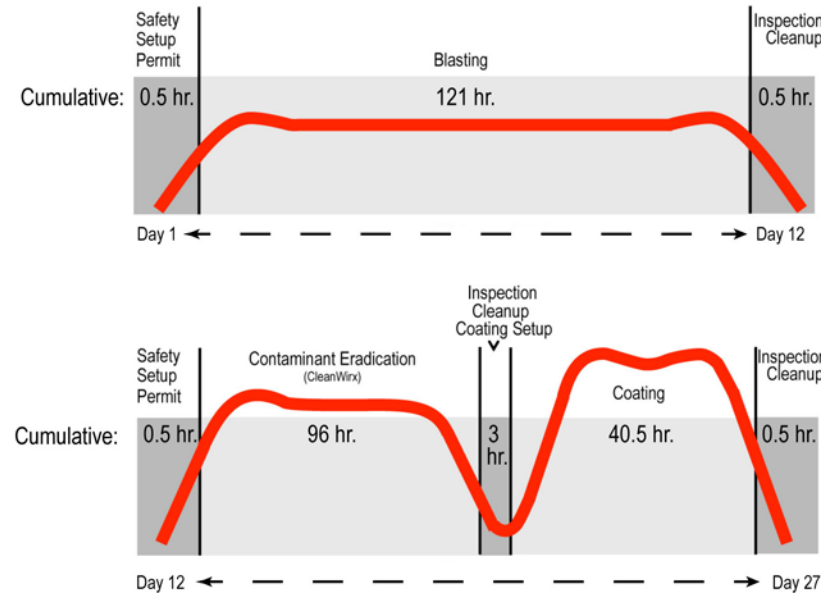
36,000 sq. ft. @1,350 sq. ft./day blasted and coated = 27 days to complete project

Decontamination Method

Daily Blast & Coat Productivity Curve

27 Days

Single
Continuous
Uninterrupted
Process
(Start to
Finish. No
Repetition.)
1x

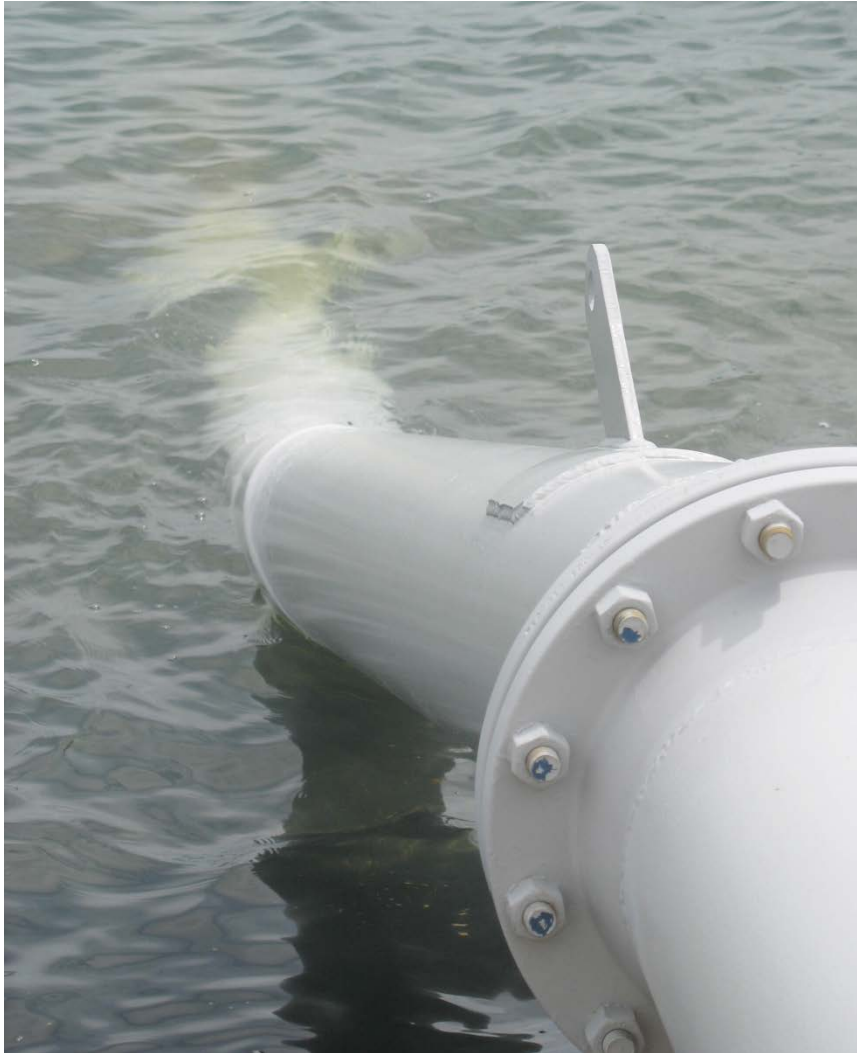
(Markham, Texas)

Piping to brine pit with 300,000 ppm salt concentration treated with CleanWirx, then coated with standard Ameron coating. Piping remained in environment for 11 years with NO additional coating or maintenance.

Identical “control” piping was prepared using Conventional methods, then coated with identical standard Ameron coating. “Control” piping required four separate coating/corrosion maintenance projects during the same 11-year time period.

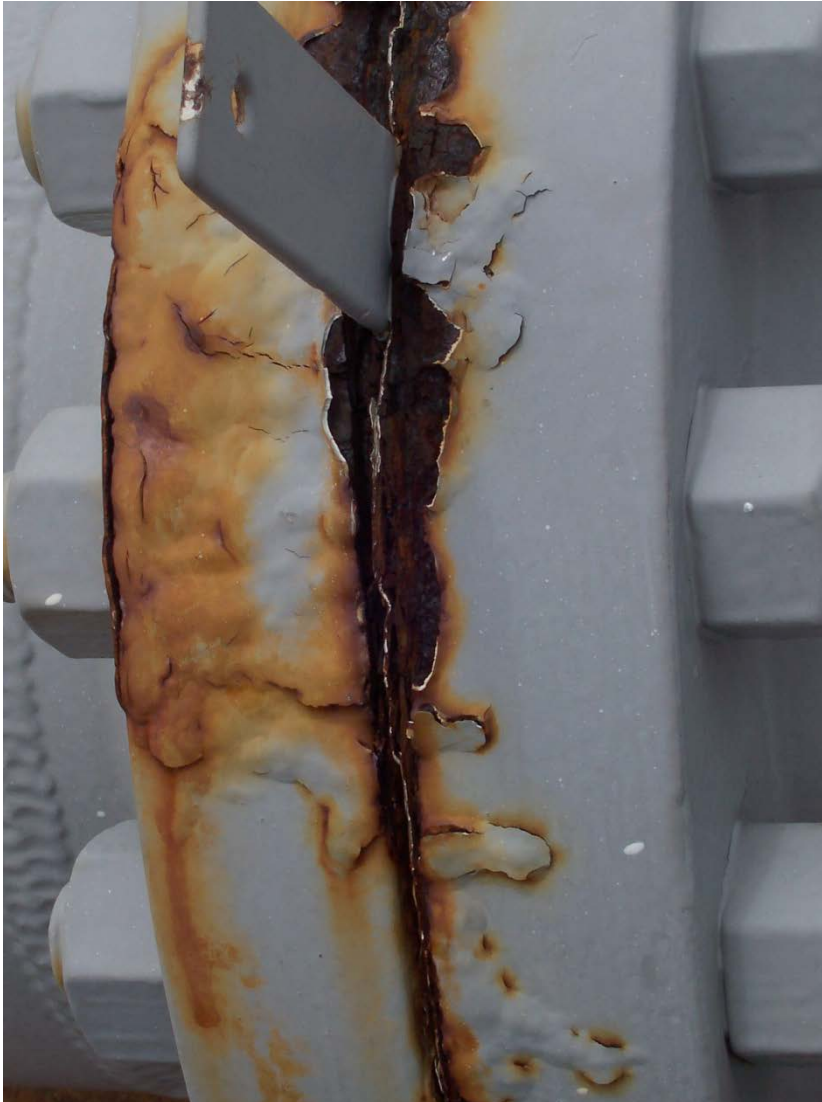
(Markham, Texas)

1. Outer flange treated with Cleanwirx.
2. Inner flange was treated using Conventional methods & products.
3. Seam between the flanges was "taped and waxed."
4. Entire component was identically coated.

Aggressive corrosion worked its way up from beneath coating to demonstrate clearly and visibly the limitations of conventional methods and products.
