Fluid intermixing in BG PXT^{®2}

September 25, 2015 || 15-386

BG Power Steering Service Center drain hose retrofit

February 25, 2005 || 05-211

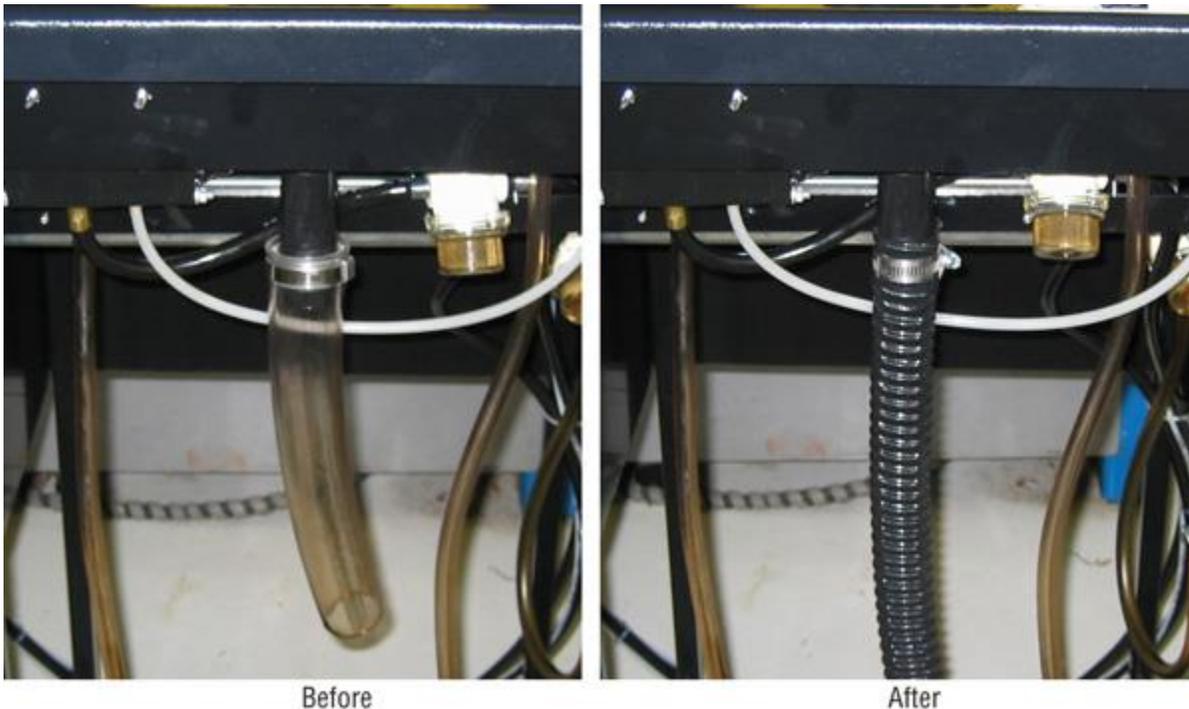
To update an old machine, the clear portion of the drain hose must be removed (see before photo).

After the clear portion is removed the new hose can be installed (see after photo).

The new flexible drain hose is available to update old machines. The Part No. is 937-024.

To remove the clear portion of the drain hose simply slide the hose up and pull down. If the hose doesn't pop off after several attempts the clamp must be removed.

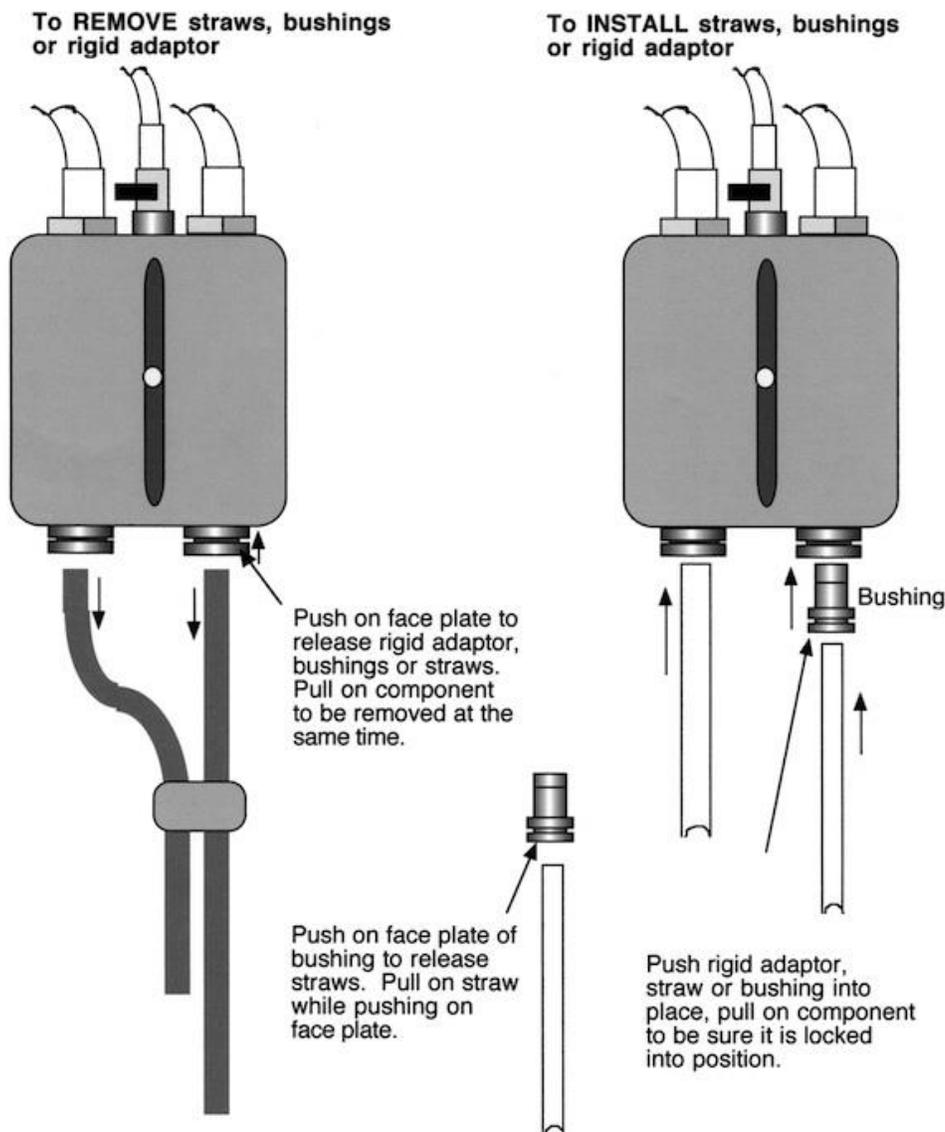
Answer: The unit is currently being shipped with the metal wand assembly installed. To remove the metal wand and install the individual straws is quite simple but not all that obvious at first glance. Do not try to fit the nylon straws onto the ends of the metal wand. The drawings on the attached sheet should help clarify removal and installation of adaptors.

Note! We have received a few complaints that the gray plastic bushing used on the small straw does not always lock in place. We are now machining a groove on this bushing to help it lock. If you have trouble, just take a knife and carve a small groove all the way around the bushing 1/4 inch from the narrow end. This will give the teeth something to catch on.

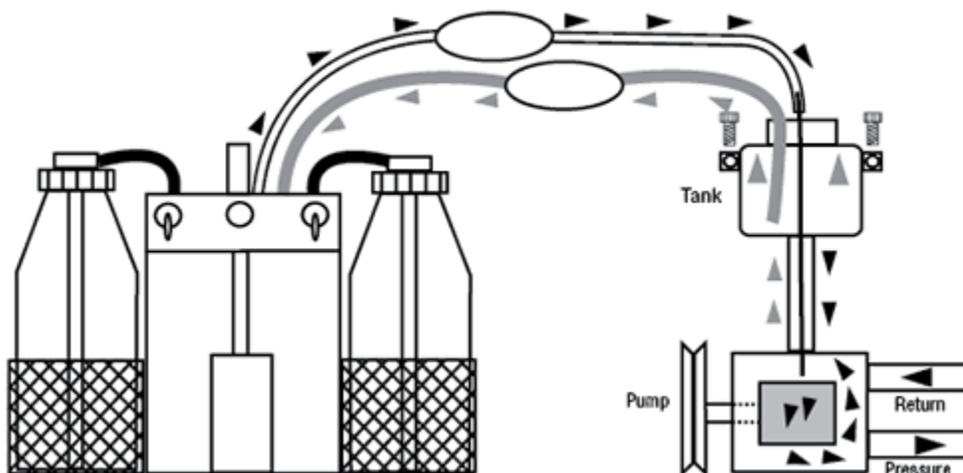
Locate the power steering reservoir and remove the two bolts holding it to the fender well. The tank is full of oil so don't tilt it over. Remove the cap from the tank. Hold the tank up to make the hose that is connected to the bottom as straight as possible. Without emptying the tank, thread the straw through the fluid and down into the hose. Keep feeding the straw in until approximately 32 inches are in the hose and until you feel the straw come to a sharp stop inside the pump.

Insert the braided hose through the mouth of the tank beside the straw until it hits the bottom of the tank. In this procedure we will be pumping product through the straw into the pump and sucking product out of the tank or reservoir.
