ALTON MILLPOND

Rehabilitation Master Plan

A Project to Enhance Shaw's Creek, a Tributary of the Credit River

April 2015

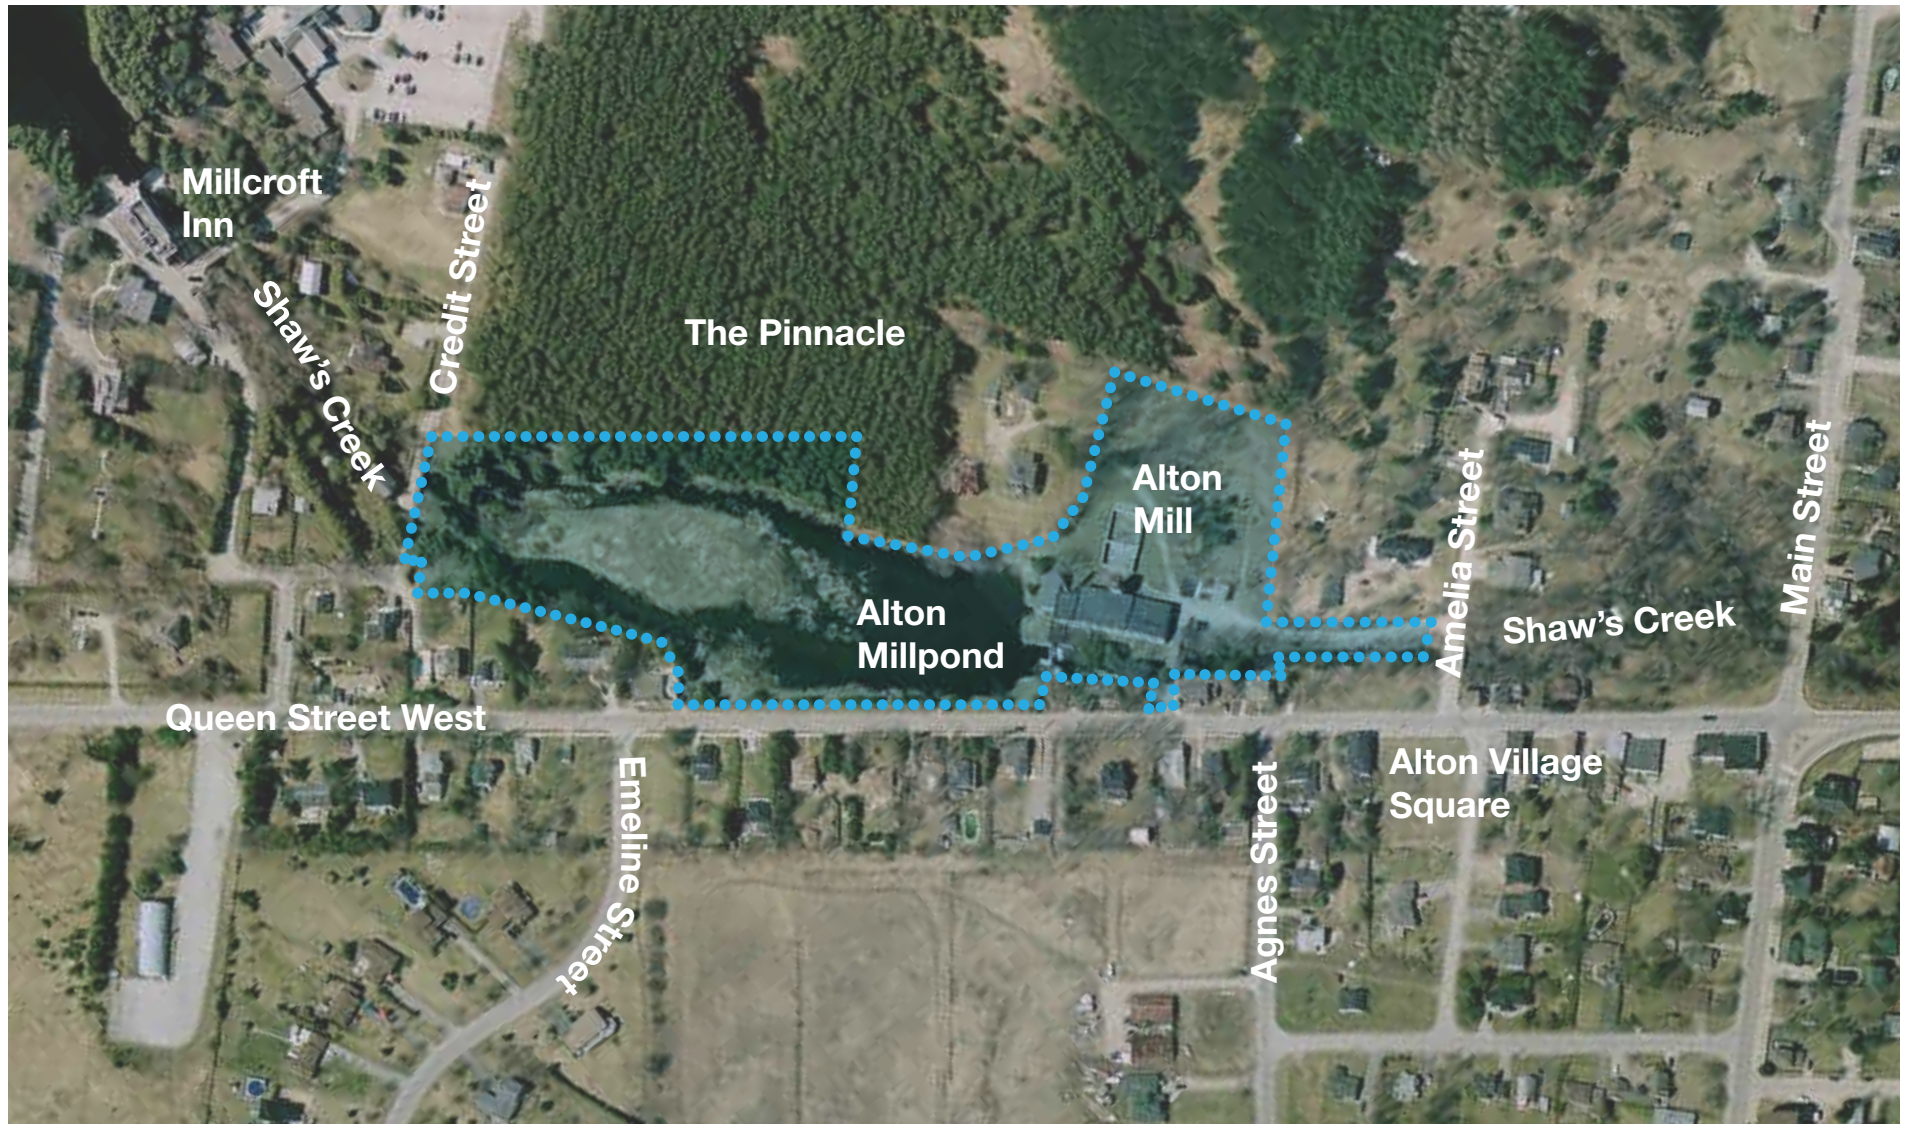
The Alton Millpond Study Area and Shaw's Creek in the centre of Alton Village

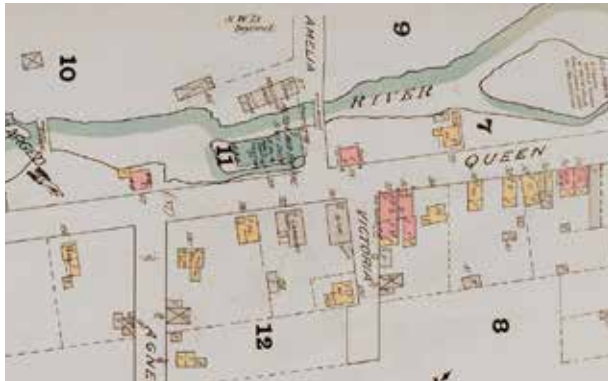
1894, Goad Fire Insurance Map

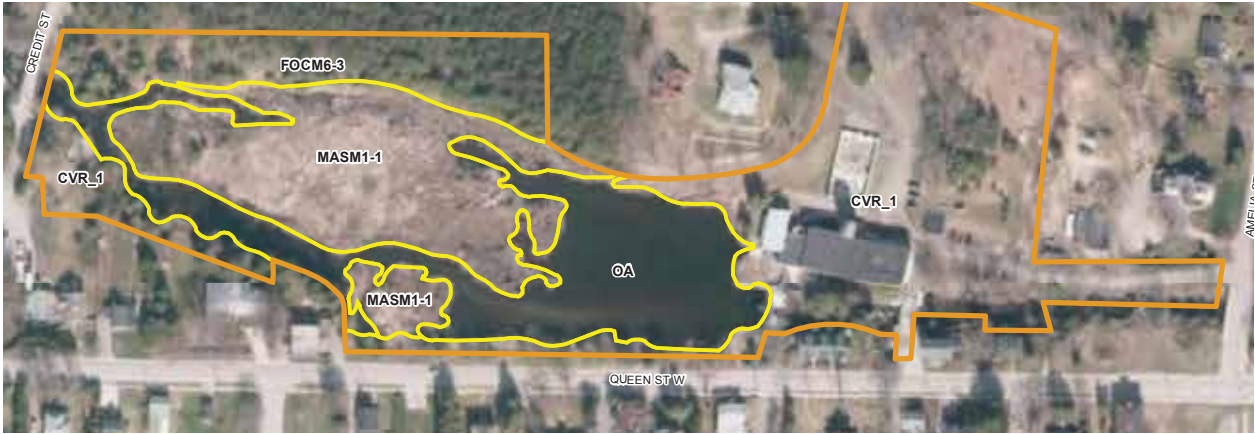
Existing vegetation communities

Ecological Land Classification (ELC)
 (CVR_1) Low Density Residential
 (FOCM6-3) Dry-Fresh Scotch Pine Naturalized Coniferous Plantation Type
 (MASM1-1) Cattail Mineral Shallow Marsh Type
 (OA) Open Aquatic

The Study Area consists primarily of disturbed and cultural vegetation communities as shown in the figure on the next page. The Terrestrial and Wetland Ecology Existing Conditions report (see Appendix) identifies the following five significant plant species within 1km of the Study Area: Hart's-tongue; Rugulose Grape Fern; Carey's Sedge; Butternut; Slender Stubble-Moss. Of these species, the millpond Study Area has suitable habitat for Butternut and Slender Stubble-Moss.

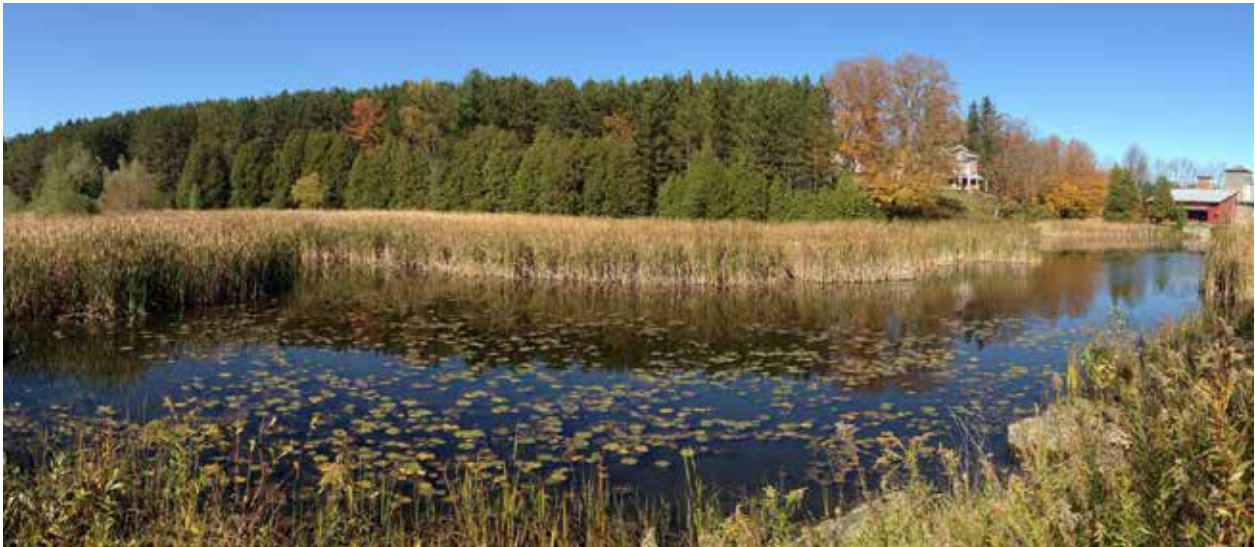
The Millpond (shown in the foreground) is characterized as a Cattail Mineral Shallow Marsh. The Pinnacle (shown in the background) is characterized as a Scots Pine Naturalized Coniferous Forest.

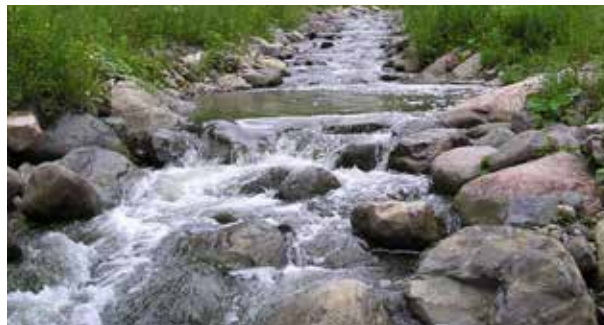
The stream restoration of Morningside Creek, ON, undertaken by the Toronto Region Conservation Authority, incorporates riffles, pool sequences and resting habitat

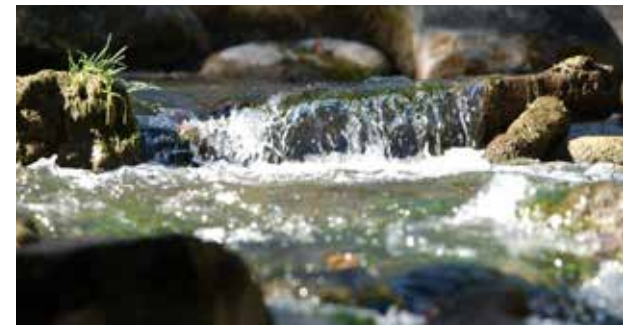
Naturally occurring riffle and pool sequences in the Credit River, just downstream of the Millpond.

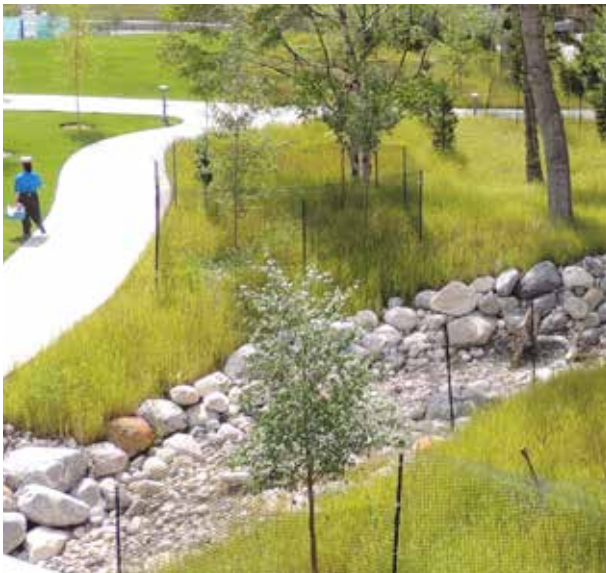
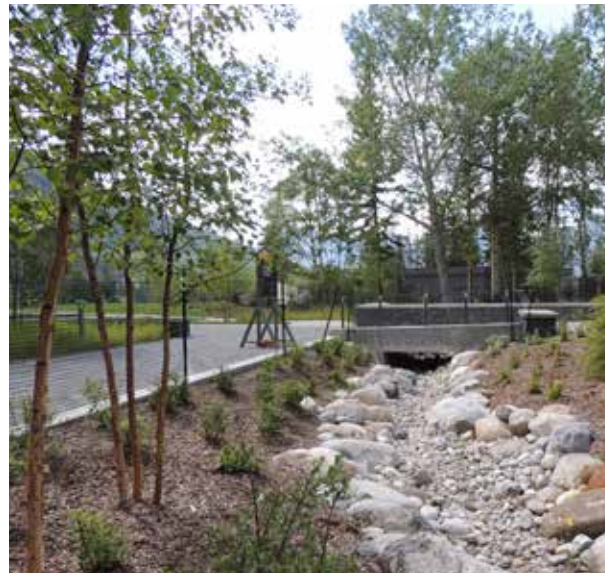
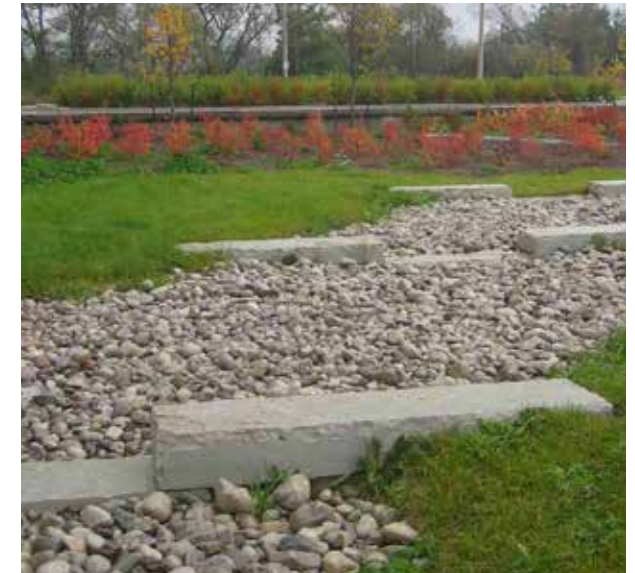
Examples of low impact measures to manage the quantity and improve the quality of stormwater runoff entering the Millpond could include rain gardens, bio-swales or infiltration trenches

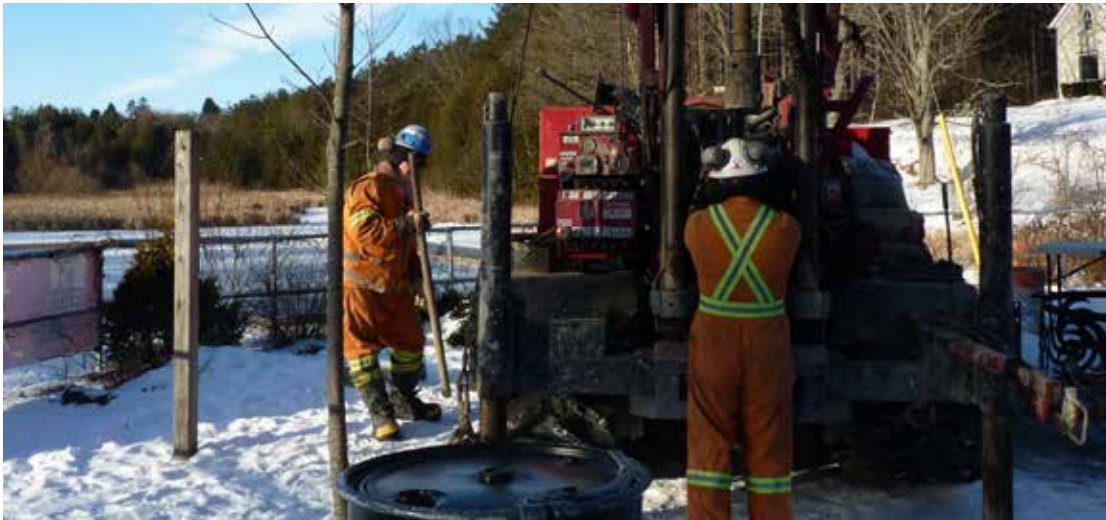
On-site geotechnical investigation, winter 2015

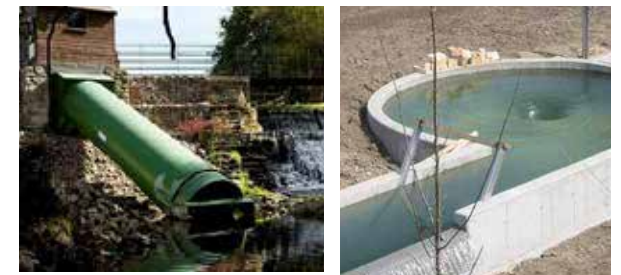
Different approaches to hydro-electric generation could include small scale hydro-electric generators, Archimedes Screw (above left) or gravitational vortex generators (above right).

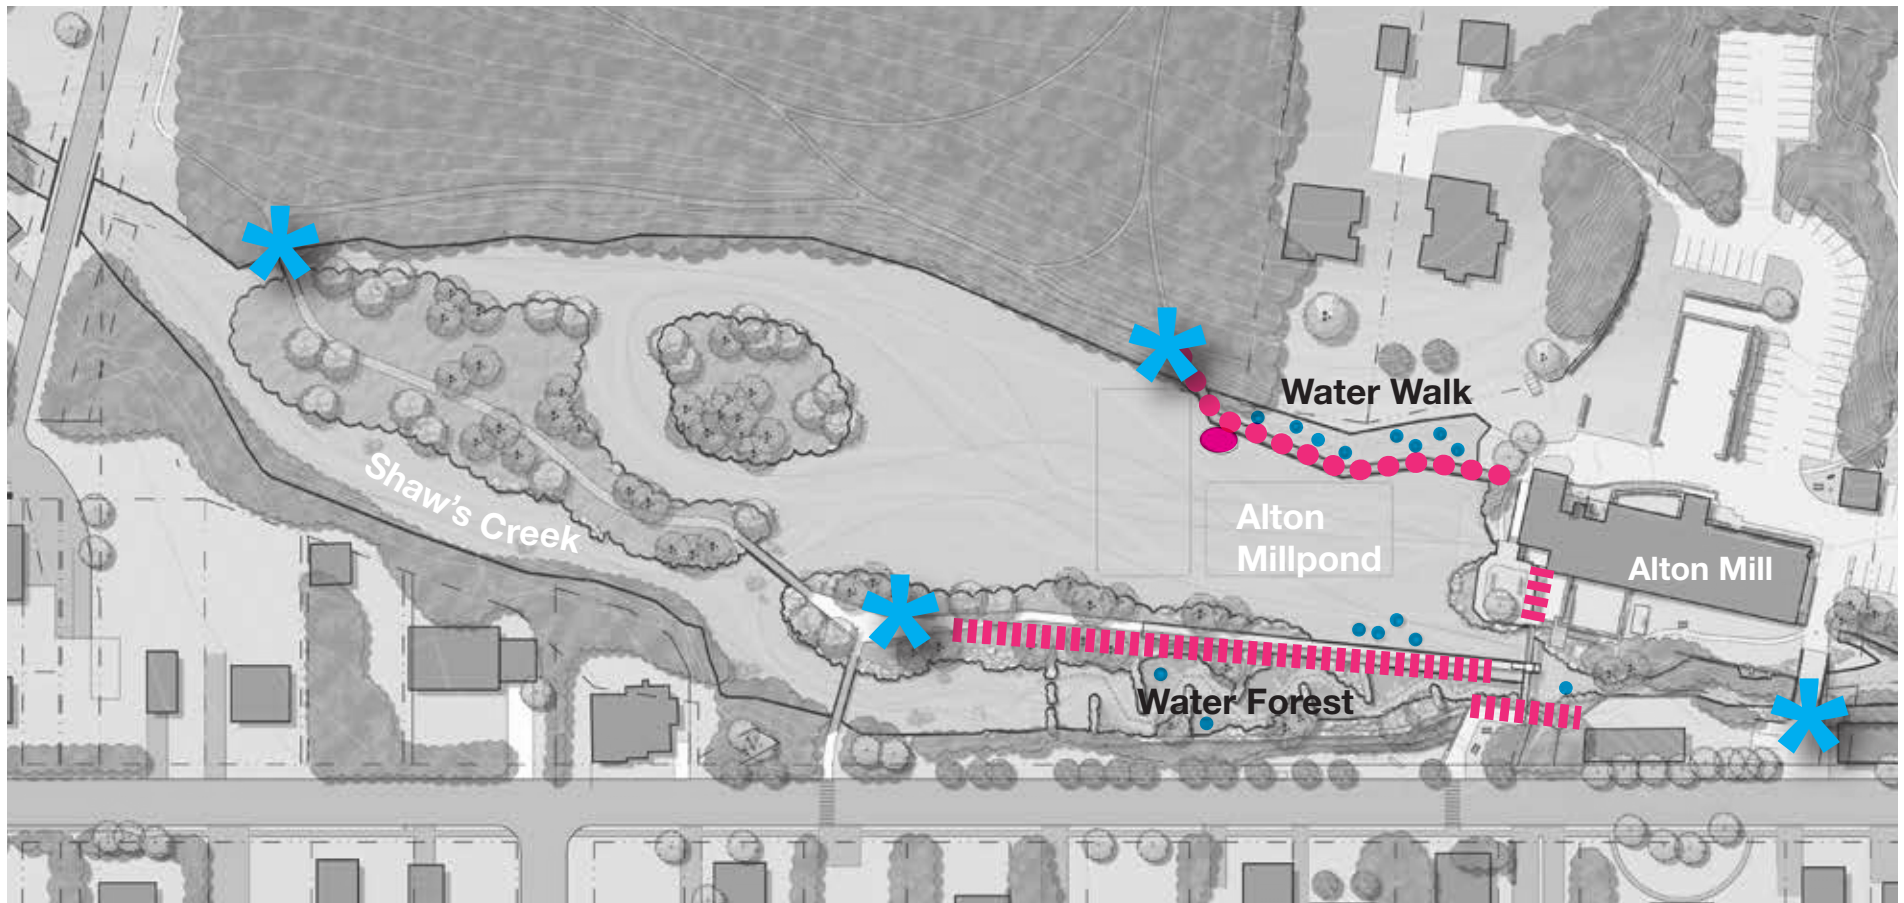
Water Space Art Locations

Water Space Art acts as a visual narrative identifying specific locations to infuse a remediation story into structural elements, wayfinding and the educational interpretation aspects related to ecological function. (See figure above)

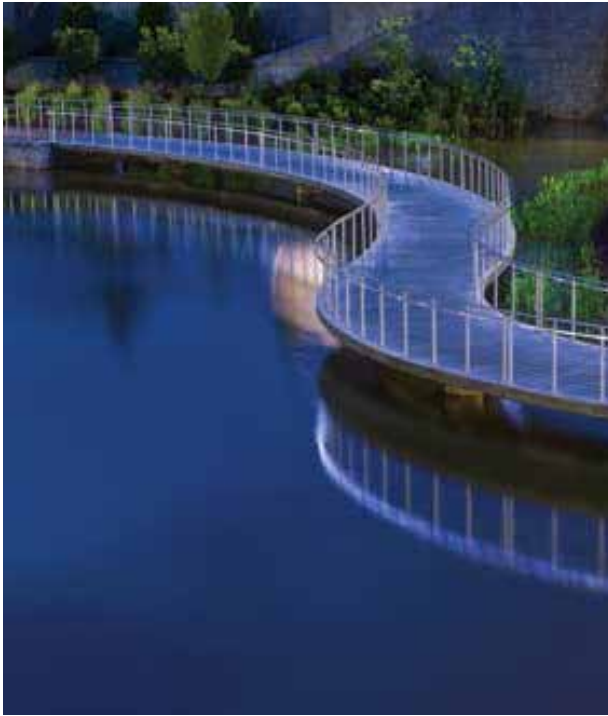
Water Walk

Vegetated floating phytoremediation islands and a floating boardwalk extend the trail system through the millpond, assist in providing shade and cooling of the pond temperature and help to reduce waterborne pollutants. They could also provide a privacy element for the adjacent properties. Water currents are created that eliminate stagnant pond areas. The walk can incorporate concealed associated infrastructure for water-powered light shows or other aeration elements. Solar powered waterfalls and water displays engage and animate along the floating walkway.

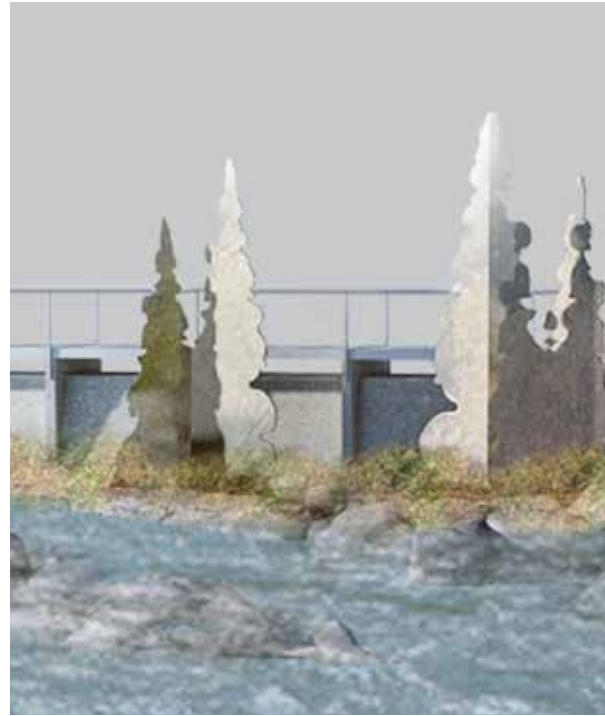
Water Forest

Rotating, floating vegetation islands and mirror polished stainless steel tree templates use wind and water currents to engage the sensory and visual experience of the fishway. The reflective steel tree surfaces extend views of the Queen Street riparian creek edge integrating the pond / creek separation structure into the overall landscape of the Millpond. The reflective steel shapes also mirror the islands as they move, animating a choreography. Concrete retaining walls become a kinetic mural of nature reflected.

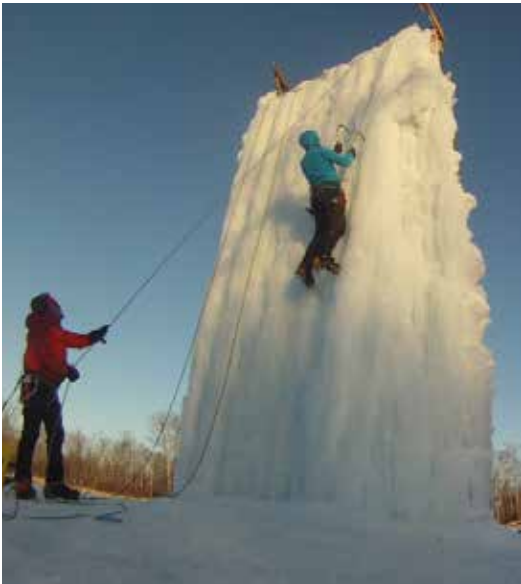
The floating platform is a key element of the Water Space Art narrative. It is a movable element that acts as stage for summer and winter activities and place to house a solar-powered dredging platform. An integrated waterfall serves as a backdrop to pond activities and assists in water aeration and cooling. In the winter the waterfall aspect transforms into an ice climbing tower. A solar panel roof with an open timber frame provides the water runs for the waterfall. The platform could potentially also serve as a stage for outdoor concerts and other functional purposes.

In winter the waterfall aspect transforms into a climbing feature

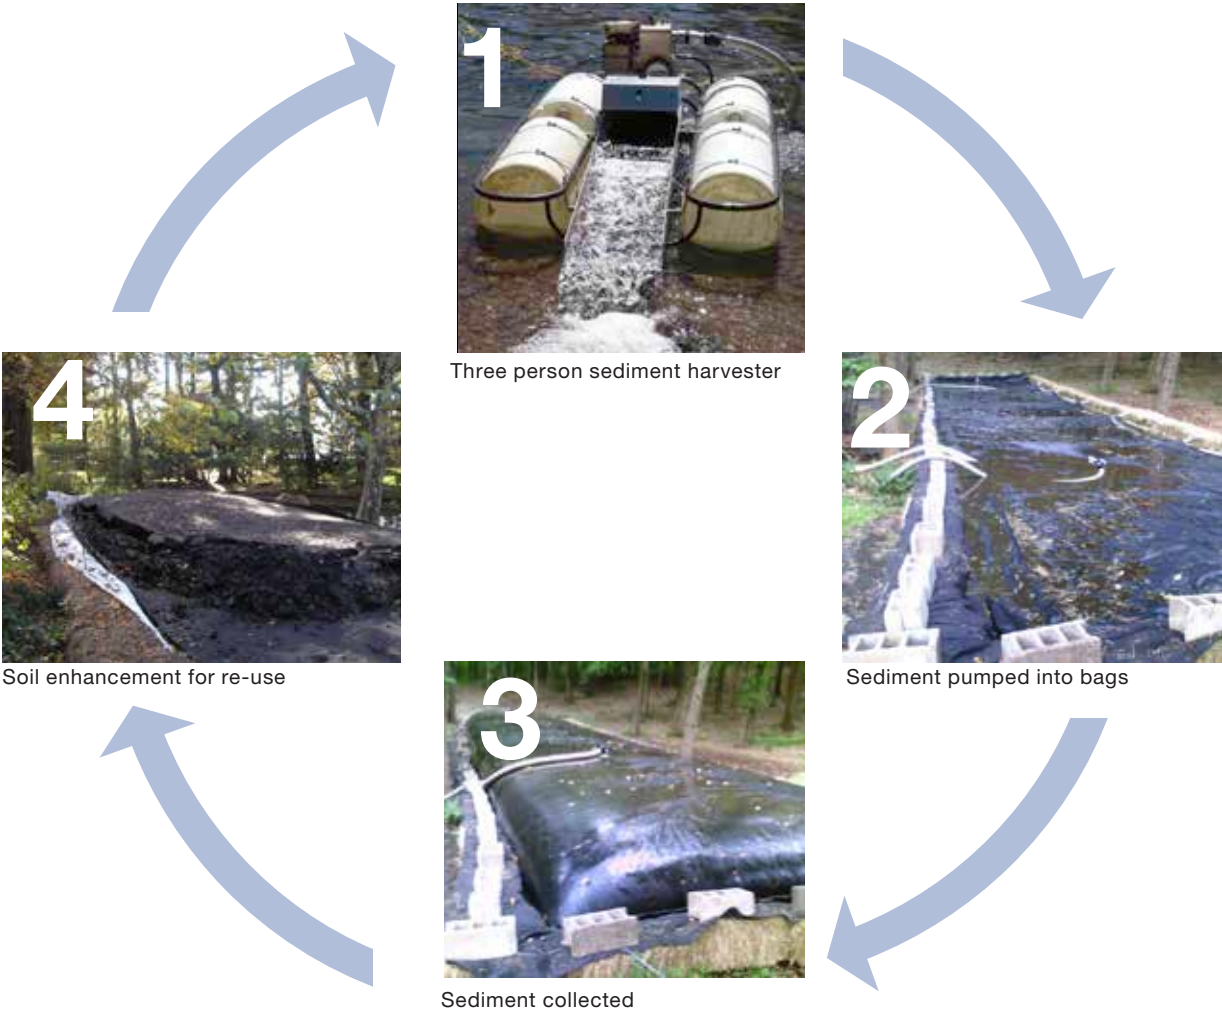
Small scale harvesting of sediment for re-use as soil enhancement can be undertaken through a three person dredging process. As sediment build up occurs, the dredging device can respond with minimal intrusion and expense.

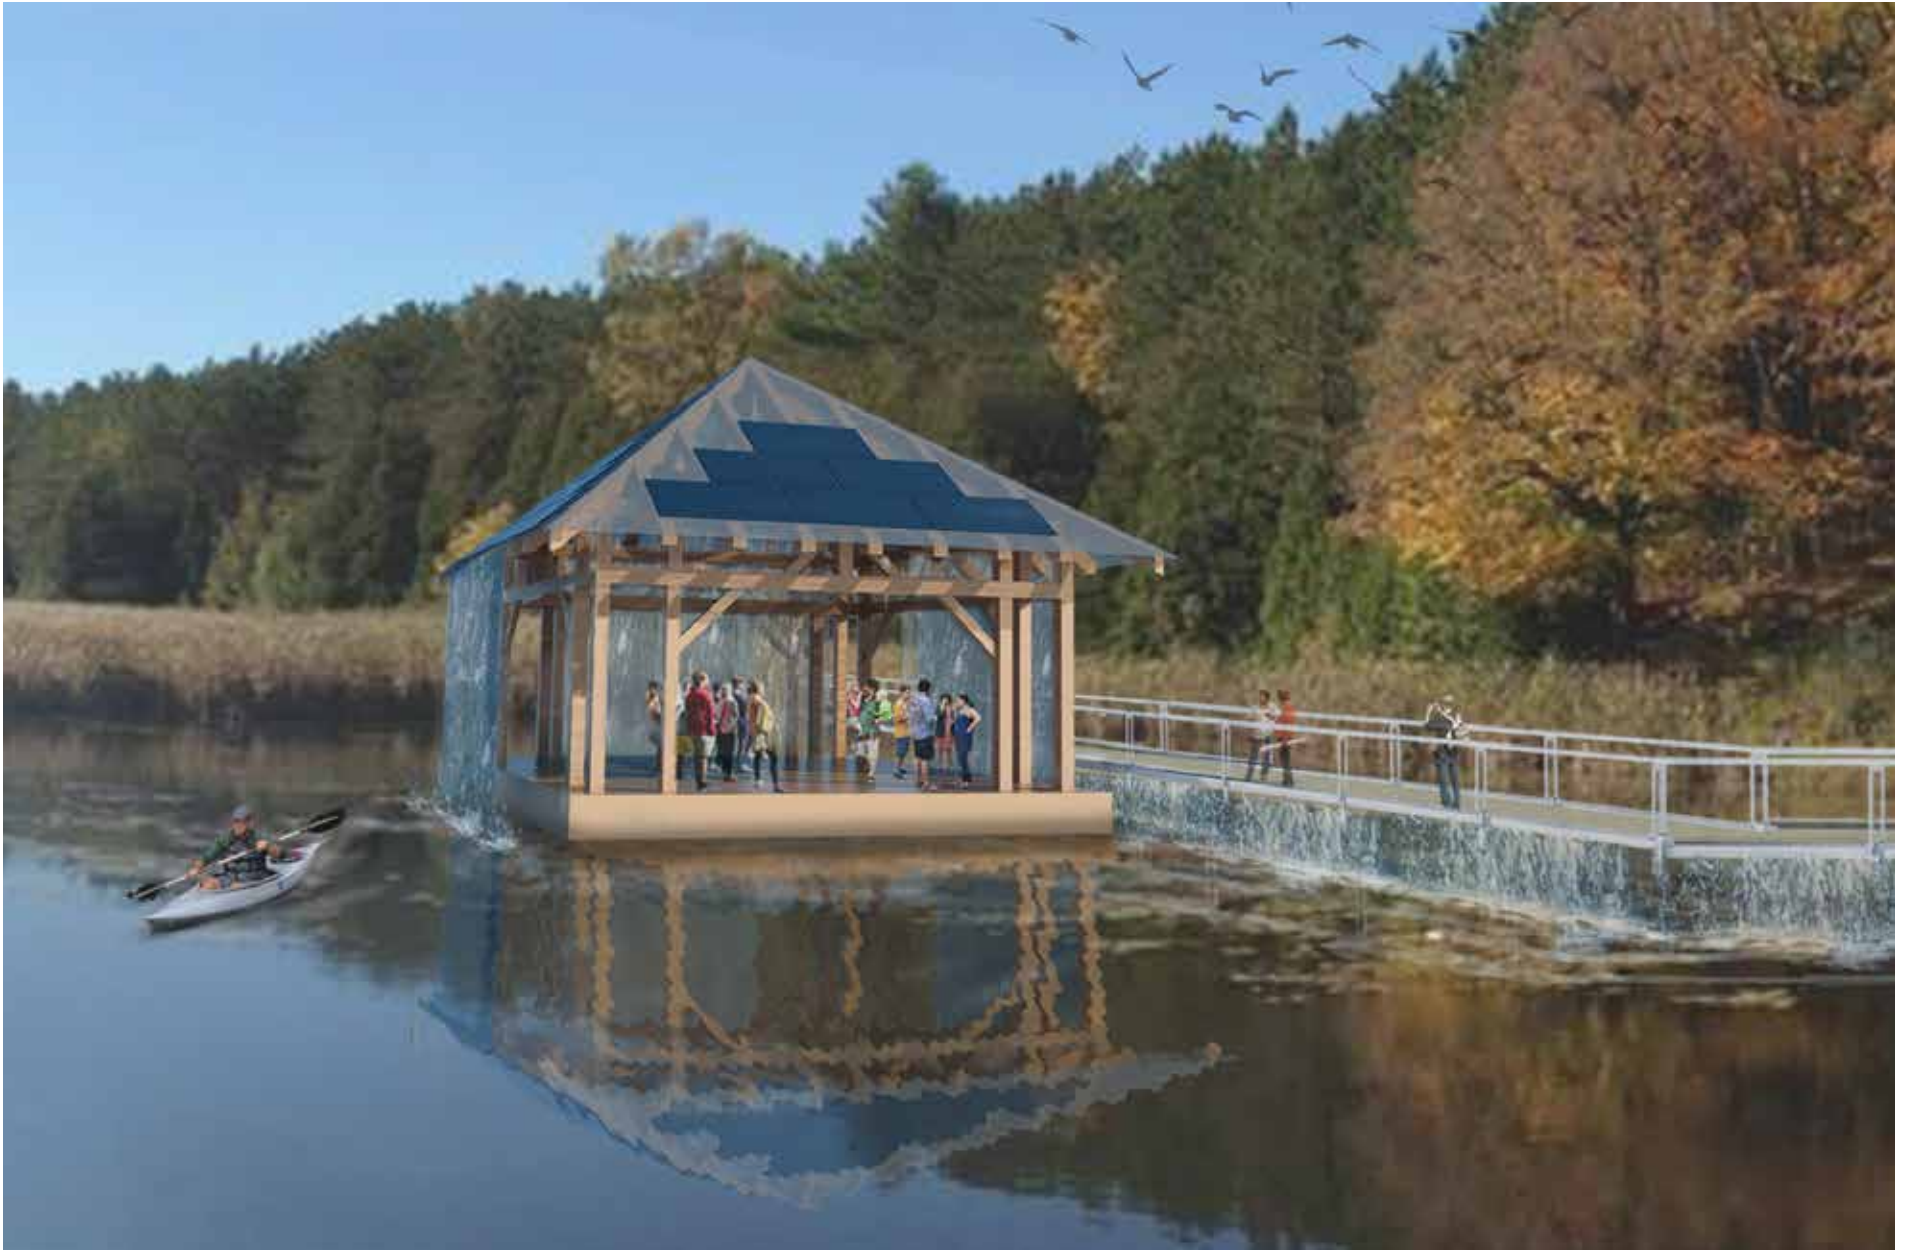
The Floating Platform is a venue for solar water display, stage and event space and houses the solar-powered dredging platform

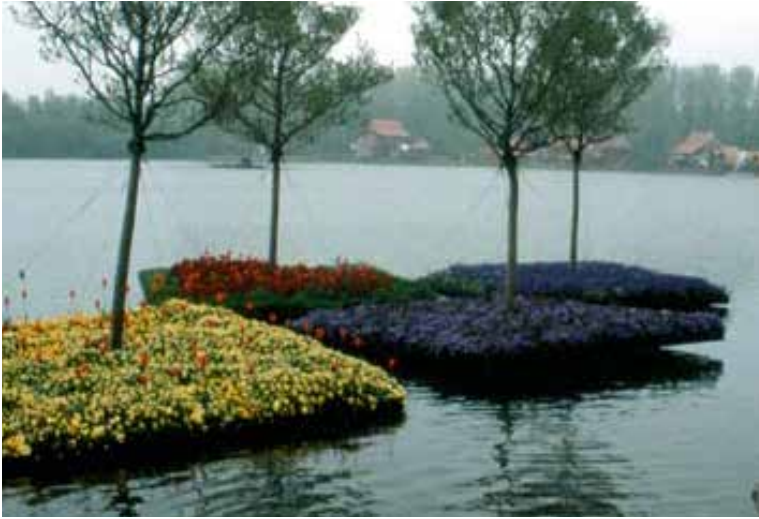
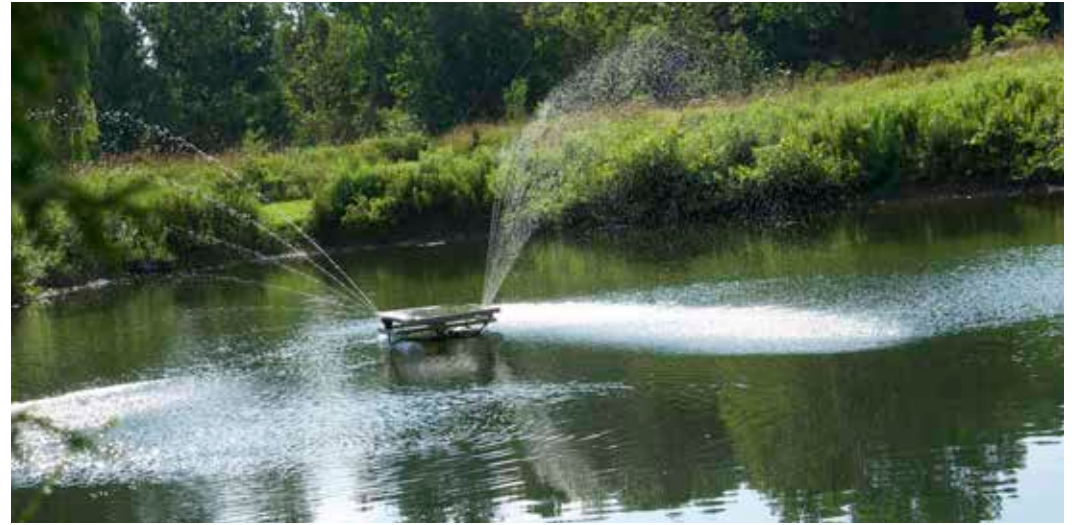
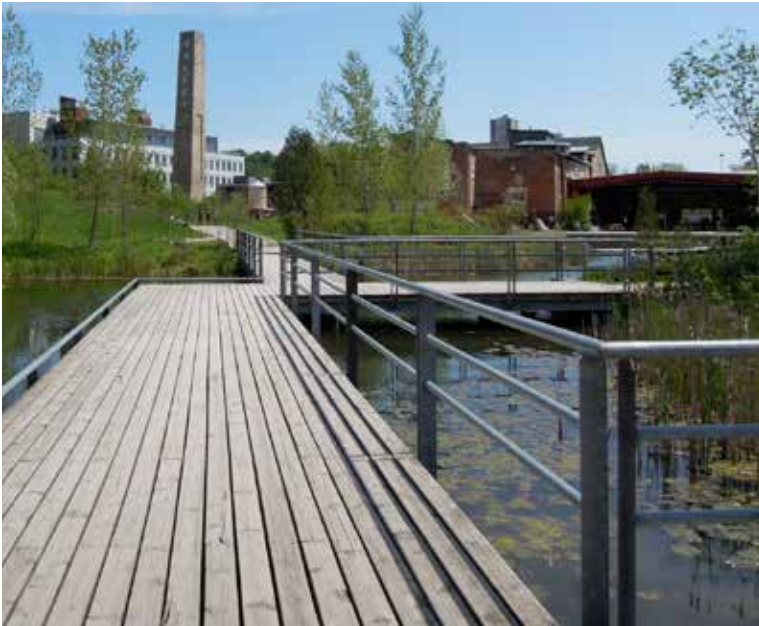
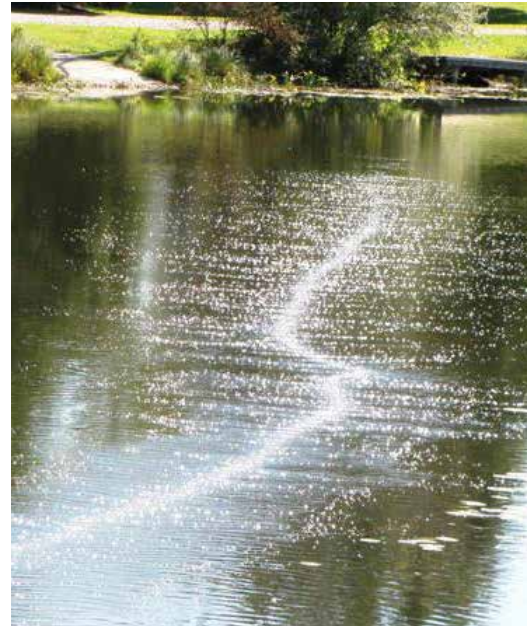
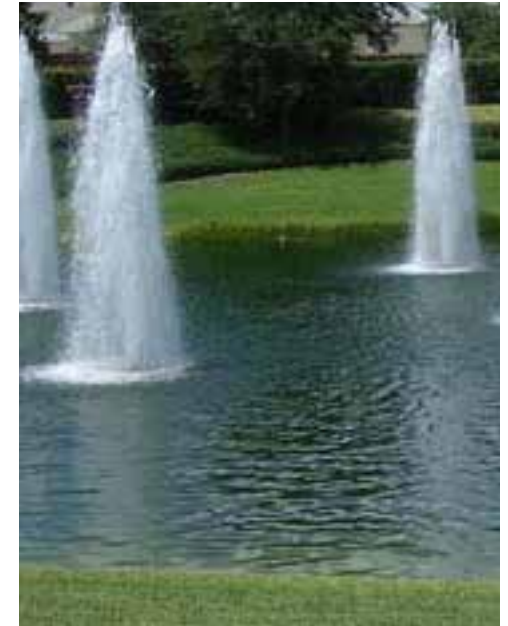
Planted phytoremediation islands and floating walkways add shade to the pond areas and help reduce waterborne toxins. Trees planted to the water's edge and to the berm will also assist in this process.

A flat stagnant water surface allows the sun to heat the surface water. Disturbing of the pond water surface with ripples can assist in reducing the reflective heat build up in the water. Art opportunities to address water temperature include solar-powered floating aeration devices, solar-powered waterfalls and water displays to provide evaporation.

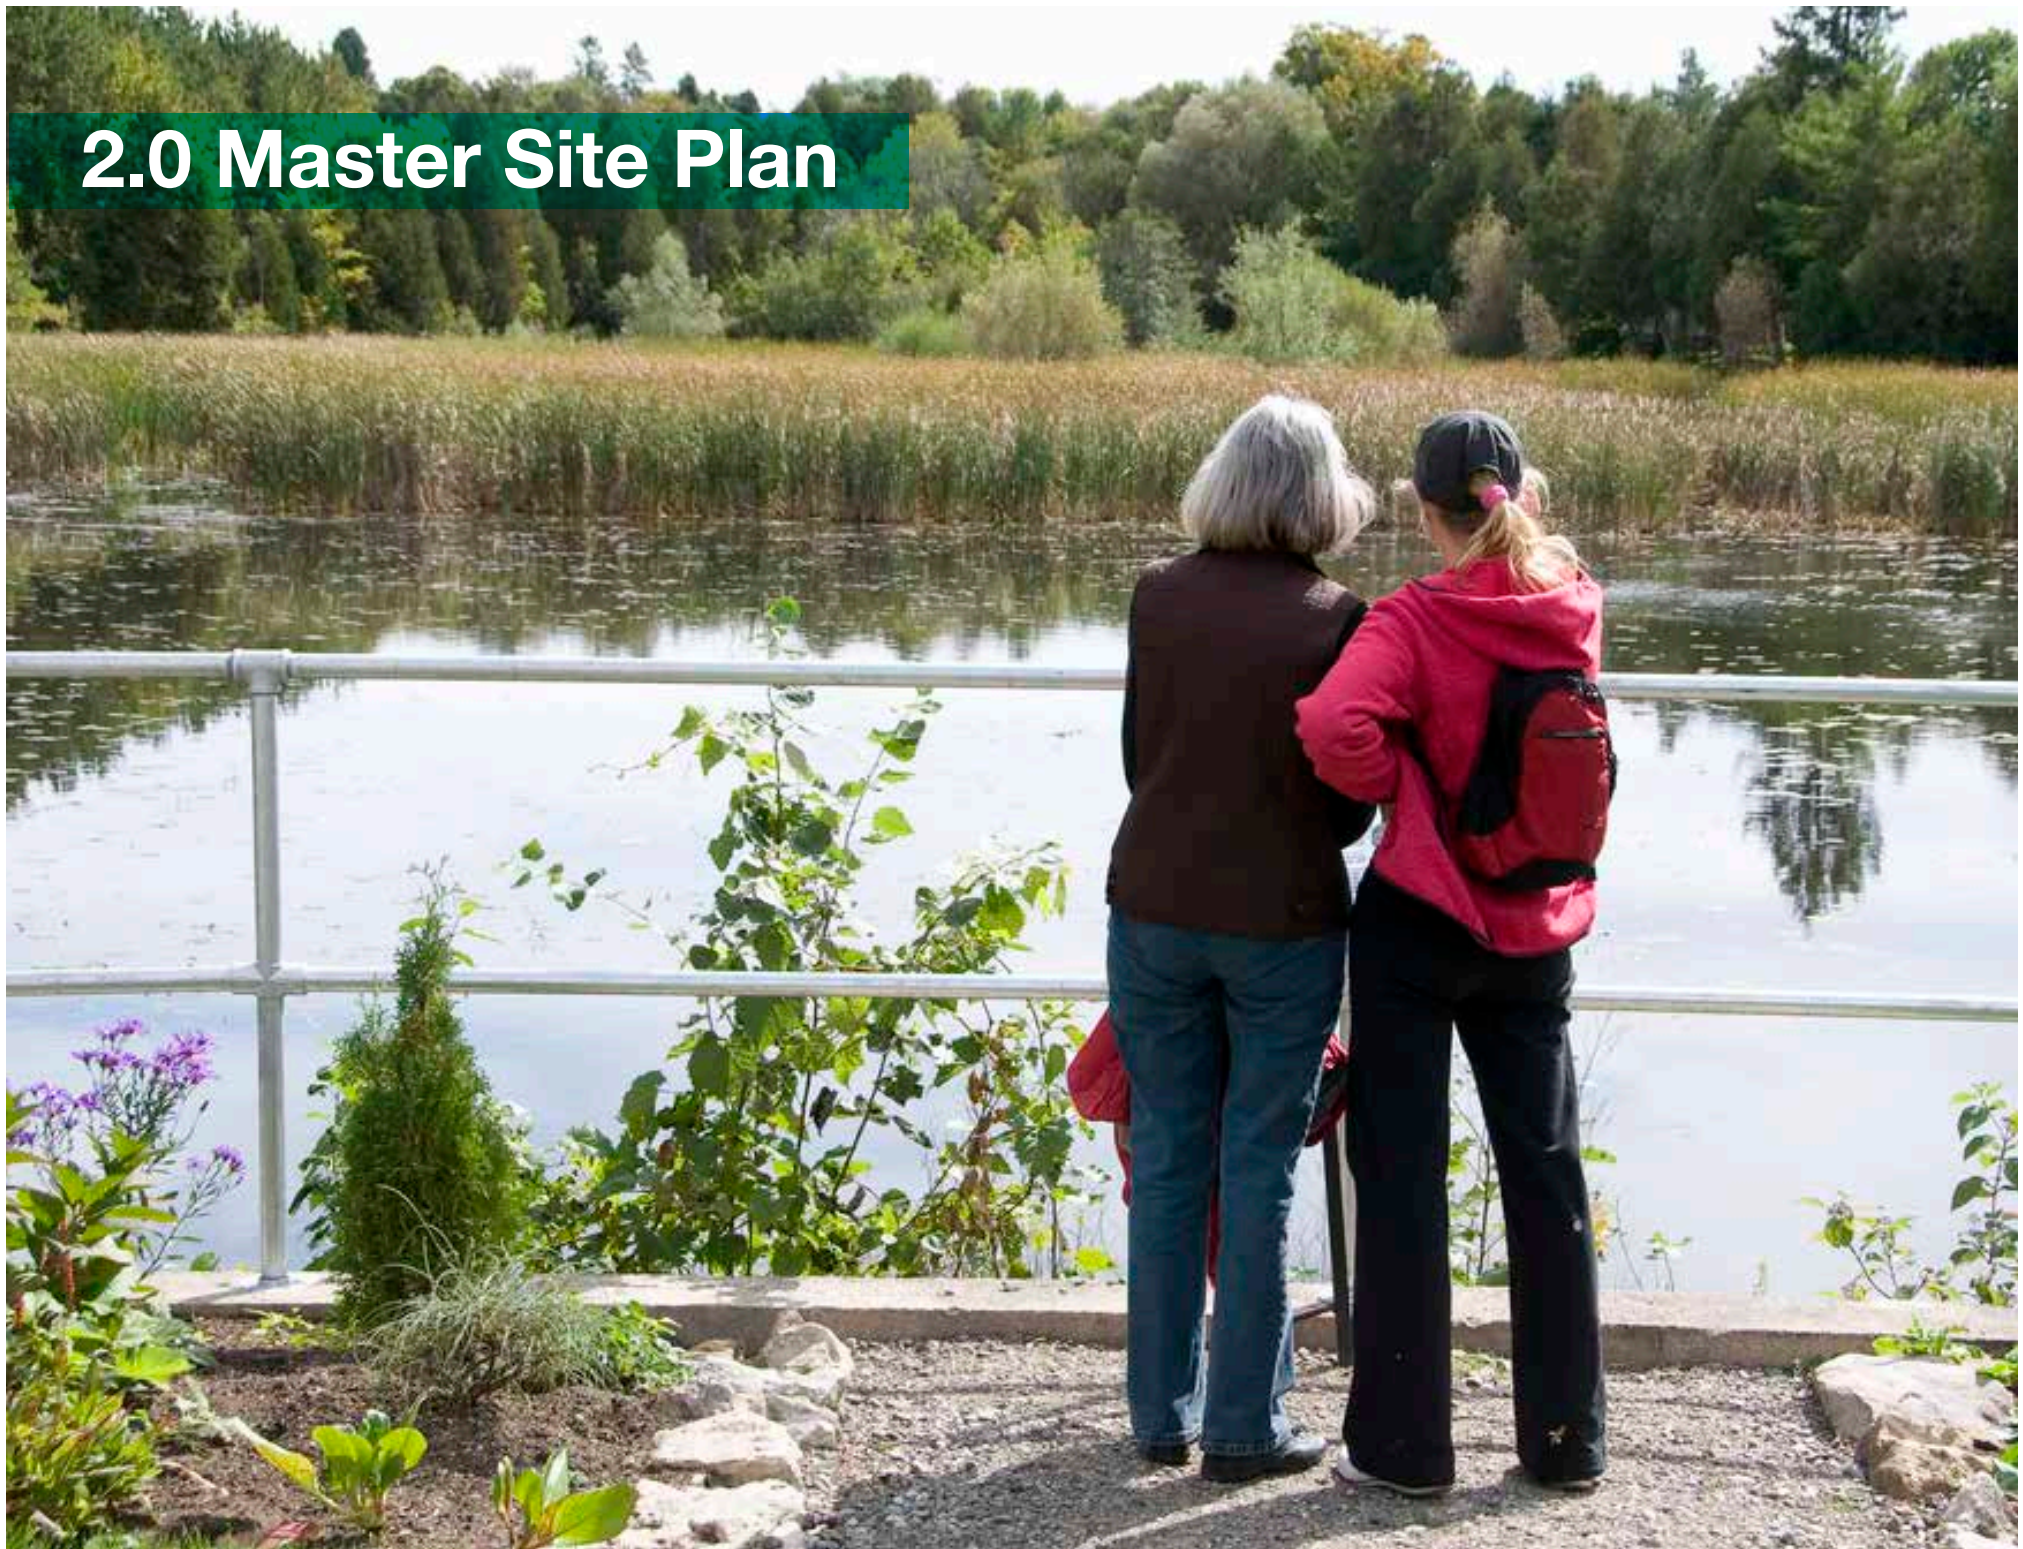
The Master Site Plan

The following plan is an illustrated description of the plan for the site and surrounding context. Detailed 3D illustrated descriptions of component areas of the site are included in the following pages.

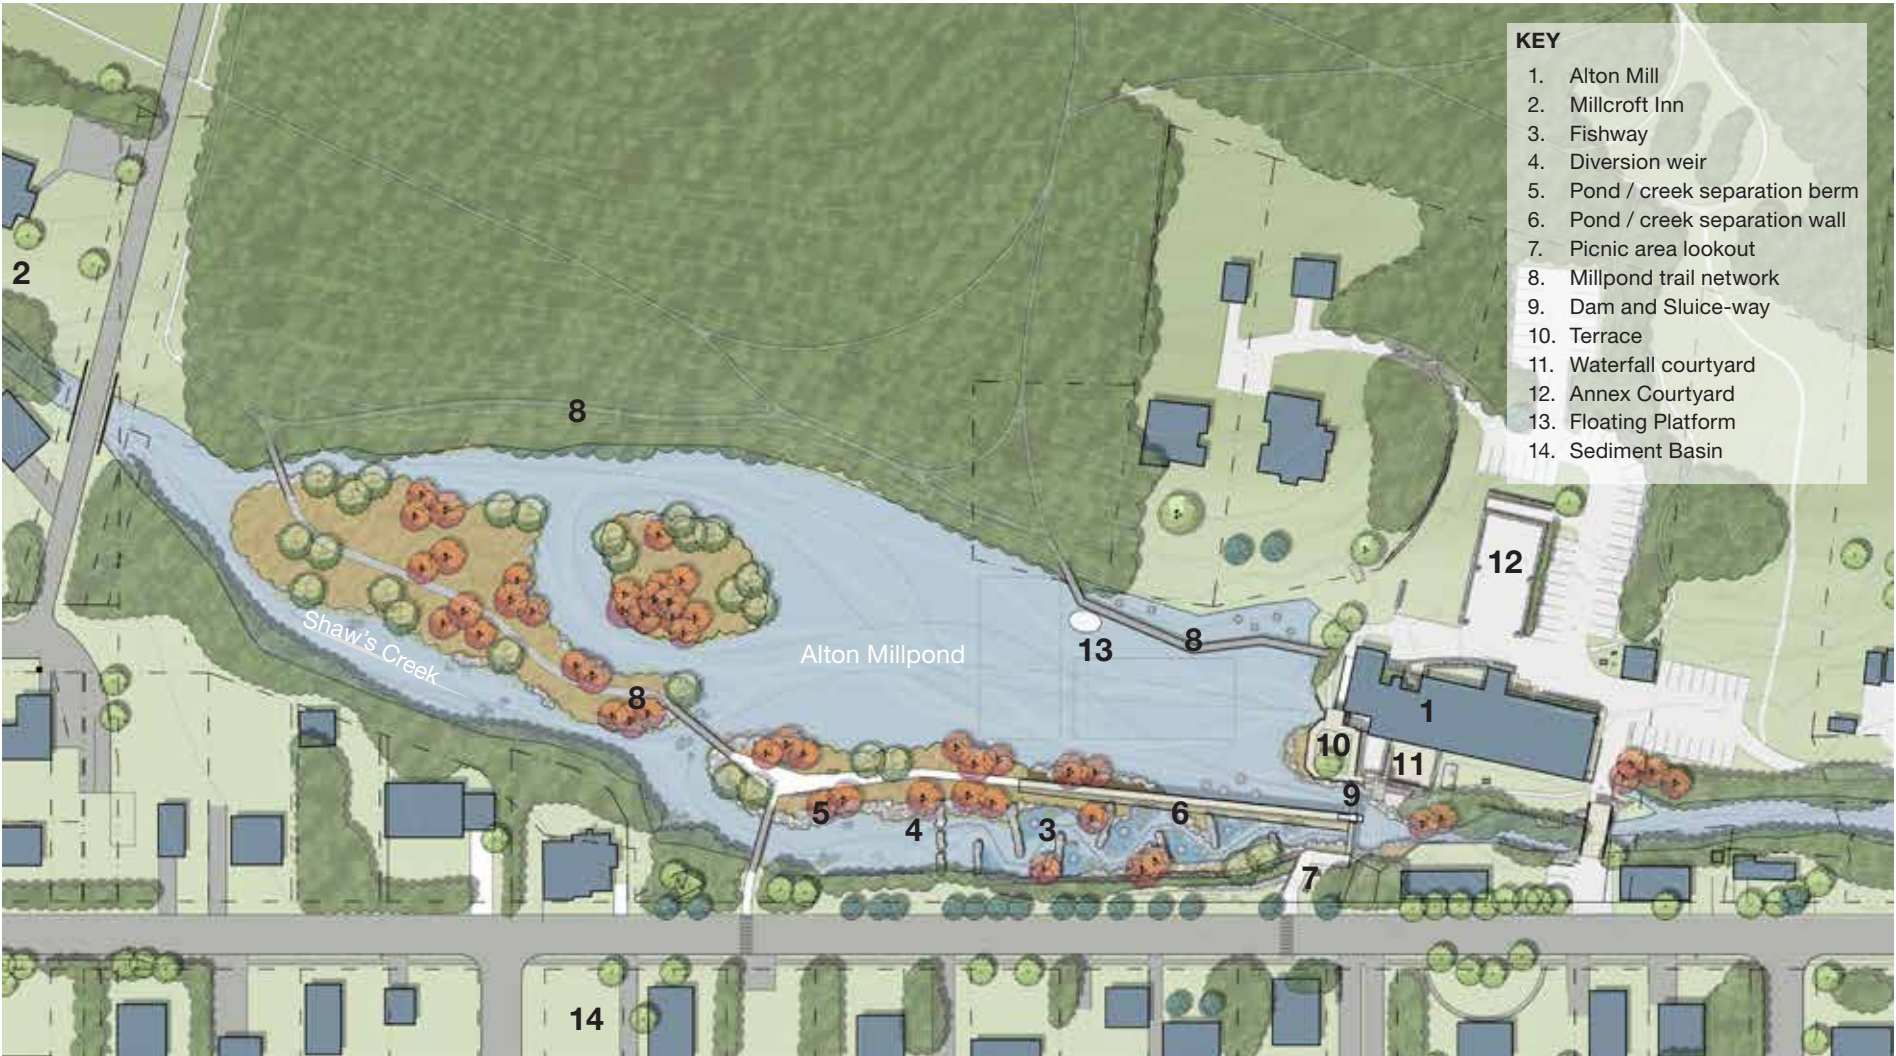
The Master Site Plan is intended to show the preferred way of bringing together the design and planning principles outlined in section 1.
