ALTON MILLPOND

Rehabilitation Master Plan

A Project to Enhance Shaw's Creek, a Tributary of the Credit River

April 2015

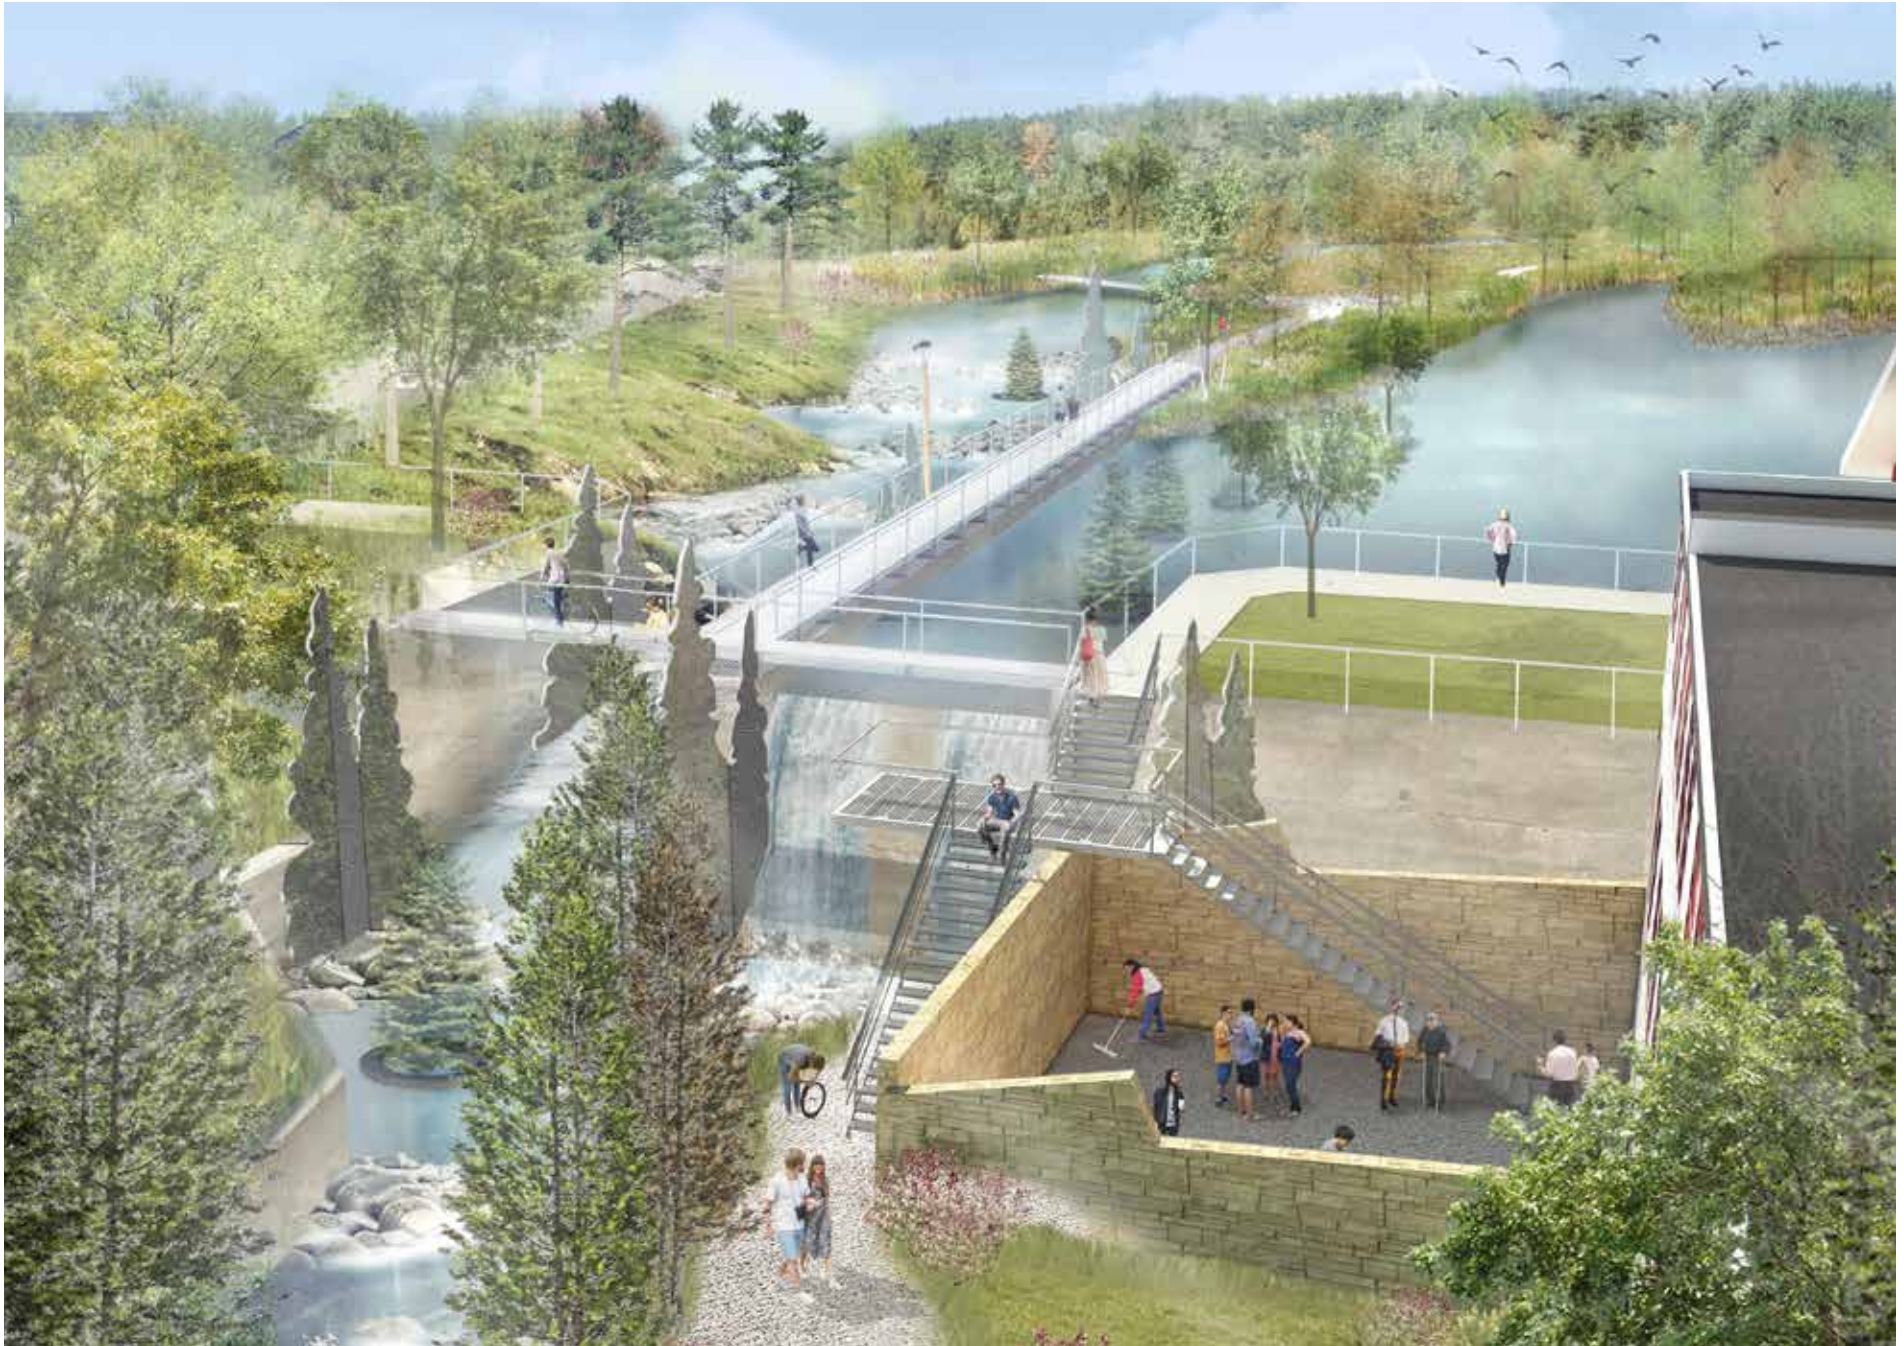
Aerial view looking up the fishway from the Waterfall Courtyard

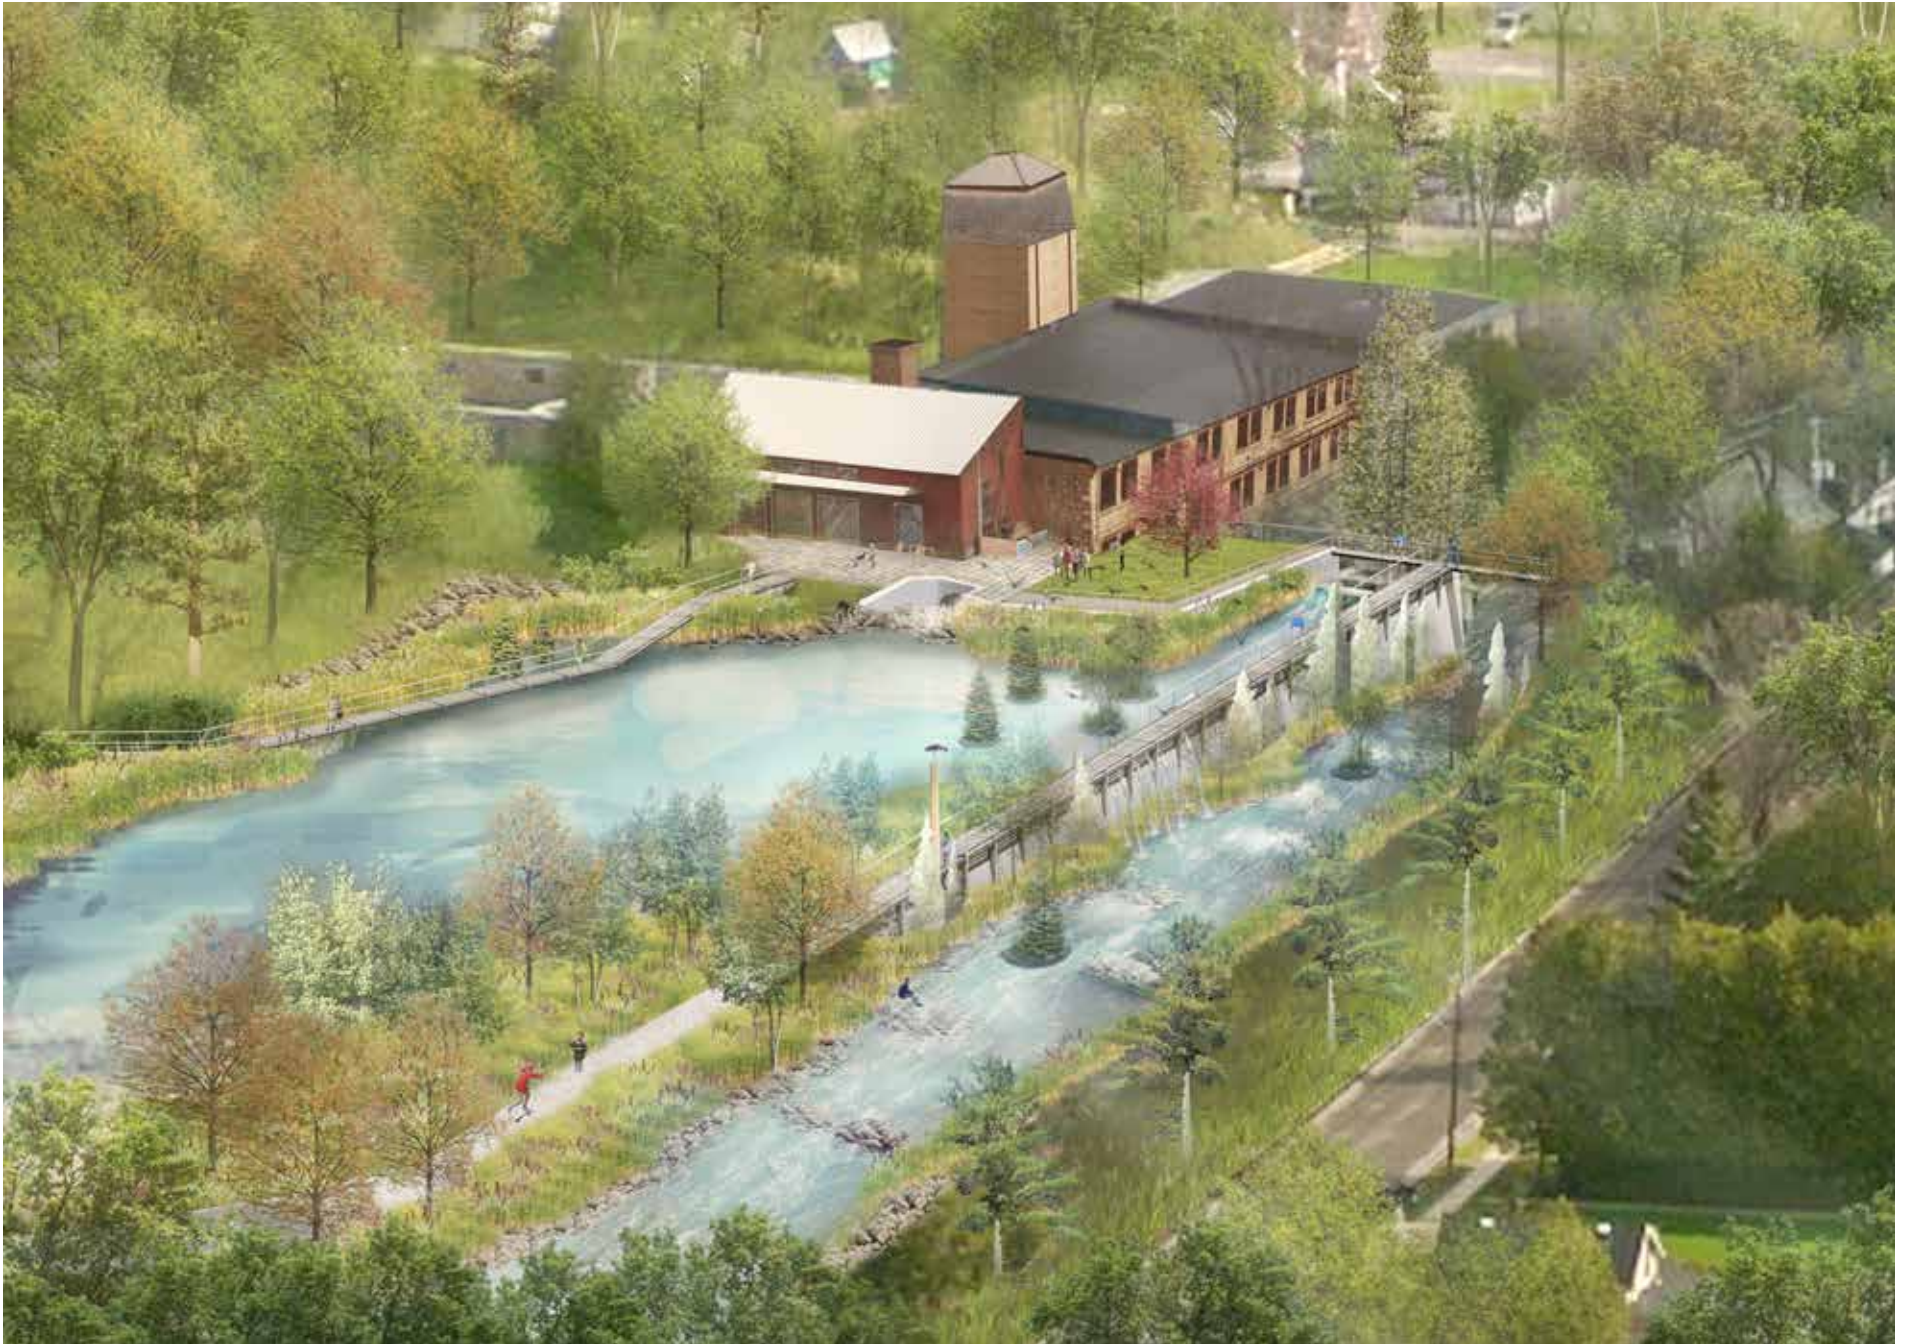
Aerial view looking over the fishway and millpond
