No more problems

Ever since Greller's Backhaus in Langenzenn has replaced the kneading troughs of its bread roll lines with UltraLow-Hygiene Technology, mold stains are a thing of the past.

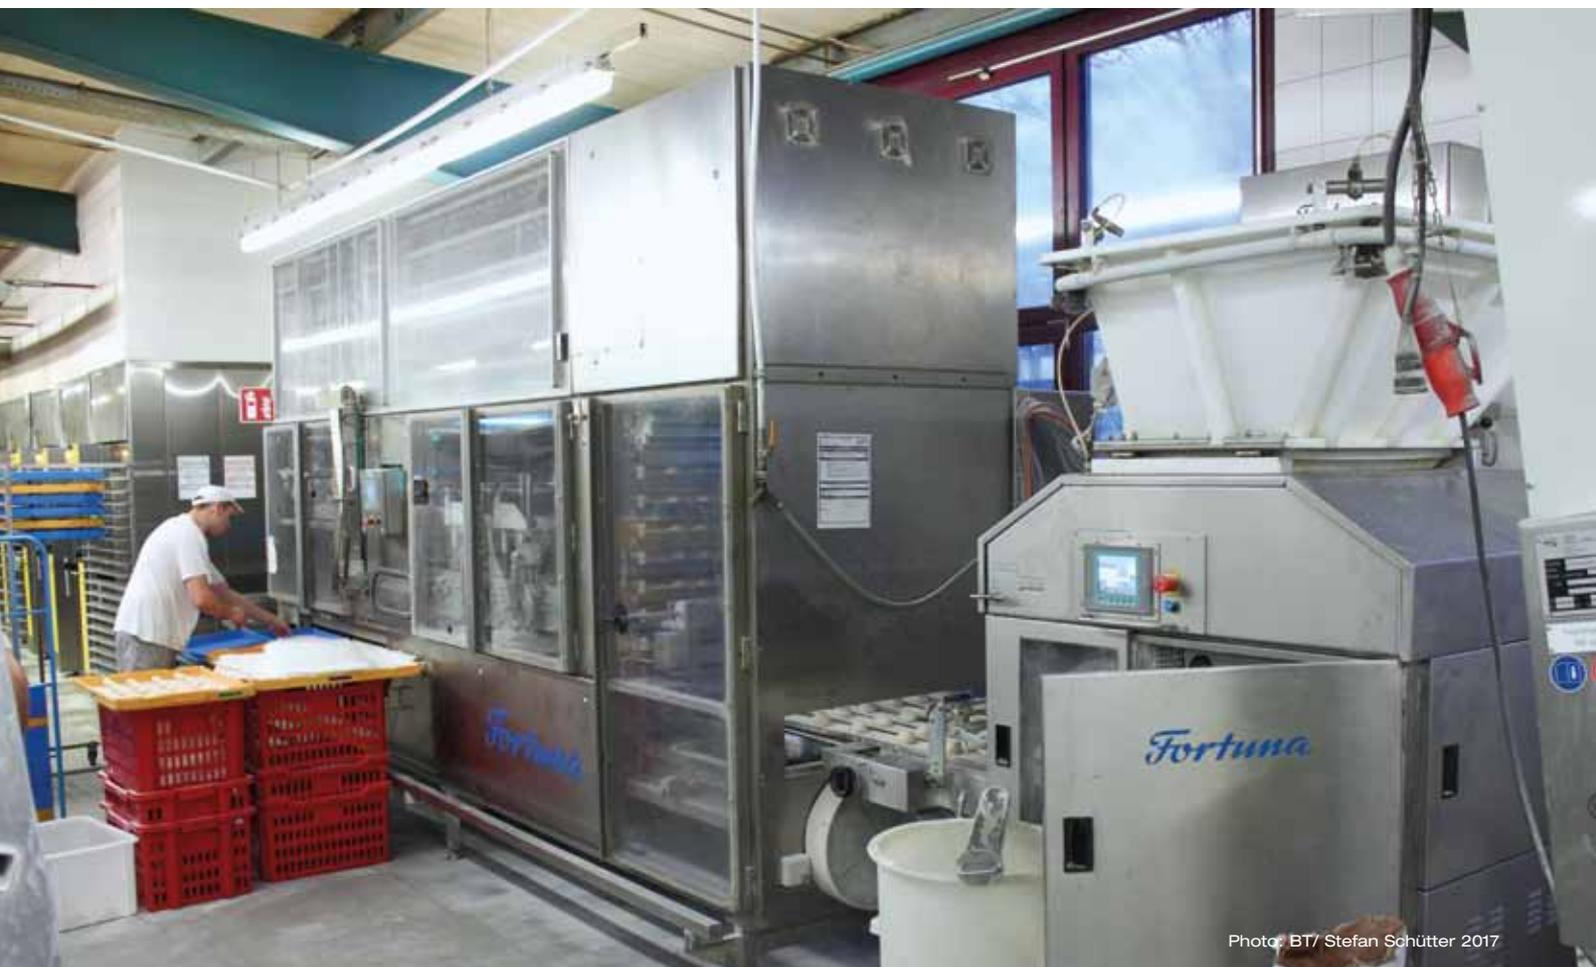
[1] The spreading belts of the dividing system were not provided with a coating, because the dough pieces are only on them for a couple of seconds. [2] All 360 proofing troughs and 20 cutting means as well as the lower band of the long molding unit have been coated since early 2015, however. [3] As can be seen, the troughs in use on the line no longer suffer from mold stains. The troughs shown in the picture were cleaned with a brush two weeks ago.

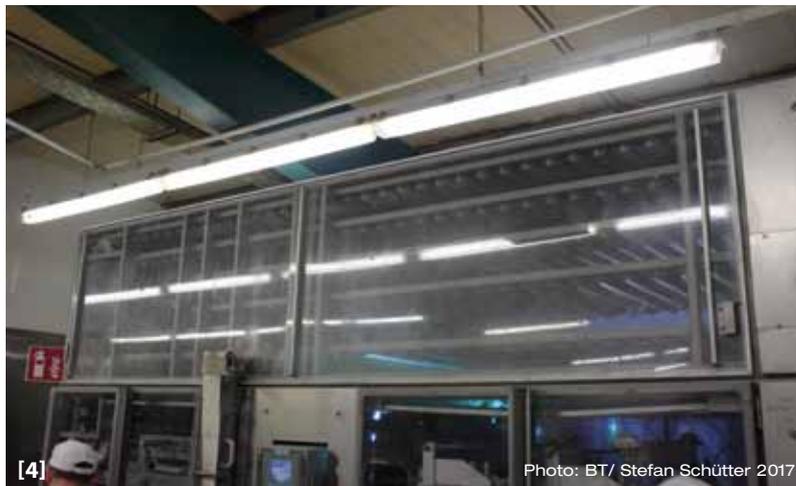
[4] The processing time through the proofing cabinet is almost one hour, which is why the troughs were provided with an antibacterial coating. [5] For the manufacturing of split rolls, a single flour duster directly behind the dividing system suffices. Kaiser rolls use an additional duster ahead of the embossing apparatus. [6] The hygiene coating is hygroscopic and can absorb a share of the moisture, which the dough pieces are giving off to the troughs. That is why they are not sticking.

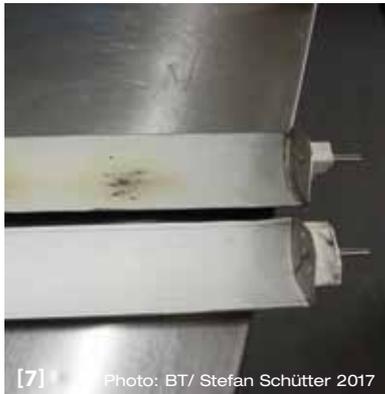
[7] Photo: BT/ Stefan Schütter 2017

[7] The uncoated troughs (top) have been subject to mold stains over time. The newly coated troughs are immaculately clean and will remain so. [8] The dough trays on which the dough pieces are automatically placed by the line do not suffer from mold stains either.

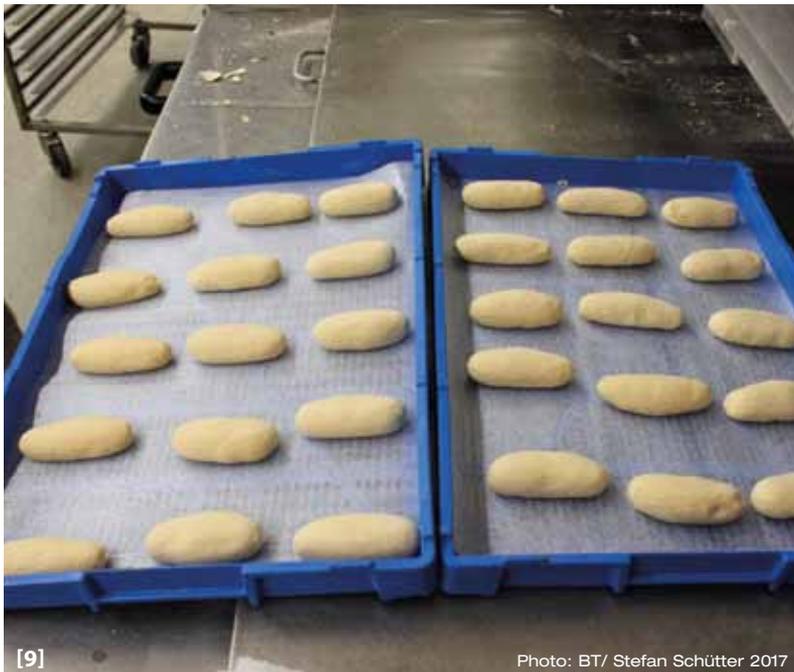
[9] For hygiene reasons, the trays for extended dough pieces are made of plastic. The placed foam pieces are replaced after 2-3 runs [10] An active UV sterilization allows the webs on proofing troughs to cure and become brittle over time. Thanks to the coating, this UV sterilization is no longer required, however.

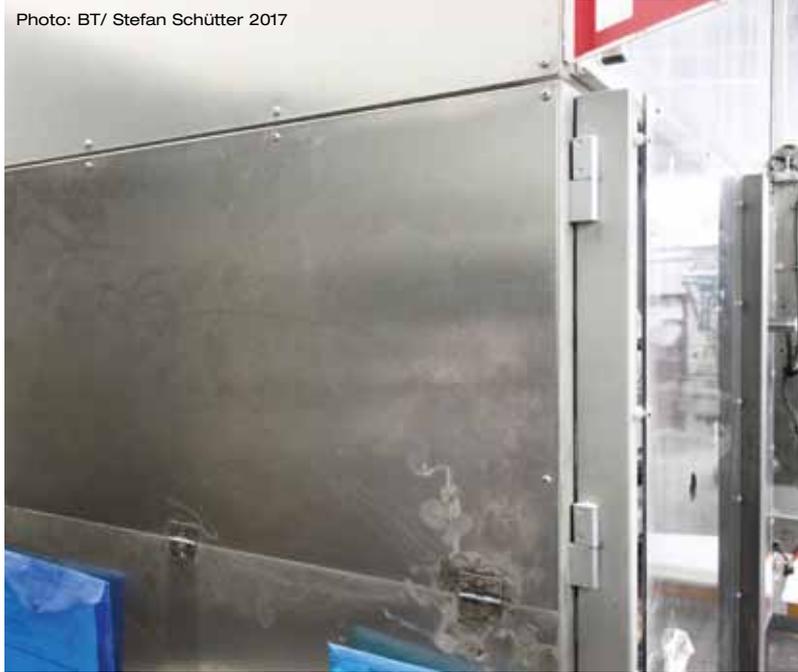
In order to be able to reach the troughs in the proofing cabinet more easily for replacement or cleaning, the line was fitted with a large "service hatch".
