# Toorumbree Creek to Belgrave Falls Reach Plan

## River Assessment and Management Plan

**December 2014**

Final report prepared by NSW DPI – Fisheries NSW, a part of the Department of Trade and Investment, Regional Infrastructure and Services for NSW North Coast Local Land Services.

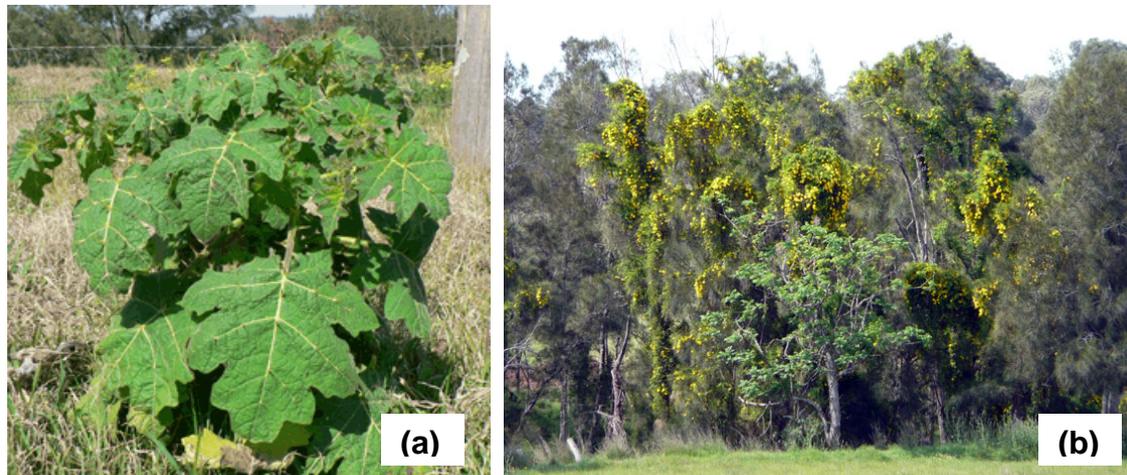
Figure 2: (a) Tropical Soda Apple (*Solanum viarum*) and (b) Cat's Claw Creeper (*Dolichandra unguis-cati*). Photos: Kempsey Shire Council and NSW DPI.

Tropical Soda Apple (*Solanum viarum*) and Cat's Claw Creeper (*Dolichandra unguis-cati*) have been identified as significant problems in the study area (Figure 2a and b).

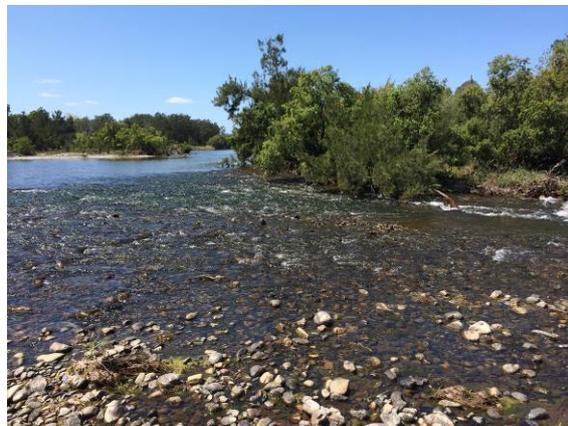
During field assessments, Toorumbee Creek appeared to be contributing significant quantities of coarse sediments in the Macleay trunk stream. It was also noted that Nulla Nulla Creek (upstream of the study site) was also contributing finer gravels of significant enough quantity to form a tributary mouth bar at the confluence with the Macleay.

Figure 5: Downstream of Turners Flat.

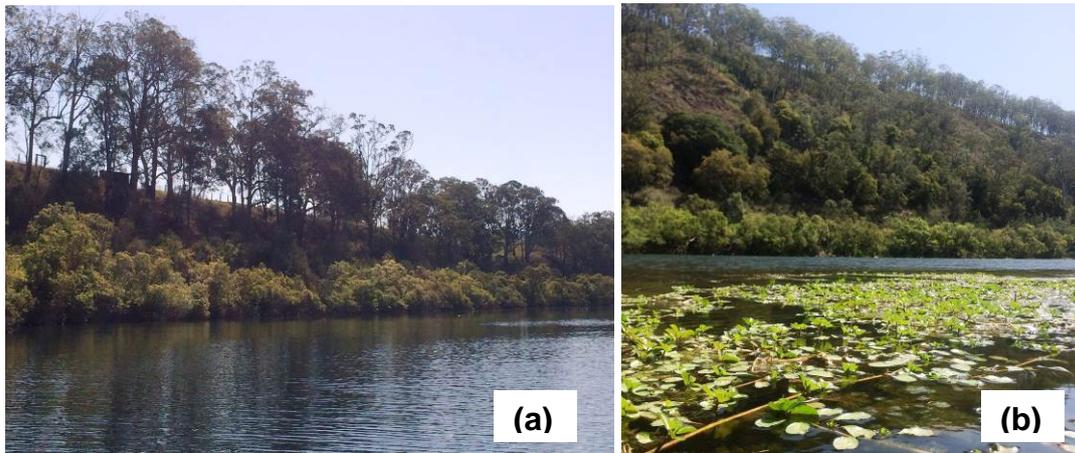
Figure 8: (a) Typical good condition riparian vegetation with *Callistemon* along the edge and *Eucalypts* set further up the bank. (b) *Water primrose* is visible in the left foreground.

Riparian vegetation condition was variable throughout the 20 m buffer study area ranging from healthy, intact areas to quite degraded stretches that were devoid of canopy cover combined with eroding banks and dominated by exotic plant species. Figure 8 shows examples of sites with good riparian vegetation and in-stream emergent vegetation.

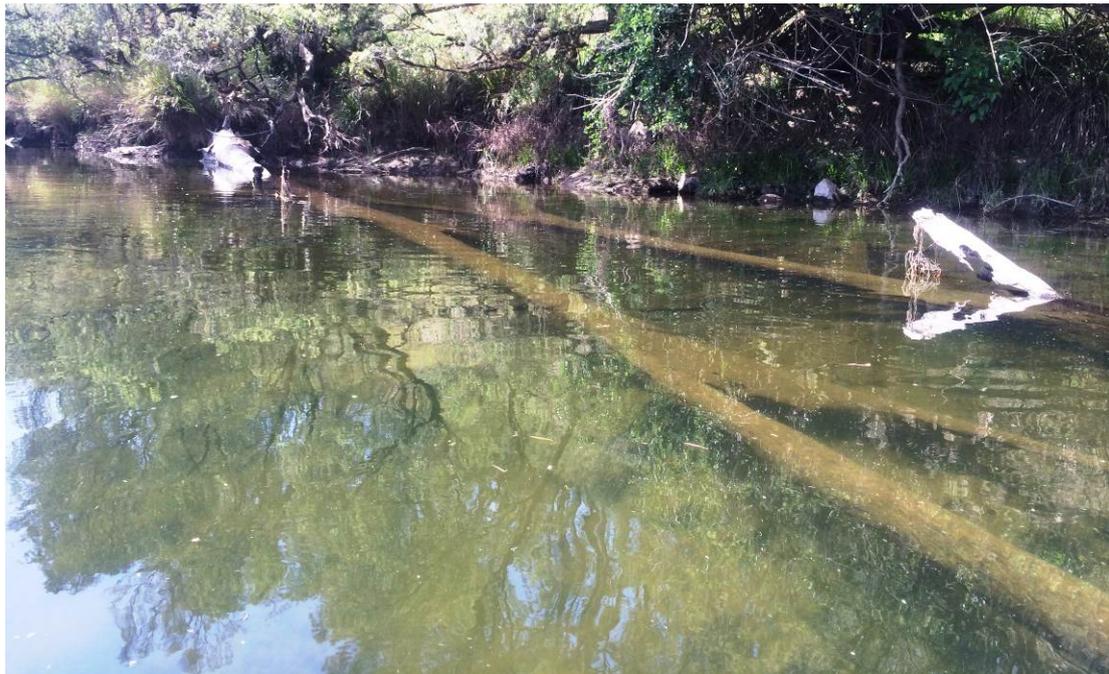
*Figure 13: In-stream snags.*

Large Woody Habitat (LWH) is a major ecological and structural element of many Australian waterways and provides valuable habitat for aquatic and terrestrial species (Figure 13). In-stream LWH provides spawning sites, shelter and resting places and territorial markers for several species of native fish. In many cases, LWH assists in developing scour pools and preventing erosion through bank stabilization. As the wood breaks down it provides food for benthic algae, invertebrates and microorganisms that form the basis of the food web.

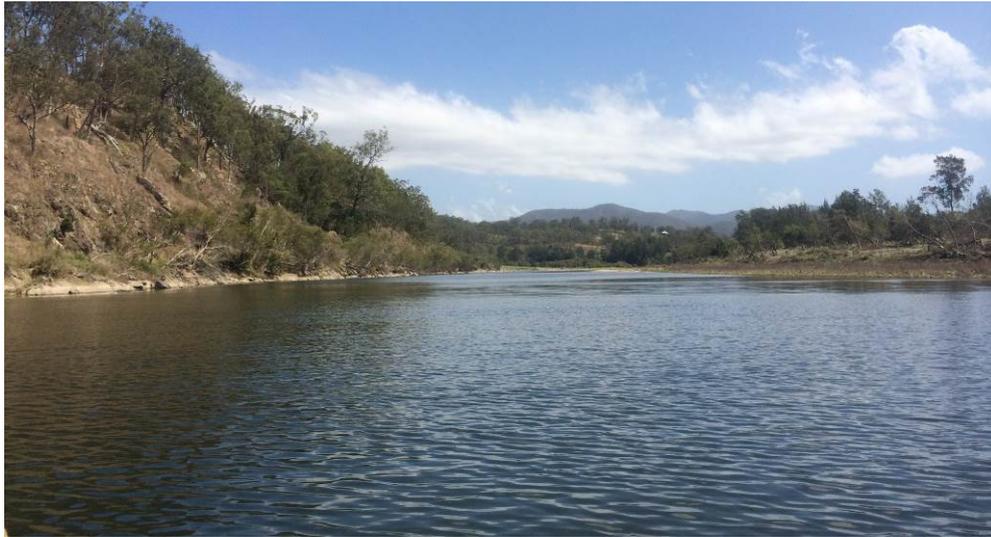
Figure 15: Drought refuge pool.

Thirty eight refuge holes were identified along the 47 km study area (Figure 15). For the project, they were defined as being those bodies of water in excess of two metres depth.

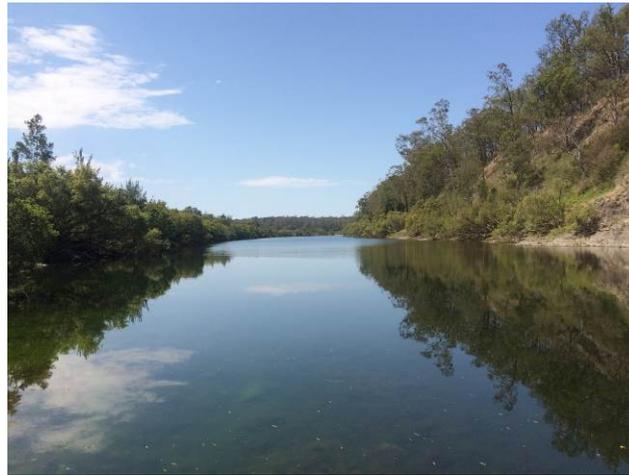
Drought refuge (Figures 15 and 17) is an essential habitat feature in determining protection and rehabilitation priorities and is weighted accordingly.

Figure 17: Drought refuge pool.

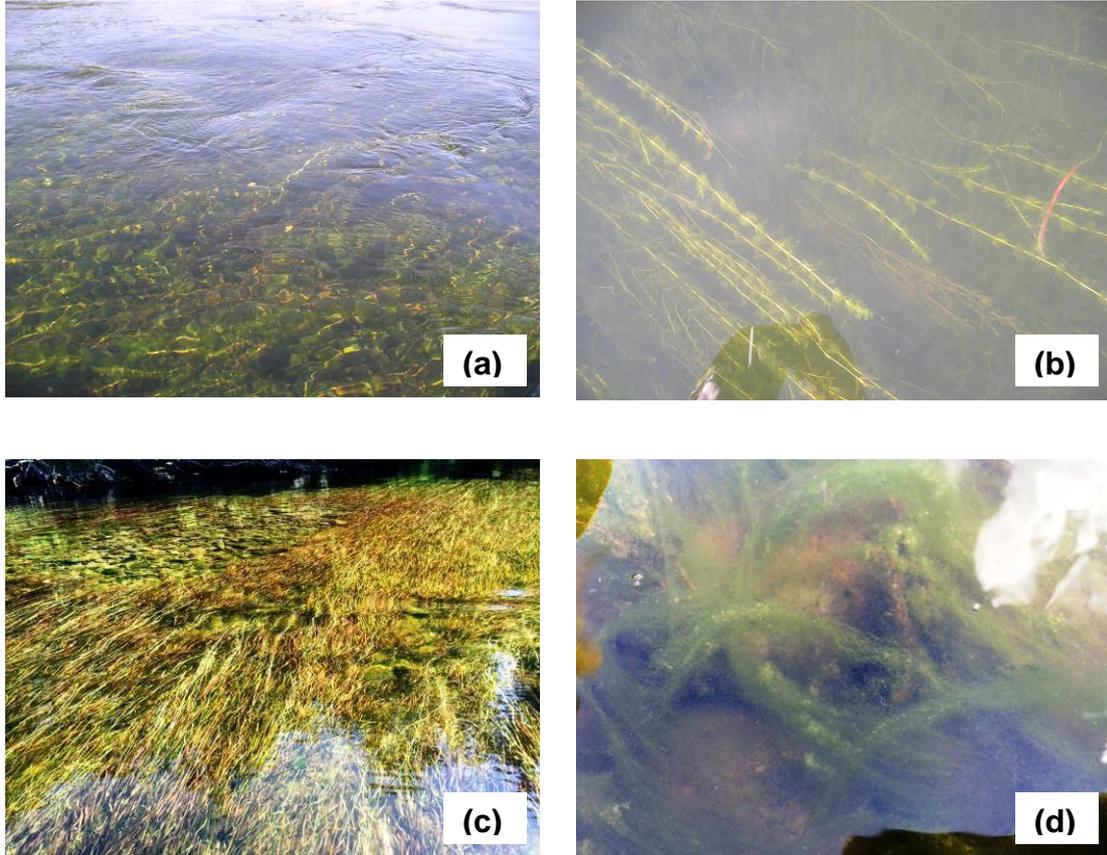
Filamentous green algae was observed throughout the study area indicating high nutrient levels, however growth never dominated or caused smothering of other species.

Submerged macrophytes also occurred throughout the study area, the most common being *Potamogeton* spp. which was observed growing in deeper water of refuge holes up to and including shallow pools (Figure 18).

Figure 18: Submerged aquatic vegetation observed (a) likely *Potamogeton perfoliatus* bed, (b) mixed species including *P. crispus* and *Myriophyllum* spp., (c) *Vallisneria nana* bed with catfish nest in back left corner, (d) filamentous algae.

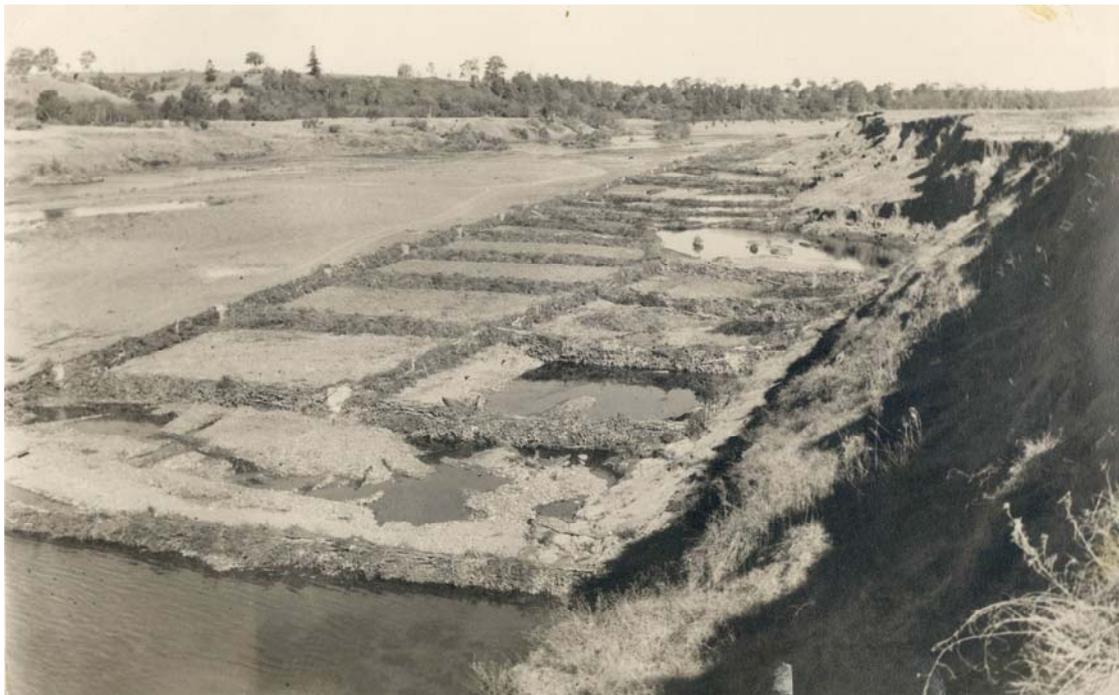
The cables were originally hung with bamboo mesh curtains interlaced with vegetation to divert water flows, but these washed away after their installation (Ron Kemsley, pers. comm.) (see Figure 24 b).

Figure 24 b: Configuration of concrete blocks, cables and vegetation screens.  
Source: Ron Kemsley, Kempsey Shire Council

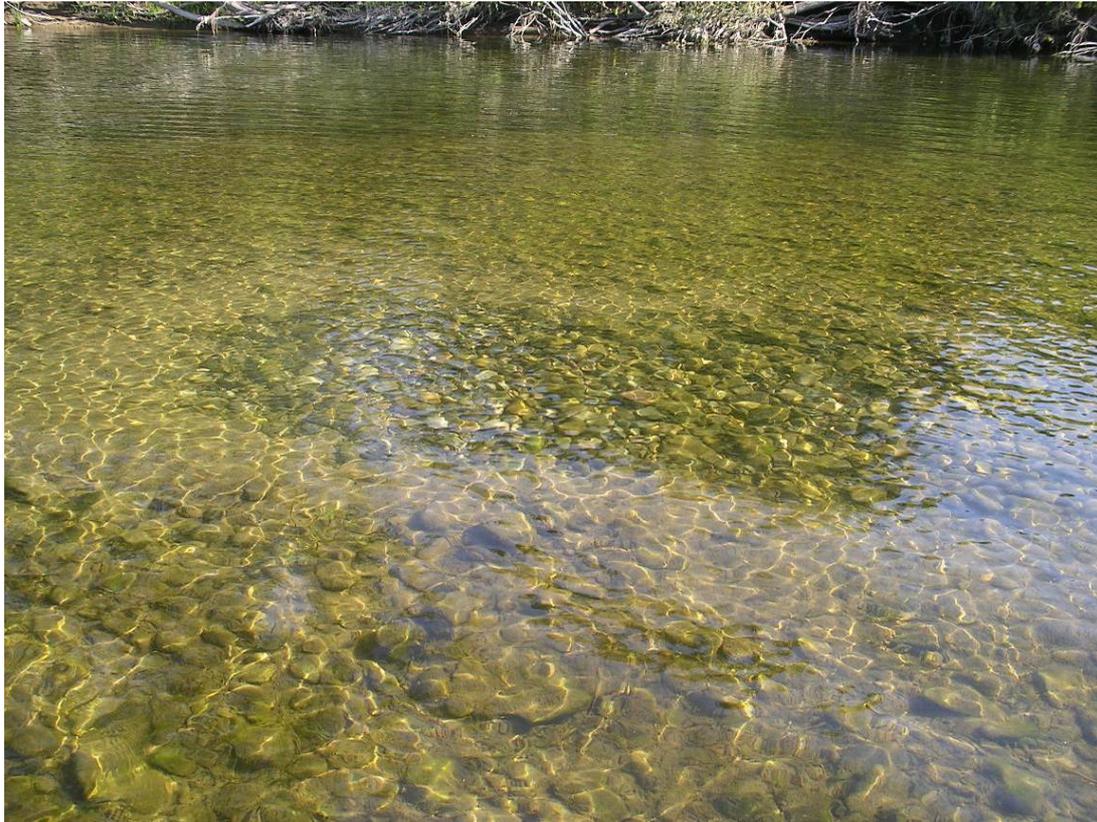
Figure 26: Circular gravel nest of Freshwater Catfish (*Tandanus tandanus*) in a shallow pool.

- Freshwater Catfish (*Tandanus tandanus*) nests were present in many shallower areas of reaches – particularly in shallow pools or in shallower sections of refuge holes (Figure 26).

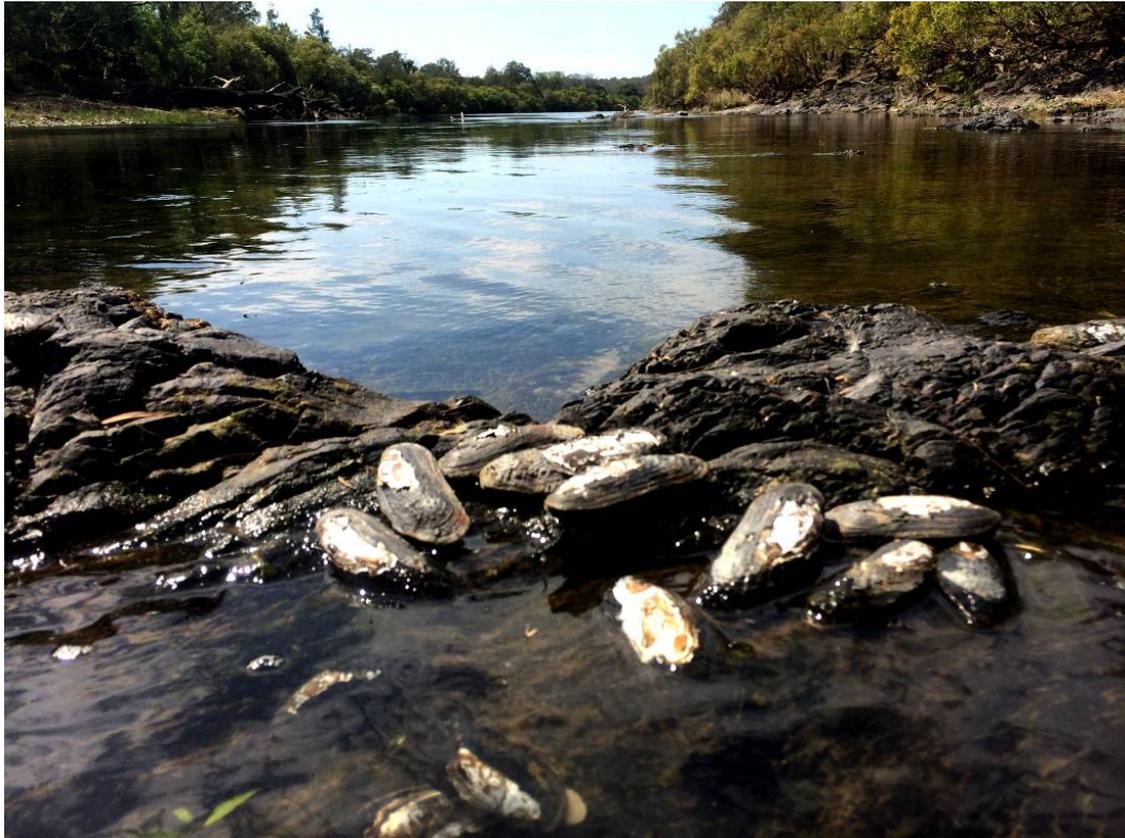
- Water Rat (*Hydromys chrysogaster*) evidence in the form of piles of live mussel hoards stashed on the bank near deep holes was not an unusual occurrence (Figure 27).

*Figure 27: Freshwater Mussel hoard (Family Unionidae) – indication of Water Rat activity.*

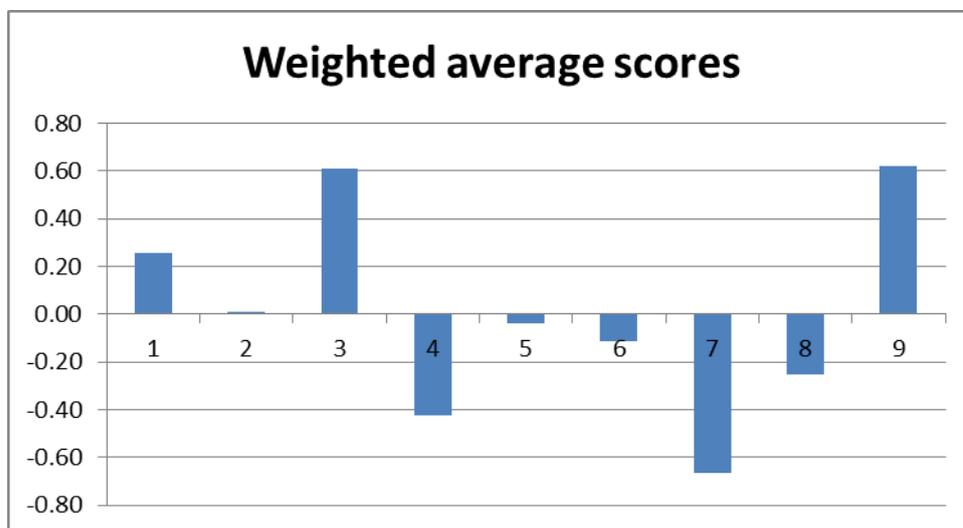
Figure 28: Weighted average scores give relative rankings for the nine reaches.

Figure 28 indicates relative ranking of the nine Reaches – those which have a positive value are ranked higher than those with negative values.

Reaches 9 and 3 were identified as the two sections in the best overall condition and hence recognised as the highest priorities for future enhancements to maintain their integrity into the future. Conversely, those reaches with poorer scores are ranked less highly for rehabilitation purposes.

The next highest ranking was attributed to Reach 3 largely because it offered the single largest number of well-sized refuge pools, providing ample opportunities for fish habitat. This provides a sound basis for improving the remaining key variables, such as the relatively low snag score in this reach.

The reach judged to be in the poorest condition was Reach 7 (-0.67 weighted average score).

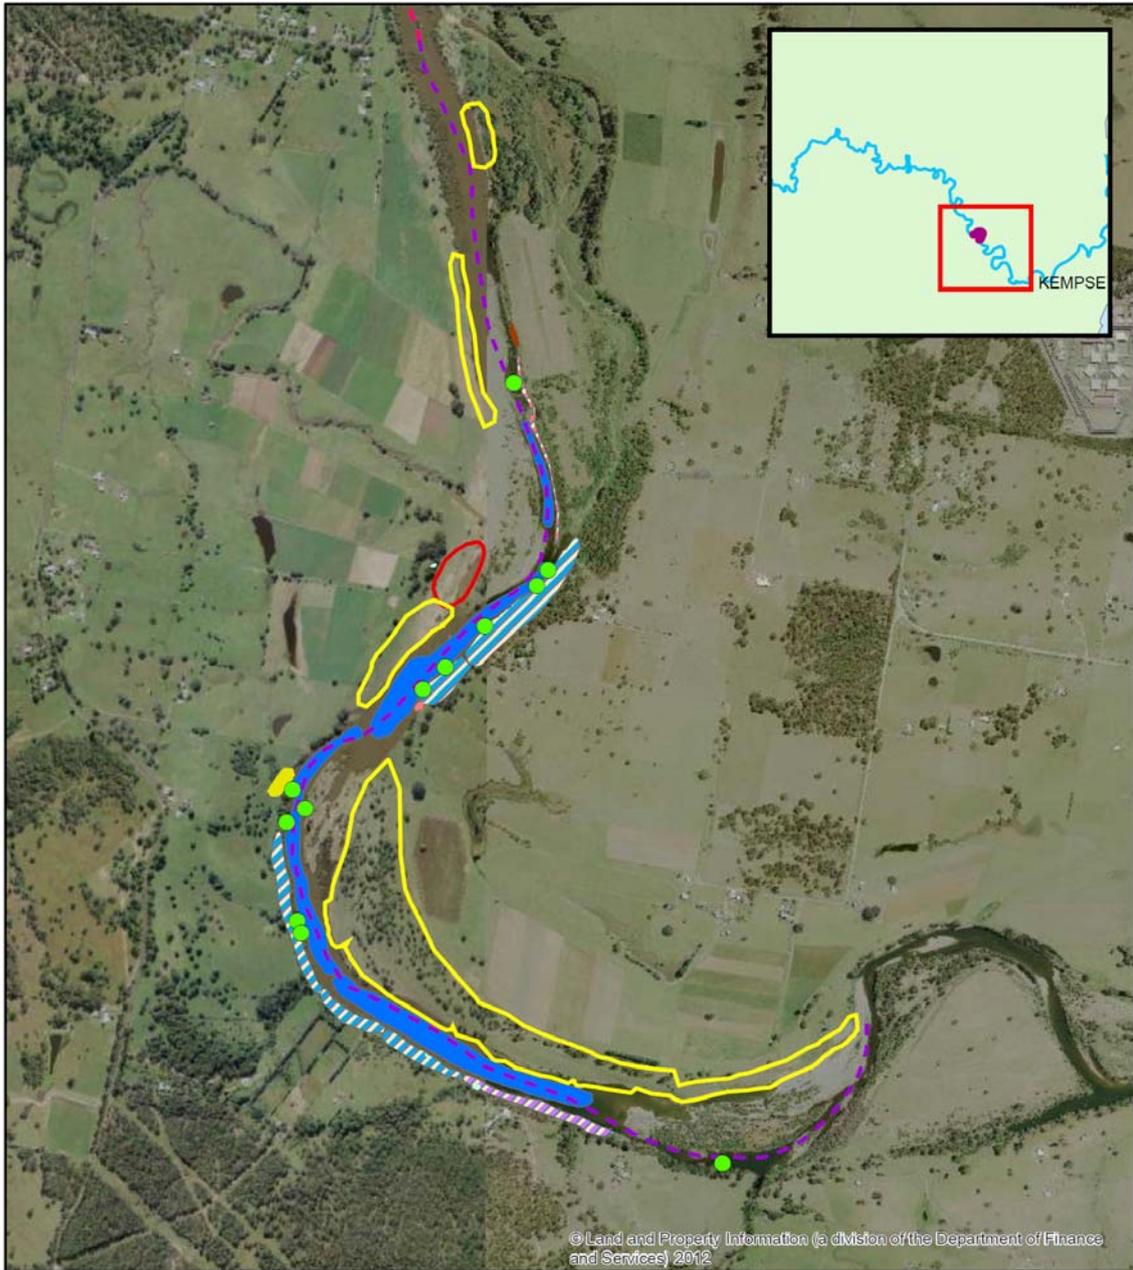
Figure 29: Recommendations for Priority Reach 3

The high levels of stock damage observed in Reach 3 also lead to a recommendation for the improved control of stock. While fencing and off-stream watering may assist in some cases, in other areas the fencing is already present and a different approach is needed. This would involve targeted negotiations with the appropriate landholders.

Figure 29 identifies areas of "highest priority" for grazing management, these relate to areas that had visible stock damage present. The remainder of the reach would also benefit from discussions regarding riparian grazing management strategies with relevant landholders.

Any such works would need to be installed with due consideration for the Macleay River's propensity to deliver high volumes and velocities of floodwaters on occasion. NSW DPI has had extensive experience undertaking re-snagging projects throughout NSW. It is recommended to seek guidance (and appropriate permits) from NSW DPI if re-snagging is identified as a potential remediation technique. Approximately 75% of Reach 3 was comprised of refuge pools, with an extremely low density of existing snag loadings. The identified refuge pools would each benefit from any increases to that current snag density.
