PRHTA BRIDGE ASSESSMENT AND REMEDIATION STRATEGIES POST-HURRICANE MARIA

Alvin Rodríguez, PE, MSCE; Elvin Pérez, PE, MSCE; Mauricio Torres, PE, MECE

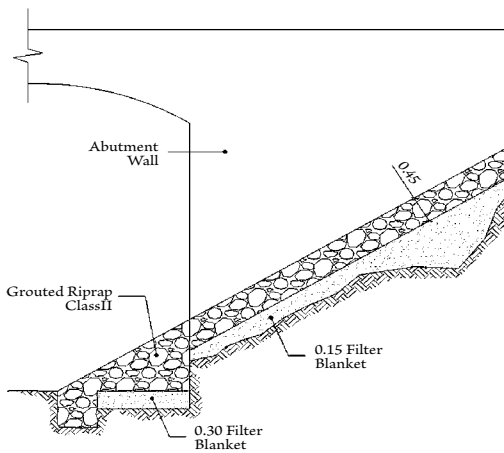
Fig. 5. Typical section of grouted riprap over filter blanket for embankment repair.

To prevent further erosion and instability behind the wingwalls, a deposit of borrowed fill material and the installation of dumped or grouted riprap were considered.

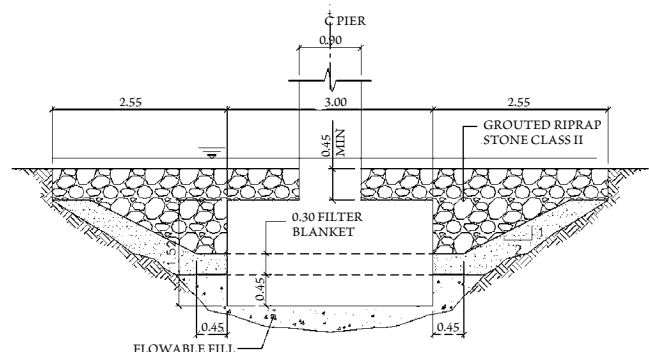
Fig. 7. Typical section for scour and exposed footing repair with flowable fill and grouted riprap.

To address the scouring conditions of the bridge abutment and pier footings, it was determined to specify a flowable concrete pour with a 28-day concrete compressive strength of 500 psi beneath the footing. If the scour extent was measured to be beyond one meter in depth below the existing footing, a filter fabric was placed around the piles to avoid negative friction loads. Negative friction reduces the vertical load carrying capacity of the bridge. A grouted riprap was then installed above the exposed footing with a minimum thickness of 0.45 meters with a slope of 2H:1V measured from the river stream line for additional protection.

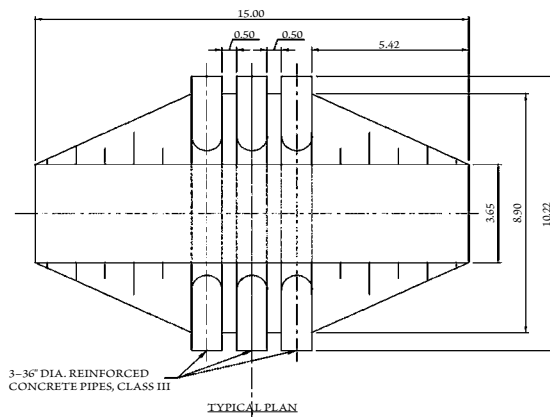
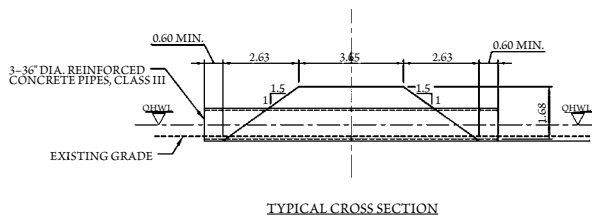
Fig. 10. Typical earth berm plan (a) and section (b) for the temporary bridge access.

Most of the work required the removal of debris, removal of loose sediments, and the installation of dumped or grouted riprap inside the limits of OHWL. During the construction phase, soil erosion and sedimentation control measures needed to be implemented to protect the surrounding ecosystem. Furthermore, the installation of silt fences and floating sediment barriers and the construction of earth berms with temporary fill for the transportation of light vehicles and equipment over the river stream were mandated.
