ASCE/SEI 31-03 Seismic Evaluation and Cost Estimate for
Seismic Upgrades for
Beverly Cleary Fernwood Campus
1915 NE 33rd Avenue
Portland, Oregon 97212

April 15, 2011

Portland Public Schools

James G. Pierson, Inc.
Consulting Structural Engineers

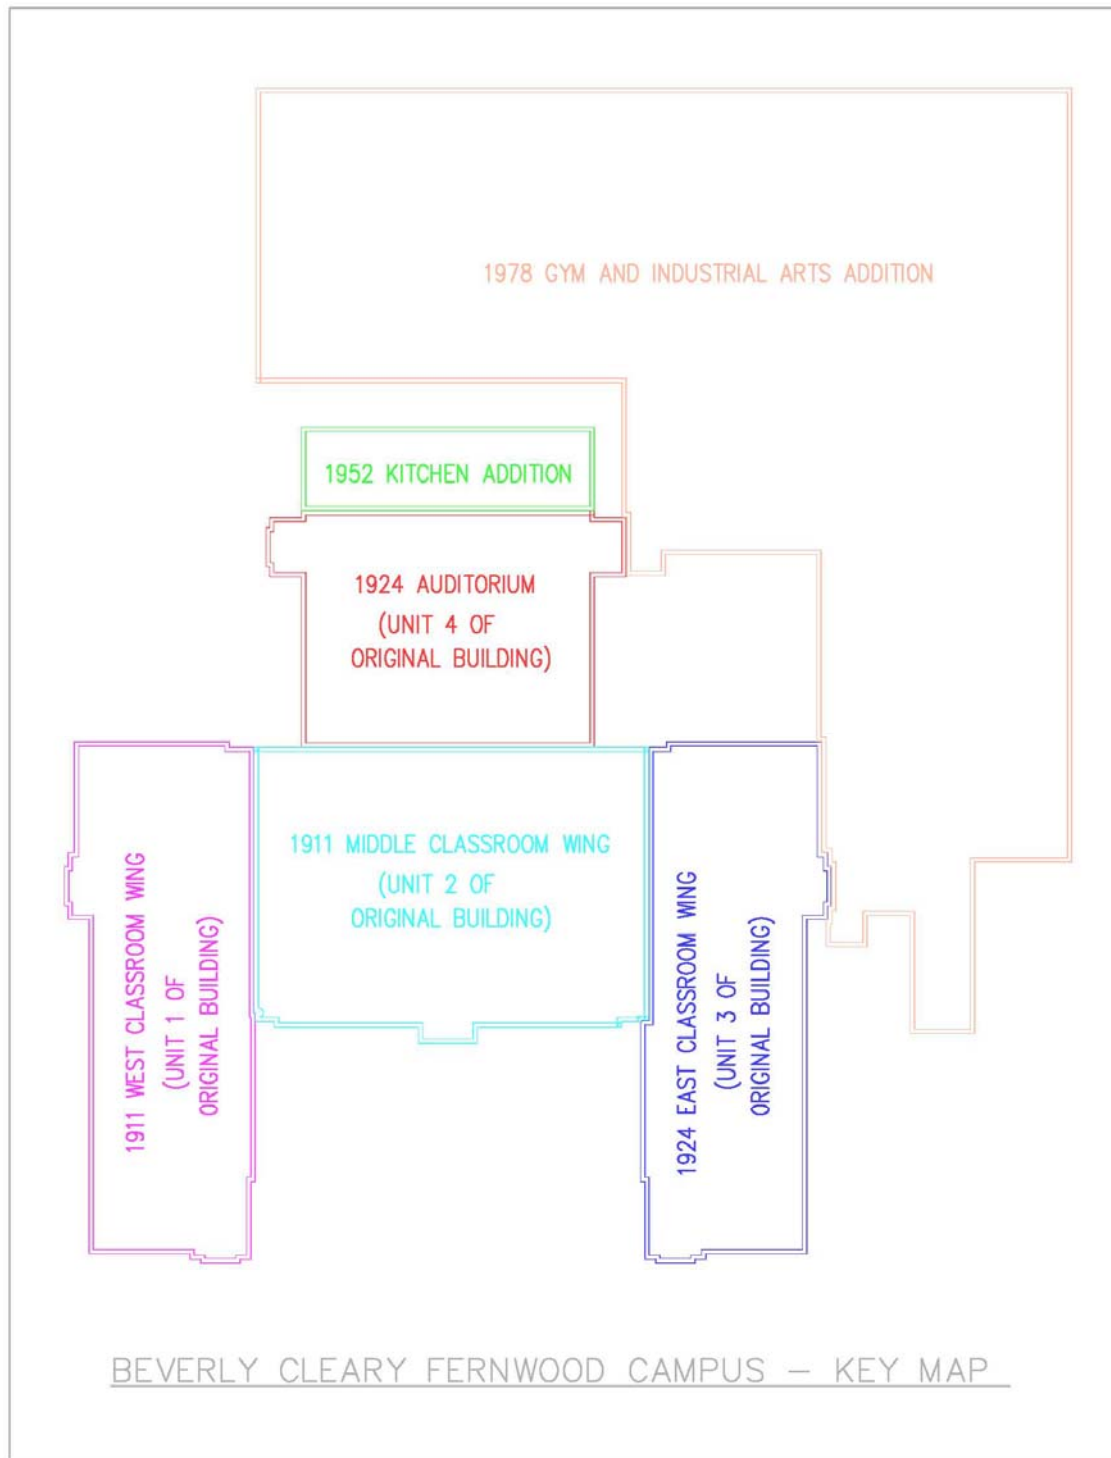
The school facility is comprised of multiple additions constructed over the years with varying types of construction. Refer to Figure 1 for a key map showing the various periods of construction. The various additions can be grouped into three areas based on the type of construction. Each area is described briefly below:

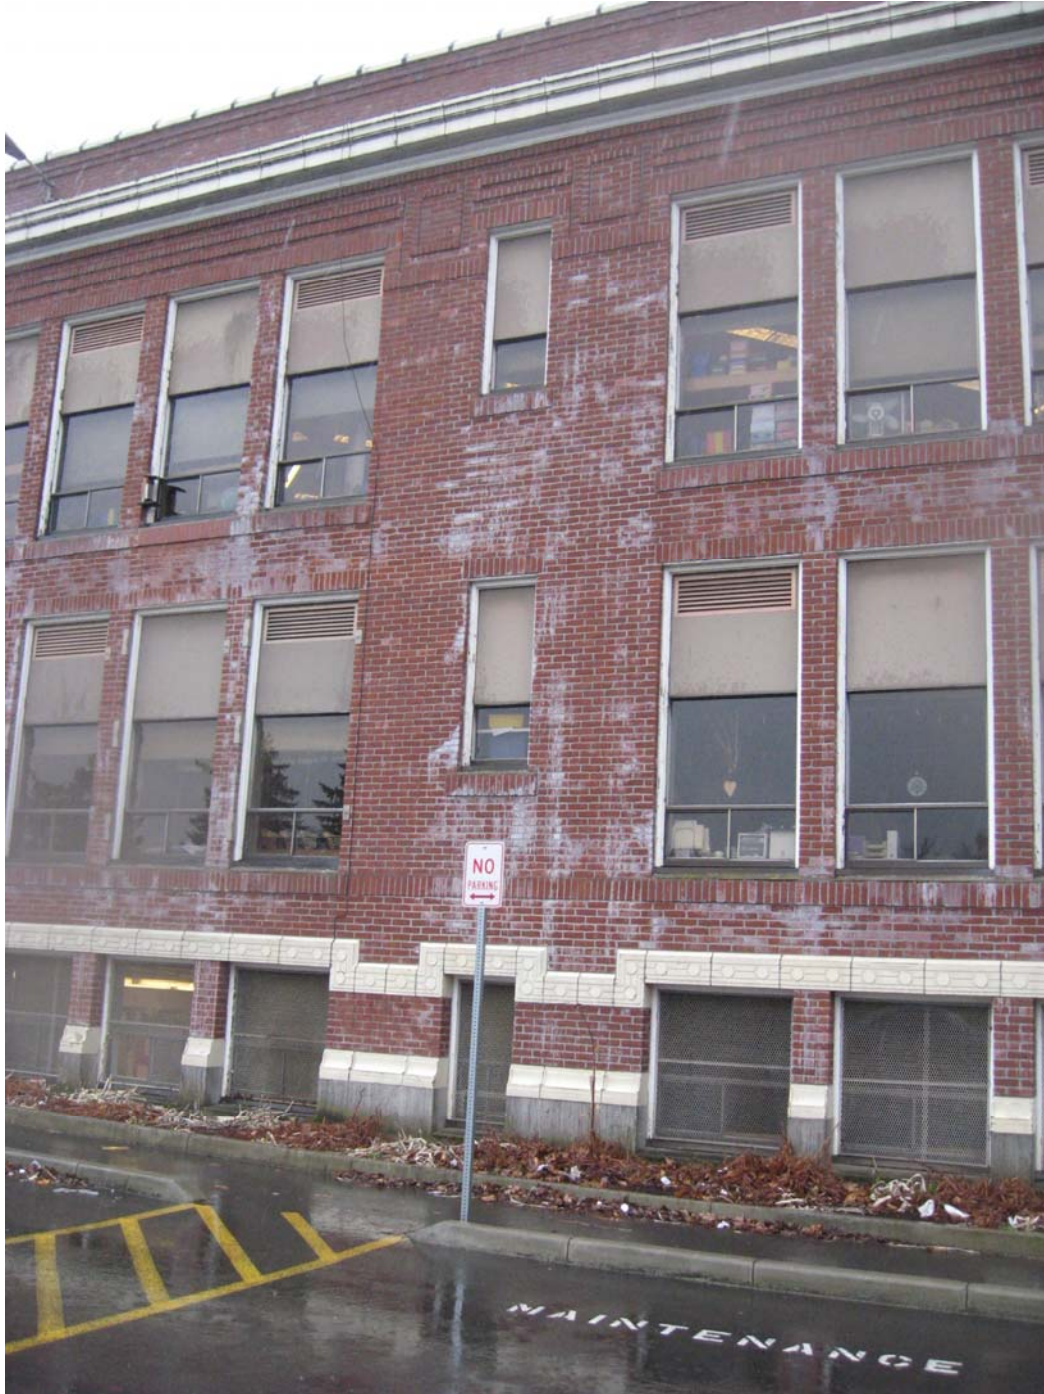
Photo 1

Generally the brick is in good condition. No cracks were observed. A white residue is present over some exterior wall areas at the Original Building. The most substantial amount of efflorescence occurs on the west face of the west wing of the Original Building. Refer to Photo 1. Efflorescence, along with water marks, occur in several locations on the interior face of the

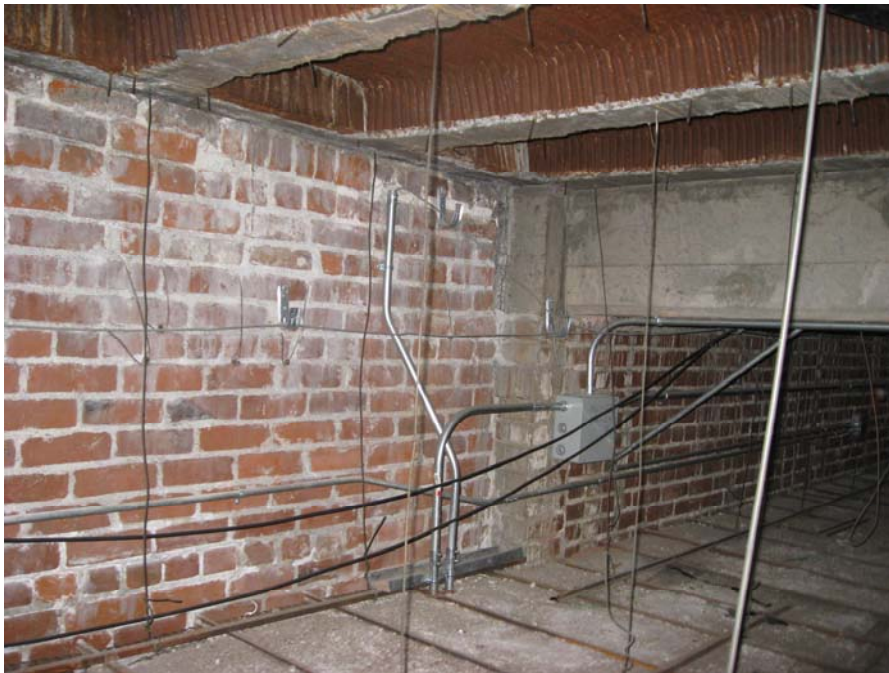
Photo 4

The exterior walls are unreinforced brick masonry; wall thickness is 13 inches at the second floor level and 17 inches at the first and basement floor levels. The exterior walls below grade at the basement level are 21 inch thick concrete. The transition from concrete to masonry occurs at about 5 to 6 feet above the basement floor level. The drawings show metal ties for some of the terra cotta trim. The brick patterns around the exterior of the building are predominately running bond absent of any header courses. The interior face of the brick walls are covered by finishes except in the space between the roof structure and the second floor ceiling. Within that space, header courses can be seen every 5 to 7 courses as shown in Photo 4.
