The structural adequacy and durability of large panel system dwellings

Part 1

Investigations of construction

R J Currie, B R Reeves and J F A Moore

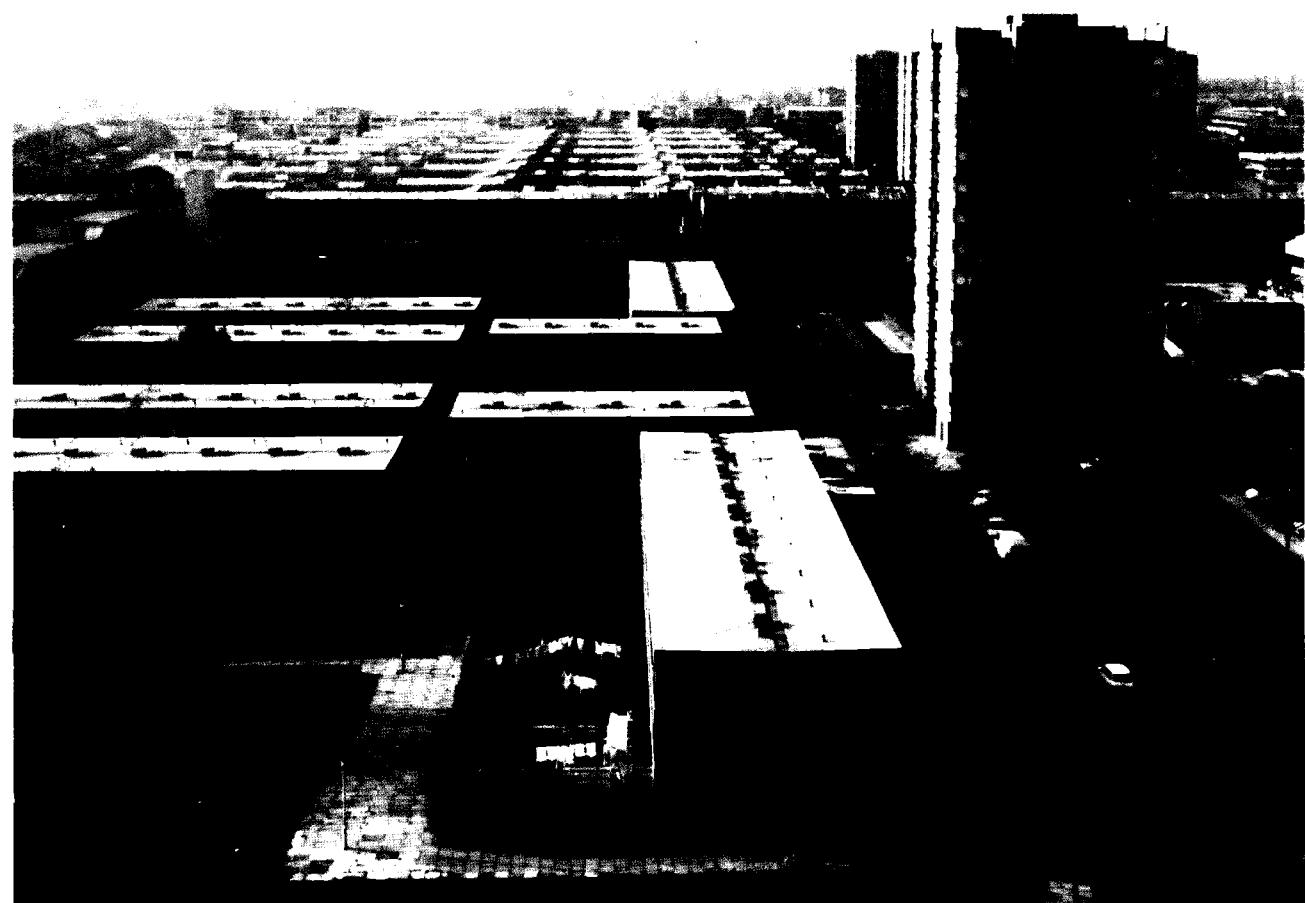
A2.2 Three-storey deck access blocks and several 13-storey tower blocks, providing approximately 4000 dwellings, were built on this large estate (Plate 1). The buildings were approximately 17 years old, and the external condition at the site was good, although there are some problems with the waterproofing and drainage details of the dwellings.

Plate 1 Balency: general view of estate

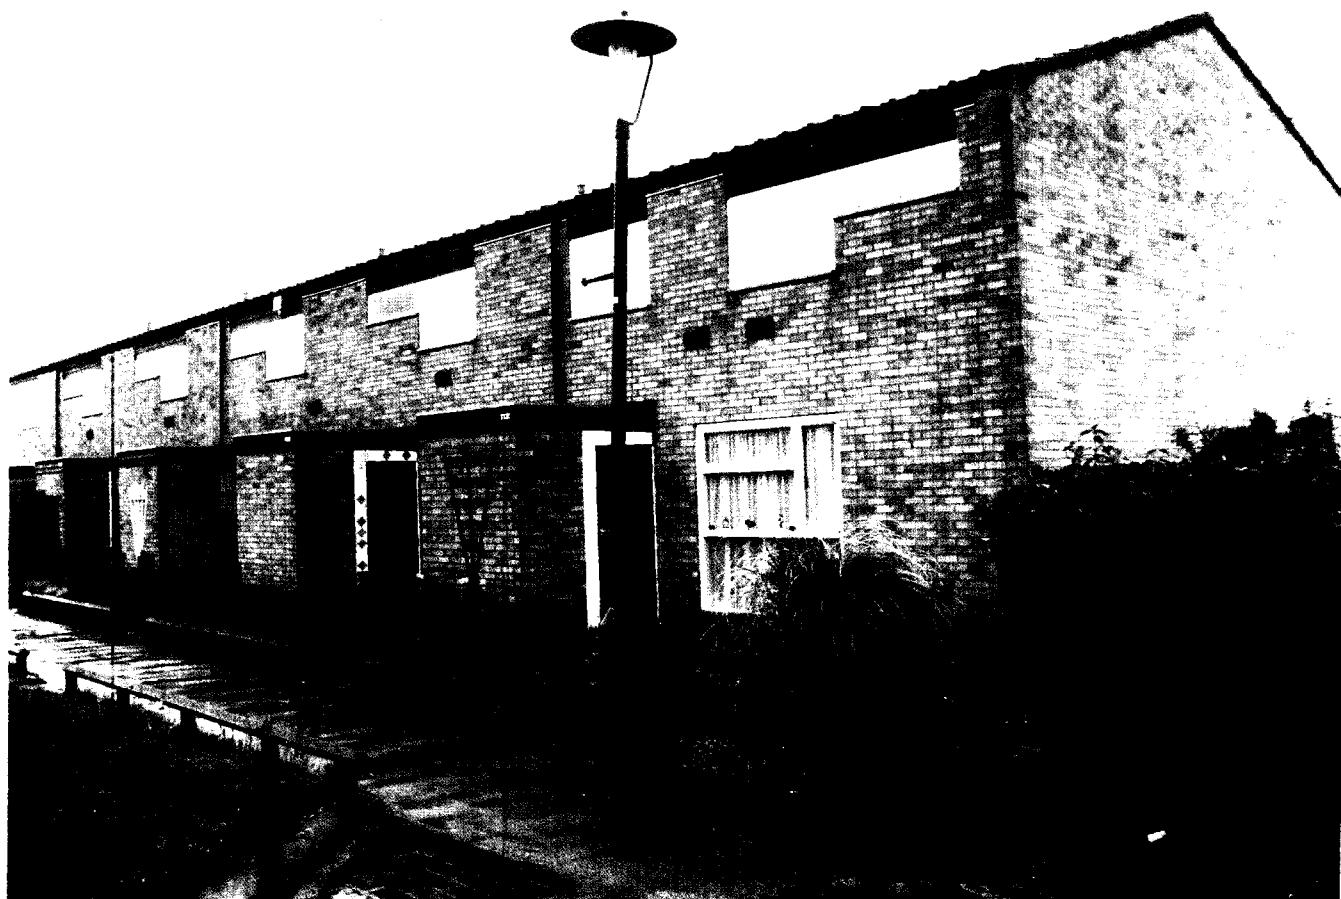
A4.3 The dwellings on one of the estates differed from the 'standard' Bryant construction in that the front and rear elevation spandrel panels had been replaced by traditional brick and block cavity construction (Plate 7), although the concrete party, spine and inner flank wall panels had been retained. These properties will be referred to as the 'modified' type.

Plate 7 Bryant low rise: 'modified' version

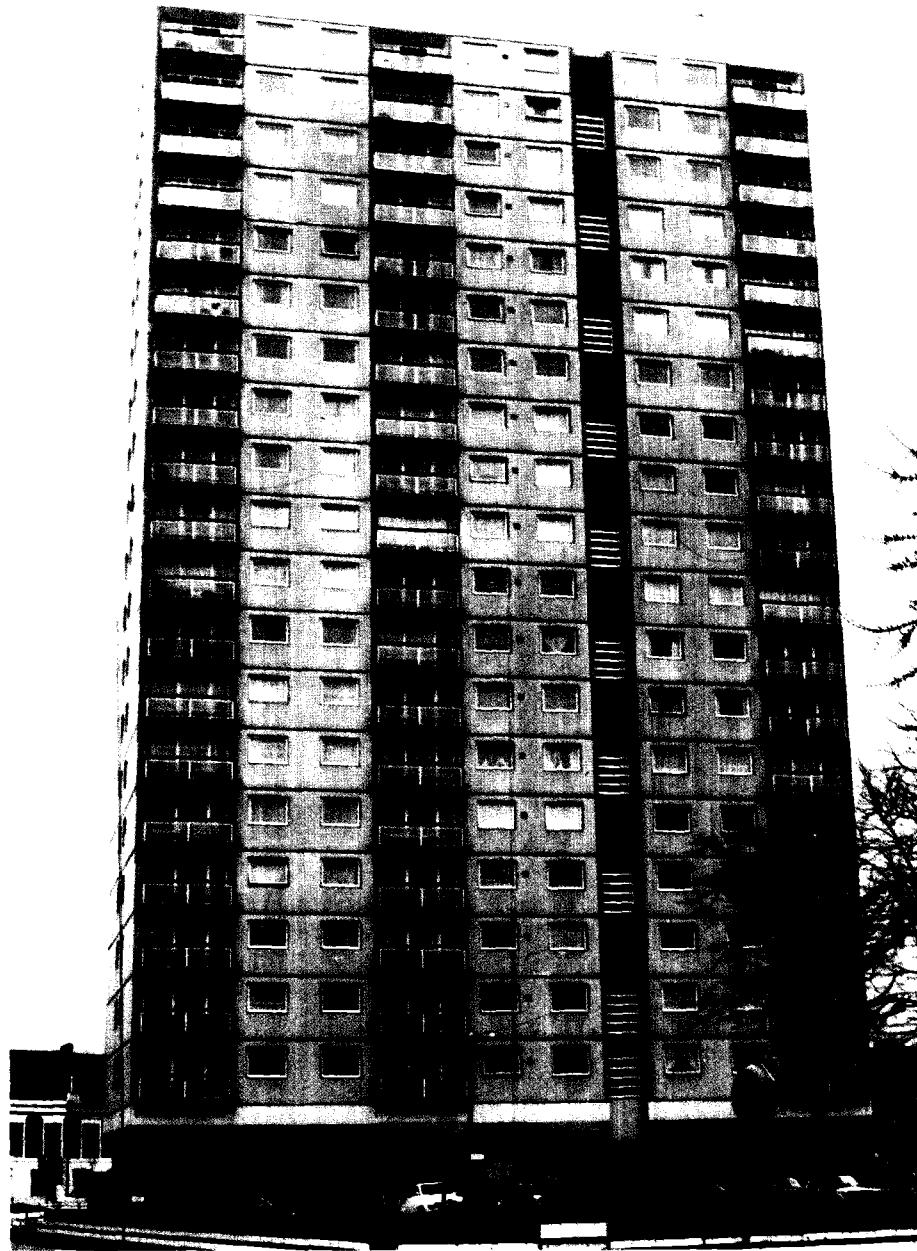
Plate 8 Camus: 20-storey construction

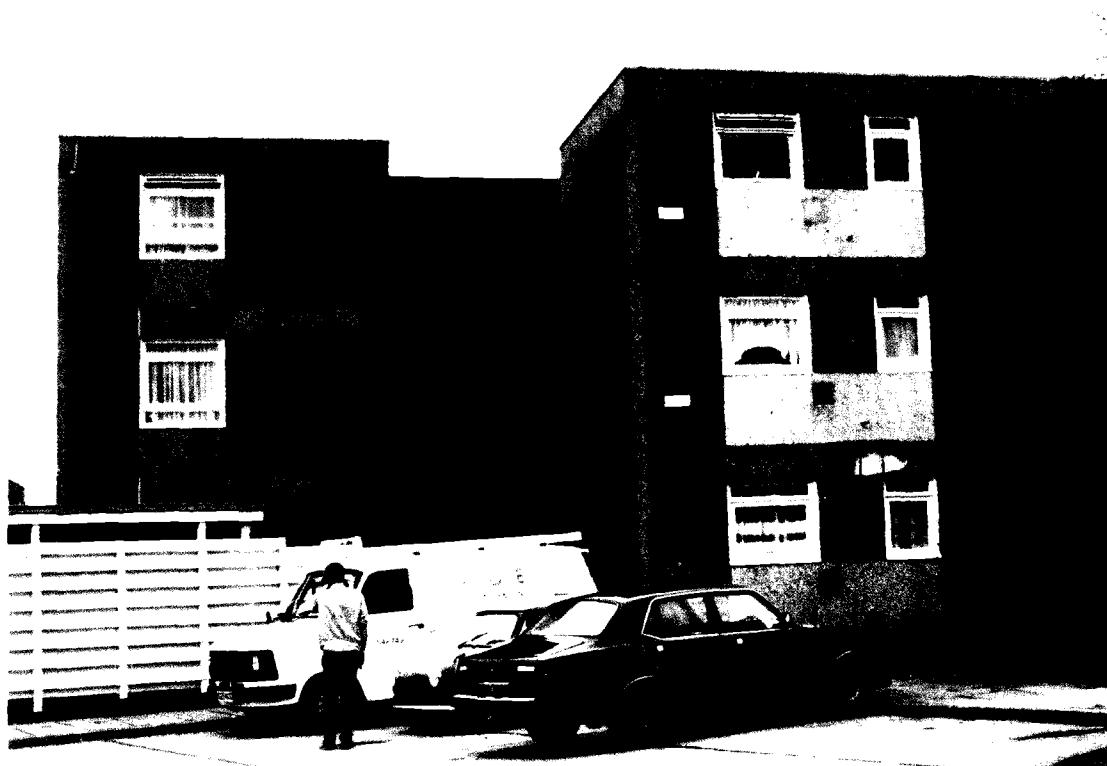
A6.2 This large estate of ninety-eight 1-, 2-, 3- and 4-storey blocks (Plate 9) was situated on a gently undulating south-east-facing site. The flat-roofed blocks were built between 1964 and 1967. The external walls were cavity construction with an external leaf of brickwork and an inner leaf of lightweight concrete, cast in half-storey-height panels. The internal load-bearing walls were storey-height concrete panels.

Plate 9 HSSB: 3-storey construction

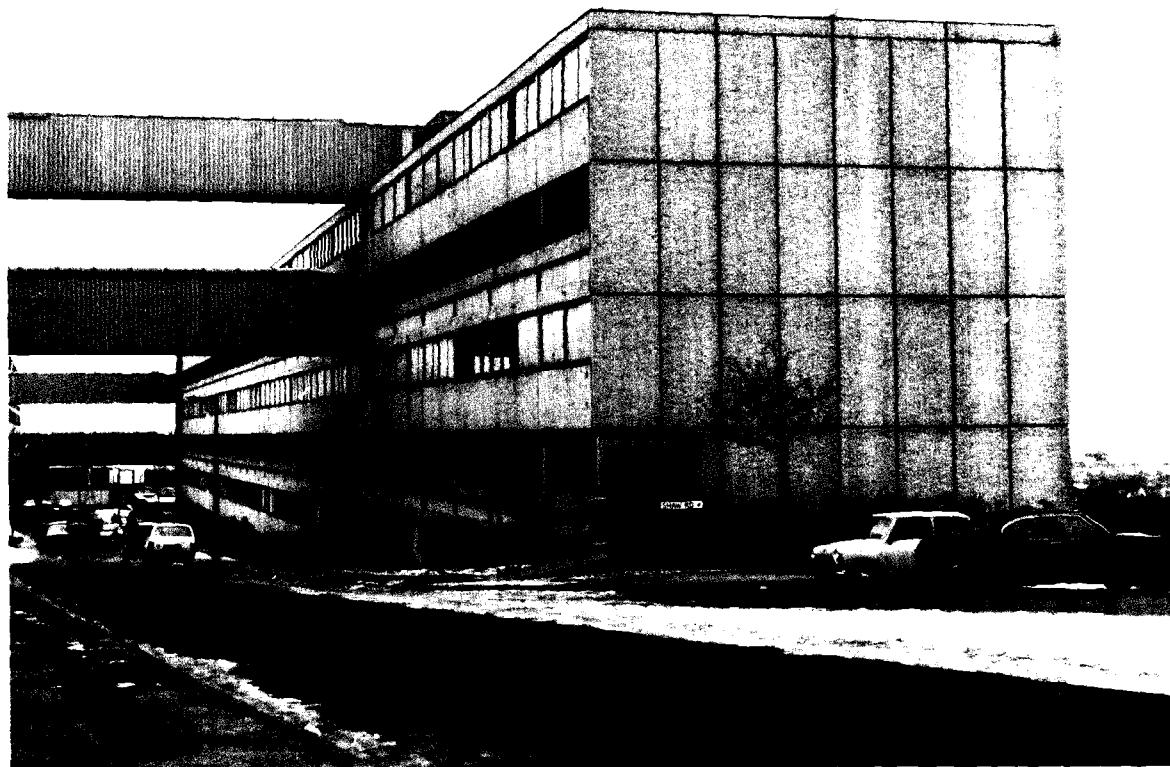
A7.2 The site was situated on a north-east-facing slope in an urban area. The eight flat-roofed blocks of 3 to 6 storeys were 18 years old (Plate 13).

Plate 13 Jespersen: 18-year-old flats

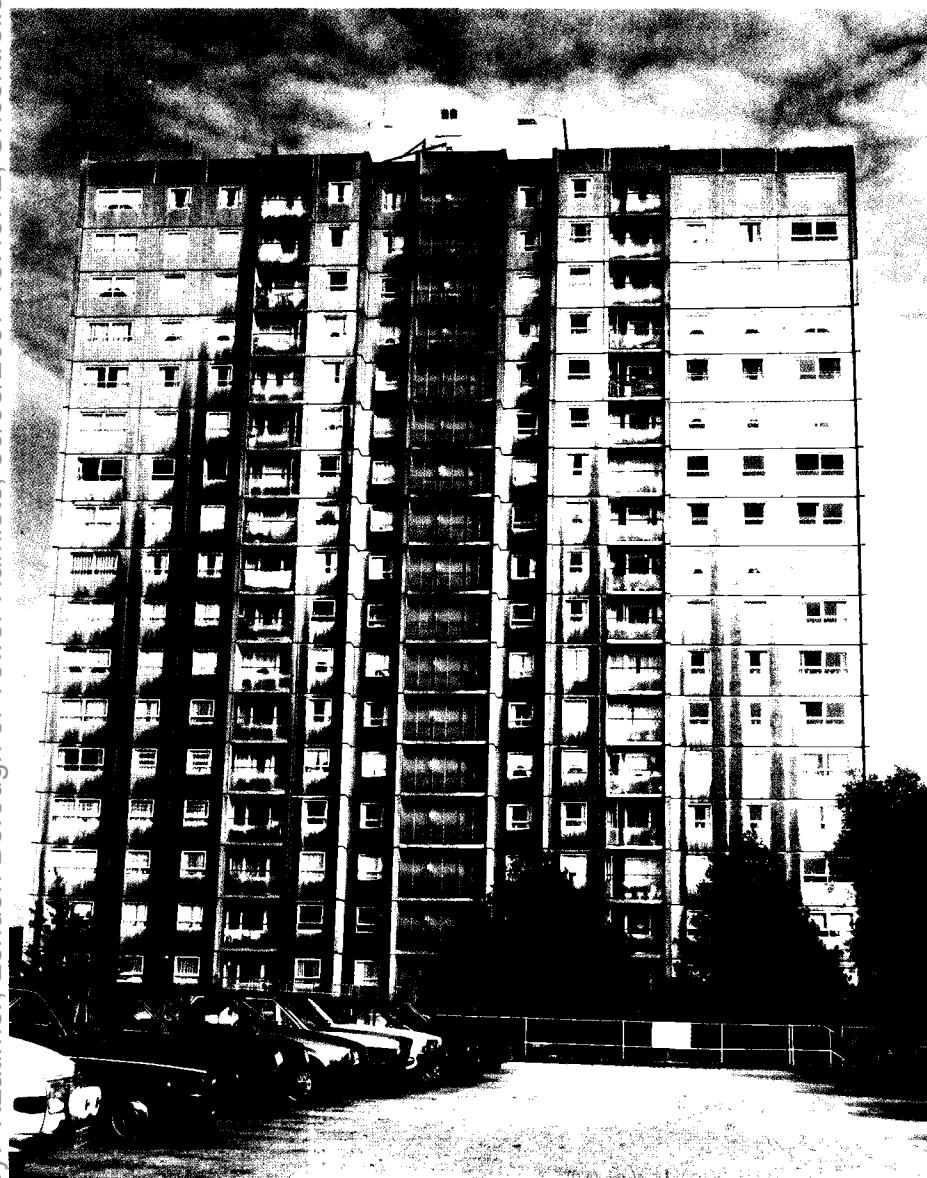
A8.4 All the Reema blocks were built between 1964 and 1968 (Plate 19) and later strengthened to resist an equivalent static pressure of 2.5 psi, using steel angles bolted to the flank wall/ceiling joints and to a number of the wall/ceiling joints in corridors adjacent to

Plate 19 Reema Conclad construction

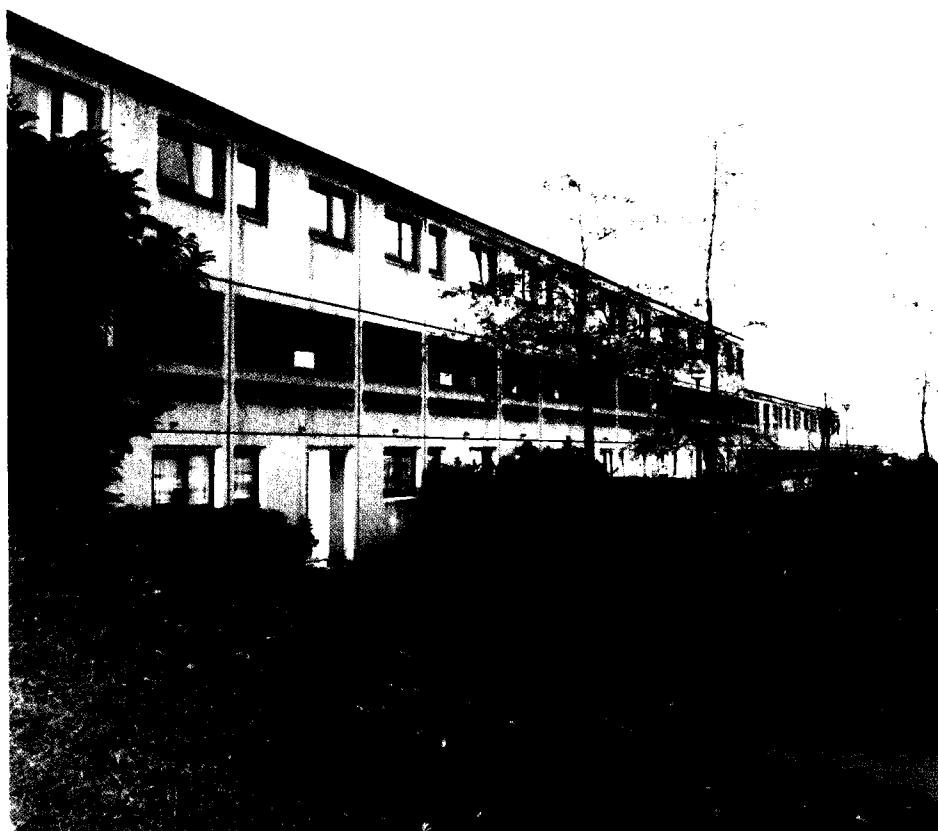
Plate 21 Selleck Nicholls Williams: 3-storey construction

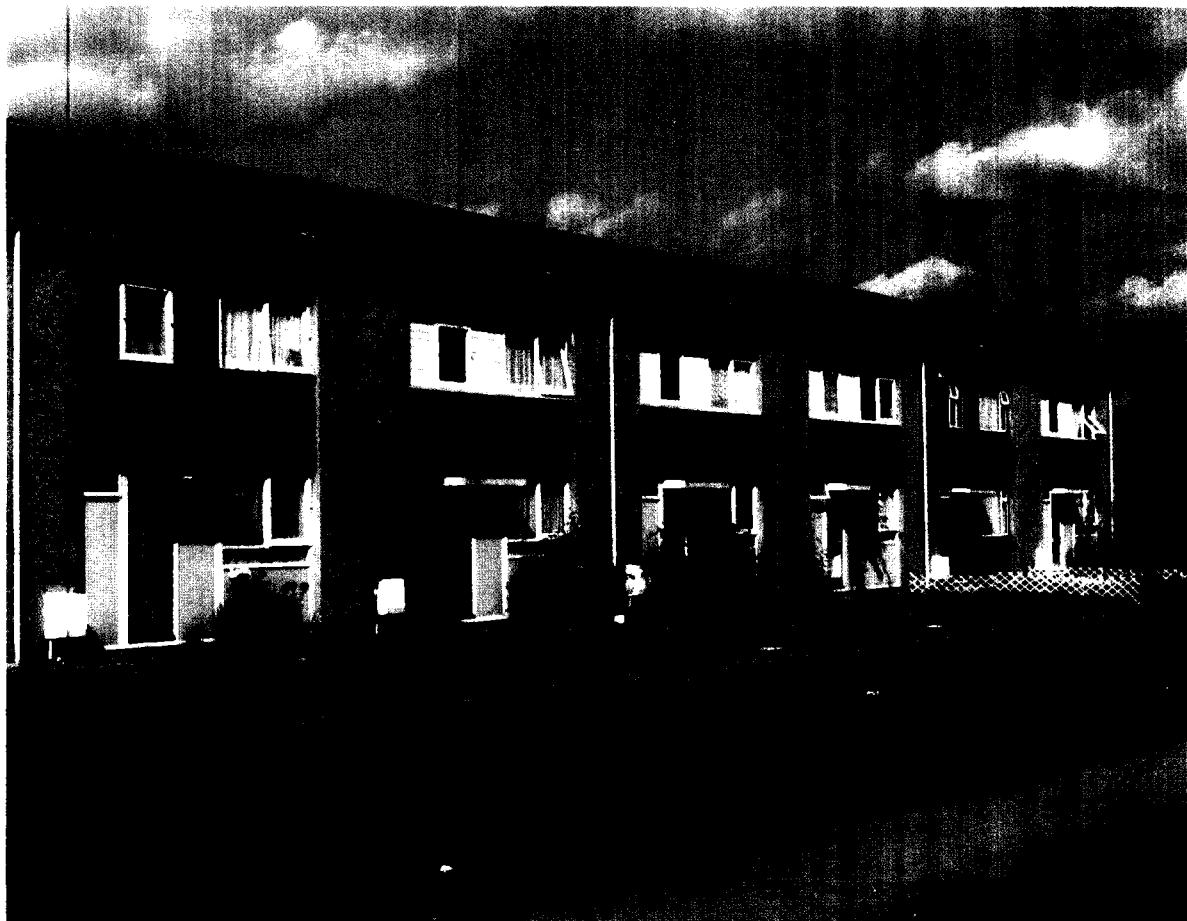
Plate 22 Selleck Nicholls Williams: 2-storey construction (variation reported by local authority)

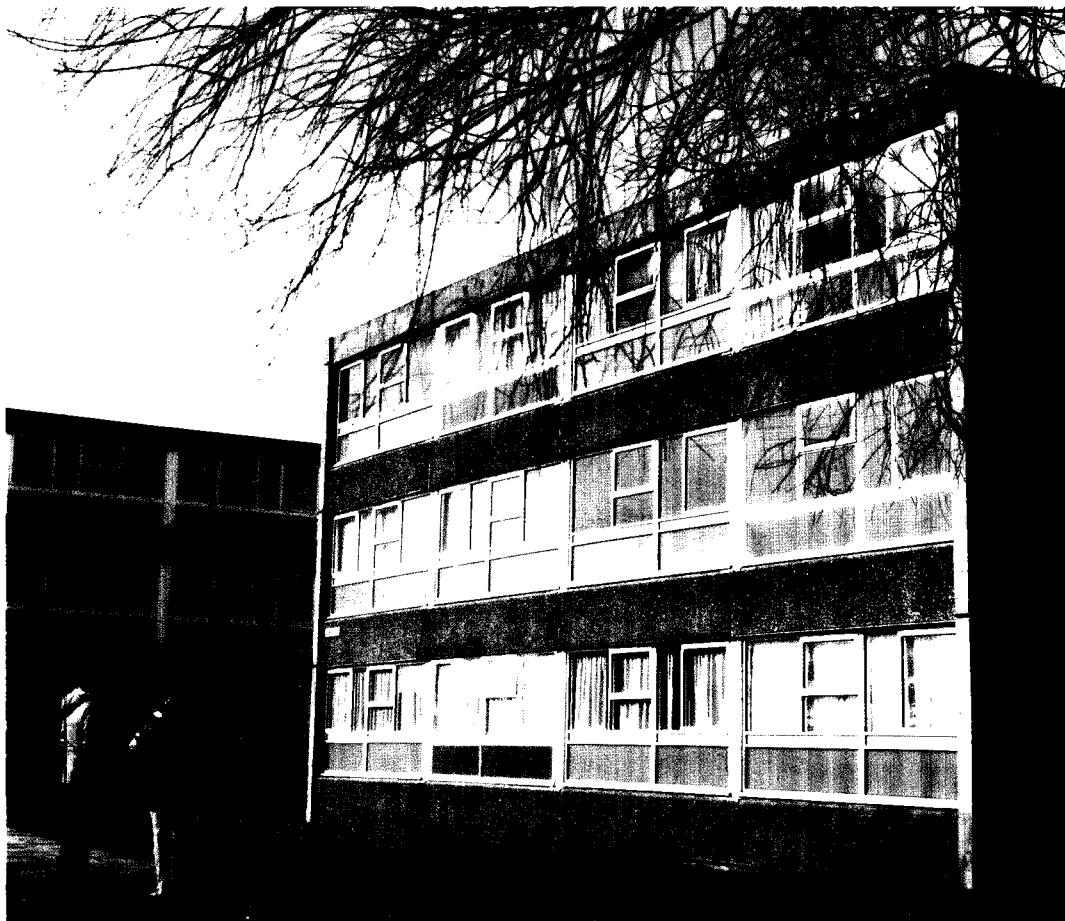
A10.2 This semi-rural estate consisted of twenty 3-storey blocks (Plate 23) and thirty 2-storey terraced blocks (Plate 24). The former were flat-roofed and the latter had conventional pitched timber roofs. The blocks were built around 1966.

Plate 23 Shepherd Spacemaker: 3-storey construction

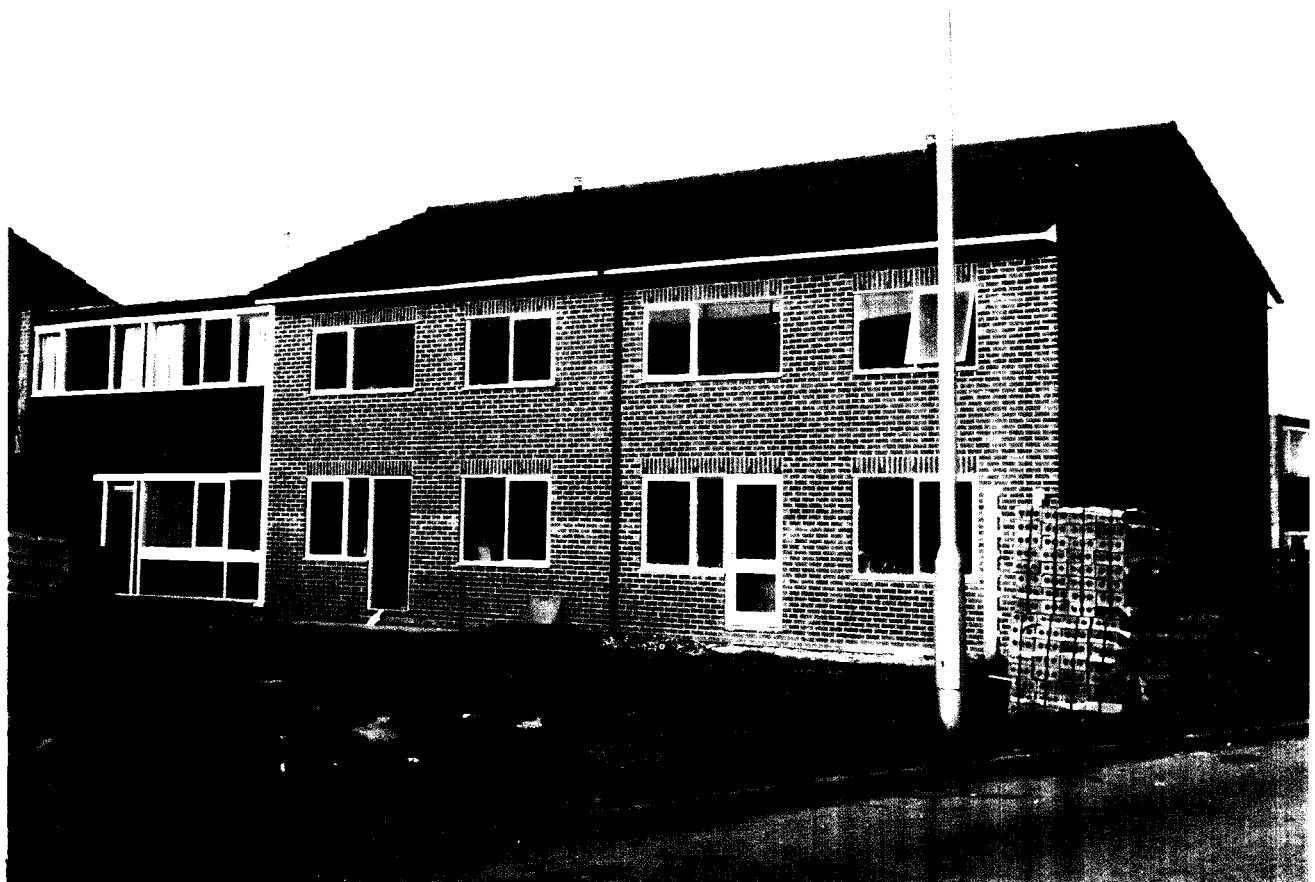
Plate 26 Skarne: renovation of low-rise dwellings (original and renovated types)

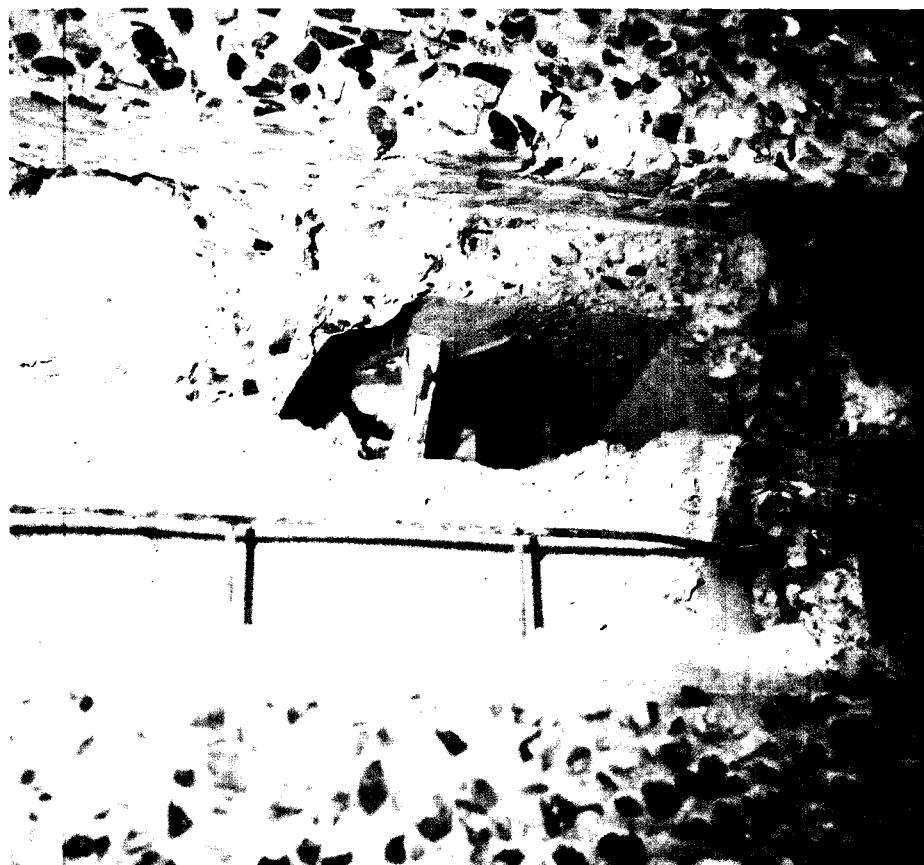
the adjacent floor slabs. The pilot holes had been drilled so that the upper ends of the bars coincided with the levelling bolt pockets (Plate 30). Since these pockets were ungrouted the strengthening was ineffective and a new set of strengthening measures are being considered.

Plate 30 Wates: levelling bolt and strengthening bar
