Floods on the Llano River, Texas — Fall 2018

Llano River Watershed Alliance

Tyson Broad - January 18, 2019

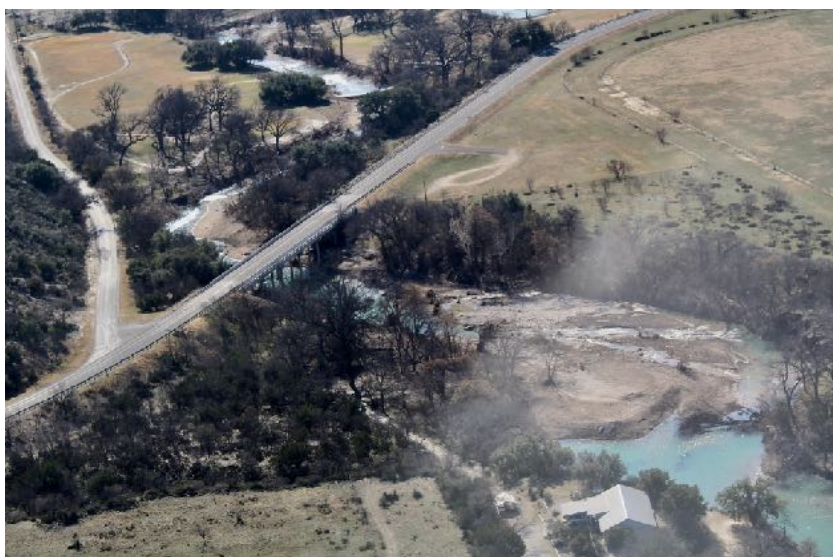
Downstream, the USGS gage on the South Llano River at the Flat Rock Crossing began to rise at 5:15am, was 3 ft higher 15 minutes later, and another 3.5 ft higher in 30 minutes, recording a peak of 26.18 ft at 10am. The South Llano River gage does not record inflows from Cedar Creek downstream, which considering the six to eight-foot gravel bar at its mouth, added significant volumes of water to the flood (Figure 7).

Figure 7. Mouth of Cedar Creek at confluence with South Llano River near Junction. Photo December 14, 2018

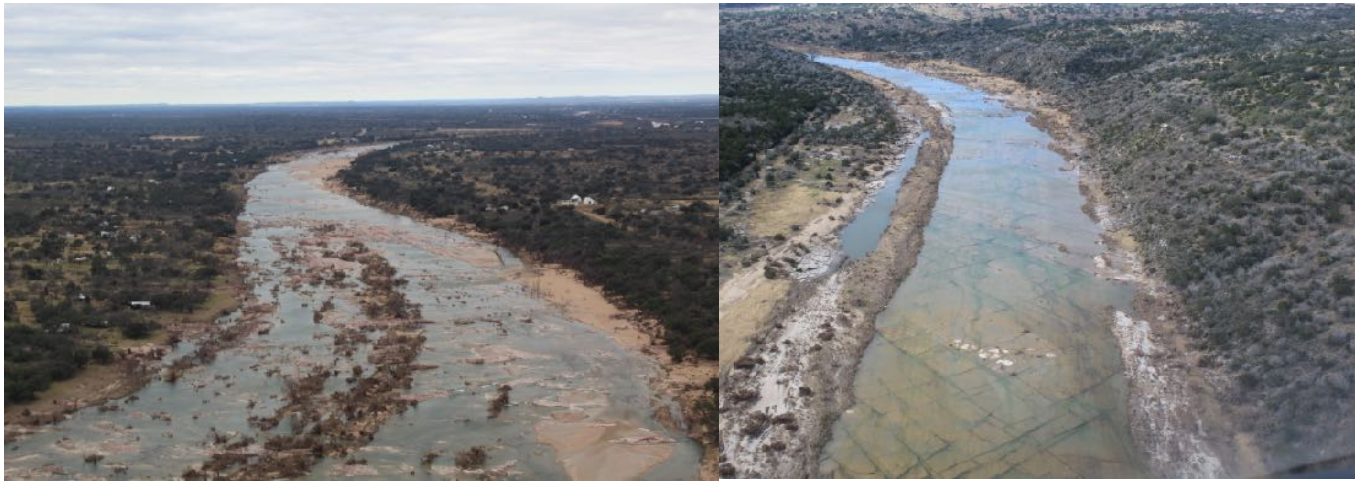
Below Yates Crossing, the Llano River leaves the sedimentary rocks of its origin and begins to cross older, more resistant Paleozoic sedimentary rocks (Figure 21). At this point, near the border of Kimble and Mason County, the predominantly bedrock channel becomes more resistant to erosion and straightens, except where weathered bedrock joints or fractures

Figure 21. Left: Llano River between Castell and Llano near Schneider Slab. Right: Llano River below Yates Crossing.

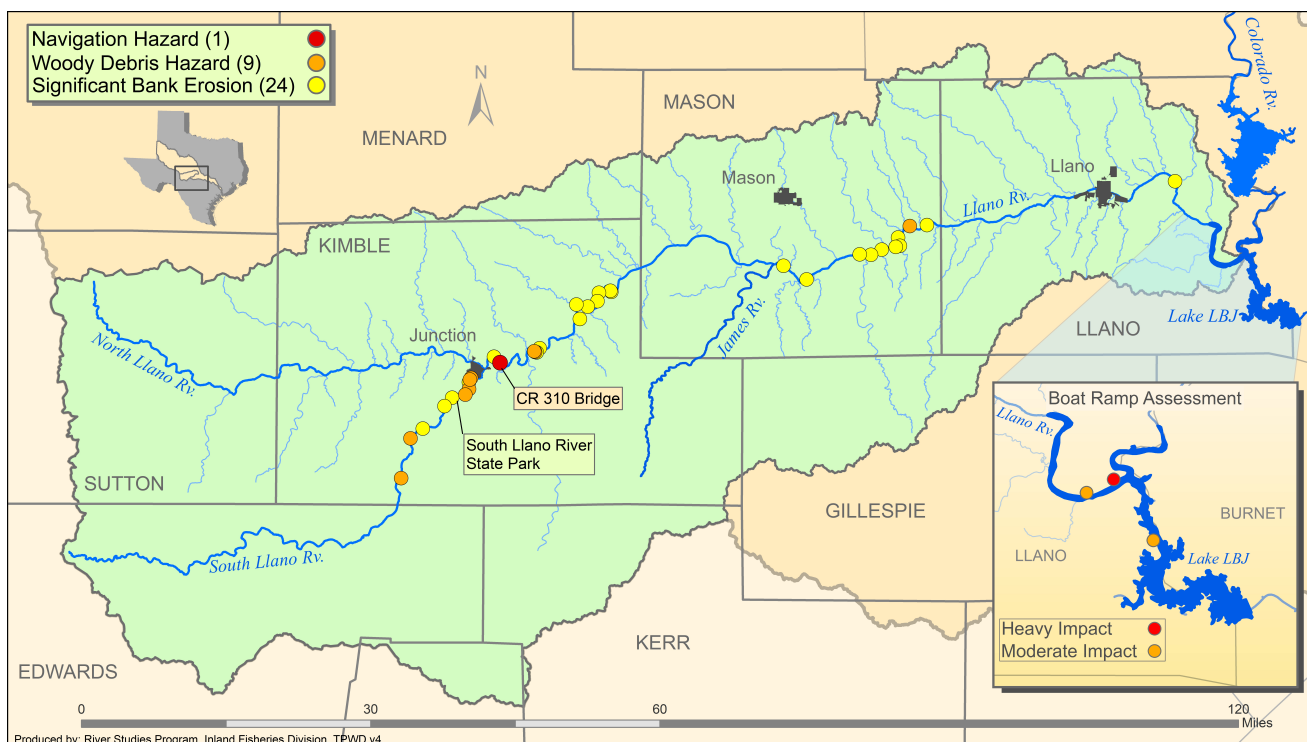
Figure 22. Location of navigation hazards, woody debris hazards and significant bank erosion features along South Llano River, Llano River, and in LBJ Reservoir. Based on aerial and field surveys, December 2018.

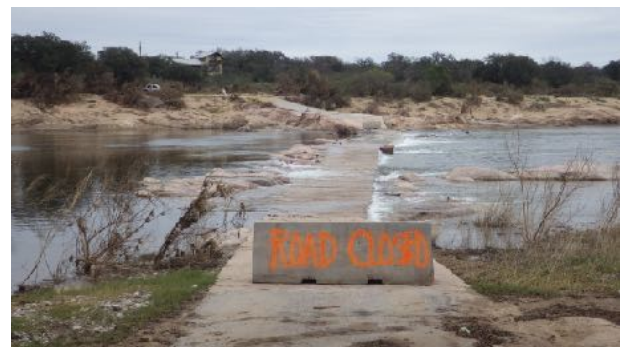
Figure 29. Schneider Slab, Llano River, November 10, 2018

November, but has now reopened. Schneider Slab remains closed. Access does not seem to have been altered. The Castell Bridge has reopened, with no significant changes to recreational access. The proposed RACA sites at the Castell Bridge and downstream towards Schneider Slab (Figure 29) lost some vegetation during the flood and may benefit from some vegetative restoration, one of the components of the RACA program.
