Delta-Type Special Trim **20**

Used in Globe Valves

1.1 - GENERAL INFORMATION

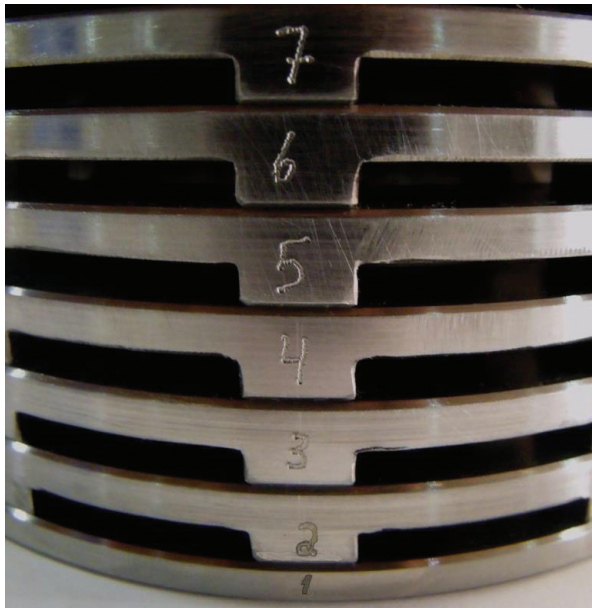
For the pinned stack, install the base disc over the valve seat, taking care to align the indexing groove machined on the bottom of the base disc with the raised indexing step located on the top of the seat ring. Place disc #2 over the base disc (see Figure 2) and so on successively, until the crown disc is installed. The alignment pin must be installed into the stack after the second disc has been mounted. This procedure will facilitate assembling discs.

Make sure that the feet of the discs are correctly positioned one on top of another, forming a straight line from the base disc to the crown disc. Failure to observe this warning may cause damage to the seat gasket or to the Delta cartridge.

Figure 2 - Feet Alignment and Assembly Sequence
