## Analysis of the e-telltales with ADRENA (J2 trimming and condition)

Imoca SMA - Giraglia 2018

CONFIG= 4 e-telltales attached on each side of the J2 at 2 different levels

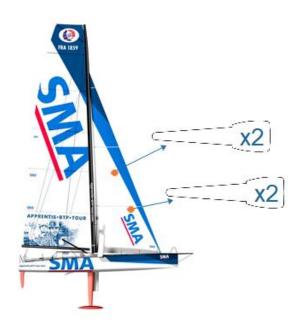
E-telltale condition	4 e-telltales resting = J2 is furled	e-telltale streaming aft	e-telltale breaking
ADRENA Condition	REST	ATTACHED FLOW	TURBULENT
Value of the standard deviation (STD)	STD < 30	30 < STD < 100	100 < STD

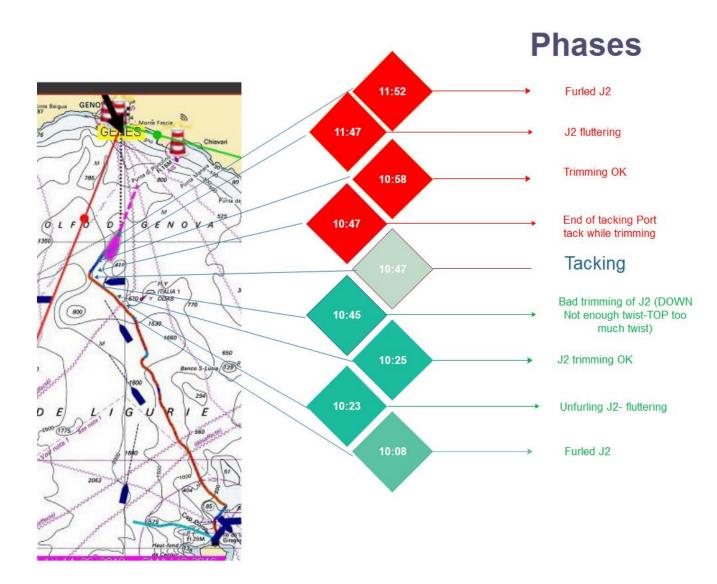
## 1 SMA unfurls her J2, sails to windward twice and furls

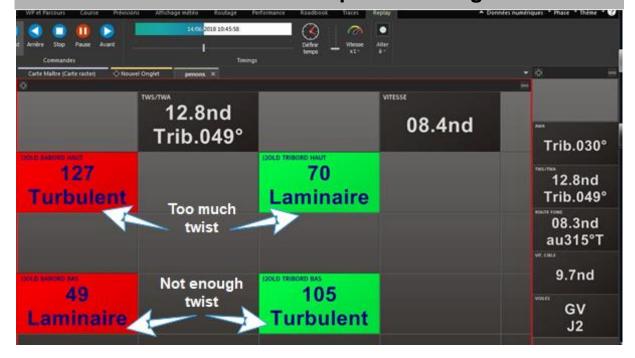
5 10h45 Starboard tack- bad trimming of J2! Beginning to tack Too much twist at the top & not enough down
