Ongoing Renovations and Improvements at the Old Schoolhouse in Grange

Discussion Document for Consideration with Limerick City and County Council Officials

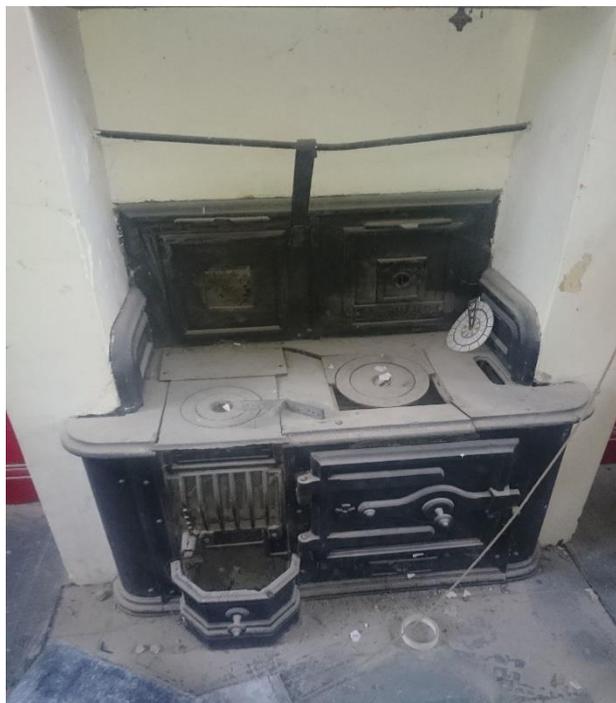
The dividing wall between the two inner rooms has been removed, leading to a good-sized single room, with great potential. A sliding divider will be installed, providing the option to create two smaller rooms as occasion may require.

Restoration works on foot of the wall removal will be undertaken, and a new wooden floor will be laid. It might be advantageous to remove the old cast-iron 'Range' fire and its small walls before fitting a new floor. With the entry to the chimney blocked up, a straight wall will be ideal for locating a small stage for performances. The fireplace at the northern end of the room could remain as a focal point. Will it be possible to fit floor insulation, prior to laying the new boards? In addition, it is thought that a suspended ceiling with appropriate insulation would greatly enhance the new large room, making it warmer and obviating a need to decorate the existing lofted ceiling.

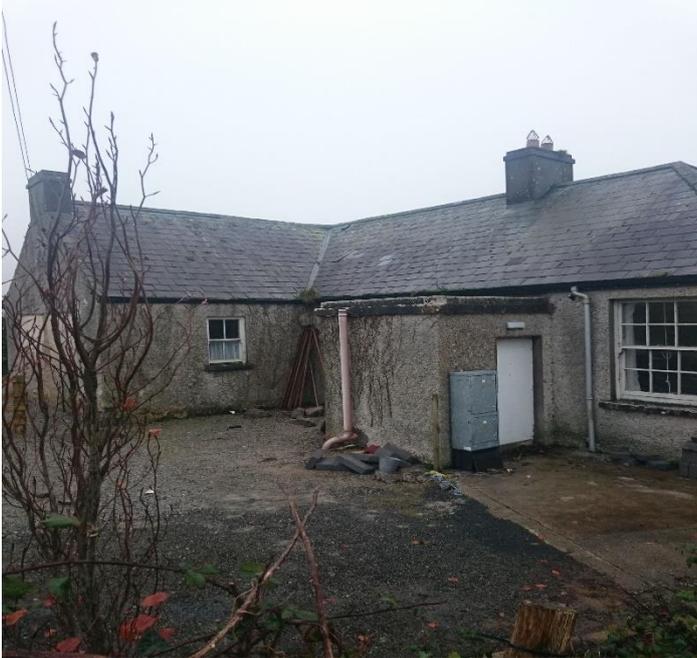
In the first instance, there is need to ensure that the building in its totality is secure from water ingress. It has been observed that views from the attic point to remaining weaknesses where daylight is clearly visible through the roof. If this is so, then remedial works are essential and urgent.

A view of the roof from outside the building – from the rear at the northern end – shows a number of slates dislodged or missing. In addition, grass/weeds growing on the roof and in and around the gutters needs to be removed.

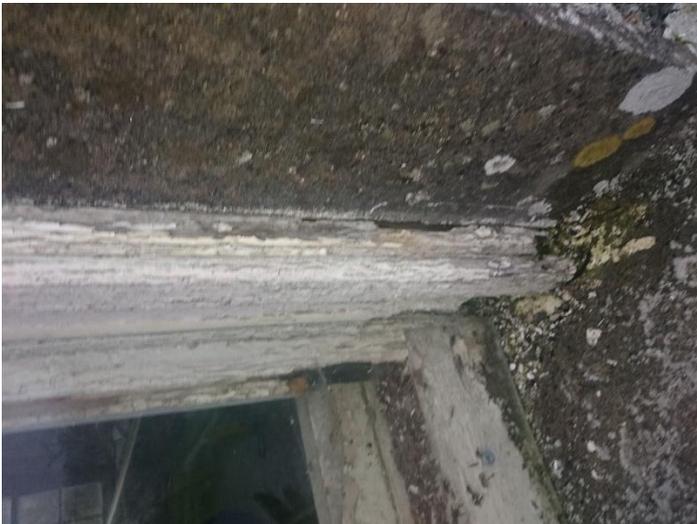
The windows to the building appear to be in poor repair – in fact, significant decay is obvious. Can they be restored and re-painted (internally and externally) or do they require replacement? In either case,

draughts need to be eliminated and openings need to be functional. Ideally, double glazing or better is required. Similarly, external doors need to be restored/painted or replaced, eliminating draughts. The main entrance door needs to look well – the existing compromise

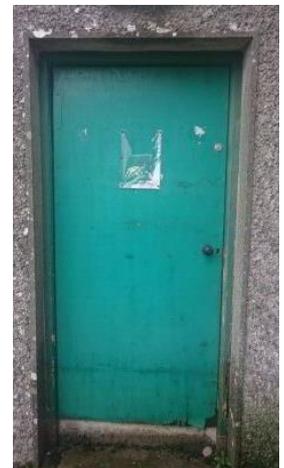
is really not suitable, going forward. A modern letter box should be installed on one external front door as well as a door bell. Alternatively, a steel post box can be installed on an outside wall at the front of the building.

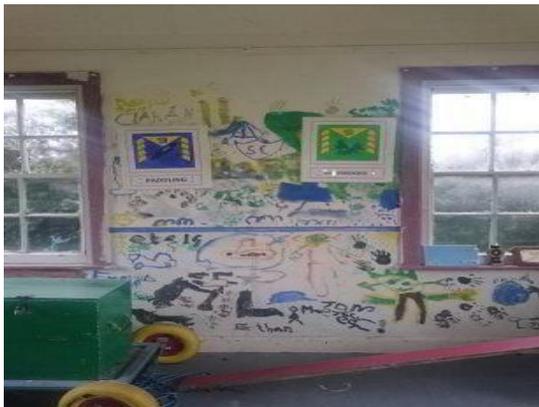
All internal walls and ceilings need to be repaired and finished smoothly and painted. A preferred solution for the new larger room has been mentioned above. Consider skirting boards. Is dry-lining required anywhere? Paintings, prints and photographs should be hung on the walls of the three large rooms – Grange should have sufficient material for this purpose.

Under no circumstances should decorated walls be defaced or marked. Relatively inexpensive whiteboards and noticeboards should be fixed to walls in each of the three rooms. In addition, movable whiteboards on stands can be used as occasions require.

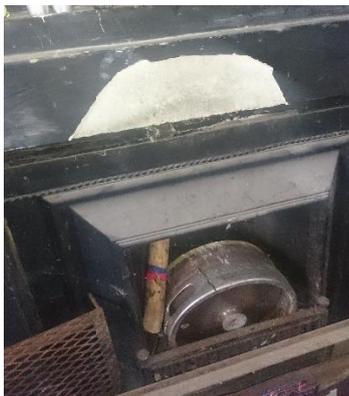
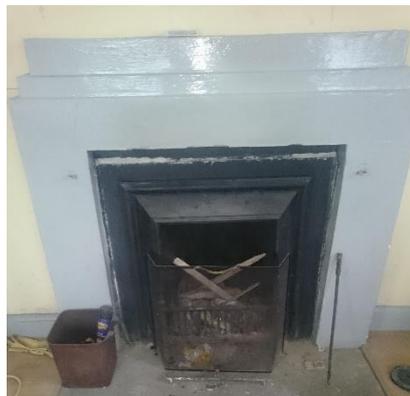
The future of the four fireplaces should be considered. Are any of them functional? Restoration in so far as possible and clean-up should be undertaken.

Or should they be removed?
