SHIRLEY PLANTATION IN THE EIGHTEENTH CENTURY

A Historical, Architectural, and Archaeological Study

by THEODORE R. REINHART and JUDITH A. HABICHT*

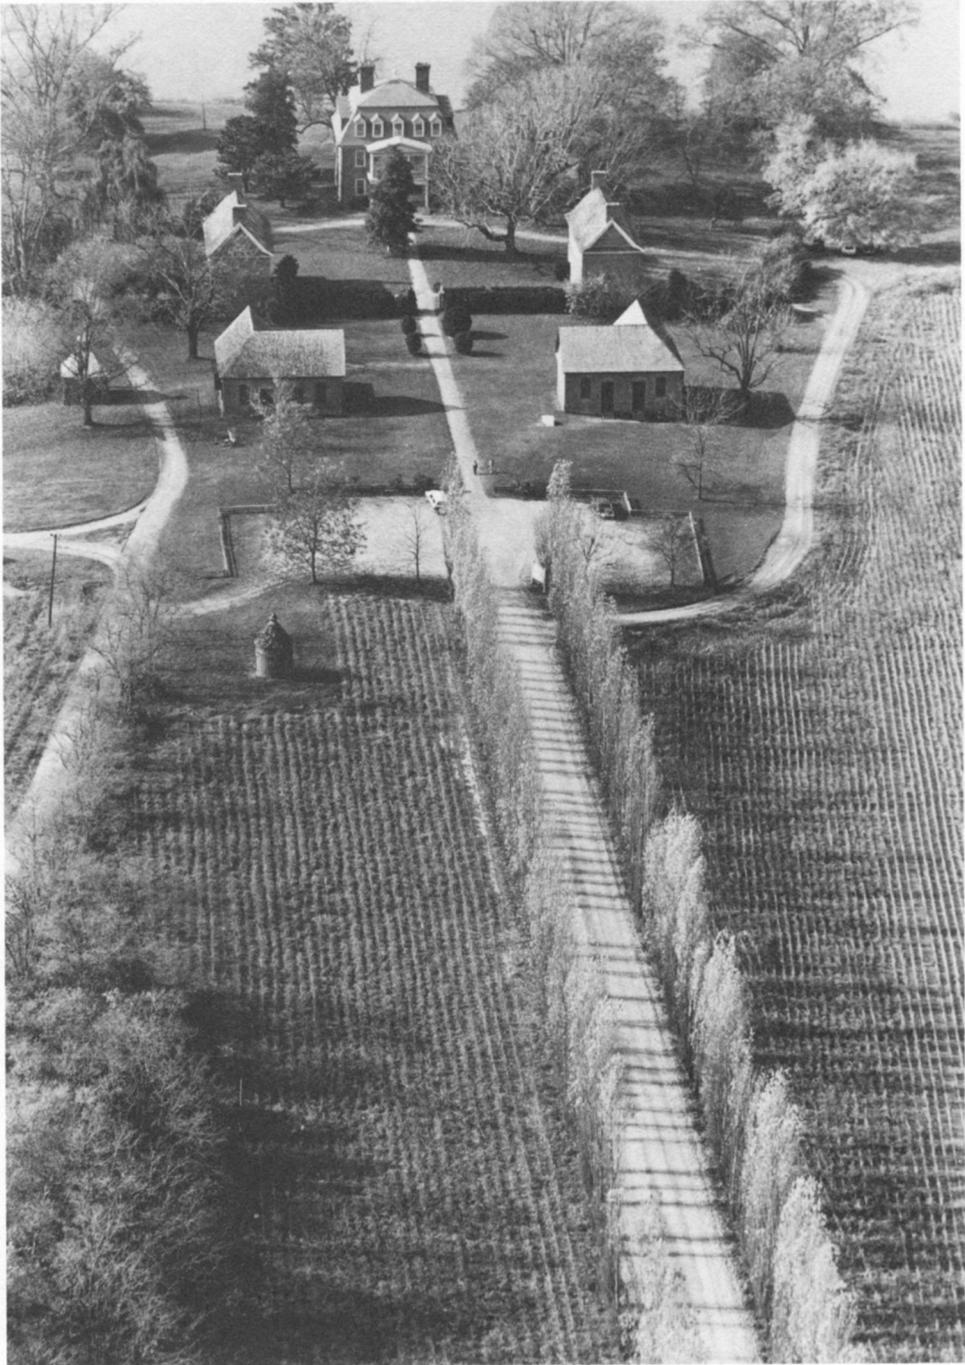
Aerial view of Shirley plantation showing the mansion and forecourt buildings (facing west)

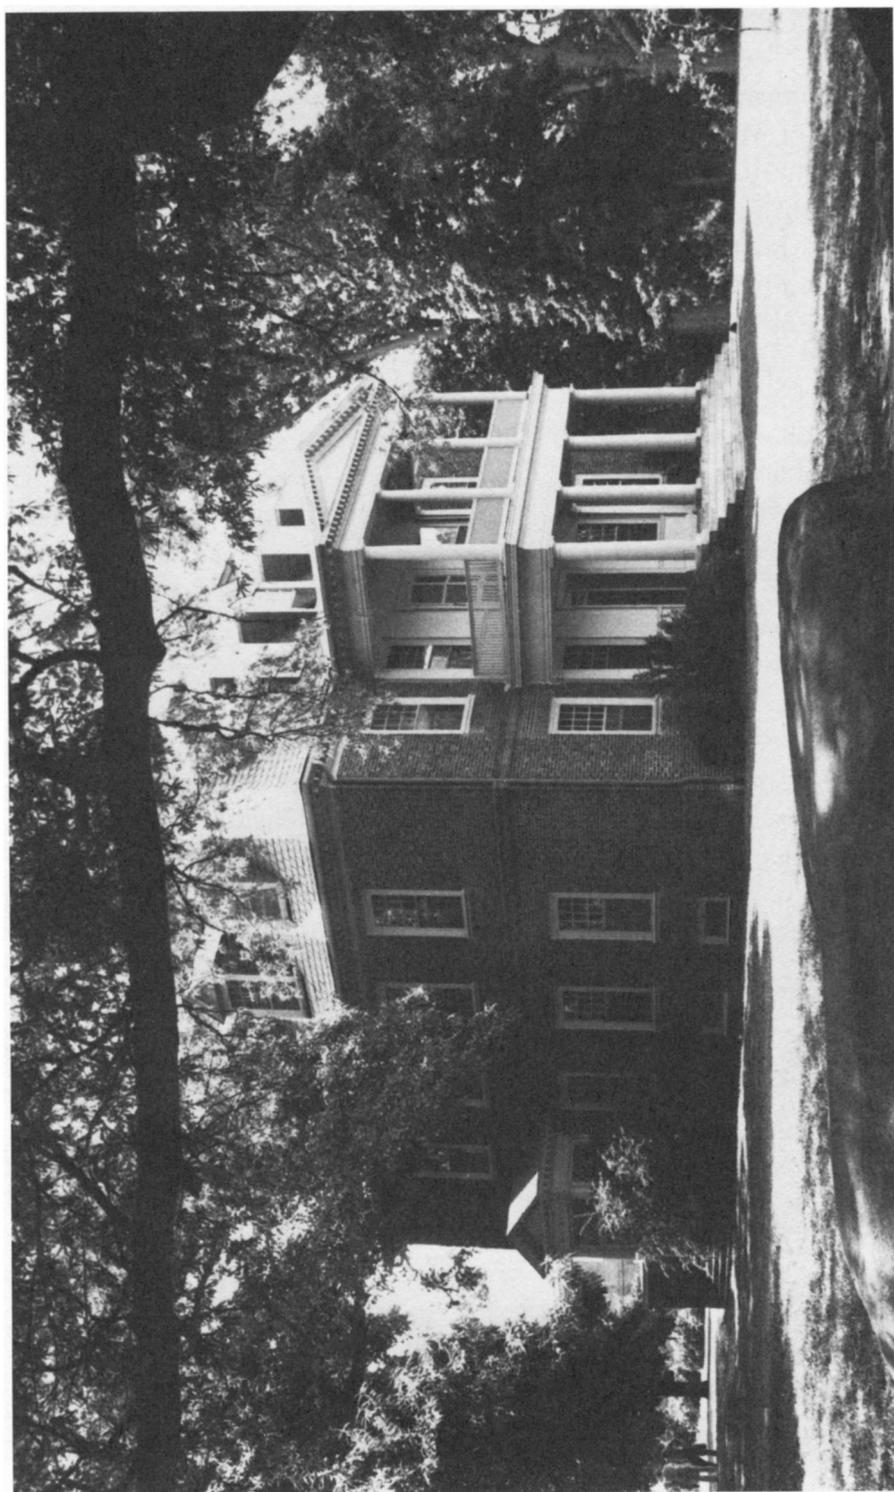
West facade of the Shirley mansion (facing south)

The three-story mansion measures forty-eight feet five inches by forty-eight feet eight inches (above the water table) and is five bays long (north-south) and four bays deep (east-west), with a mansard roof terminated by a pineapple finial. At the break of the roof slopes are two tall interior chimneys with molded brick caps. The exterior walls are brick, laid in English bond below grade and Flemish bond, with scattered glaze headers, above. The water table marks the division between the full basement and the first floor. It is finished off by a row of quarter round ovolo headers. A five-member belt course of ovolos, inverted coves, plain gauged brick, and cyma reversa bricks marks the second floor; the roofline has a deep denticulated cornice. The windows are over large: Those of the first and second story are twelve lights (panes) over twelve. The mansard roof is pierced by closely packed pedimented dormers on all four sides. The east and west facades are dominated by two-story, three-bay-wide pedimented porticoes that mark the central axis.

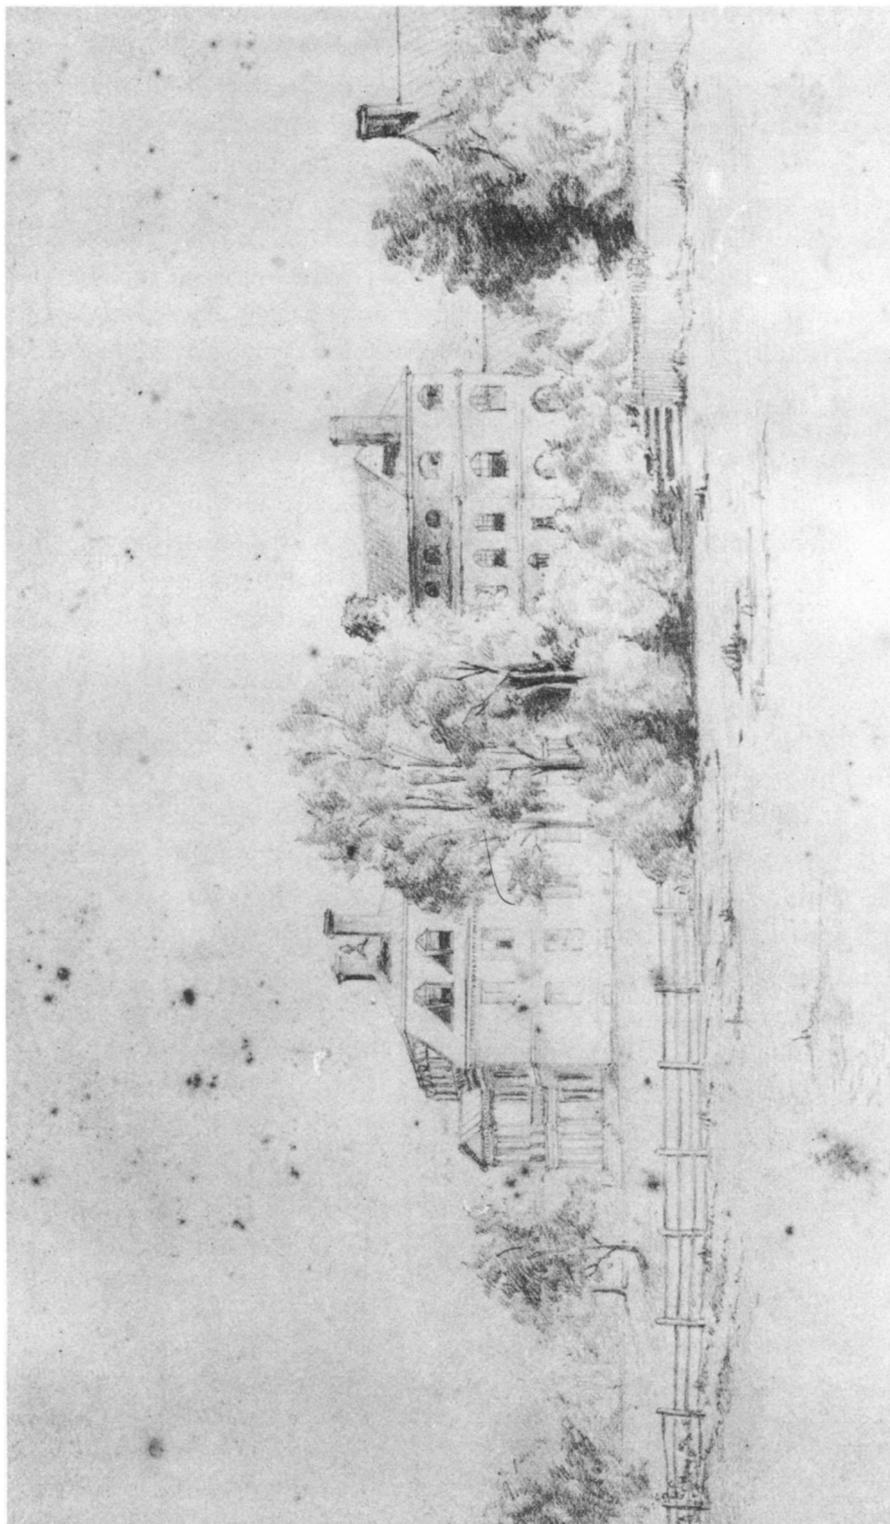
Courtesy of the College of William and Mary
Drawing of the Shirley mansion and south flanking dependency by Frederick E. Church (1851)

The mansion's two flanking dependencies presumably were nearly identical in appearance and were constructed at the same time. Archaeological evidence in conjunction with the 1851 drawing by Frederick Church allows a reconstruction of their original appearance. The excavated foundations reveal the remains of two brick structures, sixty feet long by twenty-four feet wide, with the long axes parallel to the east facade of the mansion. Each building had a full basement with two crosswalls and end chimney supports, delineating a basic hall-passage-parlor plan. The basement rooms closest to the mansion in each building were covered by full-width barrel

Like the mansion, these structures were laid in English bond below grade and Flemish bond above. As can be seen from the Church drawing, the south dependency and, by inference, also the north were two-and-one-half-story buildings with end chimneys and hipped roofs. Ceramic roofing tiles, similar to those originally used on the mansion, apparently covered the roofs, as these tiles were found in the fill of both basements and are suggested by the drawing. Large molded portland sandstone blocks found in the destruction level of the north dependency have been identified as chimney caps.³³ Waterman describes similar blocks as having been present in the loose architectural debris which marked the site of the south dependency when he visited Shirley.³⁴

From the drawing these flanking buildings appear to have been five bays long and two bays wide. The windows seem to resemble those on the standing kitchen and laundry with flat arches and segmental soffits. Rubbed bricks, possibly from these segmental window soffits, were found in the destruction layers of both structures. The windows also may have had sandstone sills, as such fragments were found at the north dependency excavations. It has not been possible to determine whether the doors had flat or segmental arches or were surrounded by molded brick elements as on the mansion. The remains of portland sandstone blocks, which may represent molded pilaster bases, were found at both sites. In addition, fragments of molded sandstone steps, similar to those found in the depression deposits, suggest that the flanking dependencies had these at least on their front or river facade. The remains of less elaborate limestone steps, similar to those on the present kitchen, were found in the destruction layer of the north dependency and might have been used on the rear or land facade.

Two string courses are seen in the Church drawing dividing the floors. Cyma reversa and plain gauged stretchers and ovolo headers were all found

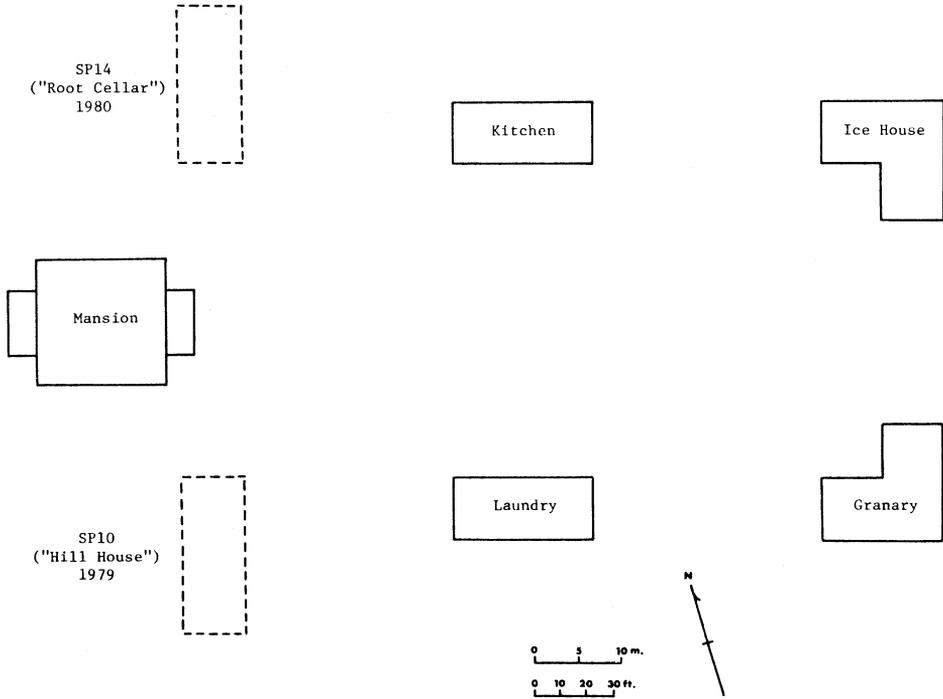
Scale plan of the Shirley mansion, flanking dependencies, and forecourt buildings. The flanking dependencies are defined by dashed lines and labeled with their archaeological designations and the year of excavation.

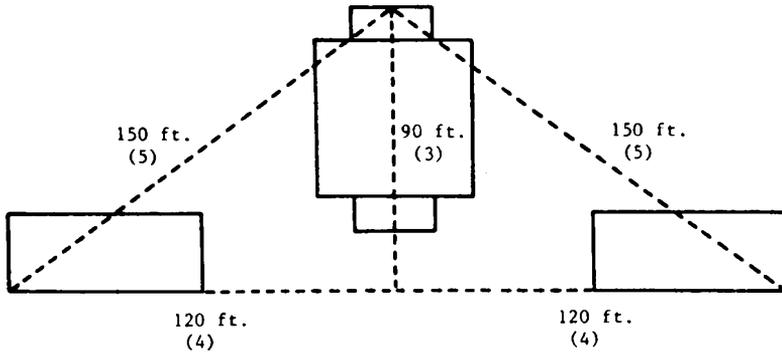
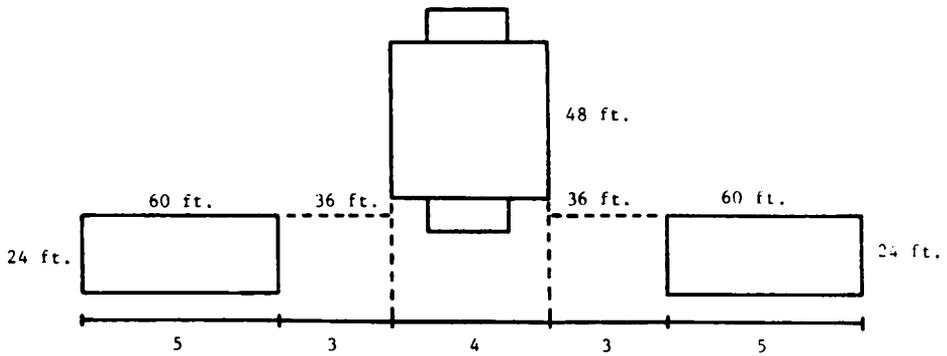
Building dimensions and interspatial distances of the Shirley mansion and flanking dependencies showing their classical arrangement

The dimensions of the mansion (forty-eight by forty-eight feet) and the flanking dependencies (sixty by twenty-four feet) are all based on multiples of twelve feet. The distance between the buildings is thirty-six feet, also a multiple of twelve. An examination of the ratio of building to interspatial distances reveals the proportions of 5:3:4:3:5 or A:B:C:B:A. Moreover, if a line is drawn through the central axis of the mansion from the end of the porch on the west facade ninety feet to a point bisecting a 240-foot line drawn along the east facades of the flanking dependencies, it forms the common side of two mirror-image right triangles, based on a thirty-foot unit. These rigid and rhythmic proportions were inspired by the classical architectural principles of the Renaissance and indicate a high degree of sophistication in both the design and the execution of the plan of these three buildings. As discussed below, the forecourt, although well balanced and symmetrically arranged, does not follow through with the precise plan established for the mansion and its flanking dependencies. This suggests that these three buildings formed the original core of the plantation, with the forecourt being a later addition. If this was the case, the flanking dependencies probably functioned as the original kitchen and office, later being converted to chambers when the forecourt was built.

With the new evidence, a reexamination of building dimensions and spatial distances reveals a sophisticated arrangement in classical proportions of the mansion and its flanking dependencies. This arrangement indicates that they were conceived and built as a unified whole by John Carter and that they formed the original core of the building complex at Shirley. Because the forecourt, although well planned and symmetrically arranged, does not tie into the arrangement, this gives weight to the argument that the forecourt was a later addition, most probably constructed under the direction of Charles Carter.

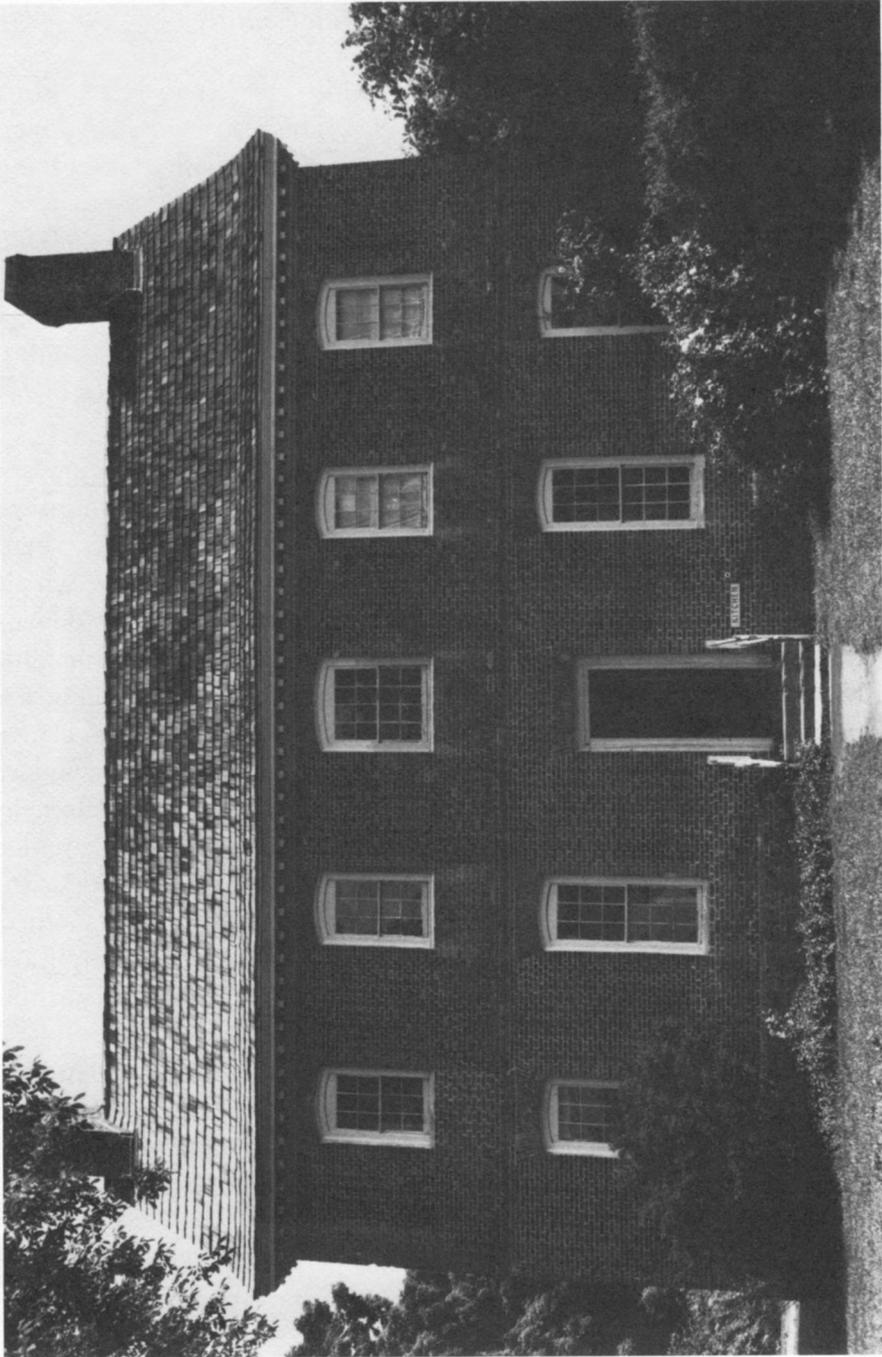
Courtesy of the College of William and Mary
South facade of the Shirley kitchen (facing north)

The two rectangular buildings at the west end of the forecourt are approximately seventy-nine feet east of the flanking dependencies and measure fifty-two feet seven inches long by twenty-three feet two inches deep. These dimensions and interspatial distances are very different from those which form the classic rhythmic proportions of the mansion and flanking dependencies. The buildings are five bays across the facades, two stories in height, and without basements. The first floor windows are nine lights over nine, while those on the second floor are six lights over six, except for the center window which is eight over eight. This placement of a broader window over the doorway also is found on Rosewell and the Governor's Palace in Williamsburg. The buildings were constructed on a basic hall-passage-parlor plan with end chimneys, similar to the plan of the flanking dependencies. The roofs, which are terminated by a sudden splay at the eaves, are pitched with gables decorated by sophisticated moldings and dentils. In overall appearance, these buildings bear strong resemblances to both Berkeley and the Nelson House in Yorktown.⁴⁰

The buildings are known today as the kitchen (north) and the laundry (south). In the case of the kitchen, the name undoubtedly reflects its eighteenth-century function. However, the laundry probably originally functioned as the plantation office, being converted into a laundry in the nineteenth century.

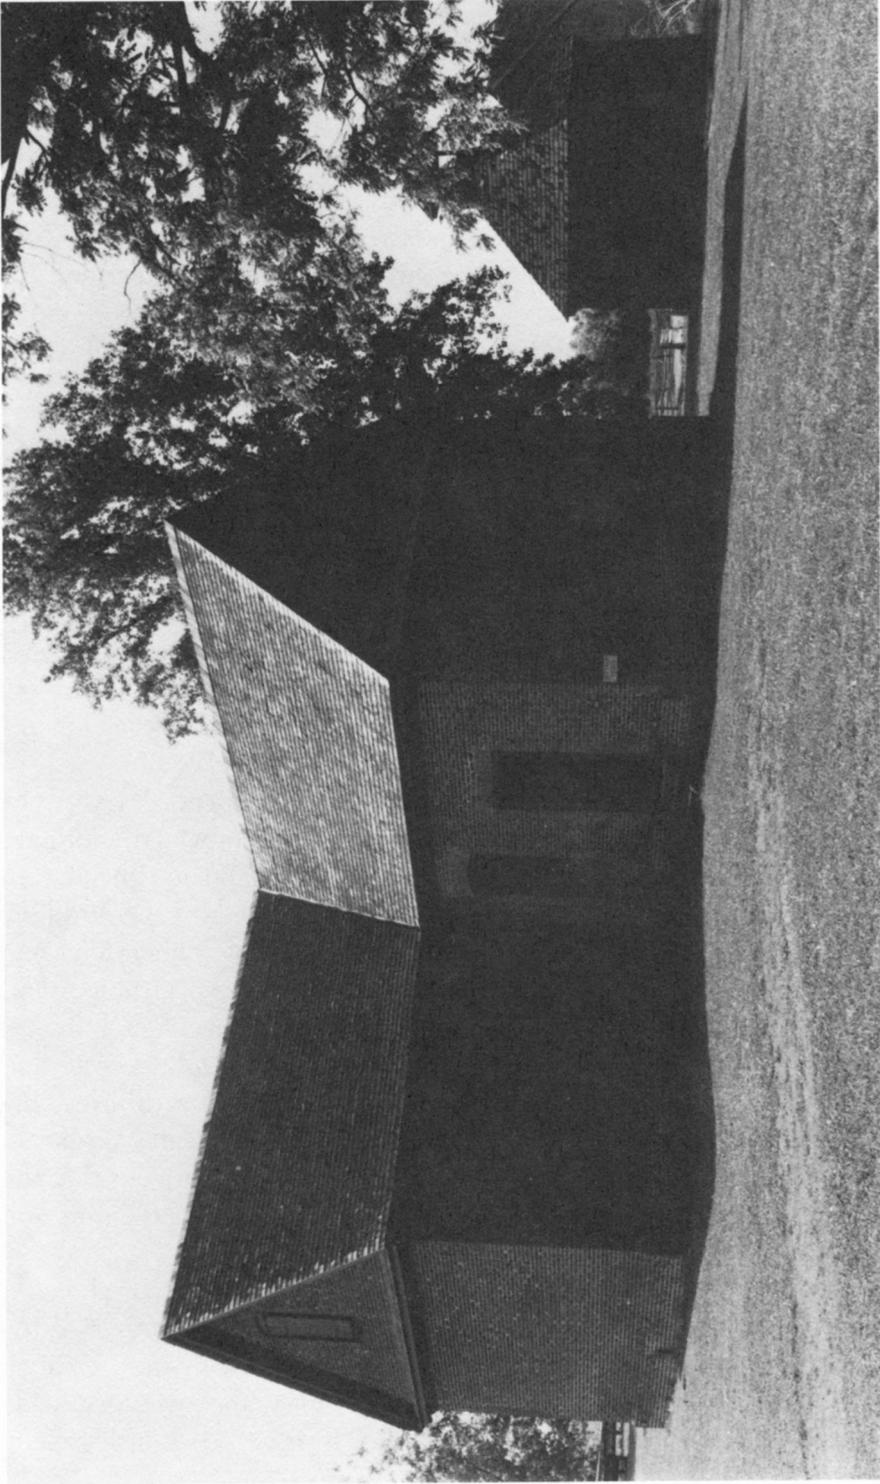
Courtesy of the College of William and Mary
North L-shaped Shirley forecourt building (facing southeast)

The two L-shaped buildings at the east end of the forecourt are forty-three feet two inches on both their long sides and have pedimented gables

on both ends. These buildings have no fireplaces and were apparently intended for use as storehouses or granaries. The north structure is built over an icehouse.
